Culvert Repair Programmatic Agreement 2020 Annual Report

**Oregon Department of Fish and Wildlife | Oregon Department of Transportation
January 2022**

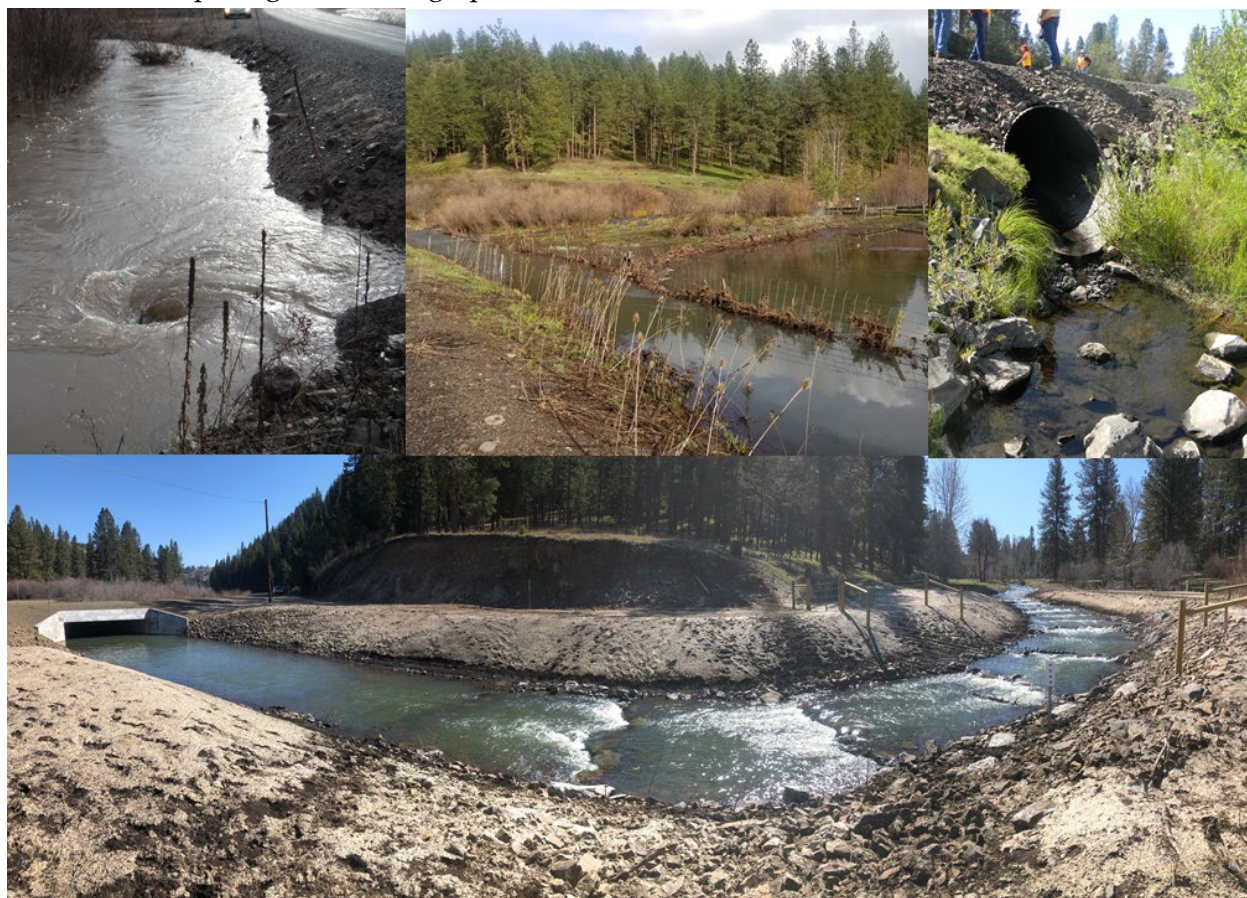
Figure 3: Whiskey Creek Culvert Replacement Project, Before and After

The Whiskey Creek culvert replacement project, Figure 3, completed by the ODOT Fish Passage Program, is one example of ODOT's commitment to improving fish passage and supporting the Oregon Plan for Salmon and Watersheds. The project replaced an undersized 5-foot diameter corrugated metal culvert with a 22-foot-wide concrete box culvert. The Whiskey Creek fish passage project opened over 15 miles of high-quality spawning and rearing habitat for ESA-listed Mid-Columbia summer steelhead, redband trout, and lamprey species at a cost of \$1.9 million. The original culvert was undersized for the stream channel, causing localized flooding and channel scour.

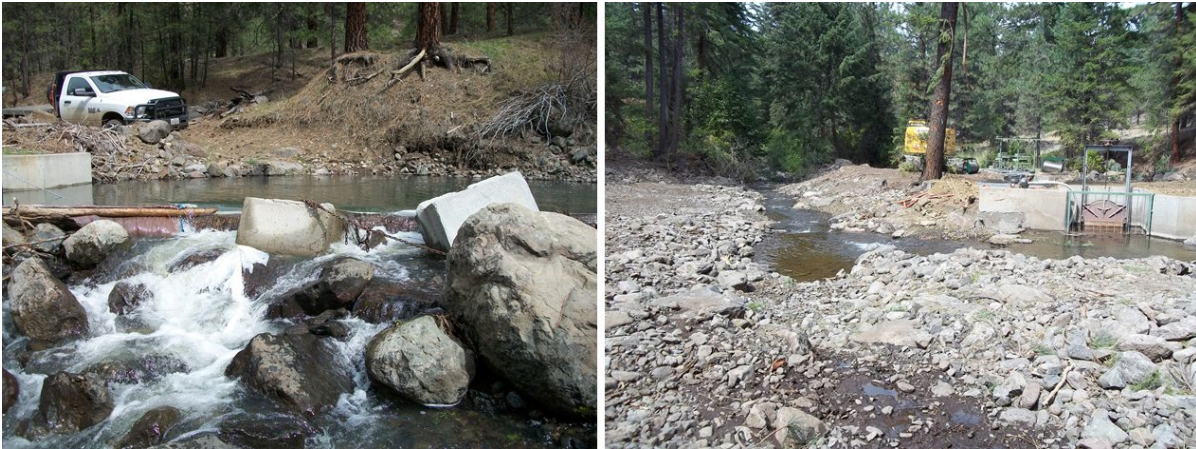
Figure 14: Rudio Creek Project Before and After

A solicitation process for Compensation Projects was not conducted in 2020, however, three projects selected for funding in 2019 were completed in 2020. NMF benefitting from these projects included steelhead and redband trout in Rudio Creek (Figure 14); Warner sucker and redband trout in Deep Creek (Figure 15); and coho, Chinook, steelhead, and cutthroat trout in Salt Creek (Figure 16). The implementation of additional projects was expected in 2020, however, unforeseen difficulties associated with COVID-19 resulted in project delays and grant agreements were extended for several projects. Access to 22.3 miles of habitat was improved through the Compensation Projects completed in 2020, for a total of 475.1 miles and 3000 acres since the first solicitation in 2015.
