Culvert Repair Programmatic Agreement 2022 Annual Report

**Oregon Department of Fish and Wildlife | Oregon Department of Transportation
April 2023**

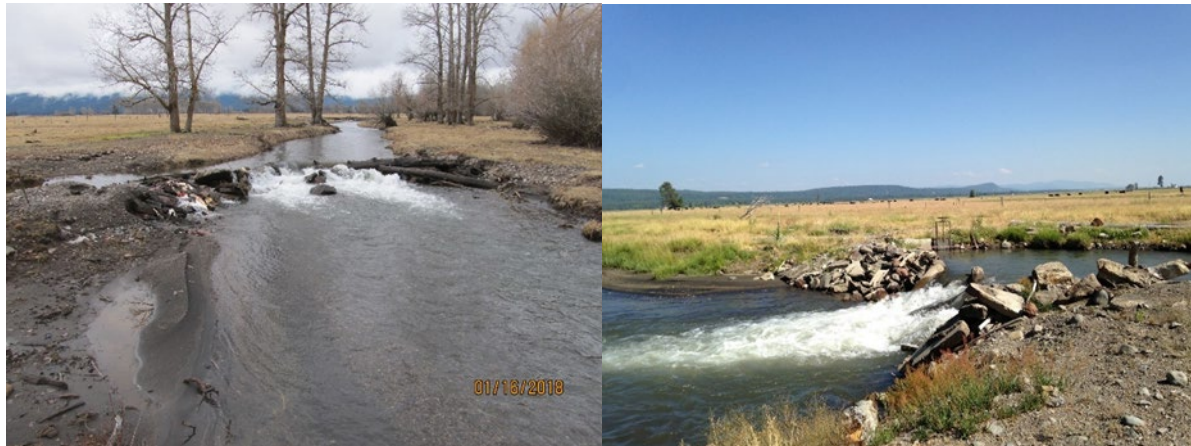
Figure 9: Annie Creek Irrigation Diversion Project Before and After Photos

This project provided volitional fish passage at two irrigation diversion pushup dams on Annie Creek, a tributary to the Wood River in the Upper Klamath Basin. Both barriers were removed and a roughened riffle was constructed to provide volitional fish passage. Both diversions were combined and a new criteria fish screen was installed to prevent the entrainment of juvenile fish. Removing these barriers allows upstream and downstream volitional passage in the lower five miles of Annie Creek.
