# Culvert Repair Programmatic Agreement 2018 Annual Report

Oregon Department of Fish and Wildlife | Oregon Department of Transportation  
January 2021

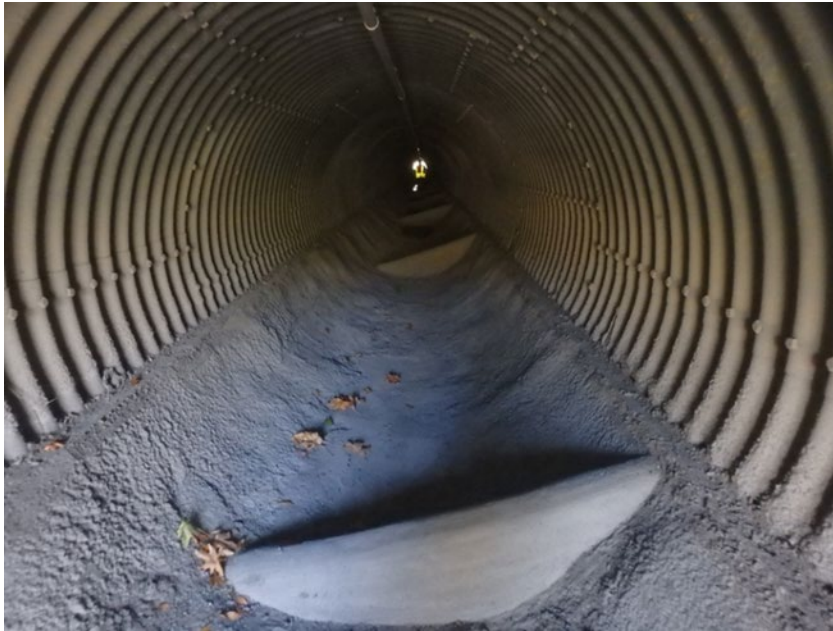
Figure 13: Invert Pave Example

outlet or tapering the concrete repair as the concrete is placed in the outlet section are two suggestions.
