**EPOXY COATED  
REINFORCEMENT STUDY**

**Final Report**

**STATE RESEARCH PROJECT #527**

June 1999

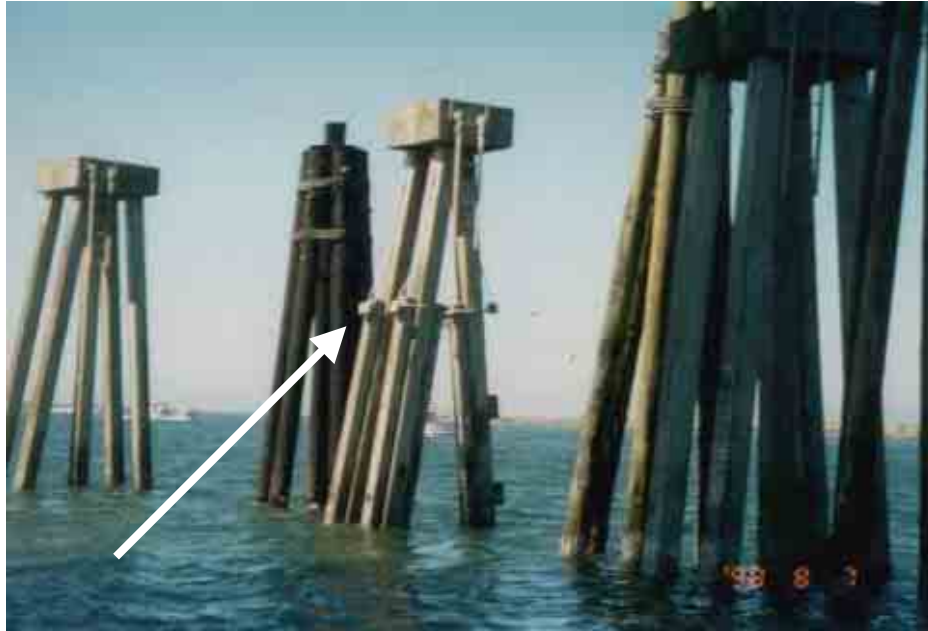
Figure 1.3: Concrete Beams Attached to the Dolphin in the Middle of the Picture

As seen in Figure 1.3, there are junction boxes at the top of each of the beams. The beams were pre-wired for taking half-cell potential measurements. The beam dimensions are 200 mm x 200 mm x 6.1 m. They were attached to the dolphin at a location where part of the beam was always in the water, another section was always exposed to the air and the middle section was in the tidal zone between the low and high tide levels of Yaquina Bay.

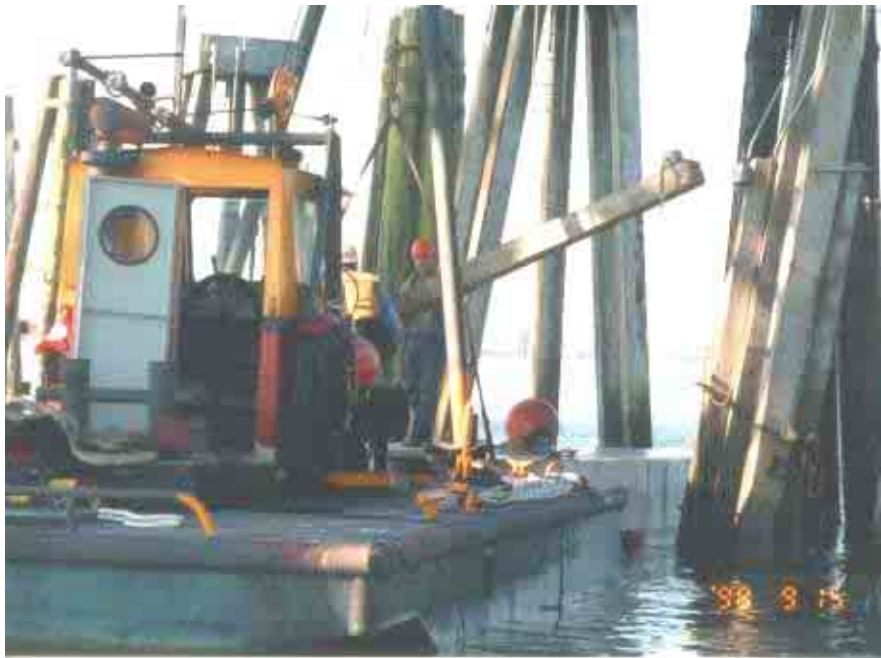
Figure 4.1: The Test Beam being Lifted onto the Barge.

In September 1998, a second test beam was removed from Yaquina Bay. This time, the beam was removed and offloaded directly onto a barge (Figure 4.1) where it was transferred to shore. The beam was wrapped in soaked burlap and plastic and transported by truck to the ODOT Materials Laboratory in Salem, Oregon.

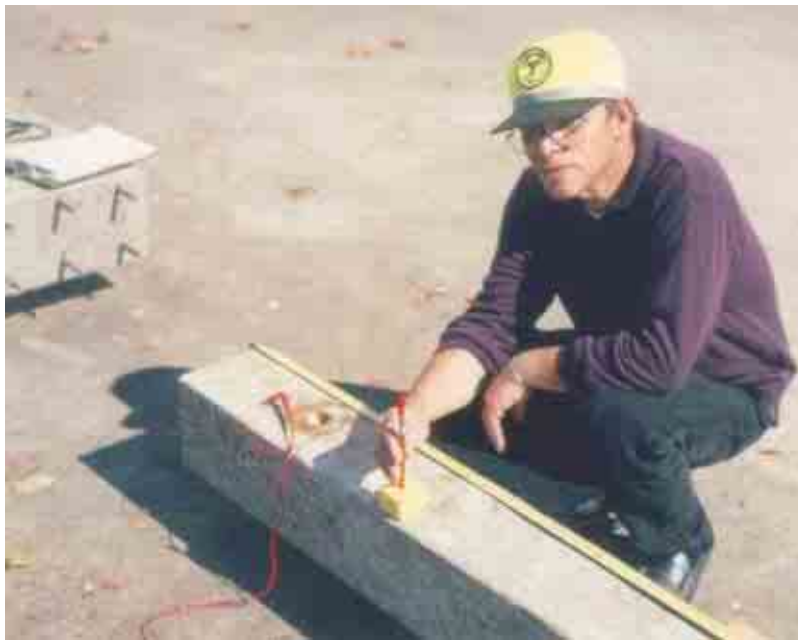
Figure 4.6: Half-Cell Potential Measurements Using Copper-Copper Sulfate Electrode

After the crack locations were recorded, half-cell potential measurements were taken. The beam had been cast with built in junction boxes and electrical connections to the reinforcing steel to facilitate the half-cell testing. The testing was done for each exposed face of the beam from the bottom to the top at approximately 150 mm intervals (Figure 4.6). The north face was not considered since this face abutted the concrete dolphin in Yaquina Bay. The half-cell measurements were made using a battery operated voltmeter and a copper-copper sulfate reference electrode.

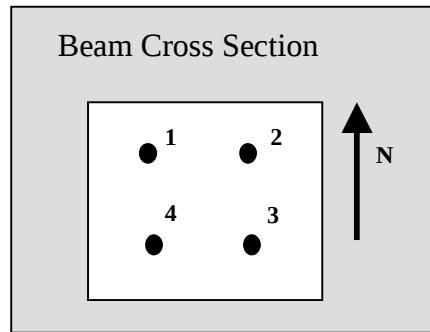
Figure 4.7: Cross Section of the Test Beam Relative to the Top End of the Beam

For reference, Figure 4.7 shows the cross section of the beam and the rebar numbering layout for the rebar relative to the top end of the beam.
