BR#08492---YAMHILL OVERFLOW --- HWY 39 (OR18) --- MP 45.76

OSU  
OREGON STATE UNIVERSITY  
CIVIL AND CONSTRUCTION ENGINEERING

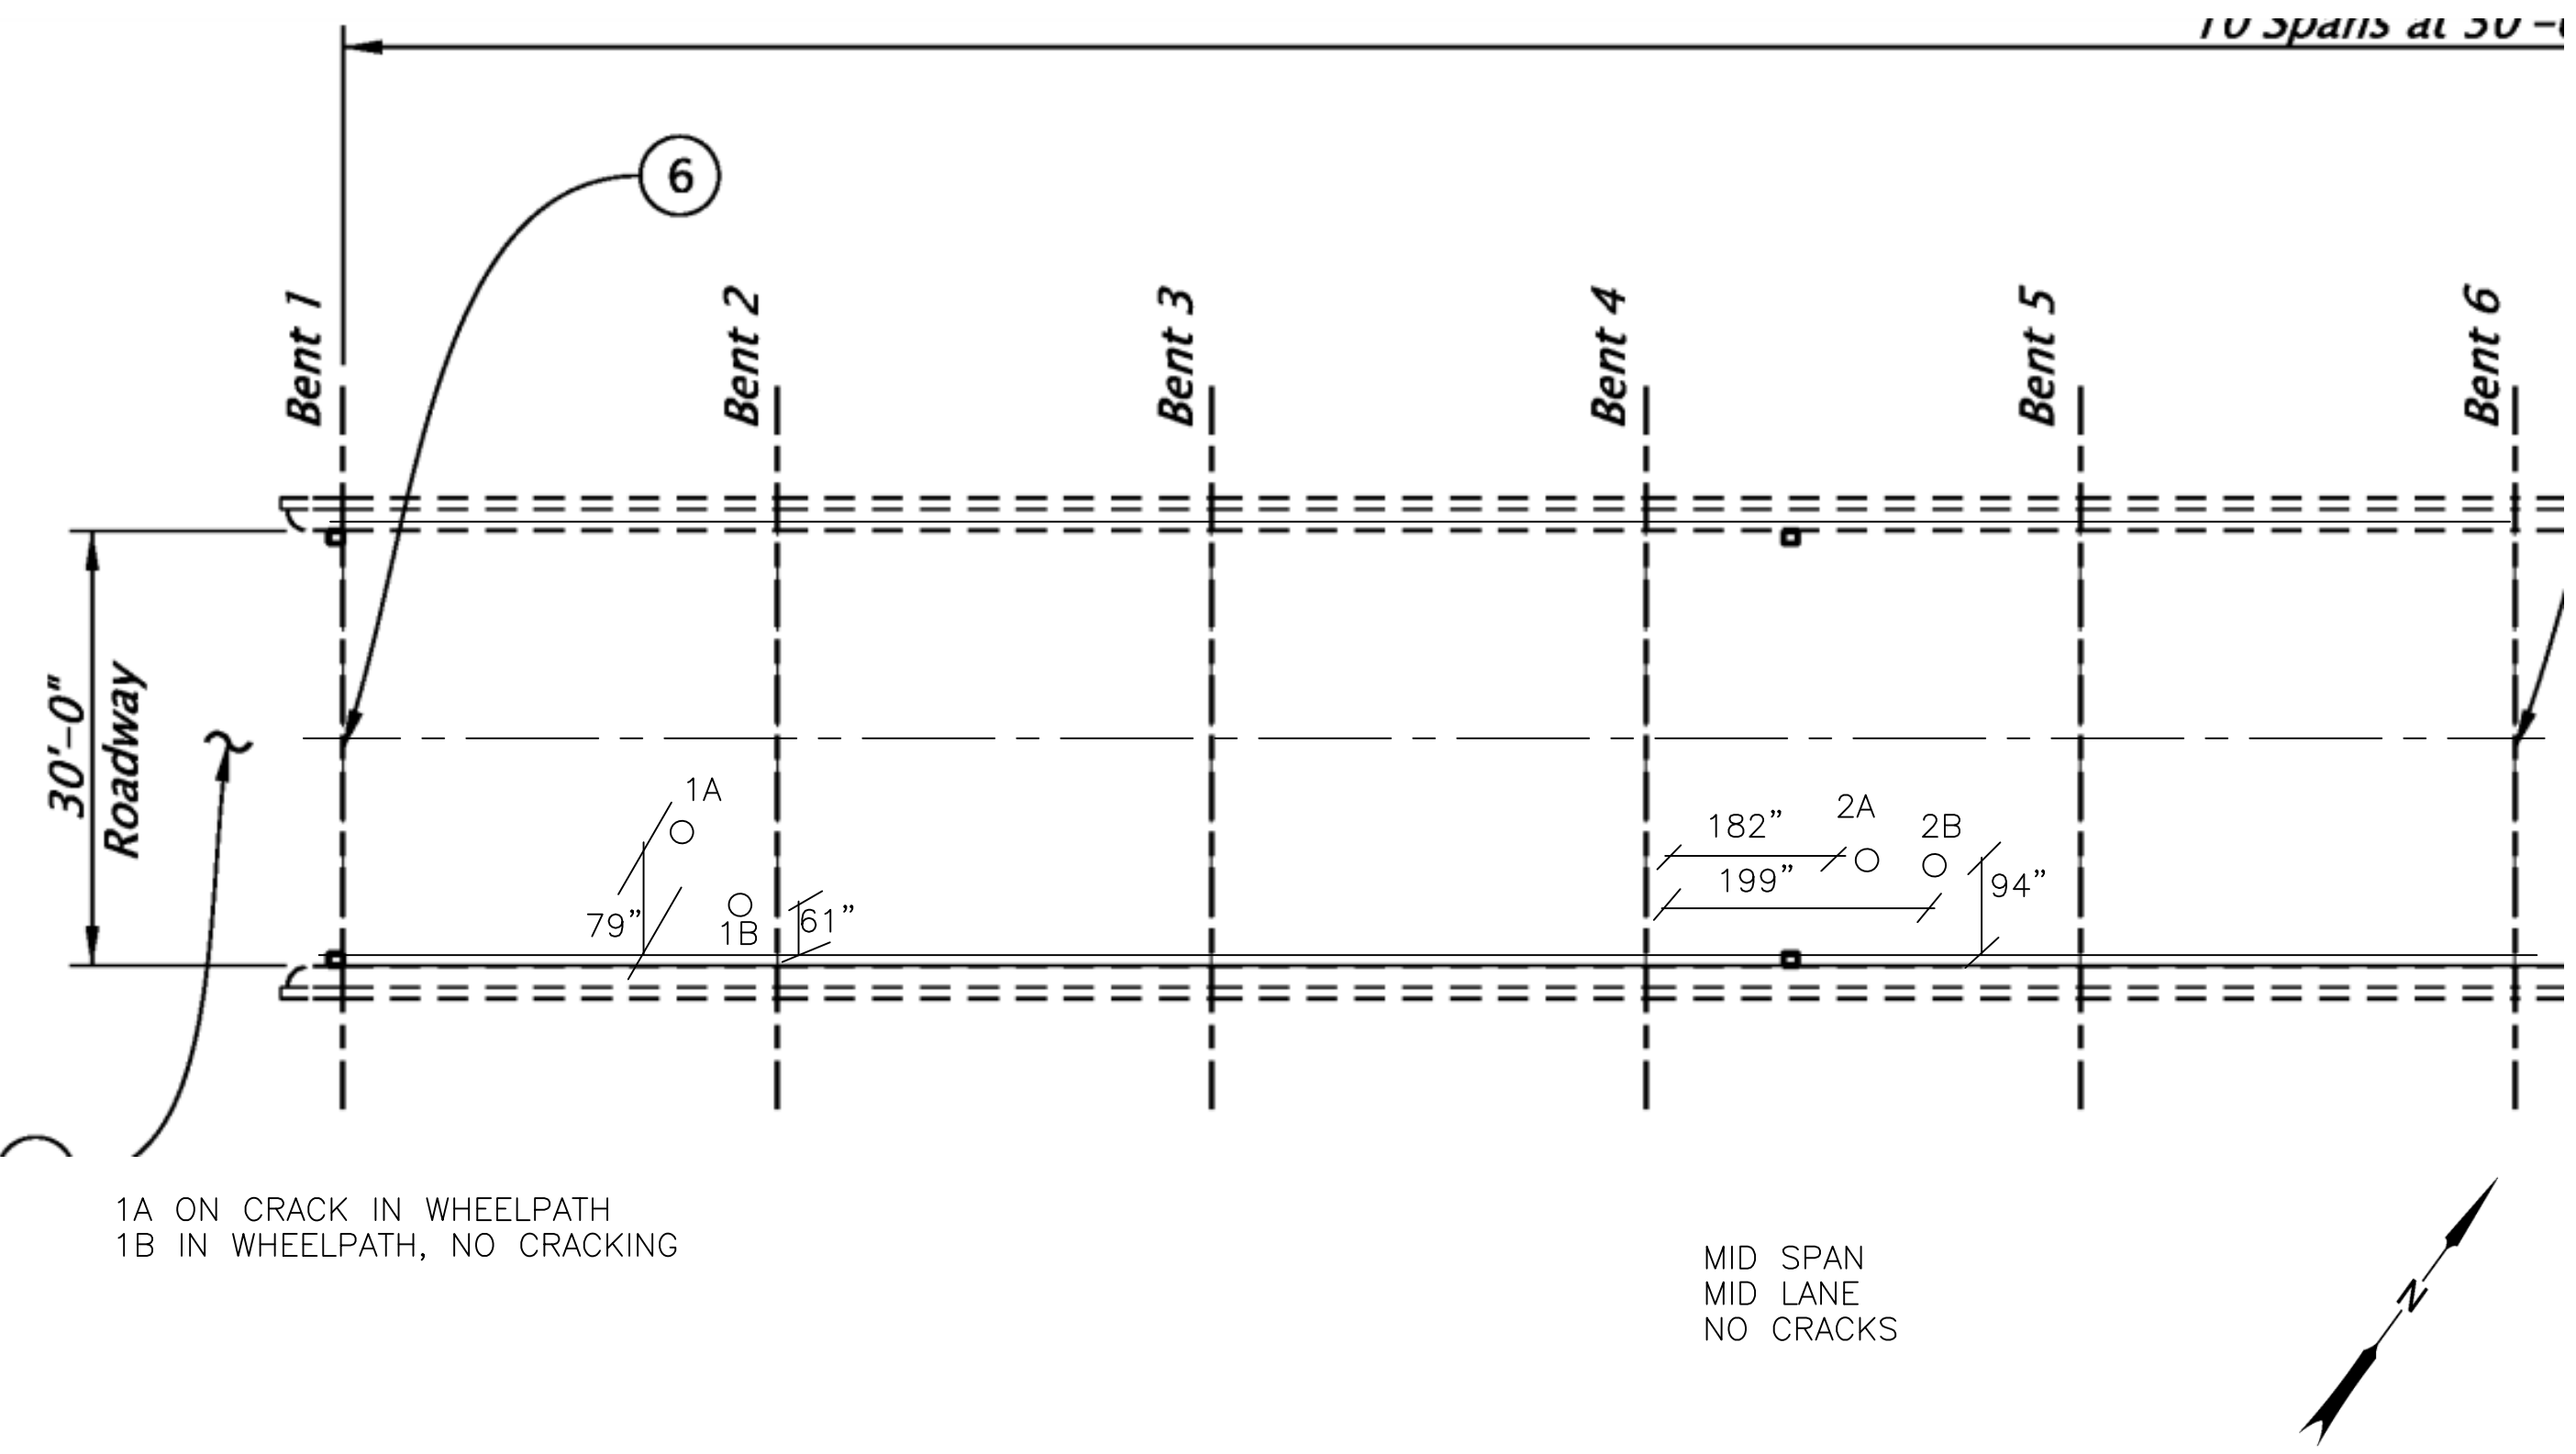
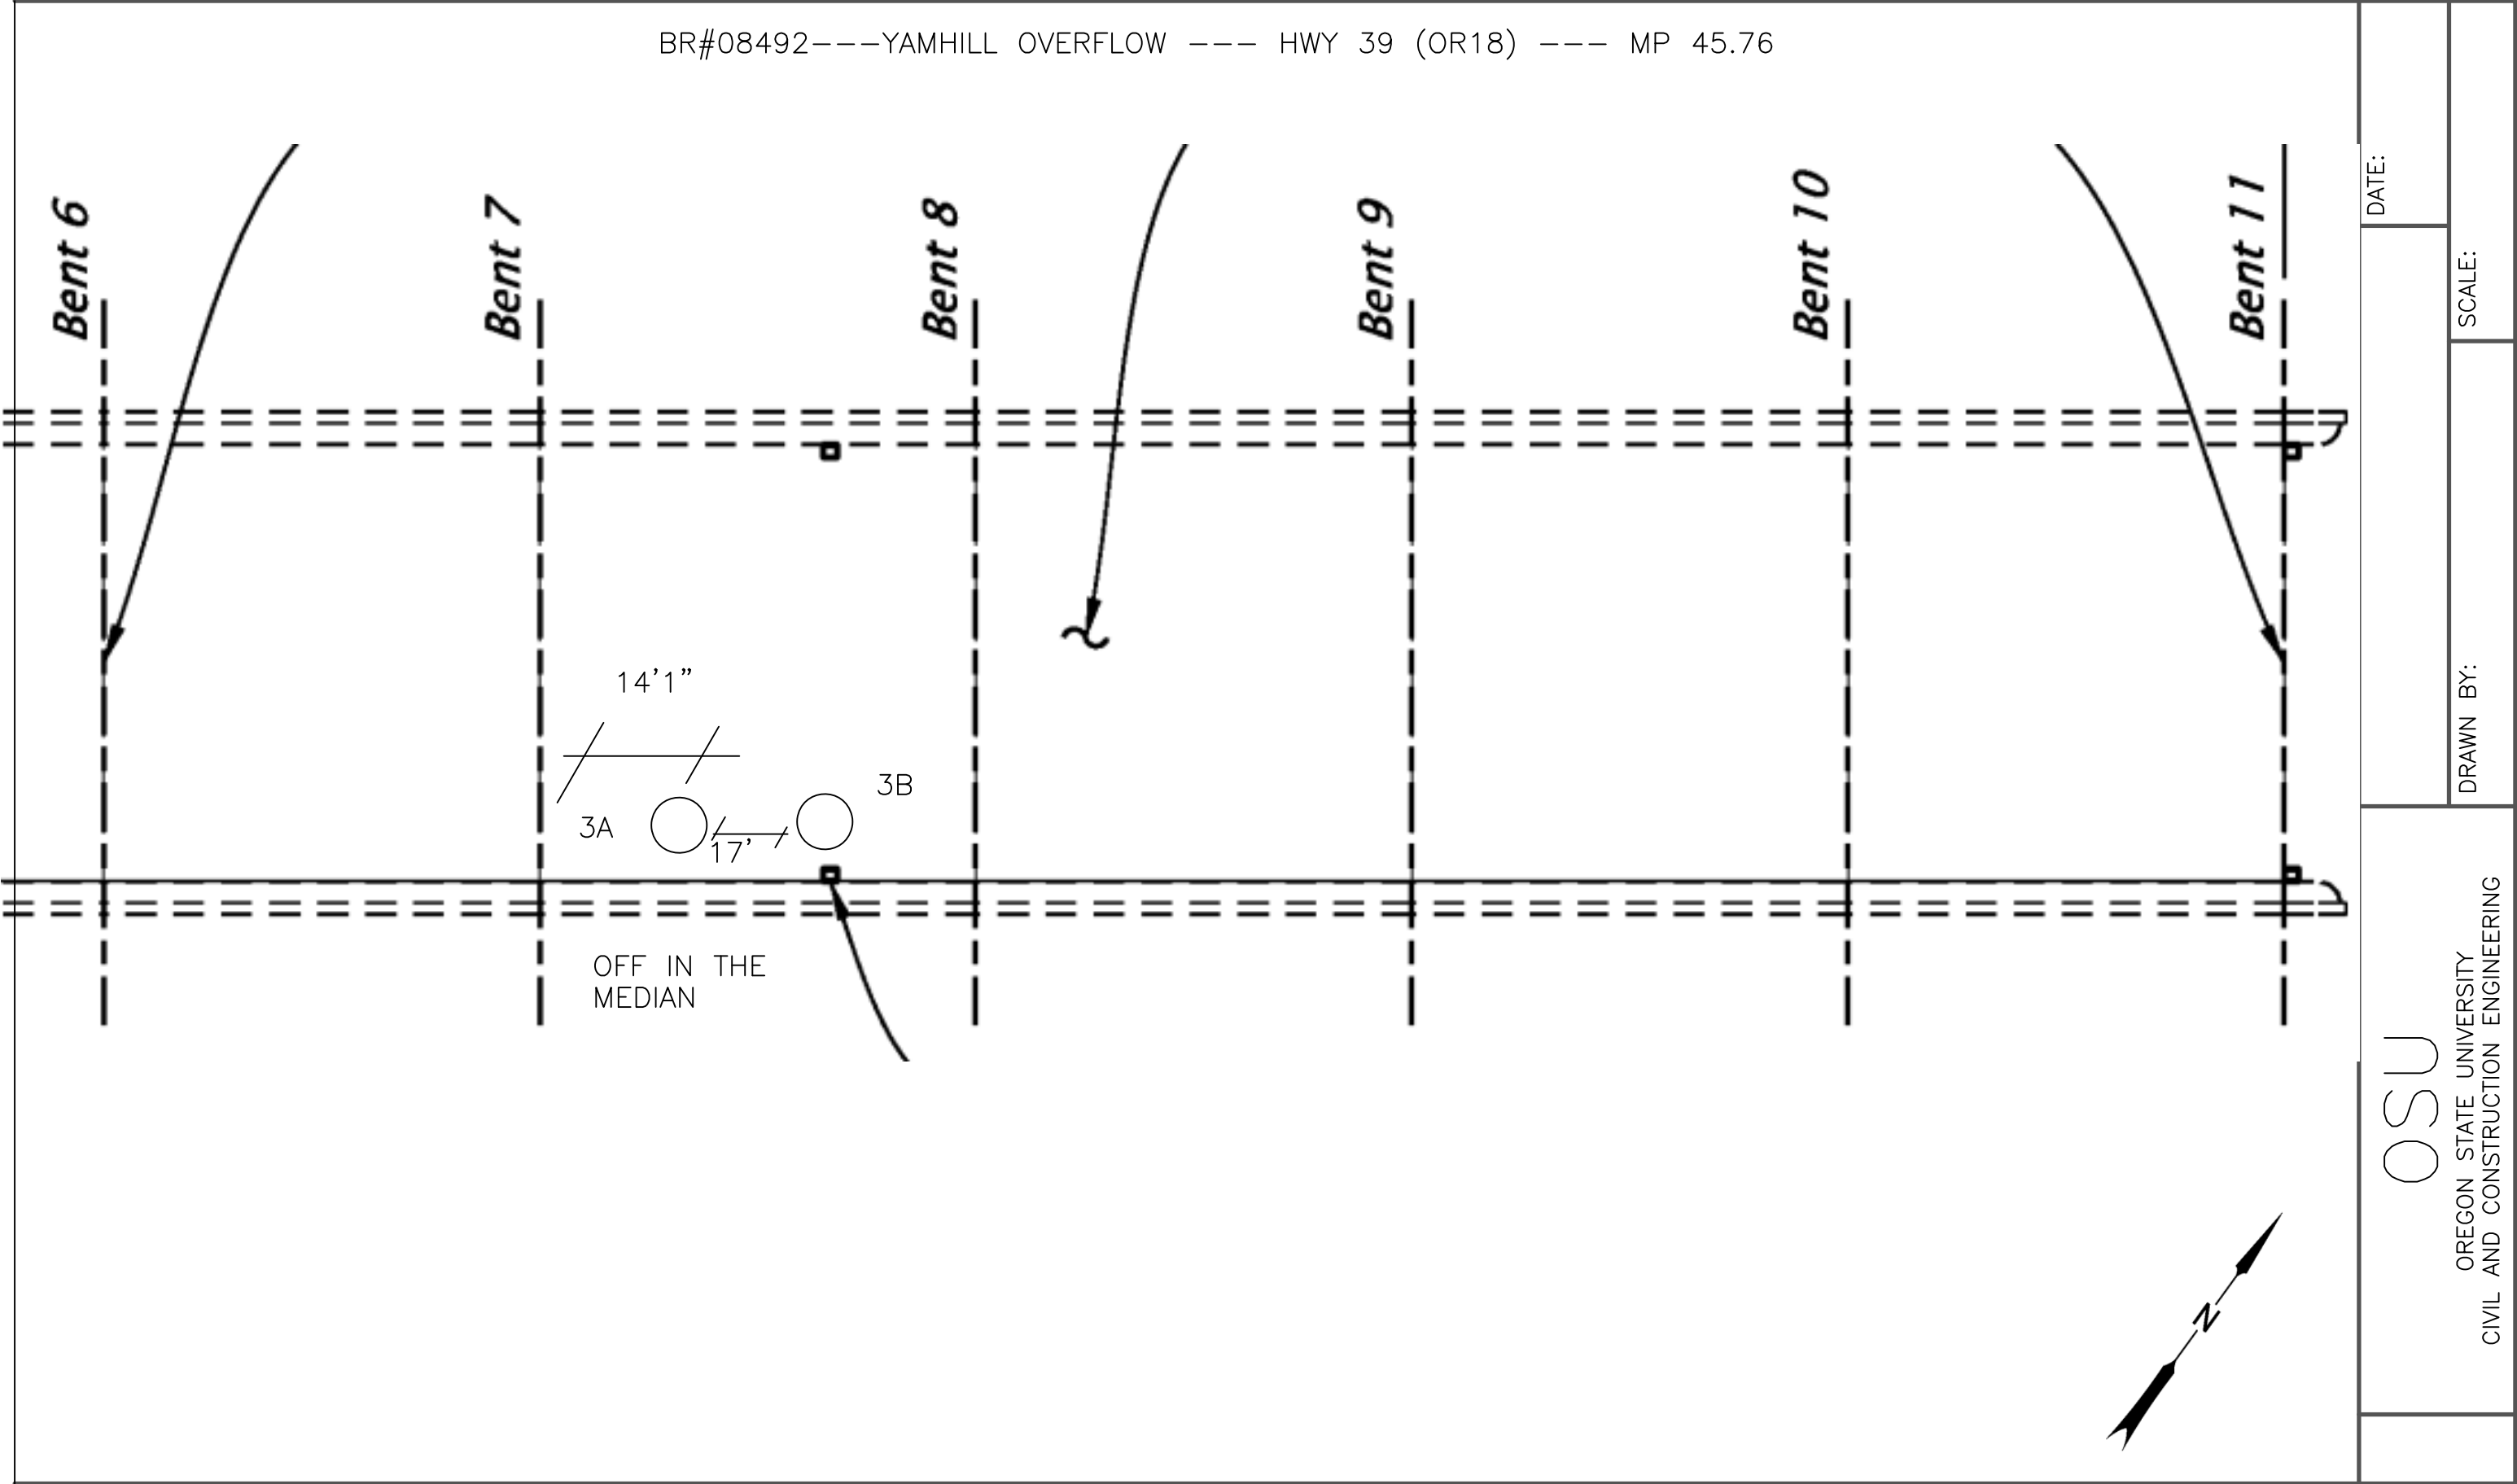
CORES LABELED

1A- THROUGH CRACK OVER BENT 2  
1B- ADJACENT TO CRACK

SOUND  
CONCRETE (NO CRACKS)  
CENTER OF TRAVEL LANE
