# **FACTORS FOR IMPROVED FISH PASSAGE WATERWAY CONSTRUCTION**

**Final Report**

**SPR 654  
OTREC-RR-11-19**

**ODOT/OTREC**

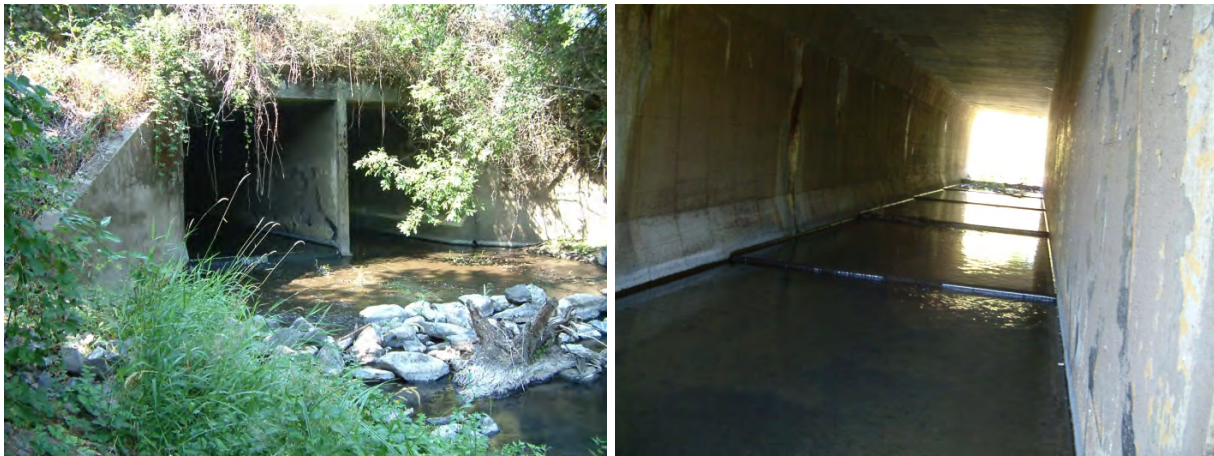
Figure 4.6: Site 04 – Oak Creek downstream and structure

Oak Creek was conveniently located within the city of Corvallis in Benton County, and it crosses Highway 20 at MP 55.16. Access to the creek is not very obvious, since the upstream side is steep, while the downstream side is covered by blackberry bushes. The upstream side has an accumulation of silt and was very deep. It was very difficult to measure depth and cross-sections upstream with the available field equipment. The structure consists of two rectangular culverts, one with baffles. Cross-sections could not be measured at the downstream side due to vegetation. Photos of the Oak Creek site are shown in Figure 4.6.

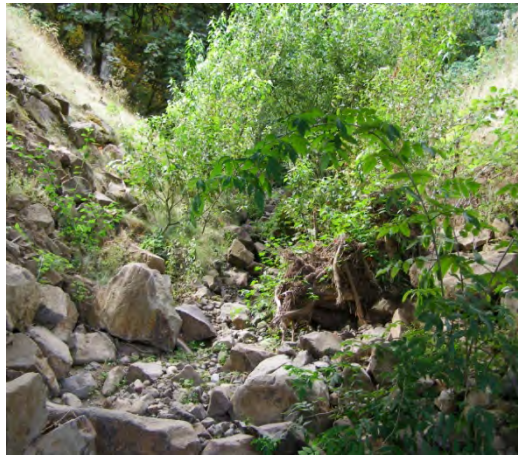
Figure 4.17: Site 15 - Miller Creek upstream

Miller Creek is located in Multnomah County, and crosses Highway 30 at MP 10. It consists of a channel reconstruction and was the second site visited by the investigating team. Access to the river bed was from upstream of the creek and was very steep (Figure 4.17). Measurements were taken for slope and cross-sections. The creek had very few fines, and all the flow was subsurface.
