# *Oregon Highway Bridge Maintenance*

## *A Pilot Training Course /Workshop*

# Bridge Scour

Doug McLain  
Clackamas County

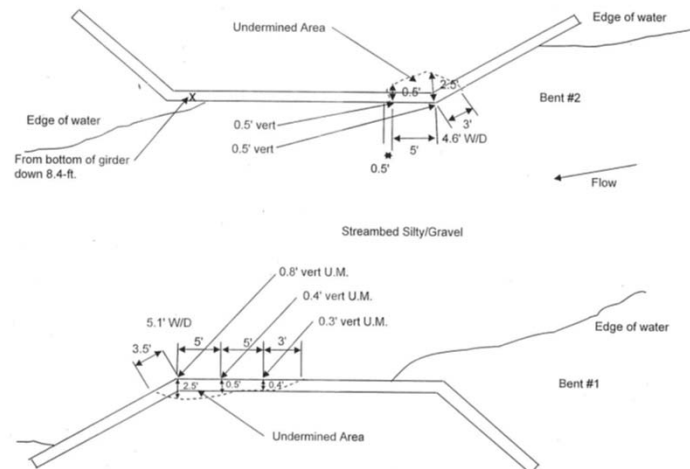
# Meadowbrook Bridge Over Milk Creek

Undermining found 2006

UNDERWATER INSPECTION REPORT					
BRIDGE NAME:	Milk Creek Beaver Creek Road	REGION:		BRIDGE NUMBER:	06198
RIVER NAME:	Milk Creek	OWNER:	County	DISTRICT:	2C
STATE HWY #:		ROUTE NUMBER:		INSPECTION DATE:	6/2/2006
COUNTY:	Clackamas	ROAD NAME:	Beaver Creek Road	MILE POINT:	0.17
FOUNDATION TYPE:		ACCESS:	3	CURRENT:	Low
DIVERS:	Shorb, James, Nelson	INS. INTERVAL:	1	VISIBILITY (Ft.):	1.5
Water Elevation:	Bent #2 from bottom of steel girder down 8.4-ft.	WATER TEMP:	55	MAXIMUM DEPTH:	5
		Constructed in:	1959

- 215 **Bent #1:** Concrete Abutment has some heavy abrasion and is in Condition State 2. The upstream end of the abutment is in the dry. The downstream corner is in 5.1-ft. of water. The downstream corner is undermined 0.8-ft. vertical and 2.5-ft. horizontal for a distance along the abutment of 16.5-ft. See sketch. The streambed consists of silty/gravel.
- 215 **Bent #2:** Concrete Abutment has some heavy abrasion and is in Condition State 2. The downstream end of the abutment is in the dry. The upstream corner is in 4.6-ft. of water. The upstream corner is undermined 0.5-ft. vertical and 2.5-ft. horizontal for a distance along the abutment of 8.5-ft. See sketch. The streambed consists of silty/gravel.

- 215 **Bent #1 & Bent #2** repair undermined abutment walls.

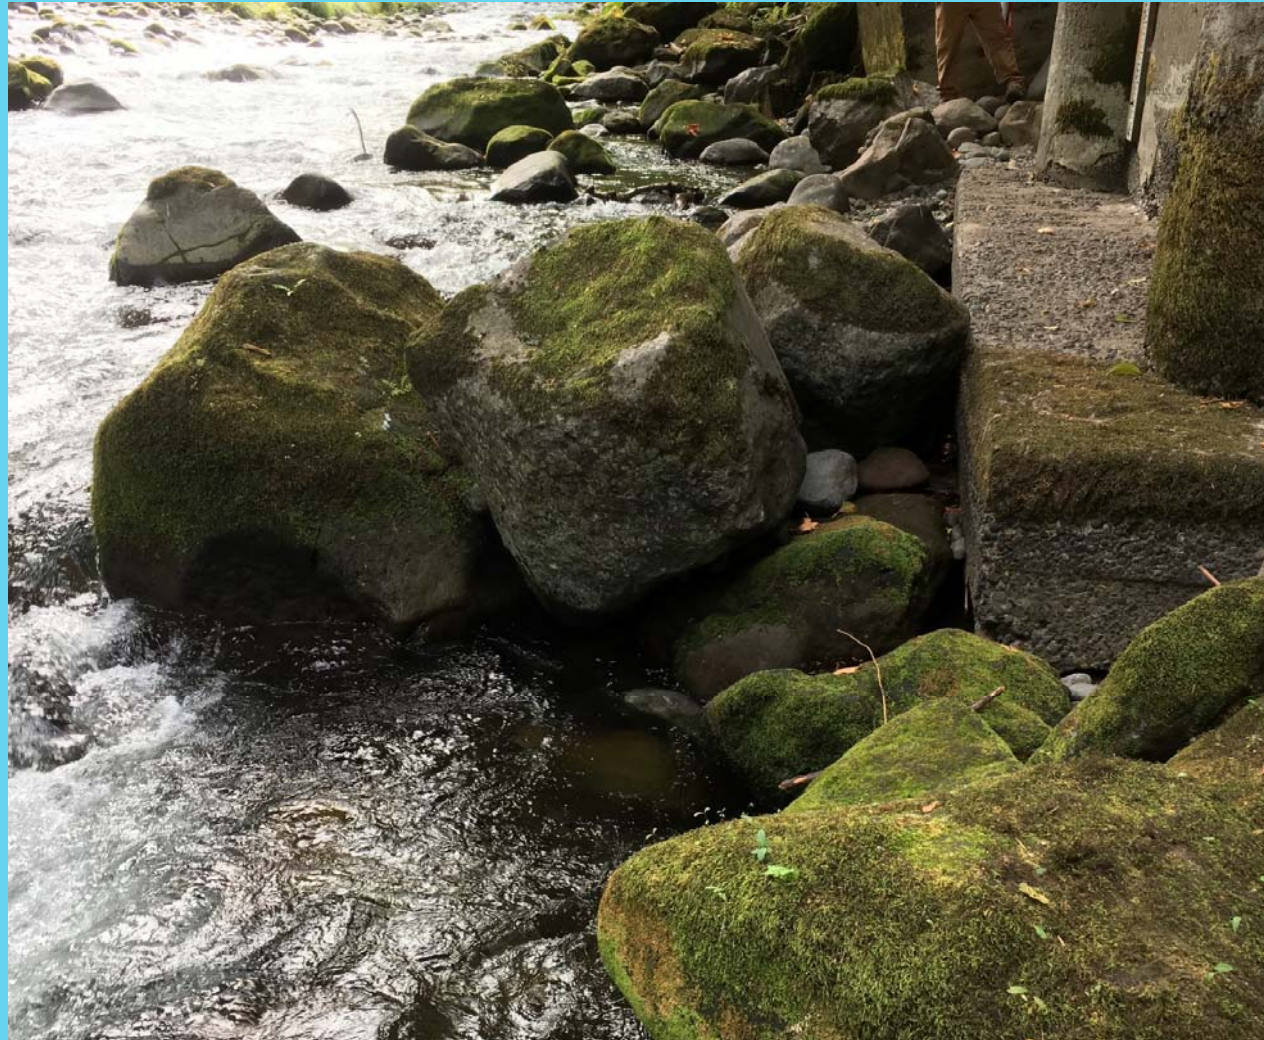
# Salmon River Bridge Brightwood Loop Road

Undermining found SEP, 2018

*Emergency* Permit Application  
process started SEP, 2018

Work started FEB, 2019

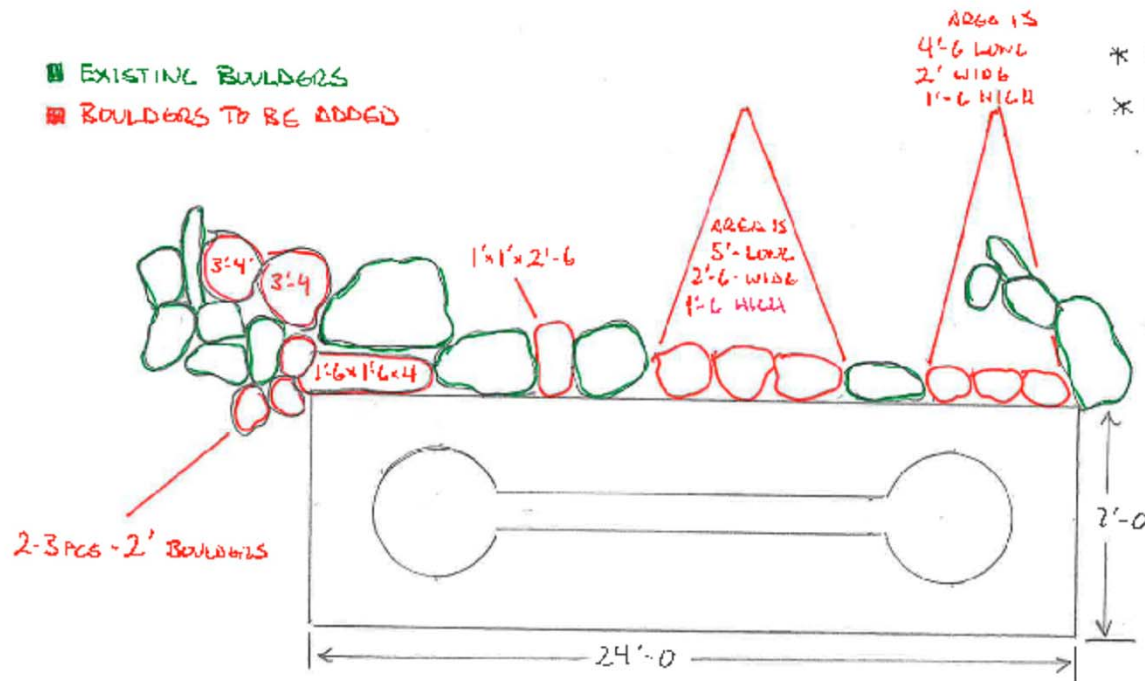
SALMON RIVER BRIDGE, # 01438  
 SCOUR MITIGATION PROJECT, BM2018.17

- EXISTING Boulders
- Boulders to be added

- \* PLACE 6-10 YD<sup>3</sup> Boulders
- \* COVER W/ 5 YD<sup>3</sup> RIVER RUN (COBBLES/SAND/NATIVE SOIL)
