## Timber Pile Cap Repairs

Travis Kinney

### Dairy Creek Over Flow Bridge Case Study

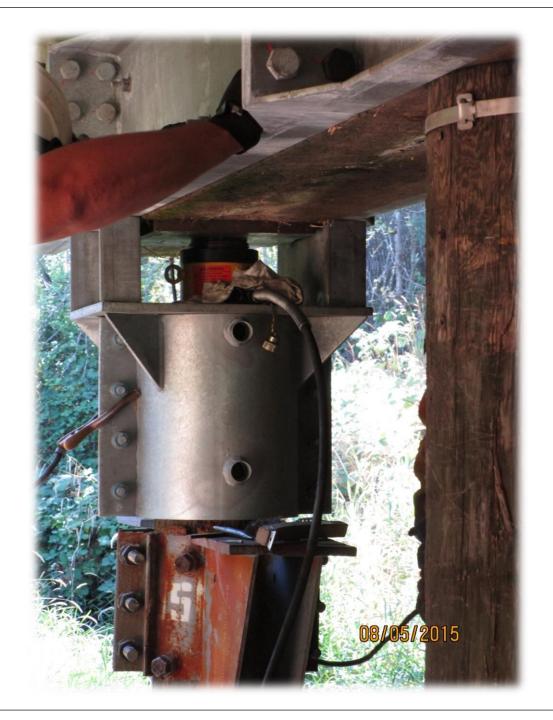
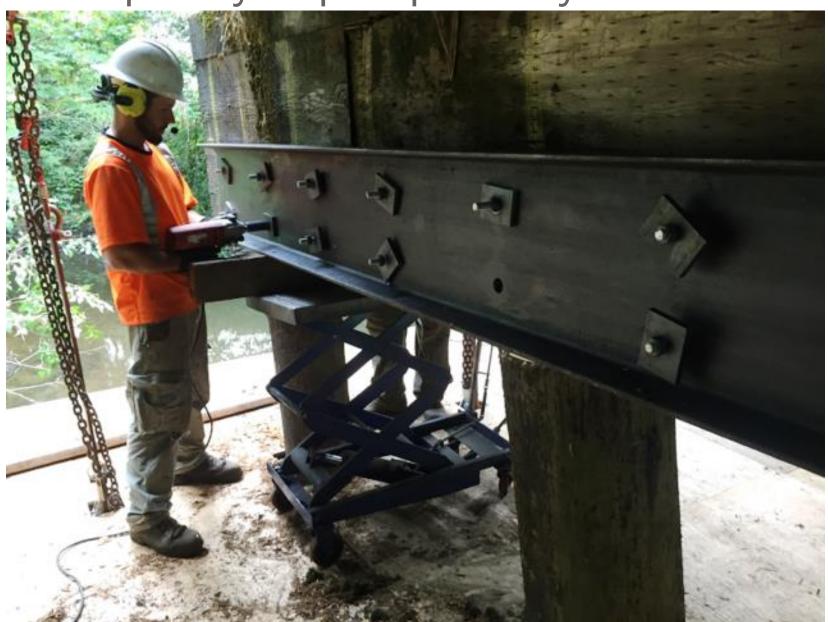
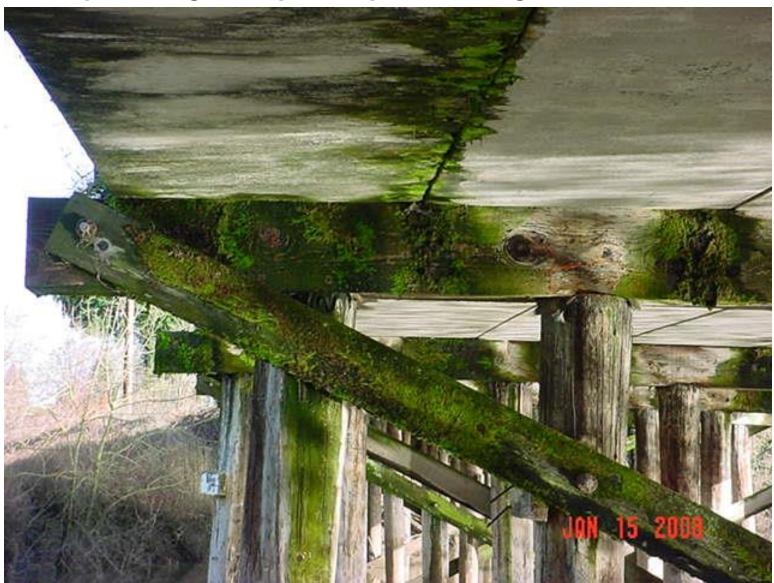
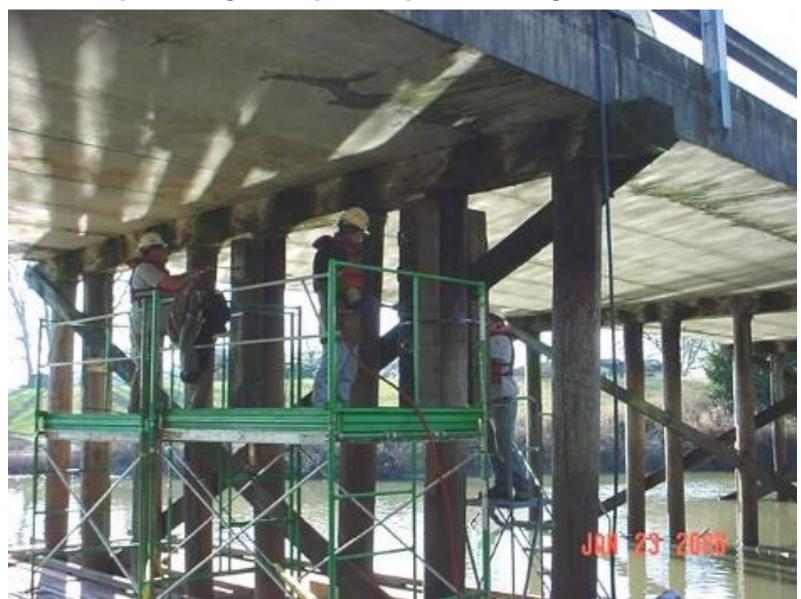
• Installing channel shims to connect steel cap to pile splice.

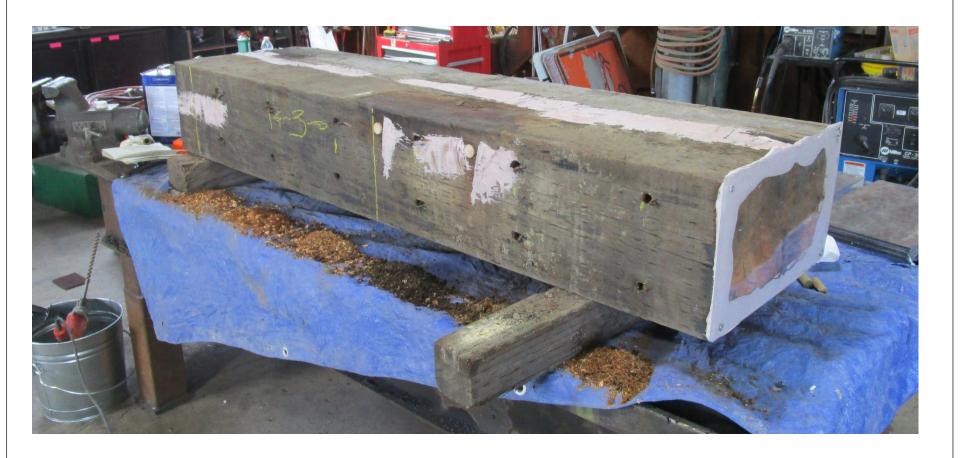
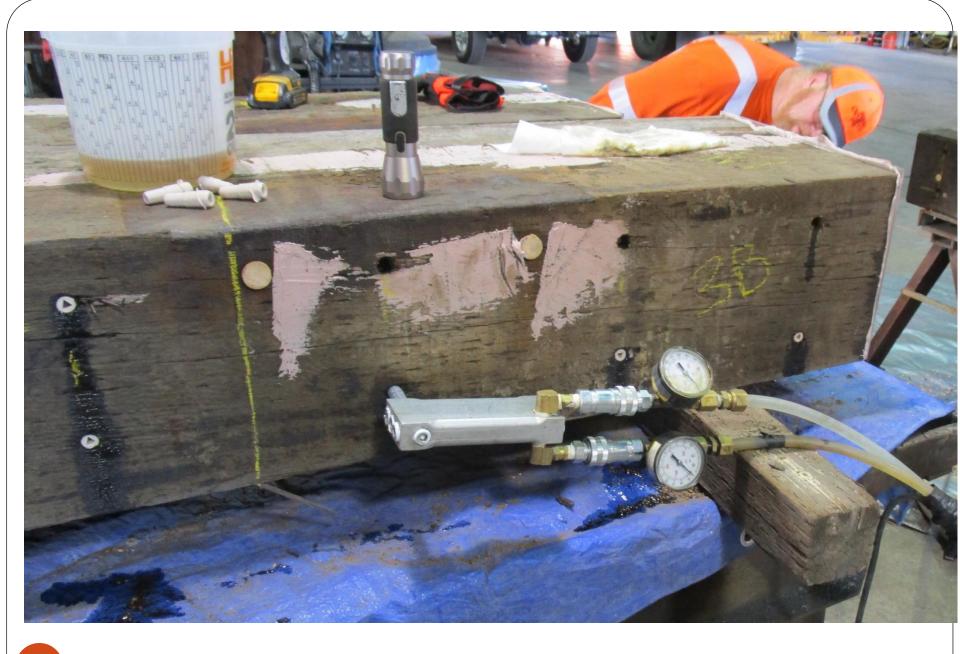
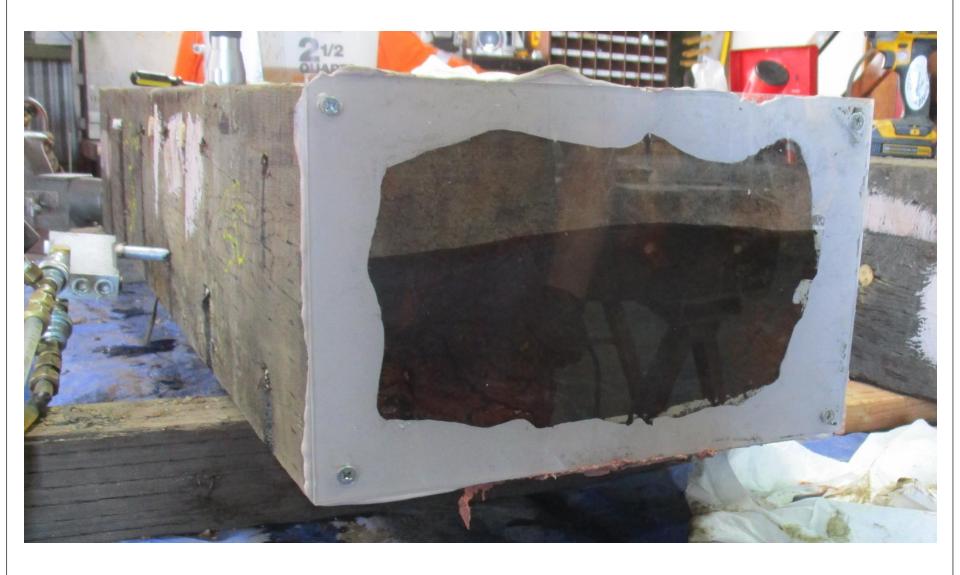
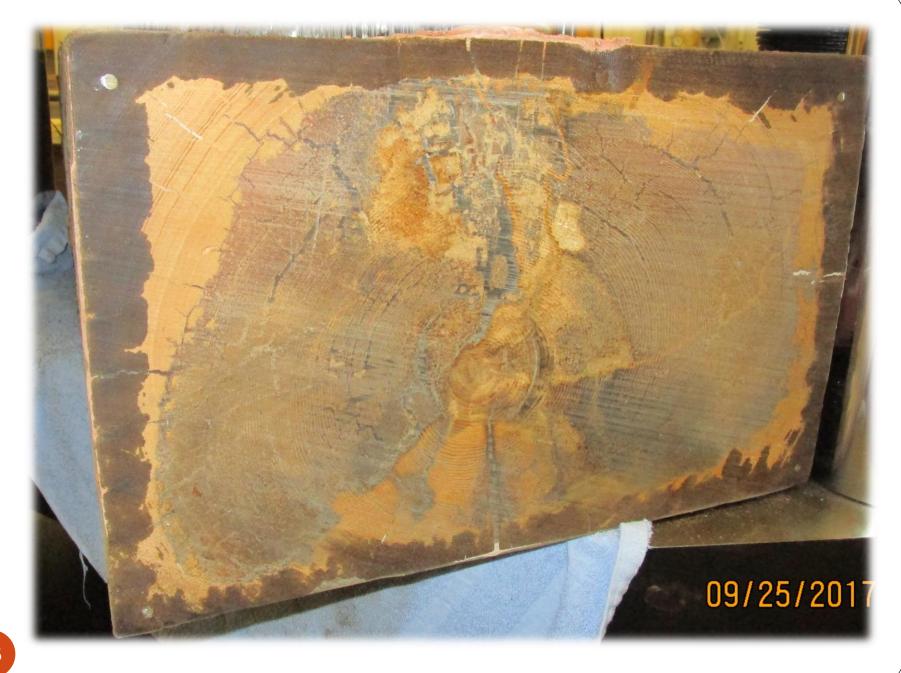
- Repair in place.
- Some caps don't function like beams but instead were used for construction and now act as a spacer between pile and girder.

# Lets try it...

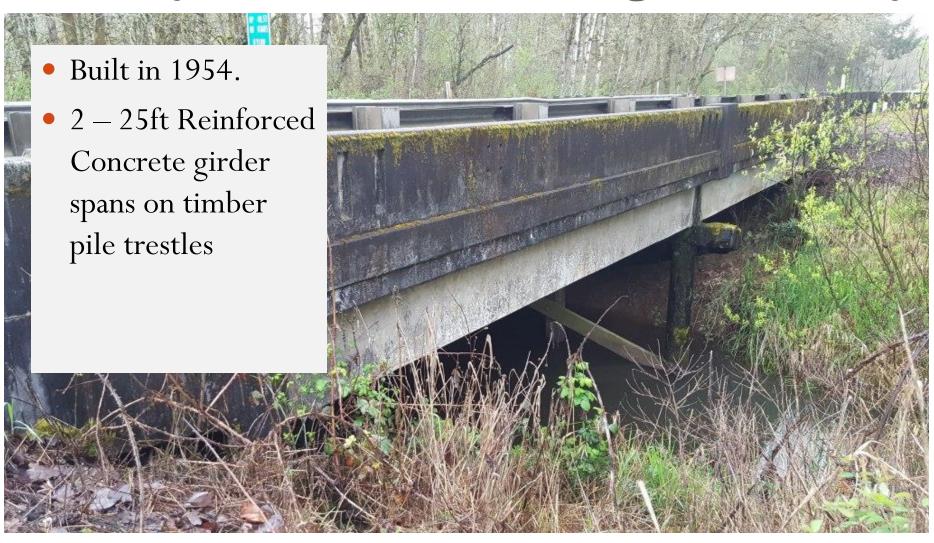
- Inspected in April of 2018.
- Identified Significant rot and crushing above two interior piles.
- Substructure condition rating reduced to NBI 4.
- Load Posting Letter Drafted
