DAVID EVANS AND ASSOCIATES INC.

Timber Pile Repair

Presented by Travis Kinney

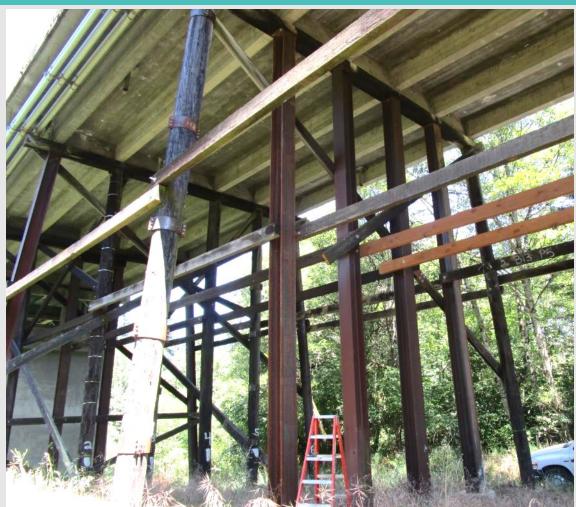
Replacing Bridges 1-piece at a Time

- 85 of the original 204 timber piles have been repaired.
- The remaining 119 are just waiting their turn.

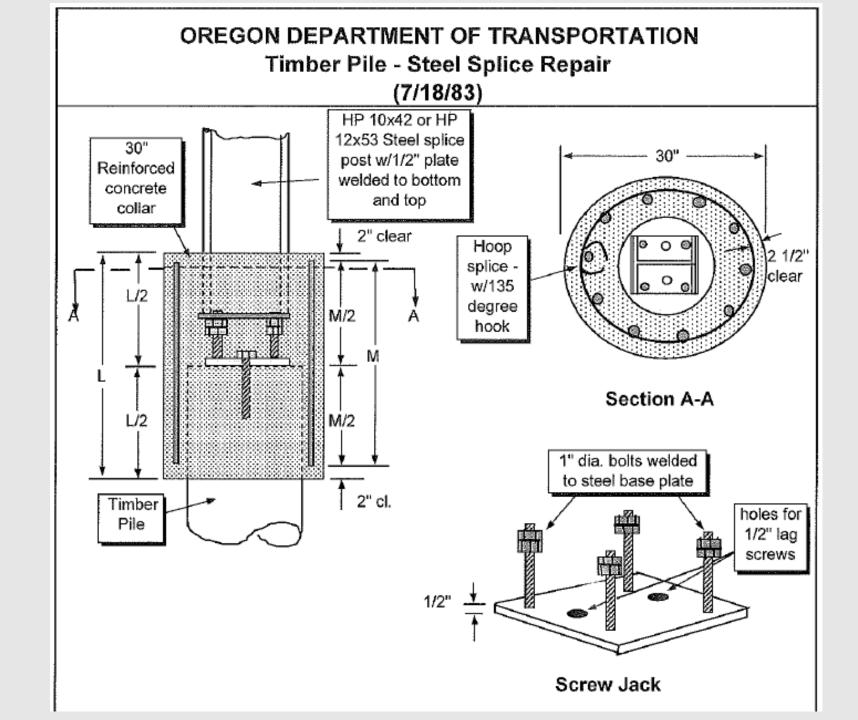
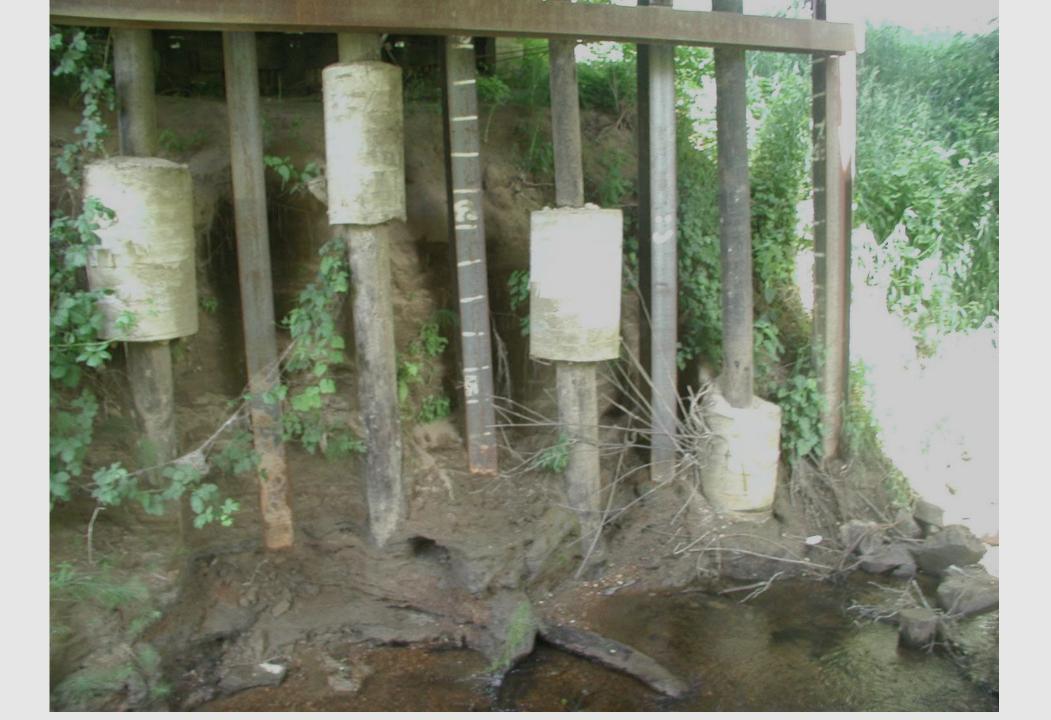
Previous Standard Pile Repair

- Splice new steel H-Pile to existing timber with reinforced concrete collar.
- Standard detail provided in 1983.
- Make splice at 100% solid timber section.
- Concrete splice has a 30" diameter and is 4' in length.
- Uses 10 #6 reinforcing bars w/ #5 hoops at 6" spacing.

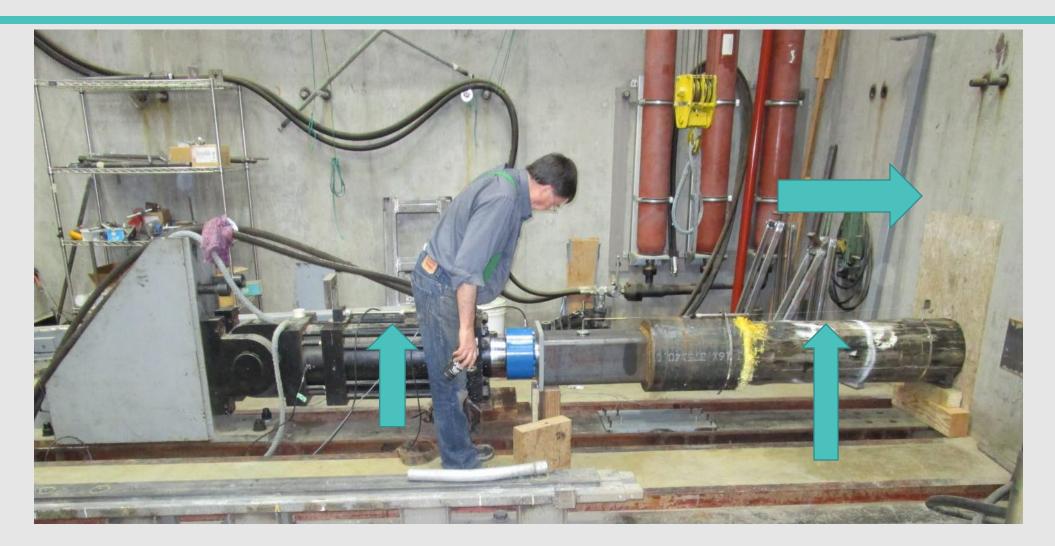
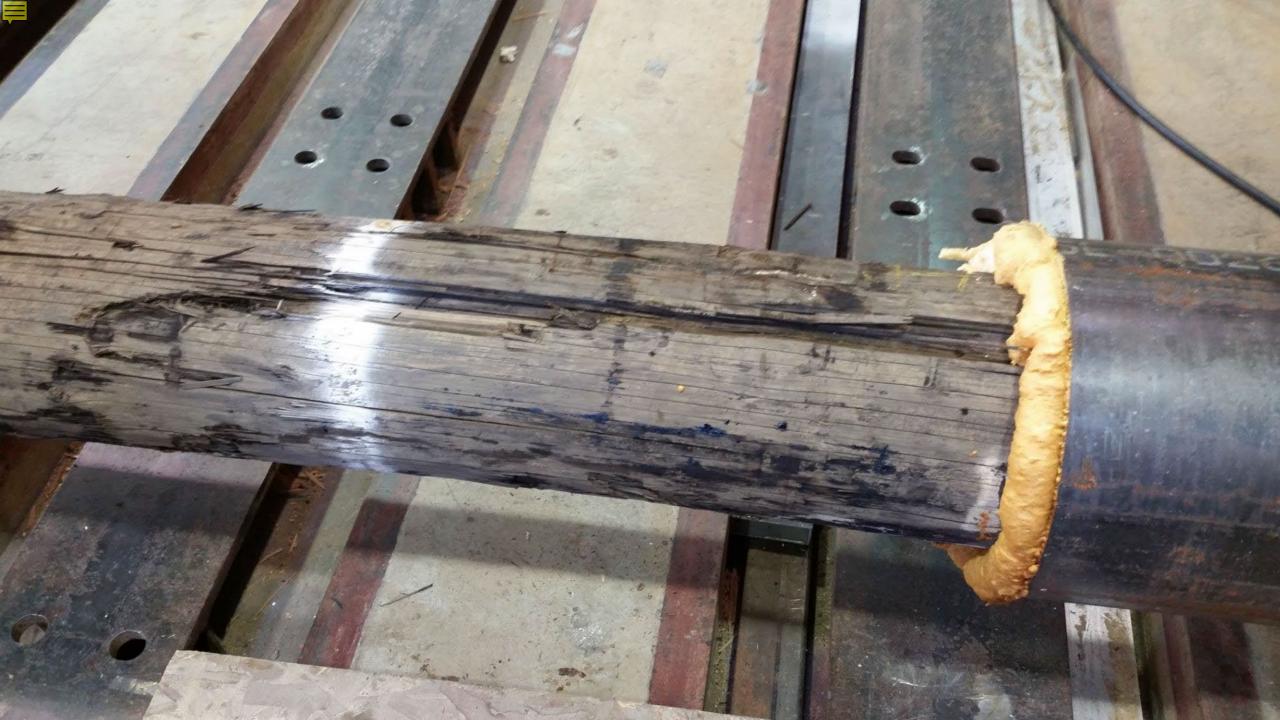
Compression Test Setup

- The jack wasn't big enough!
- No piles failed at maximum load of 300,000 lbs.
