Steel Repairs

- Emergency repairs to correct superstructure impact damage
- Two recent case studies
- Muscott Bridge
 - Highway 130 over Little Nestucca River
 - Tillamook County
- Bridge 08616
 - Highway 34 to 99W ramp
 - Corvallis

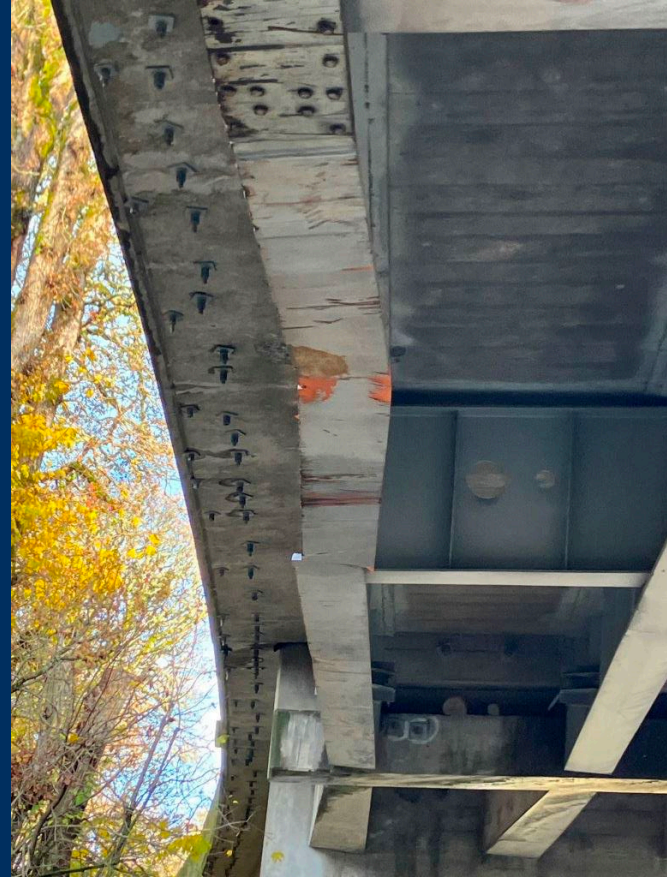
- Bridge initially closed by ODOT
- ODOT load rating
- Re-opened with temporary barrier to move traffic over south girders
- Emergency repair
