Road Safety Audit Report

US 20 Road Safety Audit

Albany-Corvallis Highway No.31

Audit Dates: March 19-20, 2012

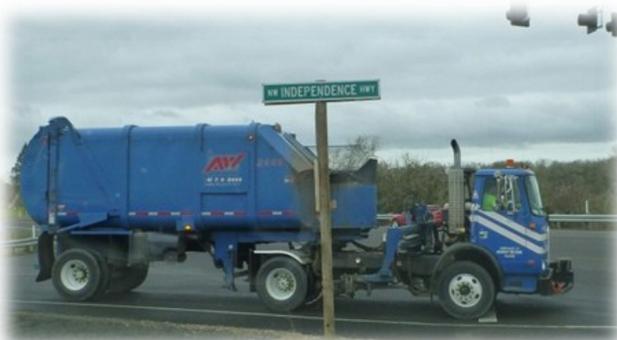
were passenger vehicles, garbage trucks were frequently observed using Independence Highway to access the nearby dump. Additionally, large trucks, buses (school and transit) and emergency vehicles were observed to turn into and out of both locations. Bicycle and pedestrian activity was low during the observation periods on the 19th and 20th of March, potentially due to the weather.

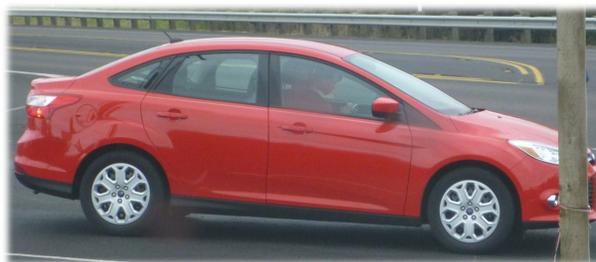
- ◆ Road Rage
- ◆ Impatient Drivers
- ◆ Disregard for Stop Signs
- ◆ Distracted Drivers

While these behaviors may not be the exact cause for the crashes recorded at these two locations, they could potentially be contributing factors. These types of behaviors could be a result of high traffic volumes, congestion and associated long driver delays (2 to 5 minutes) when trying to access the highway. A look

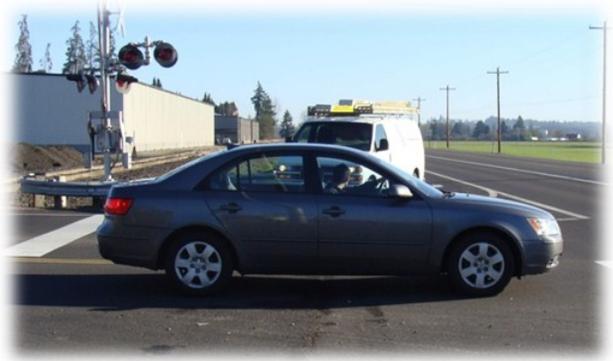
Of the four issues listed above, the RSA Team believes that the single greatest geometric issue associated with the increase in left turn crashes at both locations was the installation of the right turn lanes on US 20. This is due to the fact that a high volume of vehicles turning onto the side street block the view of oncoming traffic for drivers waiting to enter US 20 from Independence Highway or Granger Avenue.

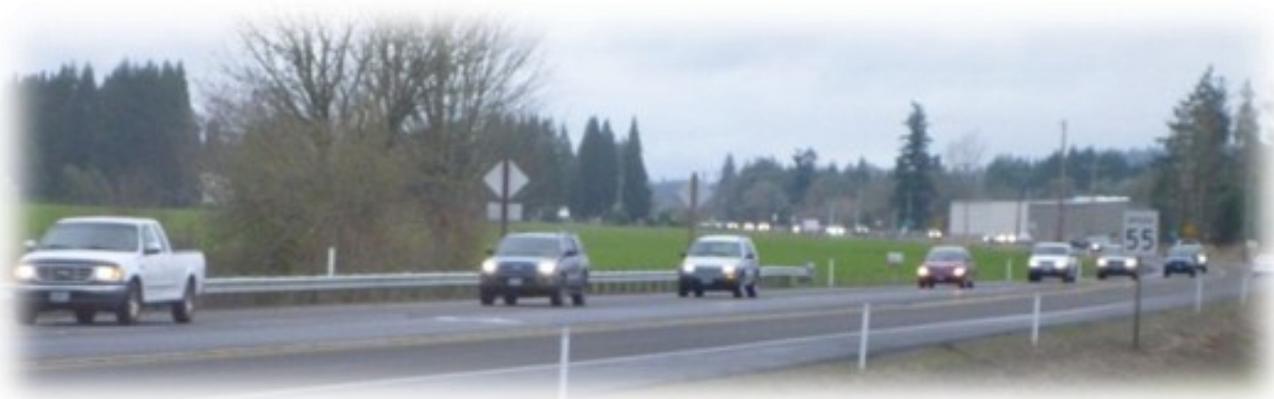
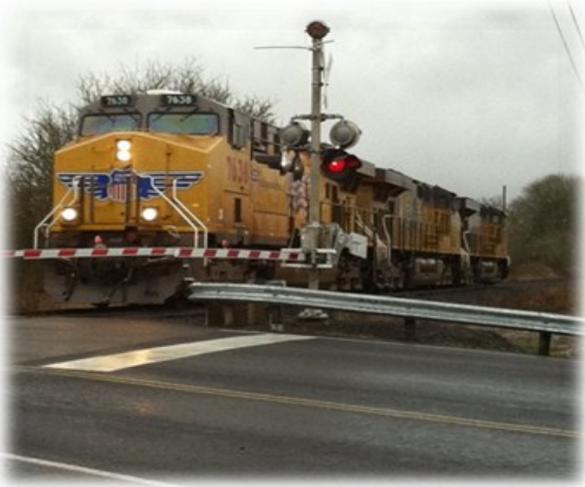
- ◆ Large Platoons of Vehicles (30+) on US 20 Create Infrequent Gaps for Side Street Traffic
- ◆ Long Queues (10+ Vehicles) and Delays (2 to 5 Minutes) for Side Street Traffic during Peak Hours
- ◆ Long Train Delay (6 to 7 Minutes) and Resulting Queues (5 Vehicles from US 20 at Granger Avenue)
- ◆ Local Traffic Diverts to North Albany Road and Springhill Drive due to Congestion

High traffic volumes, few gaps and high side street delay likely contribute to the impatient driver behaviors mentioned previously. Delay for the left turning vehicles onto US 20 was observed to be much greater than for the right turning vehicles, because the left turning vehicles need to look for gaps in both directions of traffic. The majority of crashes at both loca-

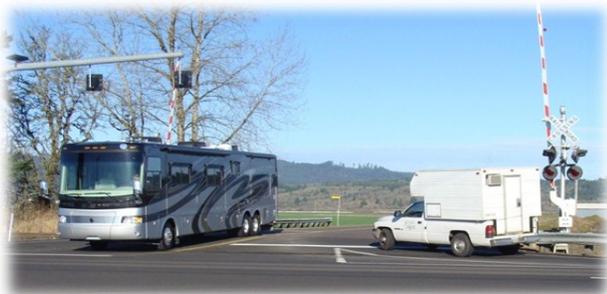
- ◆ Limited Storage between Highway and Railroad on Independence Highway and Granger Road
- ◆ Steep Approach Road Grades from US 20
- ◆ Stop Bar for Railroad set back from Crossing Arm
- ◆ Vehicles Stopping on Railroad Tracks

While there have not been any train/motor vehicle crashes recorded since 2004, the potential for these types of crashes does exist due to the issues listed above. In particular, the frequently observed driver behavior of stopping on or near the tracks (within the

area of the gates) could be a contributing factor for future train/motor vehicle crashes.
