BARBUR BOULEVARD ROAD SAFETY AUDIT

SW Capitol Highway to SW Naito Parkway

October 2015

ODOT Region 1 Traffic 123 NW Flanders Portland, OR 97209 503.731.8220 Prepared by:

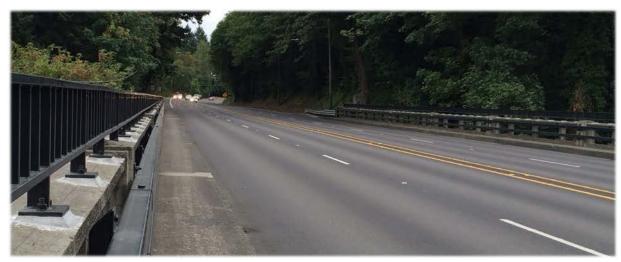
Exhibit 13. Barbur Boulevard looking southbound at Vermont Bridge

Based on field observations and data illustrated in the Barbur Concept Plan, as shown in Exhibit 12, the observed speeds exceed posted speeds. In the Wooded Section of the corridor (between Miles Street and Hamilton Street), access is relatively limited and together with the roadway character, the facility resulted in the highest speeds. Exhibit 13 shows a portion of this limited access section.

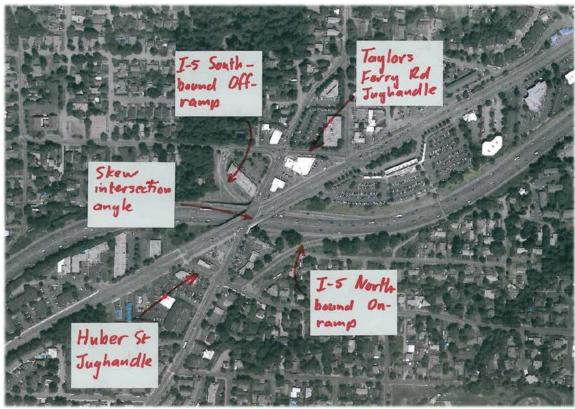
Exhibit 30. Existing intersection configuration and key characteristics of Barbur Boulevard/SW Capitol Highway

The Barbur Boulevard/SW Capitol Highway intersection is a five-legged, skewed intersection on the southern end of the corridor. Exhibit 30 highlights key characteristics of this intersection configuration that are summarized below:

- Skewed intersection angle between Barbur Boulevard and SW Capitol Highway.
- SW Huber Street and SW Taylors Ferry Road jughandles accommodate left-turns from Barbur Boulevard and SW Capitol Highway. The existing signage does not clearly define the desired travel paths for these left-turns through the jughandle configurations.
- Southbound I-5 off-ramp is located on a lower road hierarchy (SW Taylors Ferry Road) compared to Barbur Boulevard and SW Capitol Highway.
- Northbound I-5 on-ramp is located on a lower road hierarchy (SW Huber Street) compared to Barbur Boulevard and SW Capitol Highway.
- The intersection is complex due to the skewed alignment and the I-5 southbound on-ramp, as seen in Exhibit 31.

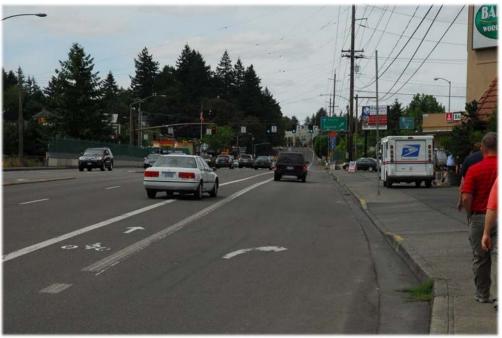
Exhibit 32. Southbound approach at Barbur Boulevard/SW Capitol Highway

- The pedestrian crossing across the north leg of Barbur Boulevard is long (approximately 120 feet), which impacts signal timing.
- The southbound bicycle lane is 4.5 feet wide and sandwiched between the through and right-turn lanes, as shown in Exhibit 32. The southbound right-turn lane to SW Capitol Highway/I-5 Southbound on-ramp is long and transitions across the bicycle lane. Vehicles regularly merge across the bicycle lane at multiple locations along its length.

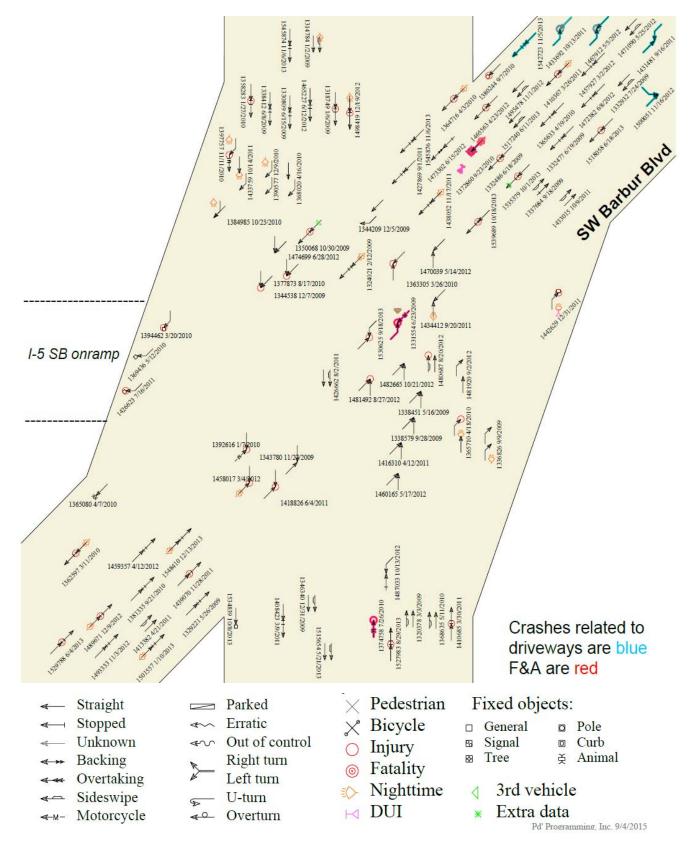
Exhibit 33. Crash diagram for Barbur Boulevard/SW Capitol Highway (2009-2013)

Crash data from the last five years is mapped in the crash diagram provided in Exhibit 33. *For orientation, Barbur Boulevard is oriented north-south and SW Capitol Highway as east-west.* Ninety three crashes were reported during this time period. The crashes (MP 6.19 to MP 6.23) were grouped as follow:

- 23 of the crashes disregarded the traffic signal that mostly resulted in angle crashes. 10 of these resulted in injury crashes which included two illegal left-turns.

- 31 total injury crashes were reported.

Table 3. Qualitative hisk hating of barbur boulevard/3w capital riighway intersection		
Function	Classification	Reasoning
Exposure	Category III	Jug handle configurations reduce conflicts at main intersection, but increase conflicts at multiple other intersections
Probability	Category III	Intersection with the highest number of reported crashes in the study corridor
Consequence	Category II	Long crossing distances, long bicycle lanes between through and right-turn lanes. 31 injury crashes reported in last five years of crash data available.
Overall	Category III	-

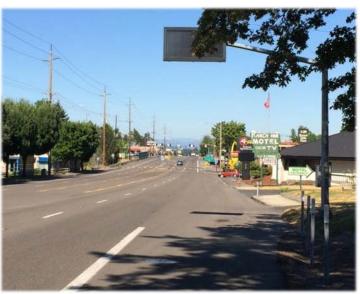
Exhibit 35. Right-turn to SW Huber St (left), shared northbound bus and bicycle lane (left)

- Better define accesses (e.g., narrowing driveways) in the southbound Barbur Boulevard right-turn lane to minimize conflict areas with bicyclists and vehicles.
- Narrow the travel lanes and provide a wider bicycle lane with buffer (4.5 feet currently between through and right turn lanes over a length of approximately 540 feet) – consistent with suggested corridor cross-section.
- Add green pavement markings at bicycle/vehicle conflict points, such as the southbound bicycle lane at Barbur Foods.
- Explore removing the southbound bus-only left-turn lane to minimize driver confusion and provide additional width for bicycle and pedestrian facilities.
- Remove northbound right-turn lane at Huber (Exhibit 35 left image) and provide bicycle lane, as well
 as better define shared northbound bus/bicycle lane at SW Capitol Highway intersection (Exhibit 35
 right image).

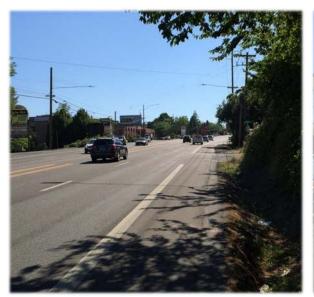
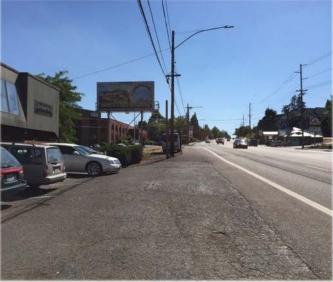
- Pedestrian connectivity, especially along the west side between SW Taylors Ferry Road (near SW Baird Street) and SW Alice Street.
- On-street parking limits sight distance from accesses and side-streets.
- Limited sight distance at SW Alice Street due to skewed angle of the roadway and topography.
- ADA issues, particularly with sidewalk obstruction, and a lack of pedestrian connectivity.

Exhibit 43. No sidewalk on southbound Barbur Boulevard approaching SW 35th Avenue (left) and no sidewalk through accesses on east side of Barbur (right)

Function	Classification	Reasoning
Exposure	Category II	Lack of sidewalk connectivity
Probability	Category I	Relatively few crashes
Consequence	Category II	Pedestrians need to cross Barbur Boulevard or walk along roadway
Overall	Category I	-

Shift alignment to the east by removing parking and add sidewalk and a buffered bicycle lane on the
west side of the roadway – consistent with suggested corridor cross-section. This also provides better
sight distance for drivers on SW Alice Street. A conceptual sketch for this improvement is provided in
Exhibit 44.

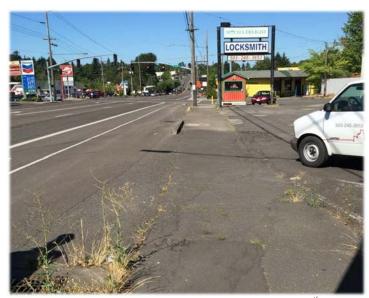
All four corners of the Barbur Boulevard/SW 30th Avenue intersection are developed, with multiple access points near the intersection. The accesses interrupt sidewalks, which introduce additional potential conflict points between pedestrians and vehicles (see Exhibit 45 and Exhibit 46). On-street parking on SW Barbur Boulevard limits sight-distance for vehicles exiting accesses in the vicinity of the intersection. Crash data from the last five years at the SW 30th Avenue intersection is shown in the crash diagram in Exhibit 47 and summarized below.

Exhibit 45. Northbound approach to Barbur Boulevard/SW 30th Avenue

Remove on-street parking and provide appropriate bicycle lane striping (see previous "Bicycle Lane Gaps and Deficiencies" section.

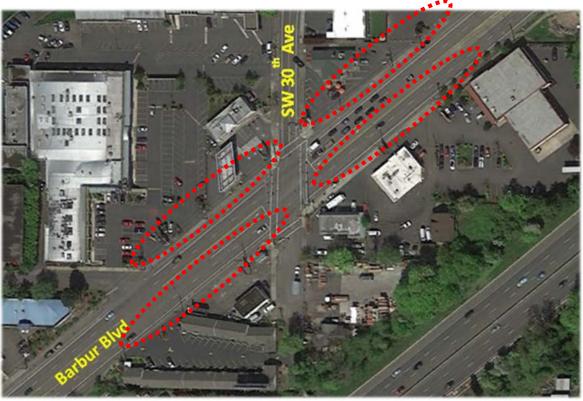
Exhibit 46. Driveways near the Barbur Boulevard/SW 30th Avenue intersection (Google Earth)

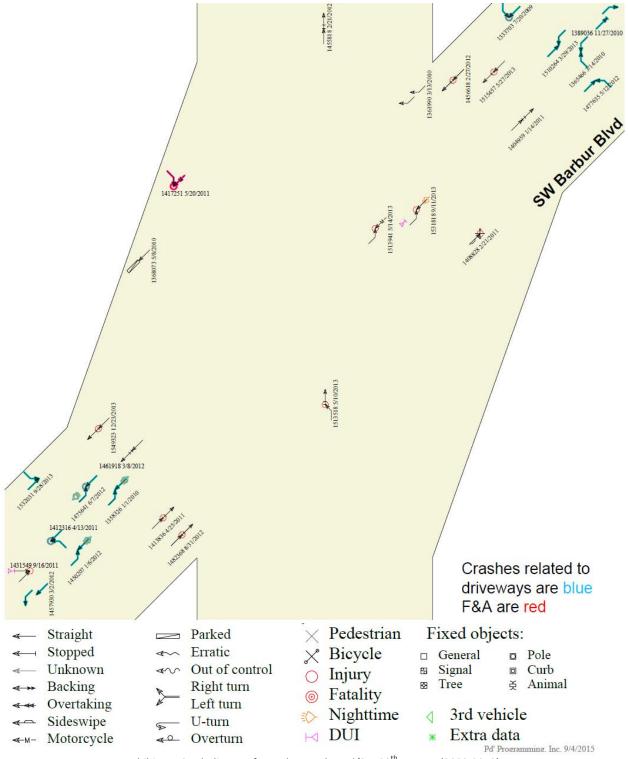
- Total of 27 crashes at this intersection, including 11 driveway related crashes (away from the intersection).
- 10 of the 27 crashes resulted in injury crashes, including one bicycle.

Exhibit 47. Crash diagram for Barbur Boulevard/SW $30^{\rm th}$ Avenue (2009-2013)

· · · · · · · · · · · · · · · · · · ·
Function	Classification	Reasoning
Exposure	Category II	High number of driveways
Probability	Category II	High number of driveway related crashes
Consequence	Category III	Driveway vehicle crashes have higher severity potential conflict with bicycles and pedestrians at driveways
Overall	Category II	-

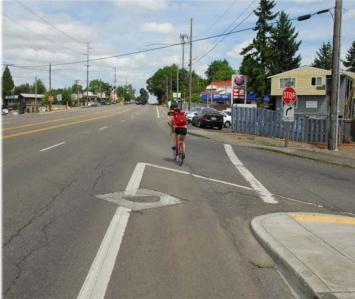
The segment of Barbur Boulevard between SW 30th Avenue and SW 24th Avenue includes northbound access to SW 26th Way via Barbur Court. There are narrow bicycle lanes (3-5 feet) and sidewalks (5 feet) on the bridge over SW 26th Way; there are no sidewalks immediately off the bridge. The right-turn on to Barbur Court is skewed, resulting in higher speeds for right-turning traffic. There are no defined bicycle lanes through either intersection with Barbur Court, as shown in Exhibit 48.

Exhibit 48. No pedestrian and bicycle facilities at bridge (left), gap in bicycle lane markings with right-turn from SW Barbur Court to Barbur Boulevard

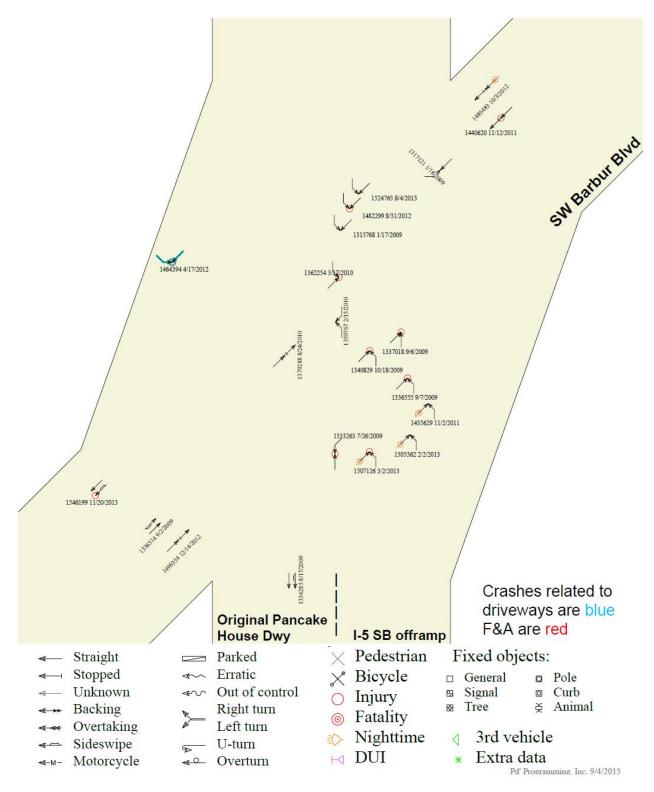
Traffic data indicates high side-street left-turns during the morning peak period (both SW 24th Avenue and Southbound I-5 off-ramp/Pancake House), as well as a high side-street left-turn (Southbound I-5 off-ramp) during the afternoon peak period. The crash data (5 years) shows a high proportion (12 of 21 crashes) of turning/angled movement crashes, as seen in the crash diagram in Exhibit 51, which are mostly related to the acute angle of the intersection. Turning movement crashes are typically side-street left-turns with through traffic on Barbur Boulevard.

Exhibit 51. Crash diagram for Barbur Boulevard/SW 24th Avenue (2009-2013)

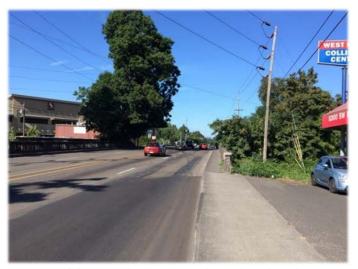
• Inconsistent sidewalks and bicycle lanes, including over the Multnomah Boulevard overpass. The bridge is 48 feet wide with no bicycle lanes and narrow sidewalks, as shown in Exhibit 54.

Exhibit 54. Bridge over SW Multnomah Boulevard

- Combine SW 22nd Avenue and SW Spring Garden Street on the east side of the intersection by T-ing them into a single intersection (this would entail right-of-way impacts).
- Explore opportunities to realign sidestreet to intersect with Barbur Boulevard more perpendicular.
- Consider options for the bridge that narrow the travel lanes to provide improved shared bicycle and pedestrian facilities, as shown in Exhibit 55. These options need to be evaluated to determine how the cross-section on the bridge would transition to/from the adjacent approaching road segments.

- Explore a bicycle-only connection via SW Carson Street and/or SW Hume Court to Multnomah Boulevard (which would require a steep ramp down) to provide an option for bicyclists to bypass Barbur Boulevard (between Multnomah Bridge and the SW Terwilliger Boulevard intersection) via SW Multnomah Boulevard.
- Replace the Multnomah Bridge to provide the desired cross-sectional dimensions based on the corridor vision and the adjacent road segments approaching the bridge.

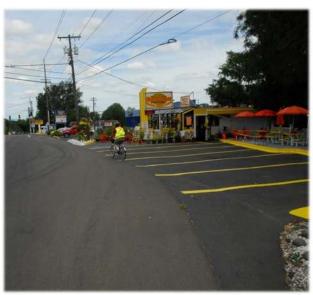
Exhibit 56. Southbound bicycle lane approaching SW Multnomah Boulevard (left), parking on southeast corner of intersection (right)

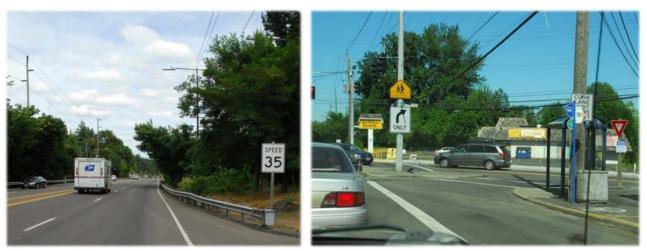
- Bicycle and pedestrian facilities end northeast of the intersection with fill embankment on both sides (Exhibit 57, left image).
- Queues on SW 19th Avenue were observed to block SW Multnomah Way, so vehicles were observed weaving through the queue to access SW Multnomah Way (frontage road).

- The northbound bus stop is nearside in the right-turn lane, providing challenges for through cyclists, right-turning vehicles, and buses merging back in to the through lane (Exhibit 57, right image).

Exhibit 57. Embankment north of SW Capitol Hill Road (left), northbound bus stop (right)

- Consider removing the northbound right-turn lane to provide bicycle and pedestrian facilities through the intersection, which will likely require modifications to the existing pedestrian island.
- If no widening is planned, then consider changing the intersection configuration by reducing lanes to 10.5 feet and providing 4-foot minimum bicycle lanes through the intersection (Exhibit 59 shows a conceptual intersection layout). There is approximately 60 feet of width available immediately north of the intersection.

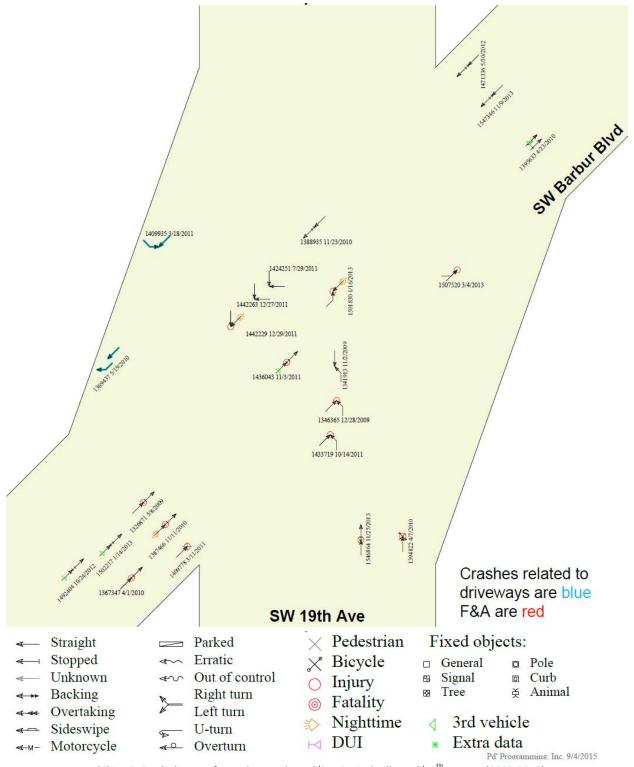
- Total of 23 crashes at this intersection, including ten rear-end related crashes.
- 12 of 23 crashes resulted in injuries, including four angle/turning crashes potentially associated with acute skew angle
- One crash involving a pedestrian on northbound Barbur Boulevard and one crash involving a bicyclist on westbound SW 19th Avenue.

Exhibit 58. Crash diagram for Barbur Boulevard/SW Capitol Hill Road/19th Avenue (2009-2013)

and 10. Quantum to the track of Darbar Doubletanayout Capitor time to day 15 - Attended the control of		
Function	Classification	Reasoning
Exposure	Category I	Relatively lower volumes vehicles
Probability	Category I	Relatively lower opportunities for conflicts
Consequence	Category III	12 of 23 crashes are injury crashes with some higher severity with turning crashes. Relative high number of pedestrian and bicycles at this intersection.
Overall	Category II	-

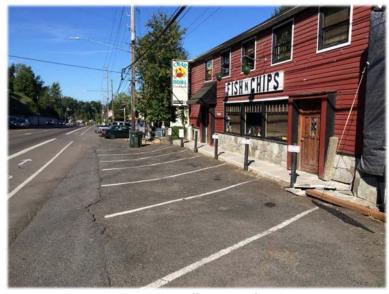
There is backing out parking on the east side of the roadway with no pedestrian facilities, as shown in Exhibit 61. On-street parking near 13th Avenue impedes sight distance from side streets and driveways.

Exhibit 61. Parking off east side of roadway

- Infill sidewalk gaps on the east side of the roadway and address ADA issues.
- Implement access management strategies as part of redevelopment.
- Consider modifying the cross-section over the embankment to either restripe within the existing guardrails or widen onto the existing road prism with a barrier, as shown in Exhibit 62.

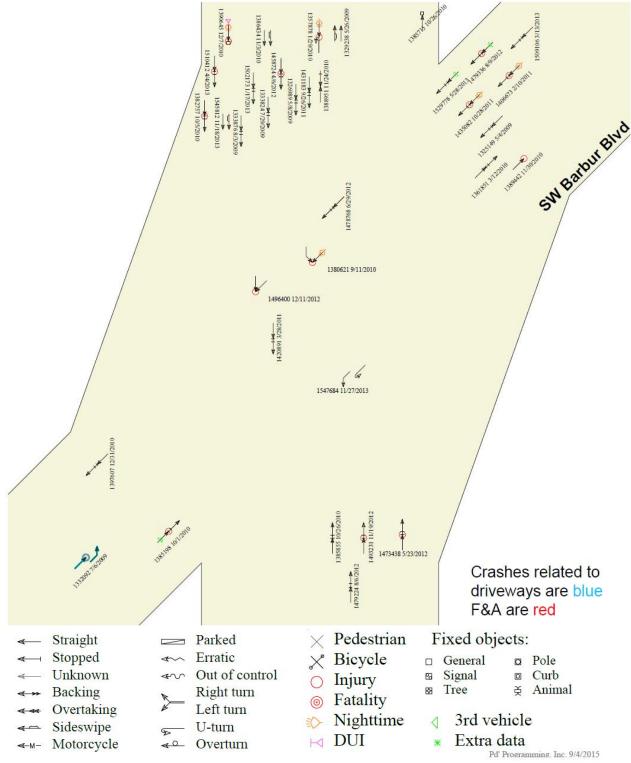
- A total of 35 crashes at this intersection with 22 rear-end crashes, with other crash types including angle, turning, driveway and sideswipe crashes.
- Of the 22 rear-end crashes, nine were along eastbound Bertha Boulevard and eight along southbound Barbur Boulevard.
- 14 of the 35 crashes resulted in injuries.

Based on observations by the RSA Team and past assessment of the Barbur Boulevard/SW Bertha Boulevard intersection, the intersection is near or at capacity. The SW Bertha Boulevard approaches are split phased, which constrains the signal timing at the intersection resulting in the intersection operation at capacity. The team observed vegetation limiting intersection visibility, particularly at the northeast corner where the geometry of the pedestrian facilities also hinders the view of turning vehicles (Exhibit 66). The large turning radii at the intersection allow relatively high speed turns.

Exhibit 65. Crash Diagram for Barbur Boulevard/SW Bertha Boulevard (2009-2013)

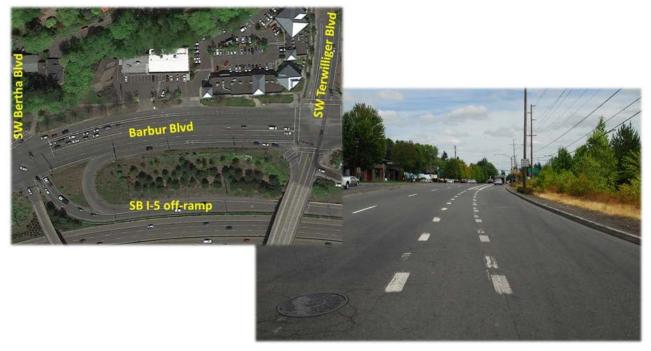
Exhibit 67. Weaving section between SW Bertha Boulevard and SW Terwilliger Boulevard (Google Earth, left)

There is a long weaving section between SW Bertha Boulevard and SW Terwilliger Boulevard involving right-turning vehicles from the I-5 southbound off-ramp and vehicles from SW Barbur Boulevard turning right at SW Terwilliger Boulevard, as shown in Exhibit 67. This creates a long conflict zone with the bike lane that is positioned between the through and right-turn lanes. In addition, there is no sidewalk between SW Bertha Boulevard and SW Terwilliger Boulevard on the freeway side of Barbur Boulevard – there is an unofficial, unpaved walking path.

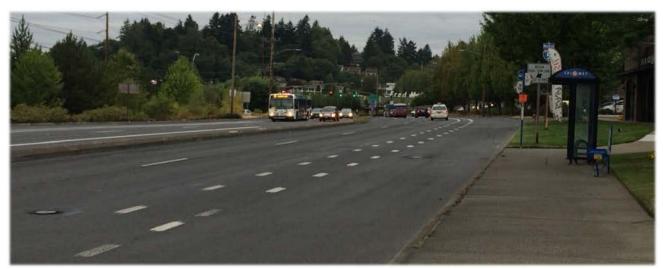
Exhibit 68. Transition to southbound right-turn lane with bus zone

There is a long transition across the bike lane into the southbound right-turn lane that includes the bus zone, as shown in Exhibit 68.

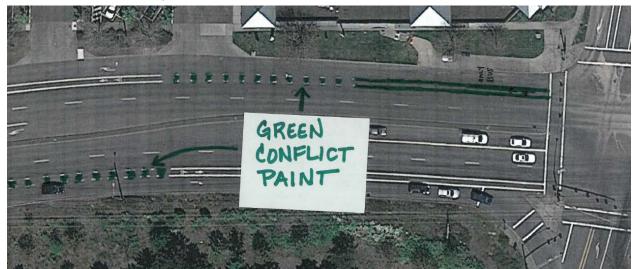
Exhibit 69. Shorten transition into westbound right-turn lane by striping and/or potential curbing

• Shorten the transition into the westbound right-turn lane and define the bus stop location, for better channelization (see top half of sketch, Exhibit 69).

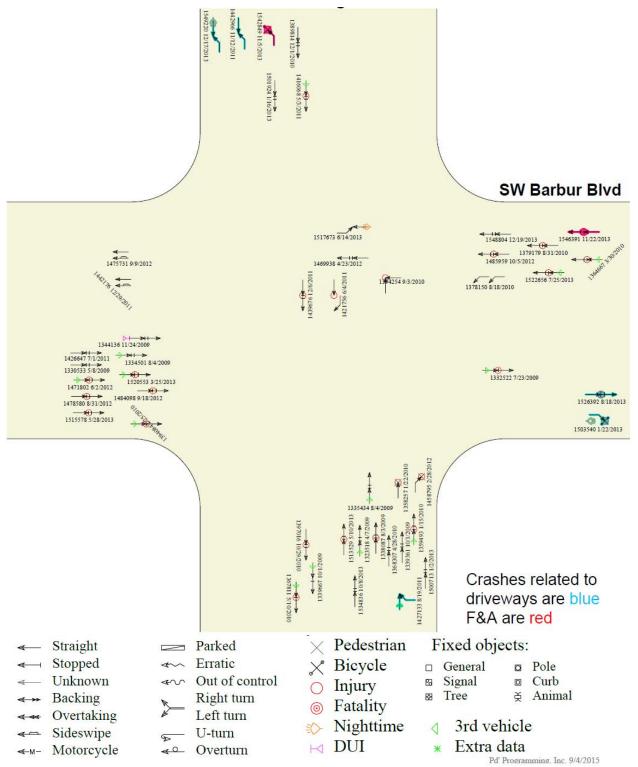
Exhibit 70. Crash Diagram for Barbur Boulevard/SW Terwilliger Boulevard (2009-2013)

- Westbound left-turning vehicles (from SW Terwilliger Boulevard) running the red-light to make it through the intersection.
- Southbound left turn queue (on Barbur Boulevard) spilling back into the through lane.
- Northbound right-turning vehicles (from Barbur Boulevard) filling the available space on Terwilliger Boulevard over the bridge so there is limited space for receiving through and left-turning vehicles (Exhibit 71 left image). Vehicles waiting to make a right-turn onto the Terwilliger Bridge regularly block the bicycle lane.

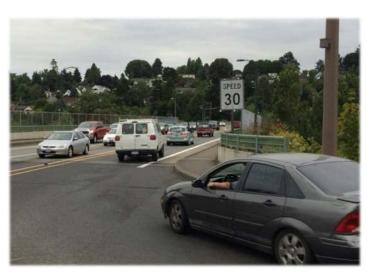
Multiple bicycles made northbound and southbound left-turns (from Barbur Boulevard) either by moving across the travel lanes into the left-turn lane or performing a two-part turn by staying on the right side of the street and using the cross-street green phase (Exhibit 71 right image).

Exhibit 71. Space limited to turn on Terwilliger Boulevard (left), left-turning bicyclists on Barbur Boulevard (right)

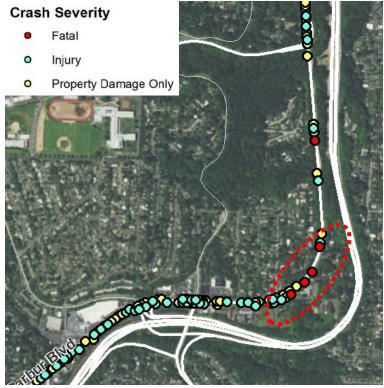
Exhibit 75. Reported crashes between SW Miles St and SW Capitol Highway (January 2004-September 2014)

There were four fatal crashes reported on the roadway curve just north of SW Miles Street over the last ten years, as shown in Exhibit 75. Three of these crashes were fixed object crashes that occurred at nighttime and involved alcohol; the other crash was a head-on collision during the day and not alcohol related. Three of the crashes occurred in the southbound direction while one of the fixed object crashes occurred in the northbound direction.

In 2014, ODOT installed tubular markers, reflectors and reflectorized yellow paint on the raised median, as well as added a speed feedback sign for southbound traffic approaching the curve. Since these improvements, no crashes have occurred in this curve.

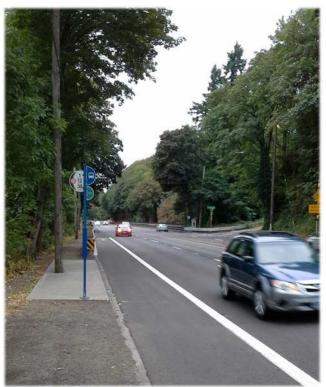
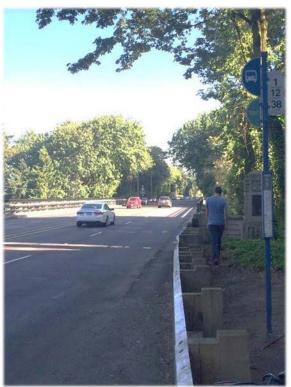
Exhibit 76. Northbound bus stop at SW Parkhill Dr. (left), southbound bus stop at SW Parkhill Dr. (right)

- Pedestrian access to the bus stops at SW Parkhill Drive and at the Capitol Highway structure is challenging (shown in Exhibit 76). The stops on the west side of the roadway are behind the guardrail right next to the bridge. There are no pedestrian facilities on either side of the roadway and the ridership indicates an average of less than 5 people a day at each stop.

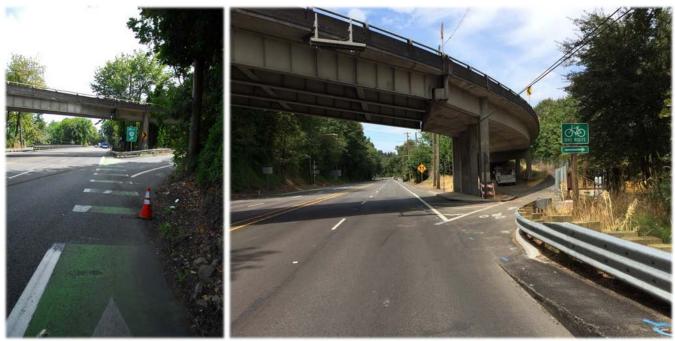
• In the northbound direction, a route for bicyclists around the flyover and merge is provided. In the southbound direction, green paint is used to highlight the conflict between the bicycle lane and highvolume right-turn to Capitol Highway.

Exhibit 77. Northbound turn to Capitol Highway with green paint to highlight conflict area (left), southbound route for bicyclists to avoid Capitol Highway merge to Barbur Boulevard (right)

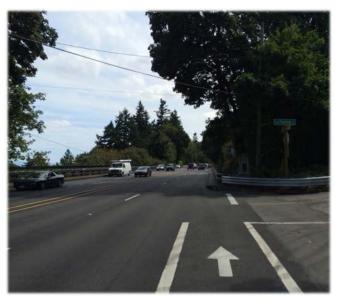
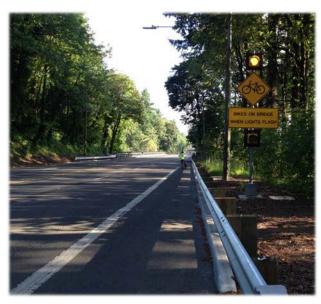
Exhibit 78. Southbound approach to Newbury Bridge (left), warning sign at northbound approach to Vermont Bridge (right)

Based on the team's nighttime visit, there is no lighting or edge line on the bridge structures, creating
a gap in lighting and visibility in defining the edges of the roadway.

- Data in the Barbur Concept Plan shows that speeds on the corridor are highest (85th percentile speed of 55 mph compared to 45-mph posted speed) through the wooded section. This is likely due to the lack of traffic signals, accesses, and roadside development. These characteristics result in undesirable speed differential between motor vehicles and bicyclists, especially over the bridges where bicyclists are sharing the outside lanes across the bridges.
- There is a gap in the bicycle network with no bicycle lanes over the bridges. There are signs activated by bicyclists that flash to indicate the presence of bicyclists on the bridges. Key issues for bicyclists include vehicle speeds, lack of dedicated space, and relying on the motorized vehicles to recognize and yield to a slower non-motorized user that must share the lane.

Replace the Vermont and Newbury bridges to provide the desired cross-sectional dimensions based on the corridor vision and the adjacent road segments approaching the bridges.

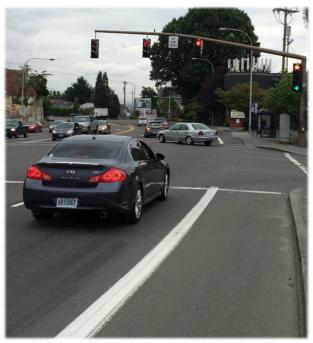
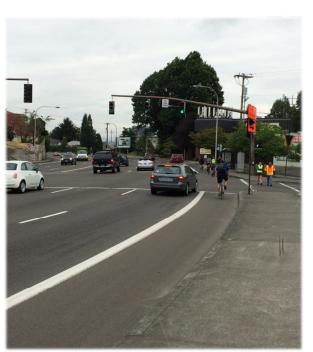
Exhibit 86. Northbound approach to Barbur Boulevard/SW Hamilton Street

- Northbound bicycles going through the first intersection, which acts like a queue jump to give bicyclists a lead at the second intersection.
- There is a "No Turn on Red Sign" on the northbound approach, but it is unclear to what this sign refers.
- There is a northbound right-turn arrow provided at the five-section signal head, although there is no right-turn lane that serves the protected phase (Exhibit 86 left image).
- There is a high volume of northbound right-turning vehicles at the second intersection, presenting a potential conflict with through bicyclists (Exhibit 86 right image).
- The pedestrian phase on the west leg begins midway into the green phase and ends before the end of the green phase, creating a very short north-south pedestrian cycle.

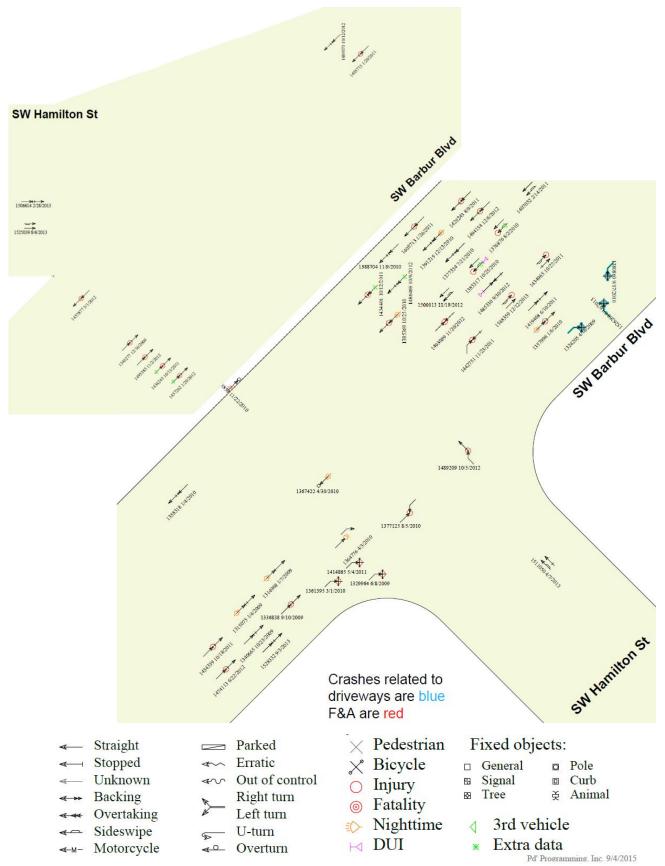
Exhibit 87. Crash Diagram for Barbur Boulevard/SW Hamilton Street (2009-2013)

- A total of 49 crashes at this combined offset T-intersections. Nine crashes were reported at the western leg of SW Hamilton Street and 40 crashes at the eastern leg of SW Hamilton Street.
- 27 of the total crashes were rear-end related crashes and six sideswipe crashes.
- 26 of the 49 crashes resulted in injuries, including one fatality.
- Three bicycle crashes were reported involving right-turning vehicles on the northbound approach to the eastern leg of SW Hamilton Street, all injury crashes.
- Three bicycle crashes were reported just north of the eastern leg of SW Hamilton Street, all driveway related.
- In addition, to the reported bicycle crashes, there is a high potential risk due to the vehicle/bicycle conflict. There are 65 and 51 bicycles going through these intersections during the weekday AM and PM peak hours, respectively.

Function	Classification	Reasoning
Exposure	Category III	High volumes for all modes
Probability	Category III	Highest number of bicycle crashes
Consequence	Category III	High potential for high severity crashes
Overall	Category III	-

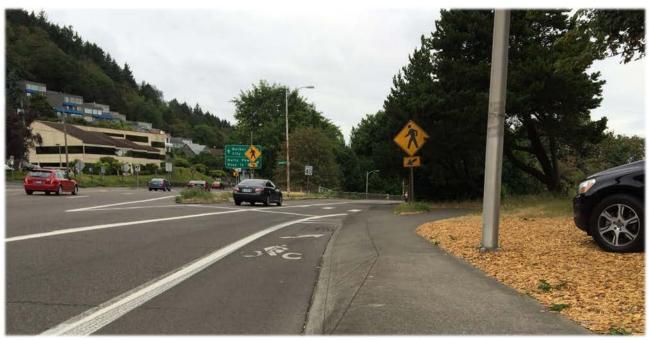
- Northbound (inbound) Barbur Boulevard splits with the rightmost two lanes leading to SW Naito Parkway and the leftmost two lanes continuing on Barbur Boulevard. The center lane approaching the split is an option lane.
- There is limited visibility at the pedestrian crossing on SW Naito Parkway, which crosses two travel lanes (see Exhibit 90).
- There is a bicycle ramp provided to a jughandle that turns bicyclists to the left to cross Naito Parkway. The ramp is steep and there is a lack of bicycle wayfinding signage.
- The RSA Team observed numerous last-minute lane changes in the road segment leading up to this diverge. These lane changes are likely drivers jumping the queue and then cutting into the line to access the Ross Island Bridge.

Exhibit 90. Bicycle ramp to jughandle and pedestrian crossing (left),

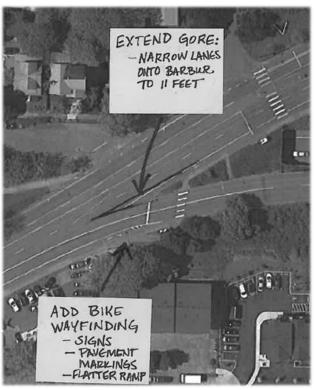
Exhibit 91. Concepts for Barbur Boulevard/SW Naito Pkwy Split

The RSA Team observed the following issues:

Relocate the gore further south using striping. This provides the opportunity to also move the bicycle ramp further south and creates additional space in advance of the crossing on SW Naito Parkway, as shown in Exhibit 91.
