#### **OREGON STATE HISTORIC PRESERVATION OFFICE**

Certified Local Government Grant Project Packet Cover Form

# Progress Report on CLG 2021 Grant for Jacob Conser House in Jefferson, Oregon.

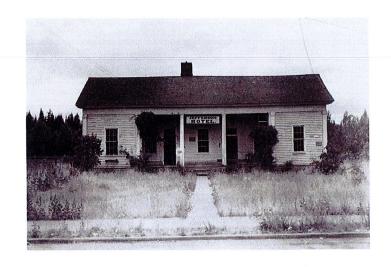
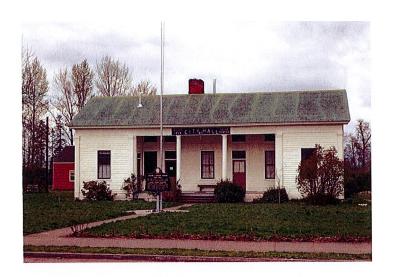
These two doors will be replaced. The door to the Event room (left picture) also has hinges on the exterior and multiple areas where locks have been added and moved. The library dropbox door will also be replaced. Both doors will have their hinges on the interior for security of the building. The third door, (not shown) is another 1939 original door on the new Museum side. It will remain and not be replaced.

The Event Room door design also was present in 1939, so the work that will be done with the replacement doors will mimic this design with three horizontal panels. Mid-Valley Glass and Millwork will adjust their contract to mimic the dimensions exactly of the Event room door.
