OREGON PARKS AND RECREATION DEPARTMENT OCEAN SHORE PERMIT APPLICATION

SHORELINE PROTECTION STRUCTURES

Seawall back to original size and height with 5'-6' riprap: Riprap double layer at bottom half of wall

**Engineering Geologic Investigation
for Oceanfront Protection Along Siletz Spit
between Tax Lot 156, Map 08-11-09DD
and Tax Lot 200, Map 07-11-34CB
Lincoln County, Oregon**

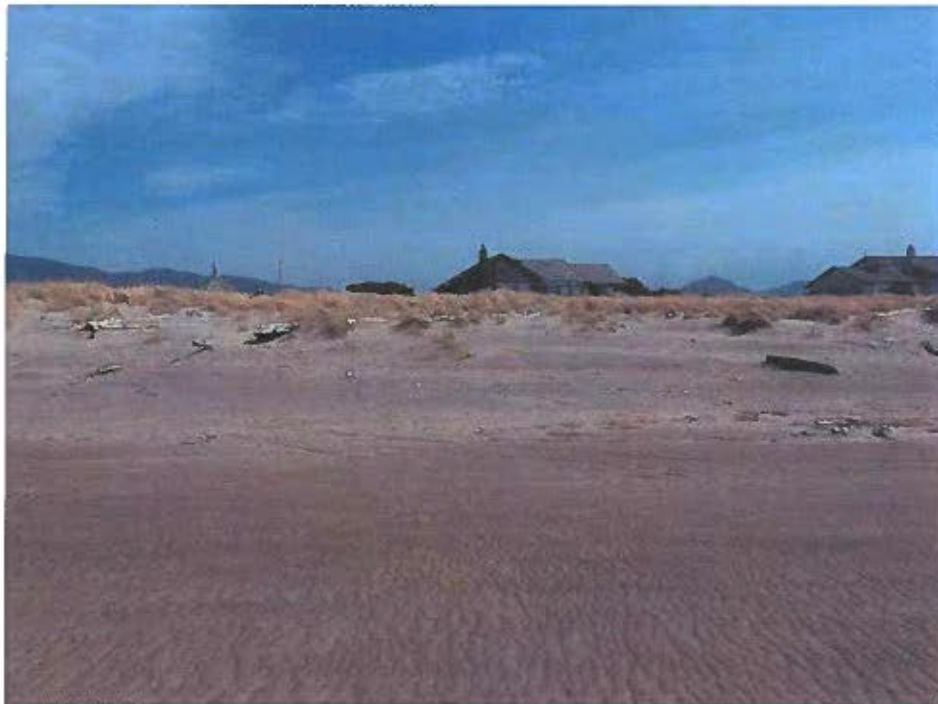
Photo 4 – Easterly view of the beach and vegetated foredune fronting the northernmost houses. Note the sand ramp and lack of well-defined erosion scarp along the beach-dune junction.

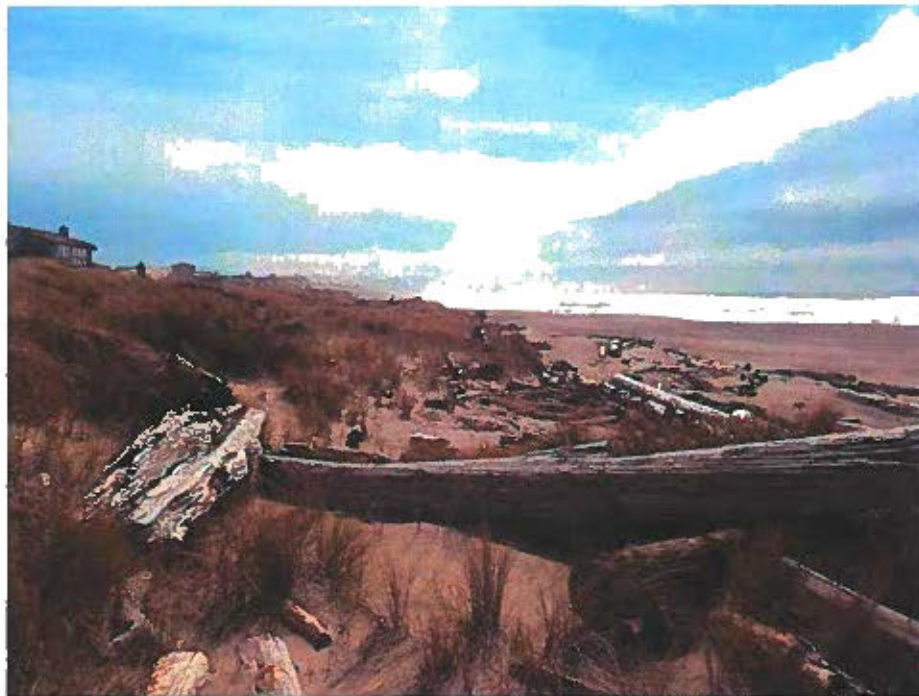
Photo 6 – Southerly view of the beach-dune junction in the area of Tax Lot 103, Map 7-11-34CC. Well-defined erosion scarps were present along the beach-dune junction south of this area.

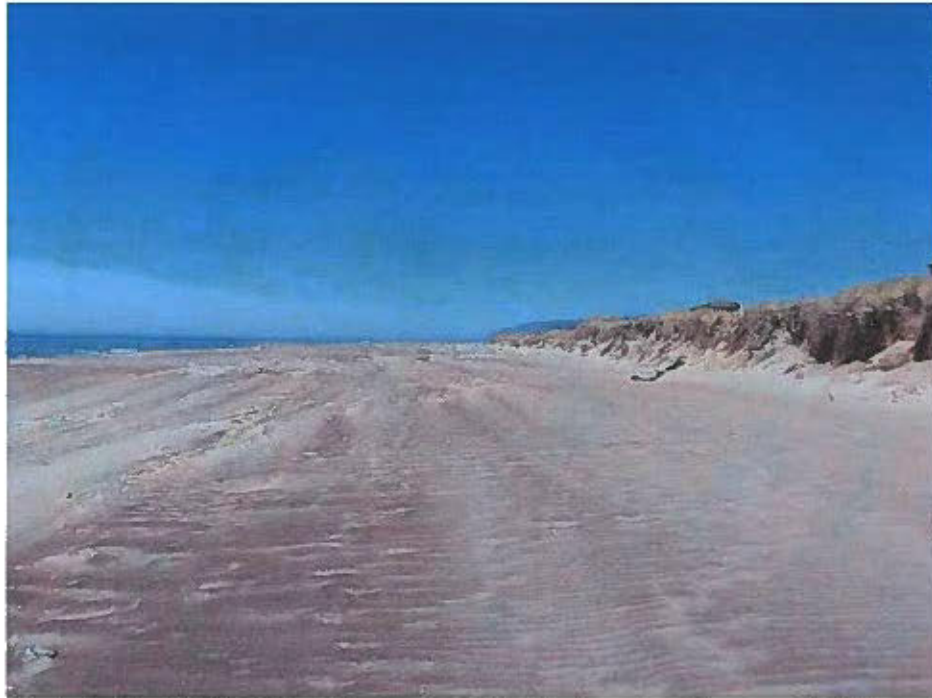
Photo 7 – Northerly view of the beach and beach-dune junction near Tax Lot 800, Map 08-11-03BB. Note the well-defined erosion scarp along the beach-dune junction.

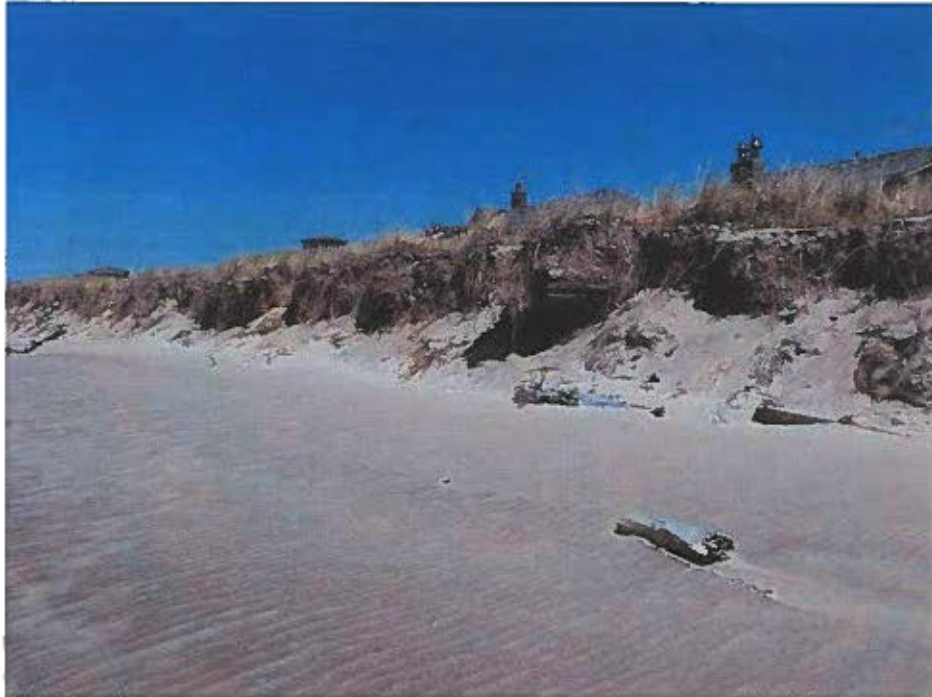
Photo 8 – View of the erosion scarp along the beach-dune junction near Tax Lot 900, Map 08-11-03BB. Note the buried drift logs having sawn ends exposed in the erosion scarp.

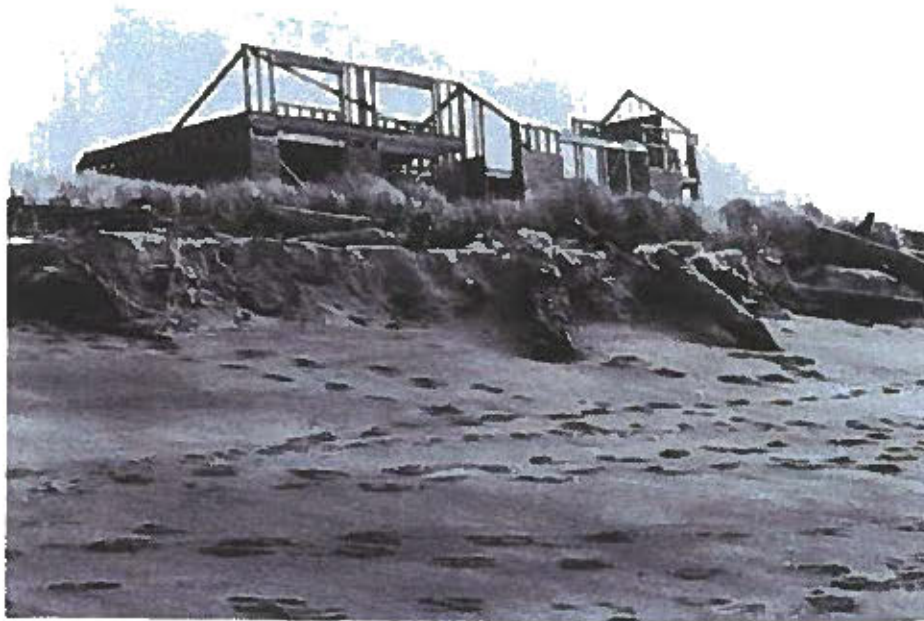
Photo 1 – From Komar and Rea (1976)

Figure 2. Erosion and destruction of the house under construction on lot 226 of Siletz Spit.

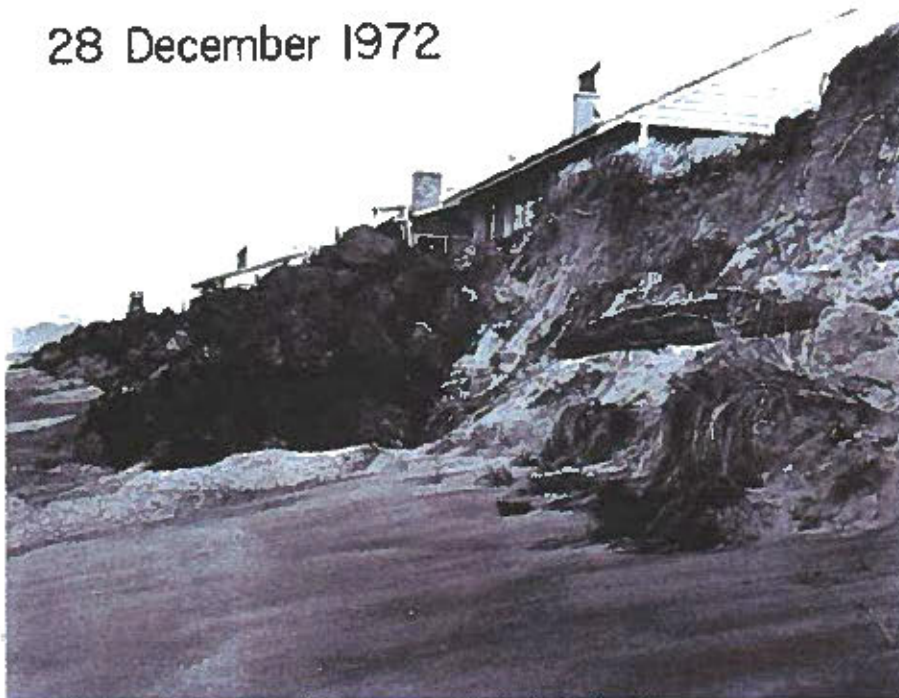
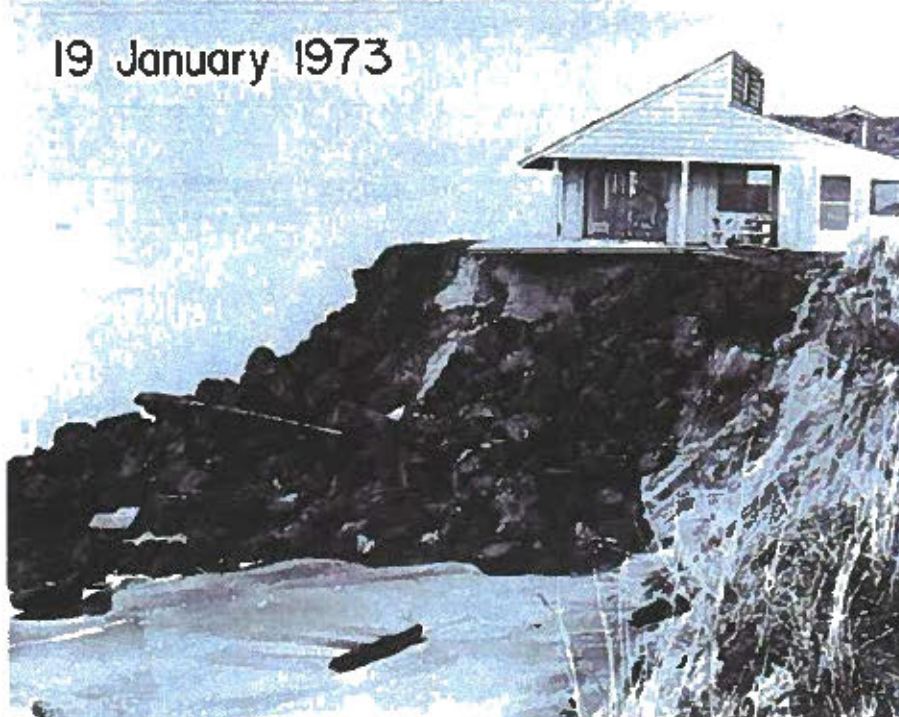
Photo 2 - From Komar and Rea (1976)

Figure 3. Erosion around the house on lot 229-A. Rapid erosion required placement of riprap fronting home in upper photo; but no riprap was installed in adjacent vacant lot, so erosion continued along the side as seen in lower photo.

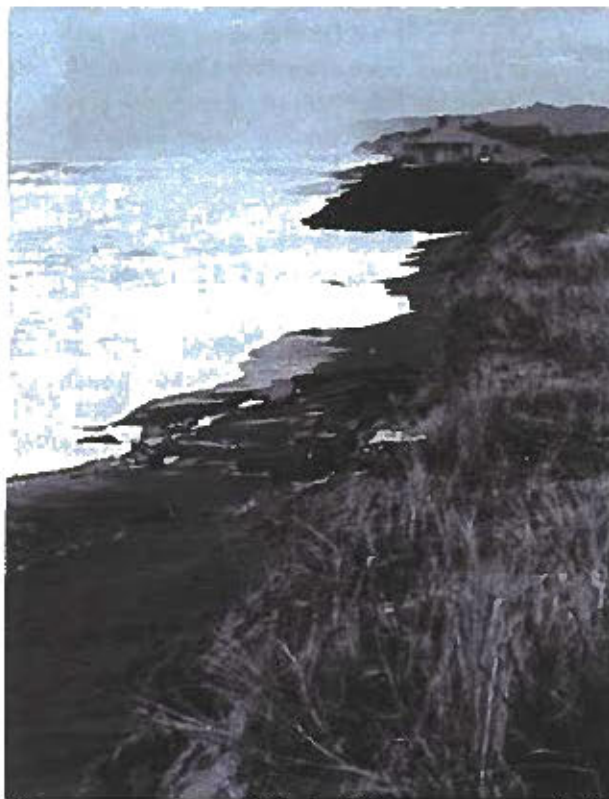
Photo 3 – From Komar and Rea (1976)

Figure 4. View of both houses of Figures 2 and 3.
