GFP Pavement Condition Rating Manual

Updated July 2010

Pavement Management Unit

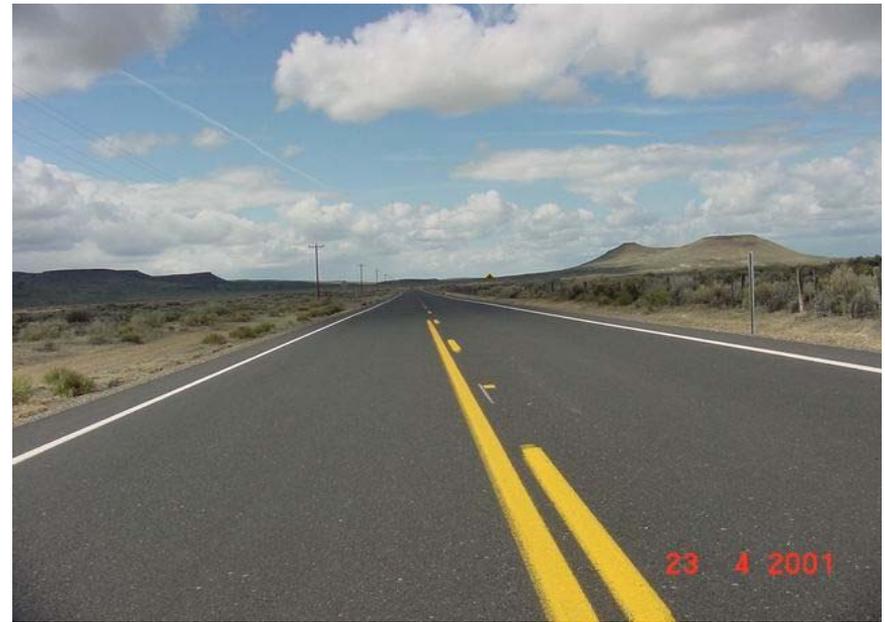
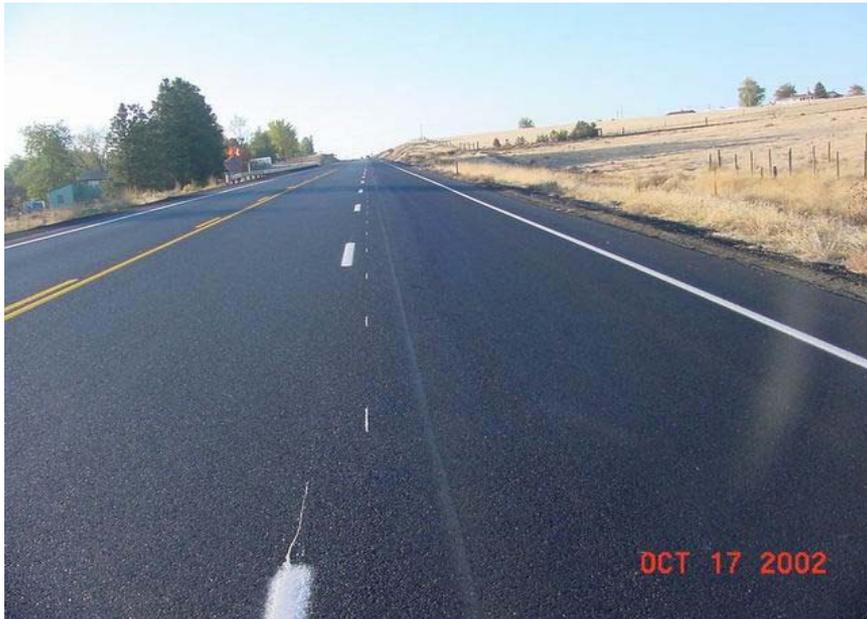
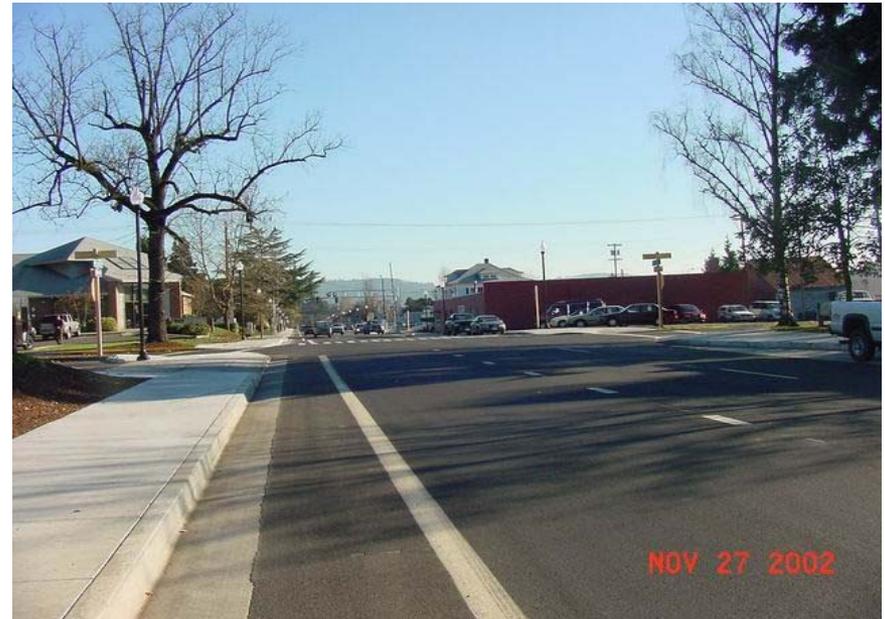
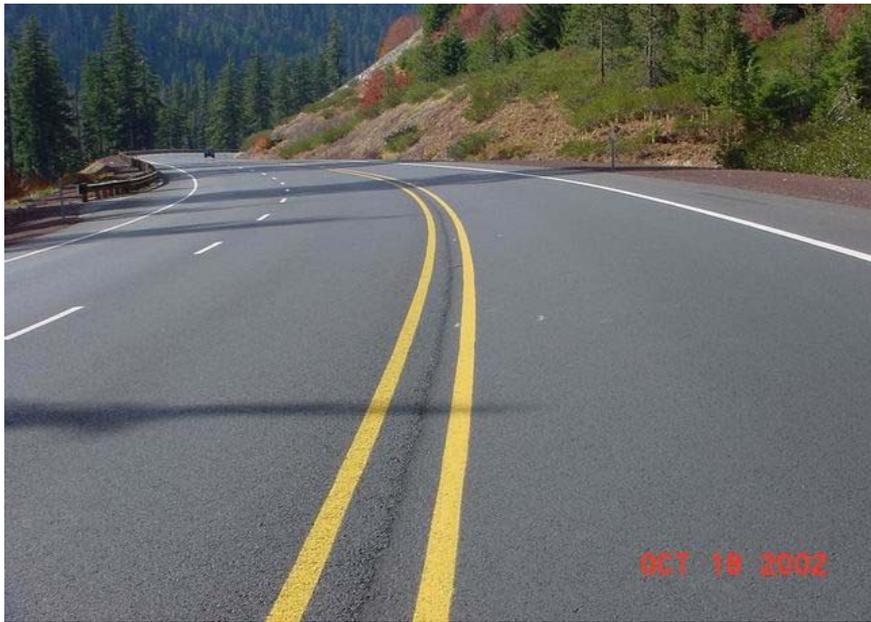
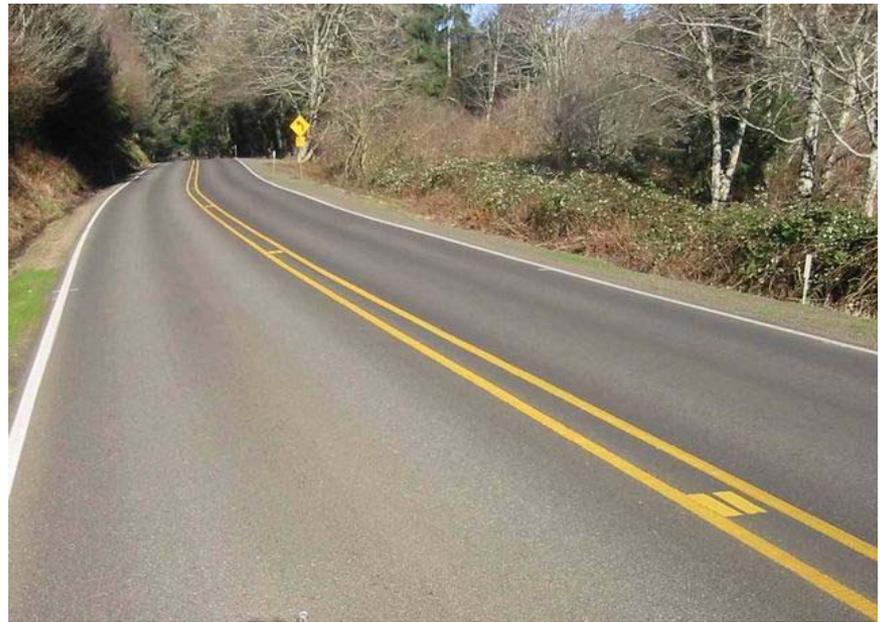
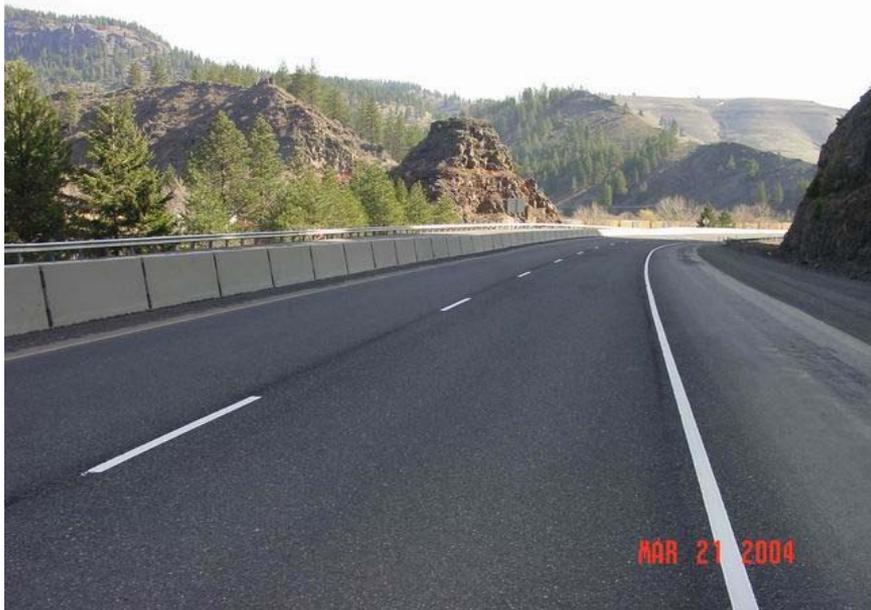
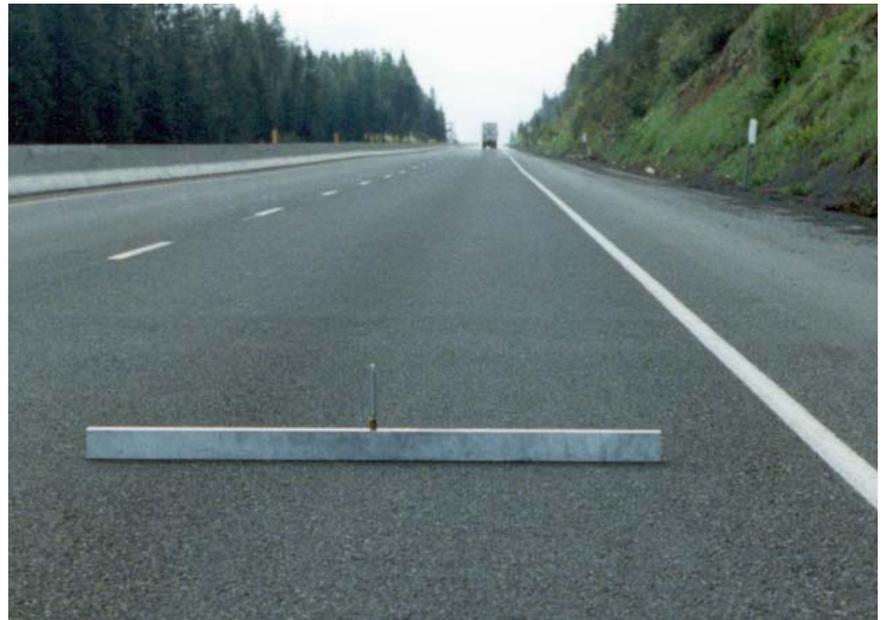
Condition – Very Good

Pavement structure is stable. No cracking, patching, or deformation evident. Riding qualities are excellent. Nothing would improve this pavement at this time. Roadways in this category are usually fairly new.

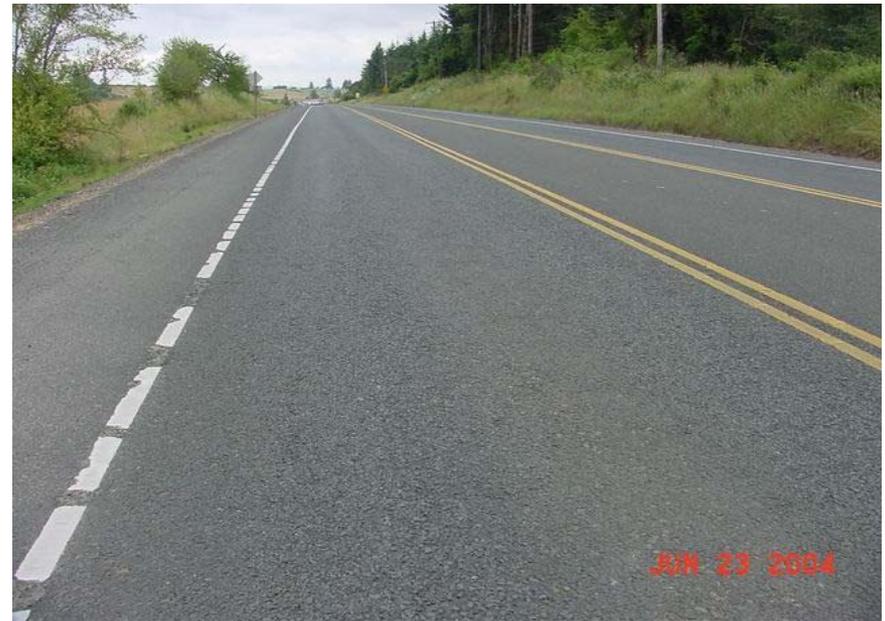
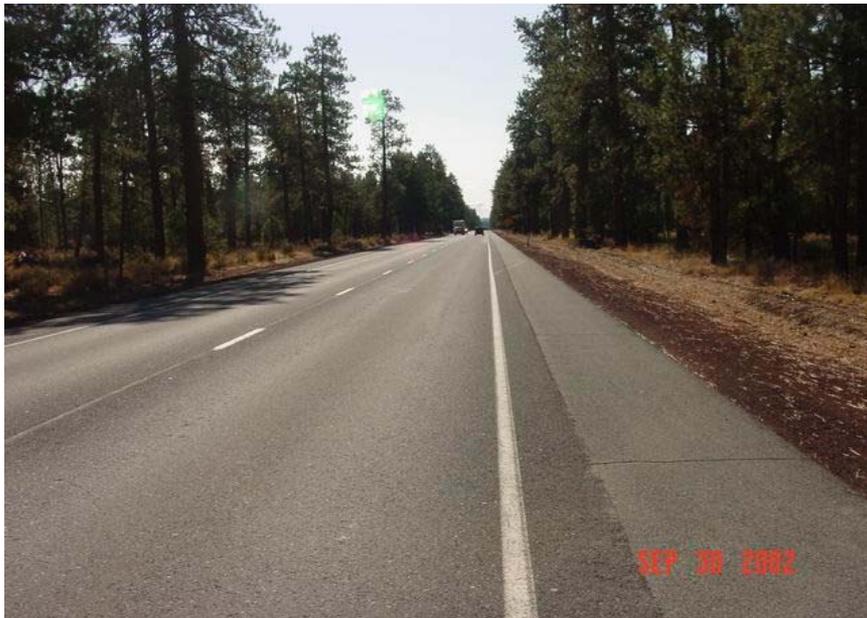
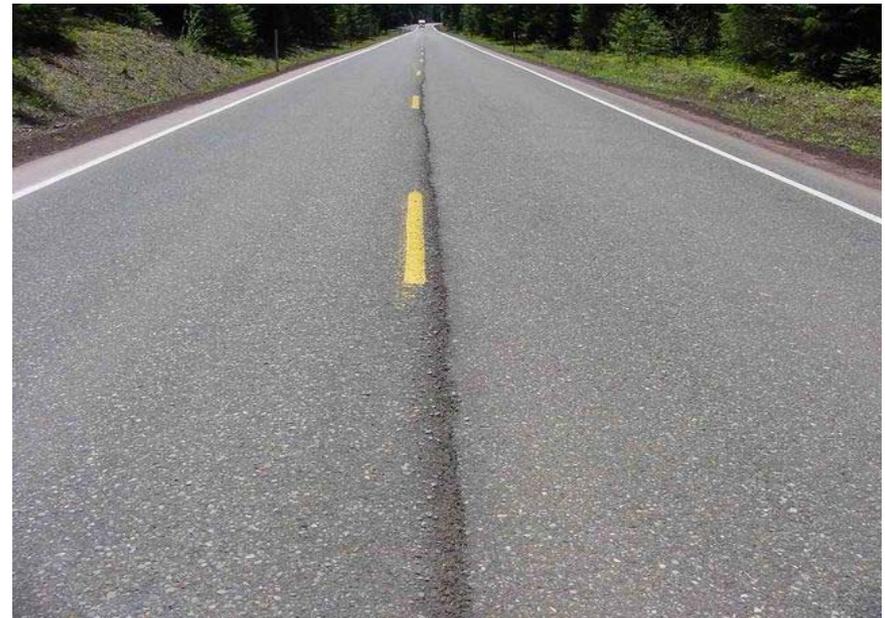
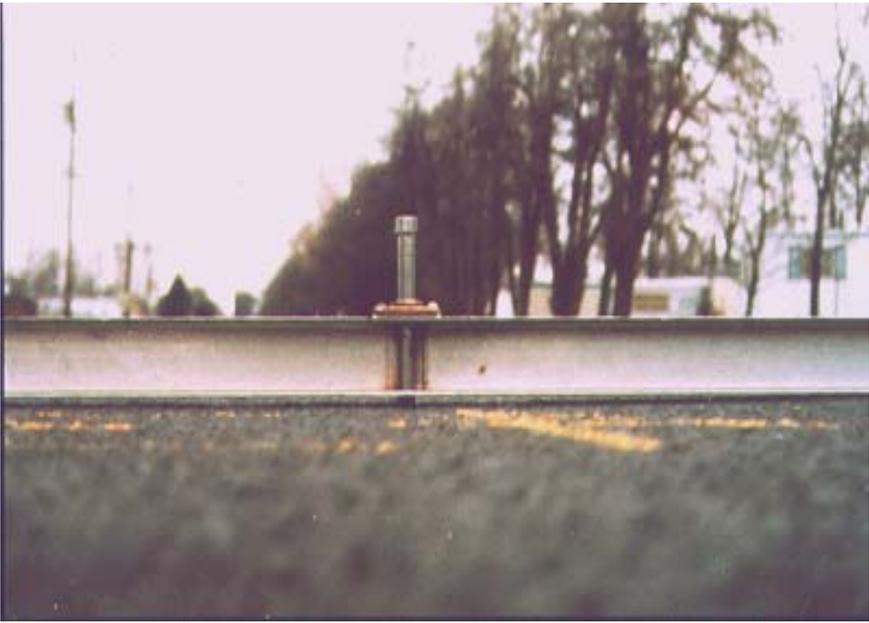
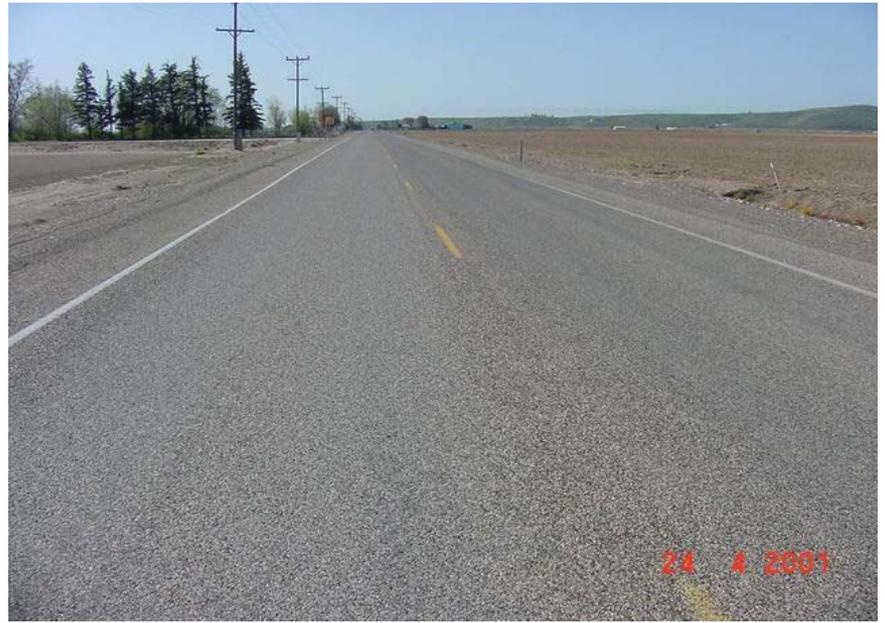
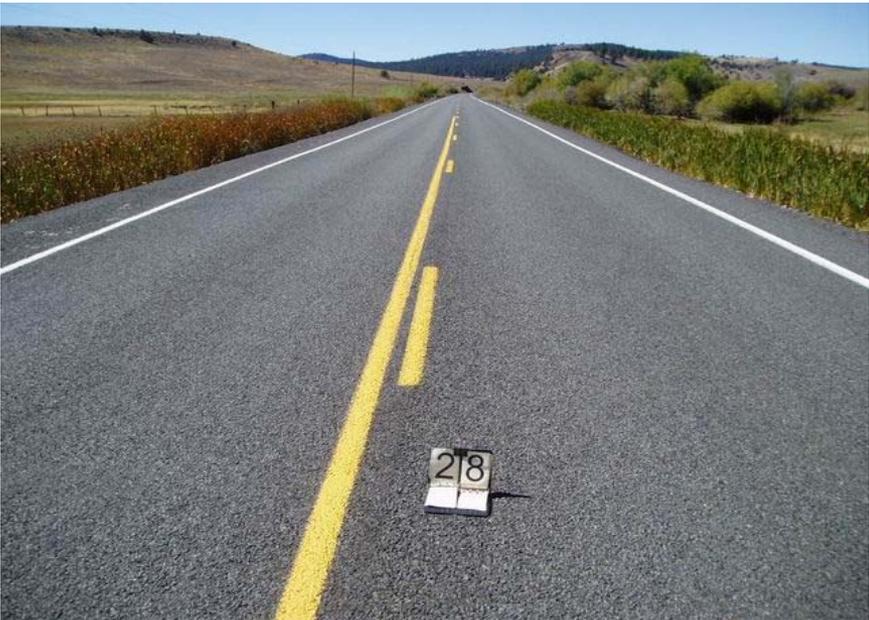
Condition – Good

Pavement is stable. Minor cracking may be present, but cracks are generally hairline and hard to detect. Minor amounts of patching and deformation may be present. May have a dry or light-colored appearance. Very good riding qualities. Rutting is less than 1/2”.

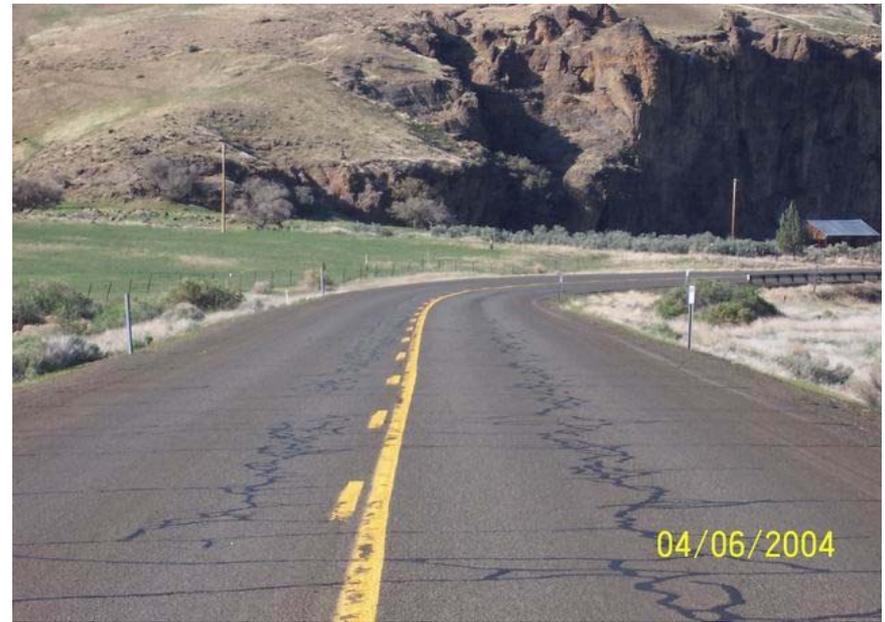
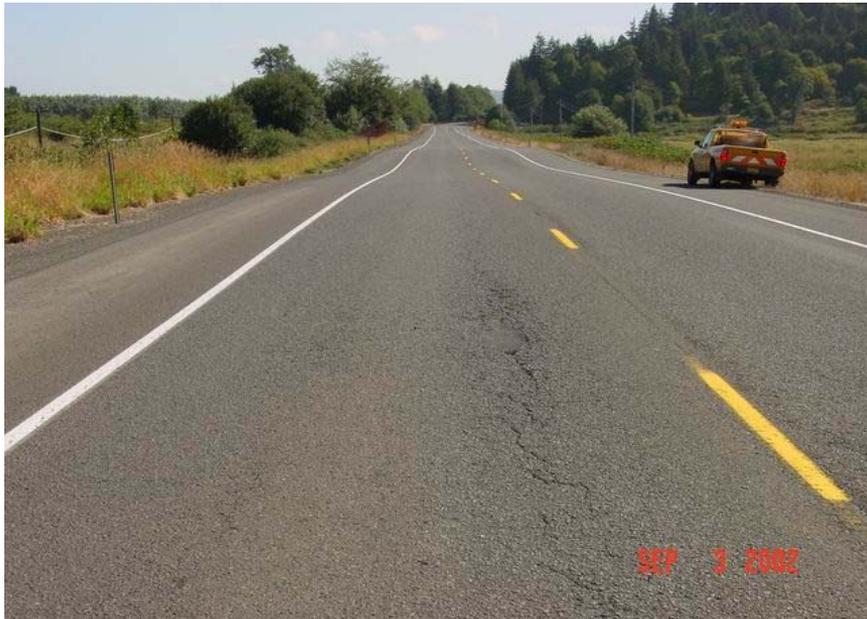
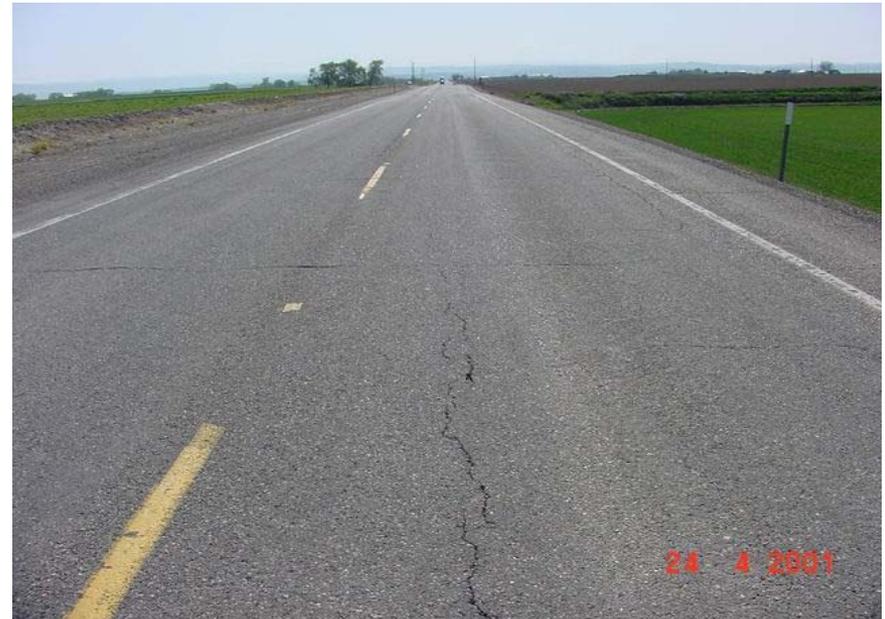
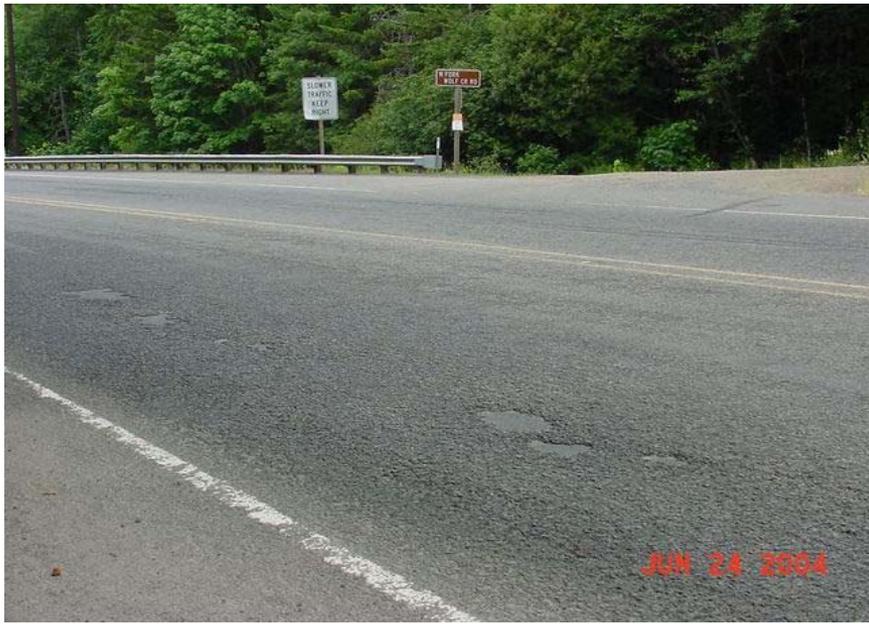
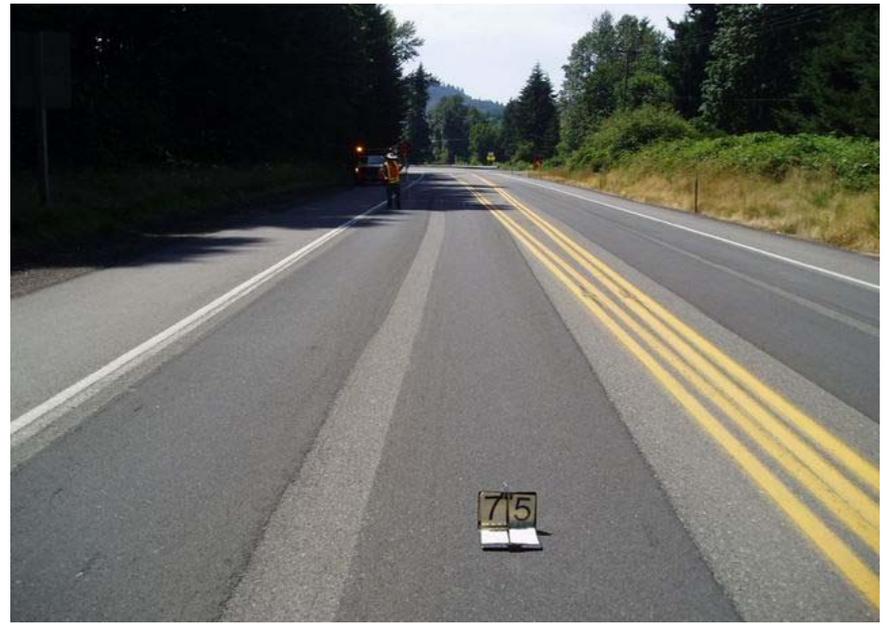
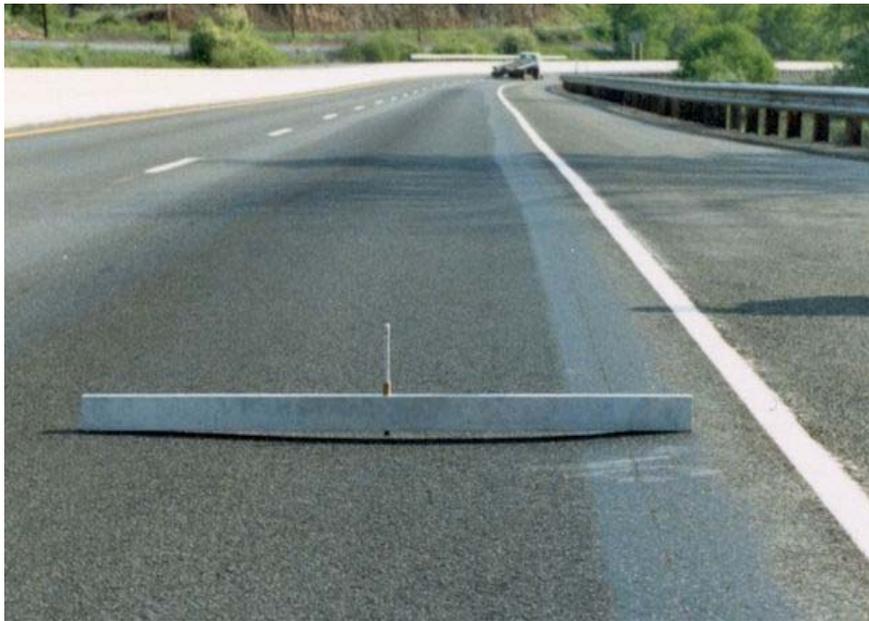
Condition – Fair

Pavement structure is generally stable with minor areas of structural weakness evident. Cracking is easier to detect. May be patched, but not excessively. Deformation more pronounced and easily noticed. Ride qualities are good to acceptable. Rutting is less than $\frac{3}{4}$ ".

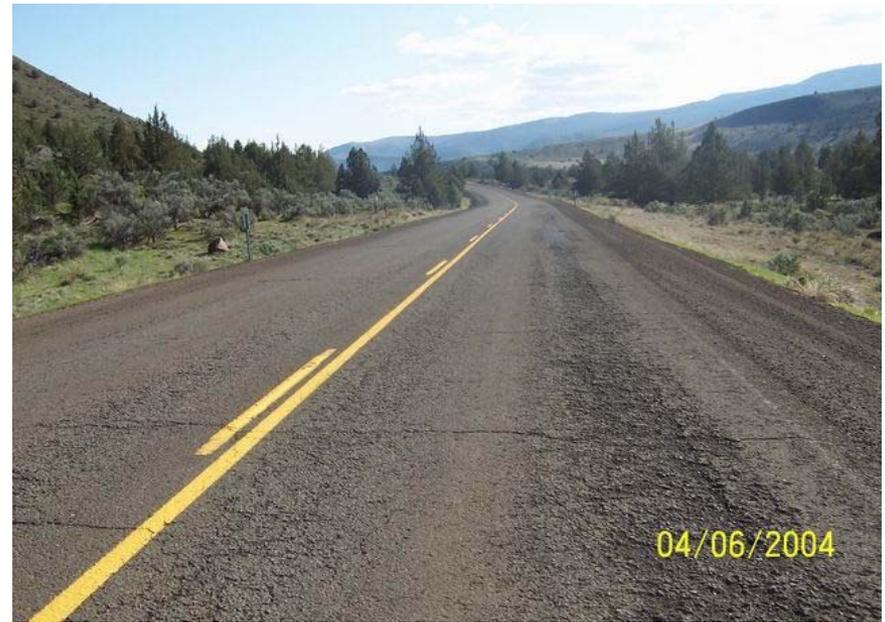
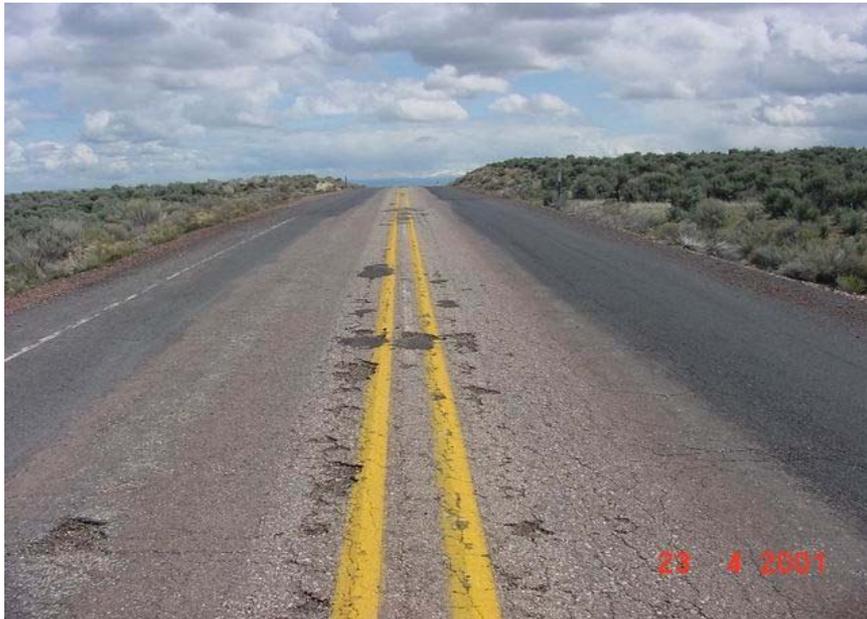
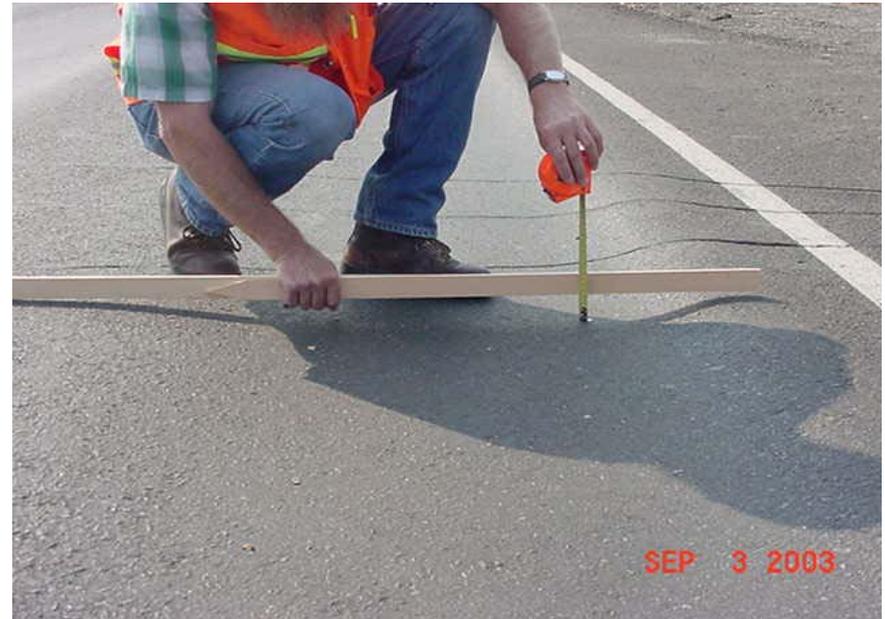
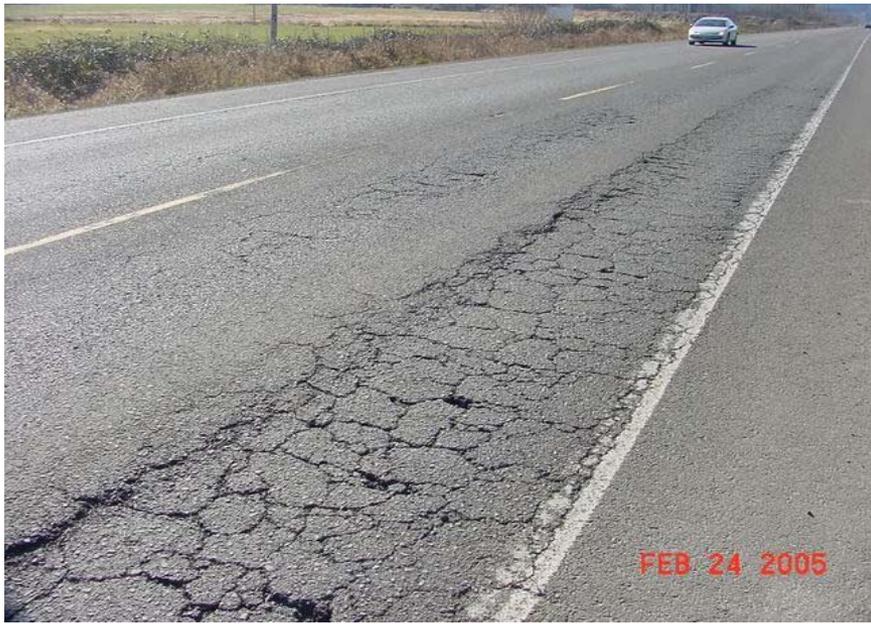
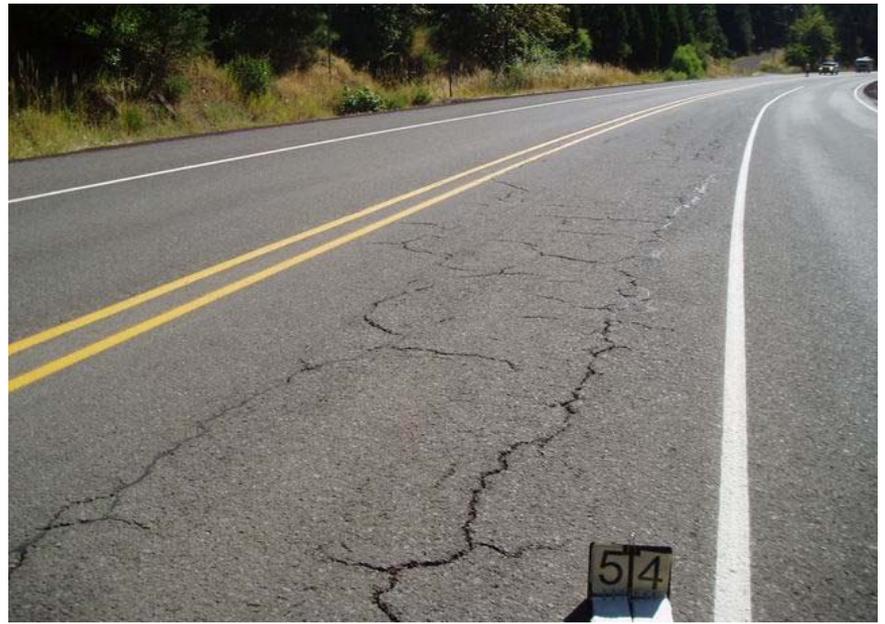
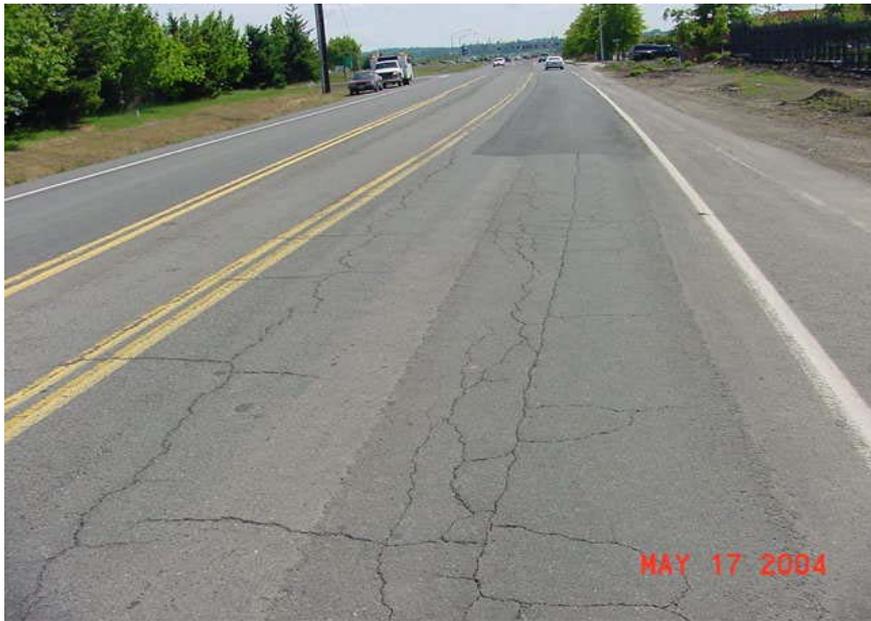
Condition – Poor

Pavement has areas of instability, marked evidence of structural deficiency, large crack patterns (alligating), heavy and numerous patches. Deformation is very noticeable. Riding qualities range from acceptable to poor. When rutting is present, rut depth is greater than $\frac{3}{4}$ ".

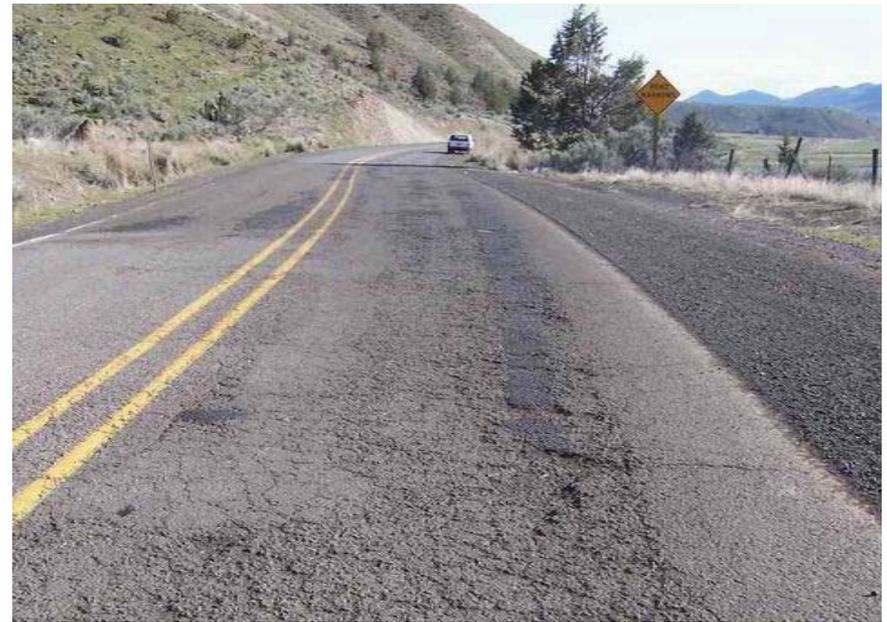
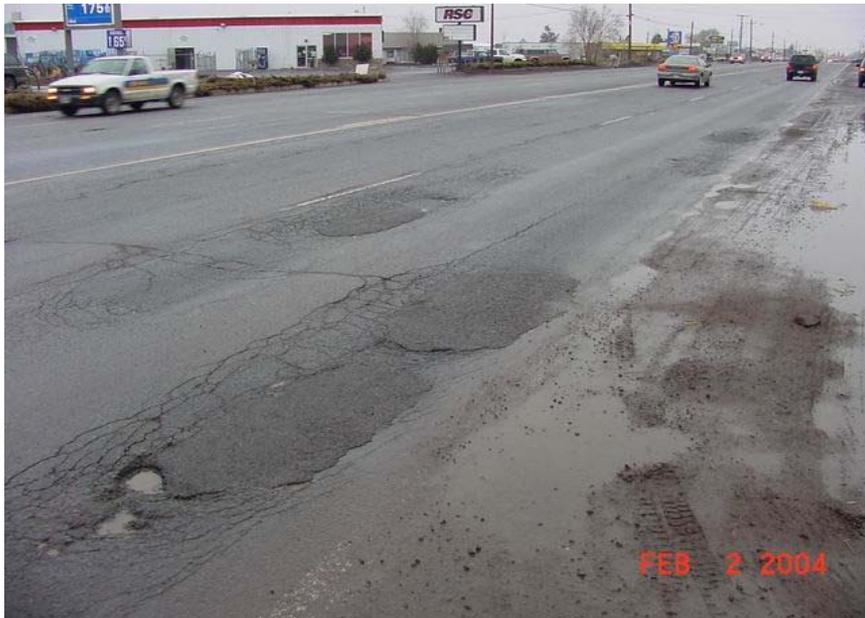
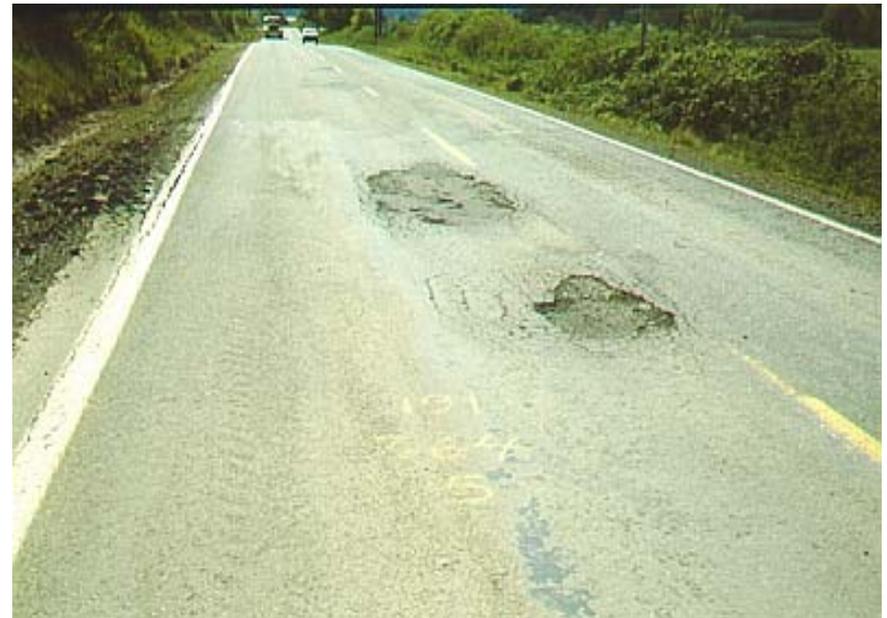
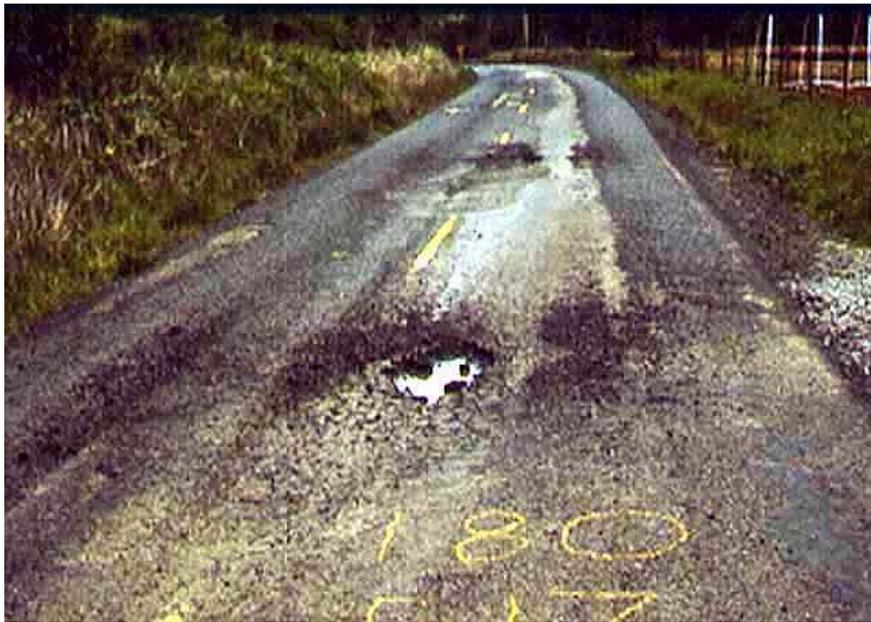
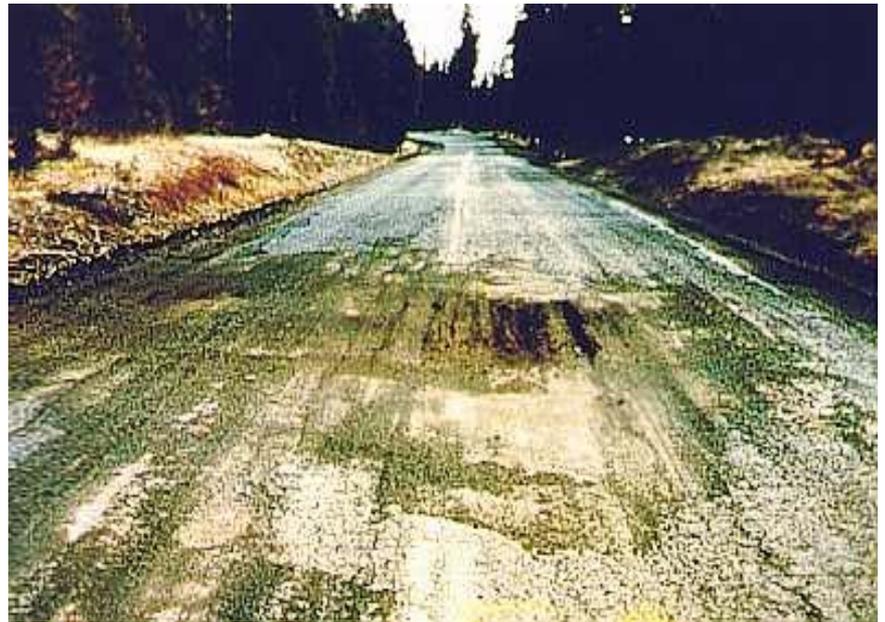
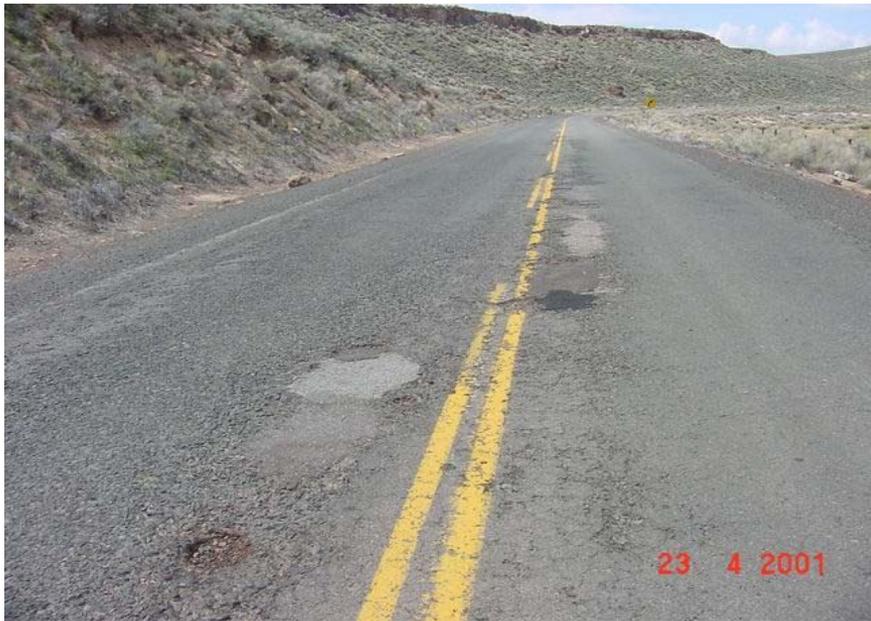
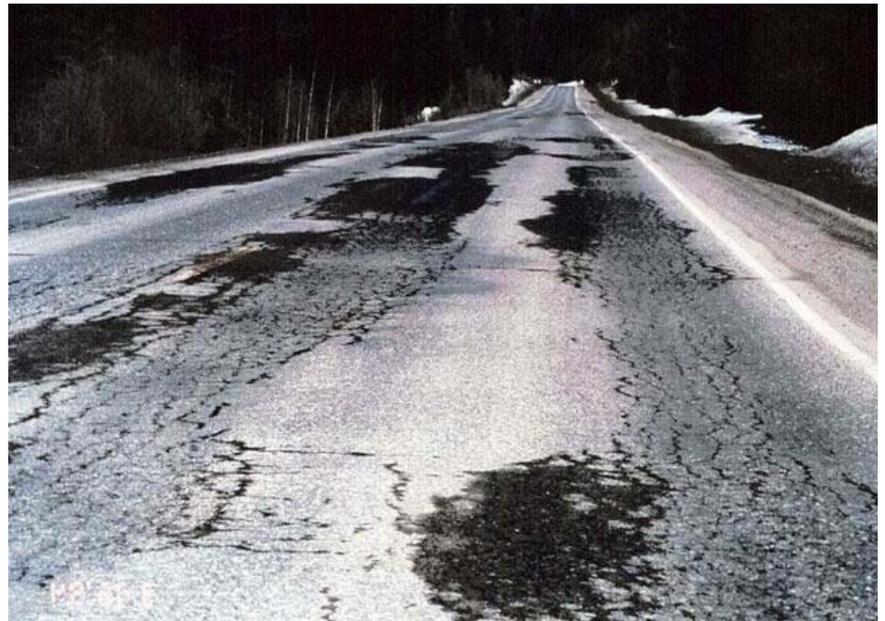
Condition – Very Poor

Pavement is in extremely deteriorated condition. Numerous areas of instability. Majority of section showing structural deficiency. Ride quality is unacceptable (probably should slow down).
