Introduction, Report Organization, and Summary of Findings

This report summarizes the existing conditions and deficiencies for the OR 126 Expressway corridor between Interstate 5 and McKenzie Highway (Main Street) in Springfield, Oregon¹. The following conditions and deficiencies are examined:

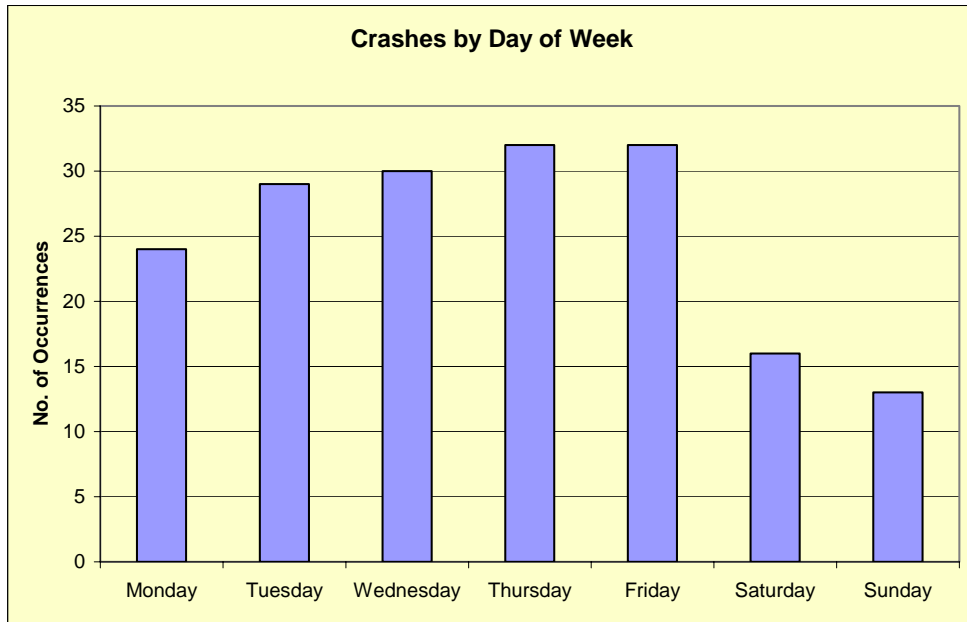
Figure 1. OR 126 Mainline Crashes by Day of Week

PRC crash data were also used to investigate crashes by day of week and time of day. Figure 1 demonstrates that crashes occur least on weekends and increase throughout the week, peaking on Fridays. Figure 2, which shows crashes by hour of the day, indicates that crashes occur more frequently during morning and evening rush hour, as well as during the lunch hour.

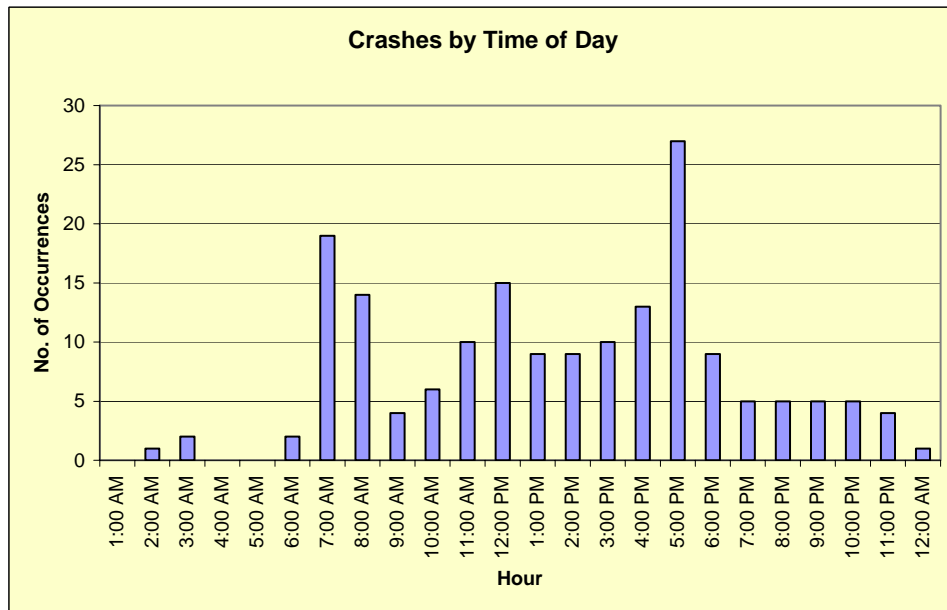
Figure 2. OR 126 Mainline Crashes by Time of Day
