**EVALUATION OF PILE REPAIR SPLICE  
DESIGN**

**Research Testing Report**

**REPORT 17384**

Oregon Department of Transportation

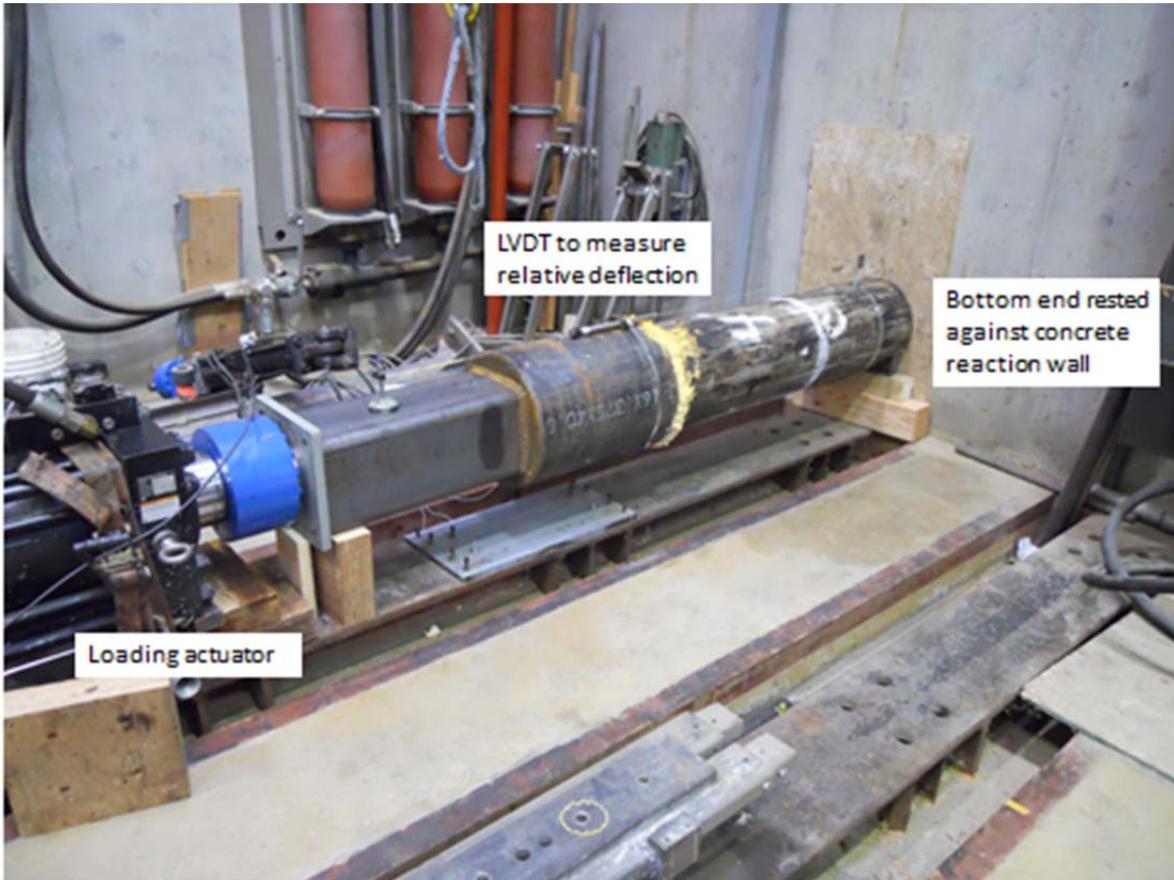
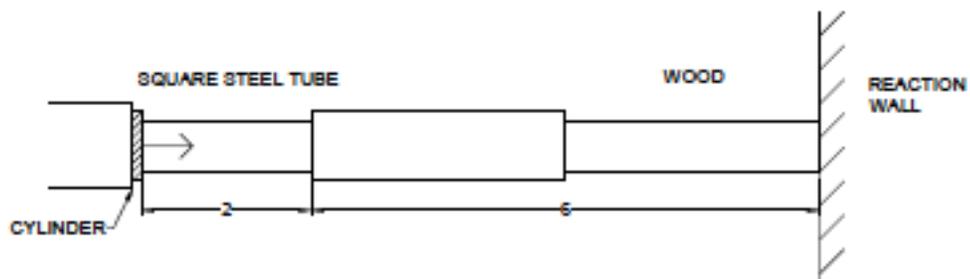
Figure 2.1: Compression pile test set up.

(All dimensions in feet)

The test setup for compression test is shown in Figure 2.1. There are no ASTM standards for testing of full size timber piles (Timber Piling Council 2002). Current design values for timber piles are developed after testing of small clear specimen as per ASTM D 143 (*ASTM D 143 2014*) and adjusting for defects and grade as per ASTM D2555 (*ASTM D2555 2011*) guidelines (*Timber Piling Council 2002*). Therefore, a set up based on ASTM D198 (*ASTM 2014*) which stipulates testing procedure for wood in structural sizes was used for this study. The compression tests were performed horizontally to ease the material handling process as well as for safety reasons. The pile was rested against a three feet deep concrete reaction wall designed to withstand a moment of 3000 kip feet (1 kip = 1000 lbs) with allowable deflection of 0.01". The pile was loaded axially using a 300,000 lbs (300 kip) actuator with a 20" cylinder travel. The cylinder was held with tie downs to prevent uplift of the cylinder that would in turn produce out

of plane loads. A linear variable displacement transducer (LVDT) was used to measure relative deflection between the steel casing and wood pile and had a gauge length of 40". The test was controlled by a constant rate of displacement of the hydraulic actuator. The rate of displacement of the actuator was 0.2" per minute and tested until failure or till the capacity of the actuator was reached (300 kip). Load, deflection of the load head, and LVDT deflection were continually monitored and logged using an automated data acquisition system. Using the monitored load and deflection data, load-deflection curves were generated for further analysis.

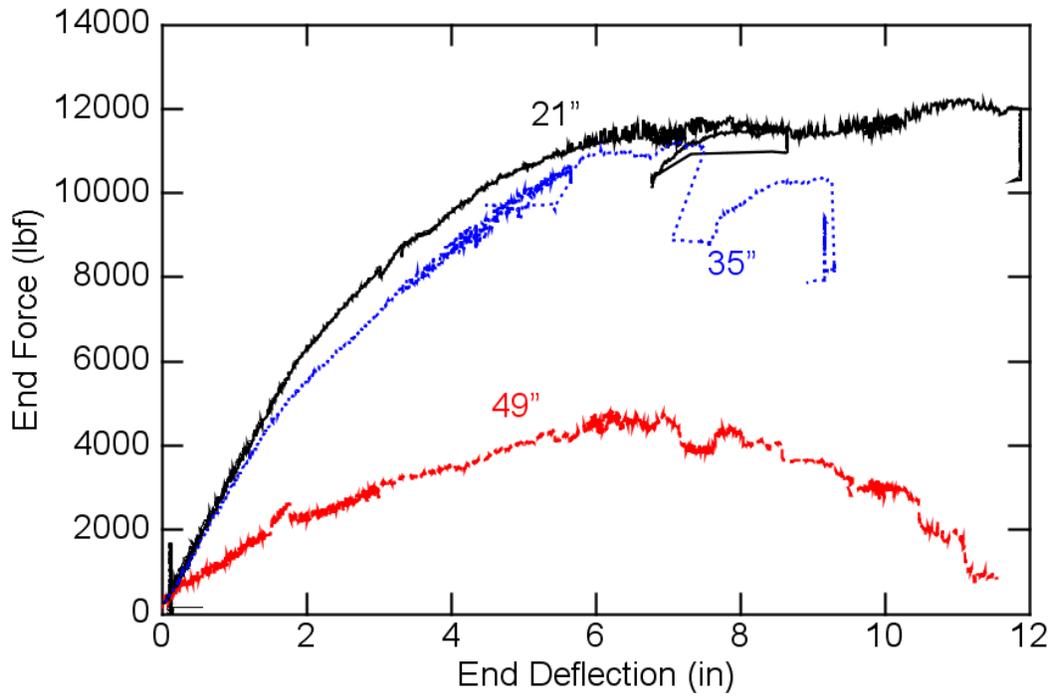
(a) End force vs. deflection at the tip

Figure 3.1: Load-deflection plots for three bending tests.

The load deflection diagram from the three flexural tests is presented in Figure 3.1. Two separate load deflection behavior is presented - tip load vs. tip deflection (Figure 3.1a) and end force or base reaction vs. tip deflection (Figure 3.1b). The base reaction is the force measured at the actuator restraint (Figure 2.2). Each curve has a characteristic linear portion, followed by a shift point beyond which the load-deflection relationship is non-linear. This represents the point that the repaired piles could be deflected to without compromising elasticity. Apparent lateral stiffness as indicated by the slope of the linear portion of the curve is presented in Table 3.2. Qualitatively a decrease in the slope of load deflection diagrams is observed as the concrete plug depth increases. This is validated by calculated values (presented in Table 3.2) of the slope of the initial straight line portion of the load-deflection plots. With the increase in concrete plug depth, a decrease in ultimate bending load was observed. Similar to compression tests, this behavior cannot be statistically validated due to lack of replication. The predominant failure mode for all three piles was through localized crushing of wood near the perimeter fill of the steel casing followed by tensile wood failure in the pile. This was more prominent in the 49” concrete plug depth pile, i.e., tensile bending of the wooden pile and exaggerated localized crushing of wood at the fulcrum point between the steel casing and the pile. The ultimate load observed would induce a lower moment (as listed in Table 3.2) on wood concrete interface than the calculated design capacity of 137 kip feet. Therefore, the splice repair did not restore the original design moment

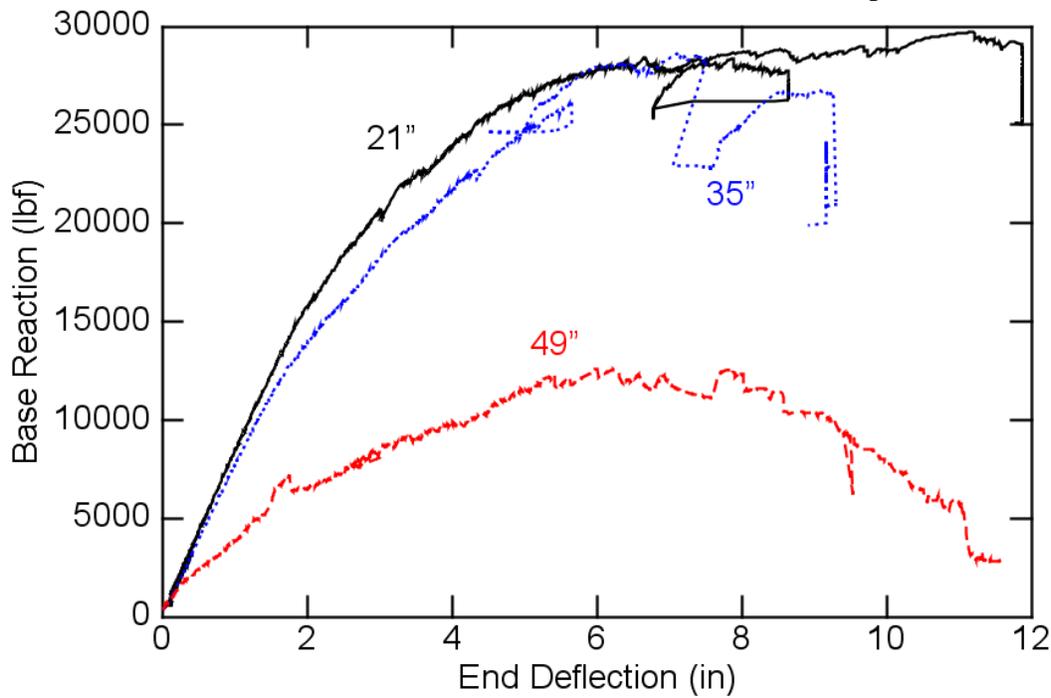
(b) Base reaction vs. deflection at the tip

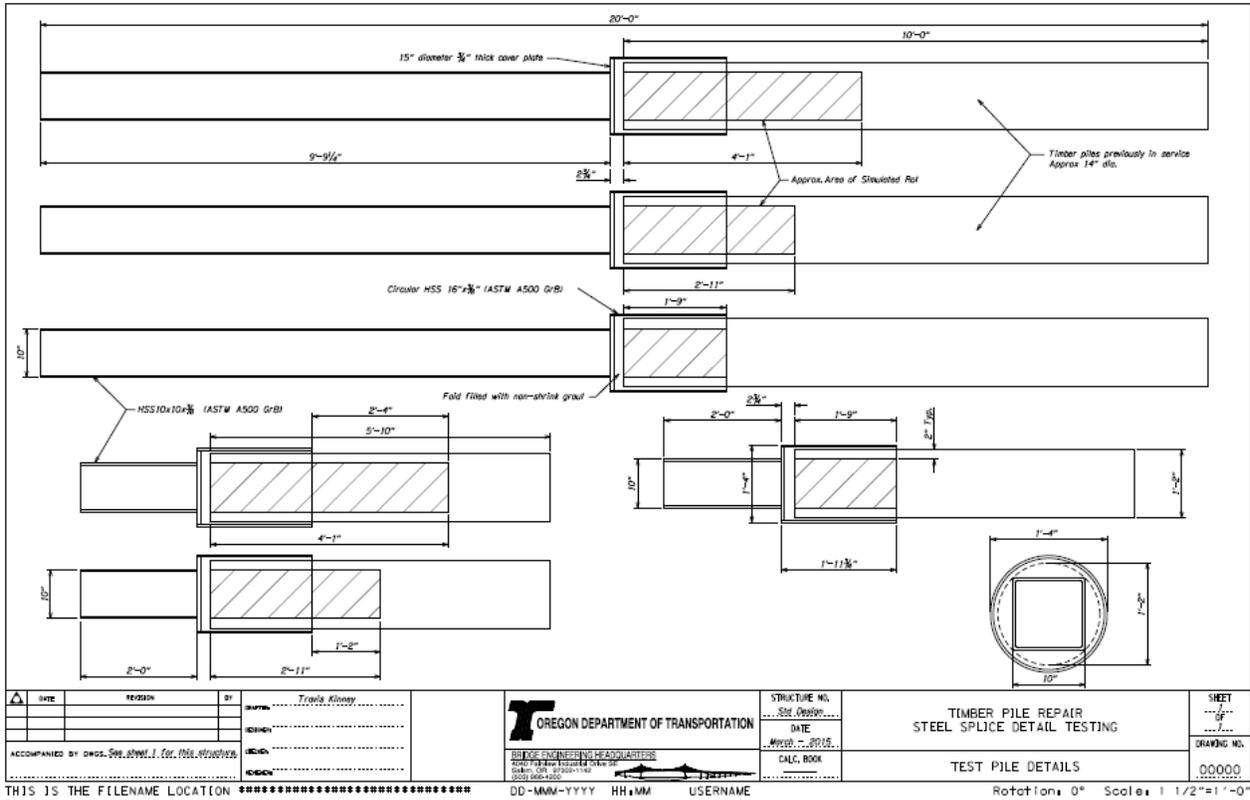
Figure A.1.1 : Timber pile repair splice test specimen detail

Six timber piles were removed from service by an ODOT Bridge Maintenance crew and brought to an ODOT maintenance yard where a pile splice procedure was conducted. Only one of the six specimens had actual rot present within the core of the pile. To mimic rot, the piles were augur drilled to desired length and then filled with concrete. Subsequently, splicing was performed following the steps outlined in the previous section. The spliced pile sections were then delivered to the Department of Wood Science and Engineering on May 1, 2015. A schematic of the piles is presented in Appendix A1. Out of the 6 piles, three were for compression tests and the other three were for flexural tests. The variable examined for both compression and flexural tests was concrete plug depth. A summary of all six pile types and a typical concrete fill depth are presented in Table 2.1. The compression piles had a square 10x10x.38 tube of length 24" followed with a sleeve that was 20" long, and the wooden pile of 14" nominal diameter was 32" long. On the other hand the flexural piles were 96" long 16" nominal diameter piles, followed by a 20" long steel sleeve that facilitated the connection to a square 10x10x0.38 pipe.

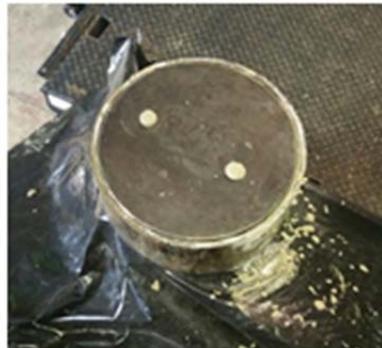
(e) Mortar mix and steel casing

Figure A.1.2 : Pictorial overview of the manufacturing process of the test specimen.

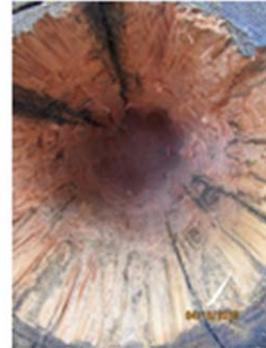
(d) Simulated rot
