**HISTORIC STRUCTURE REPORT**

**BIRCH CREEK RANCH**

**HISTORIC RURAL LANDSCAPE**

**MALHEUR COUNTY, OREGON**

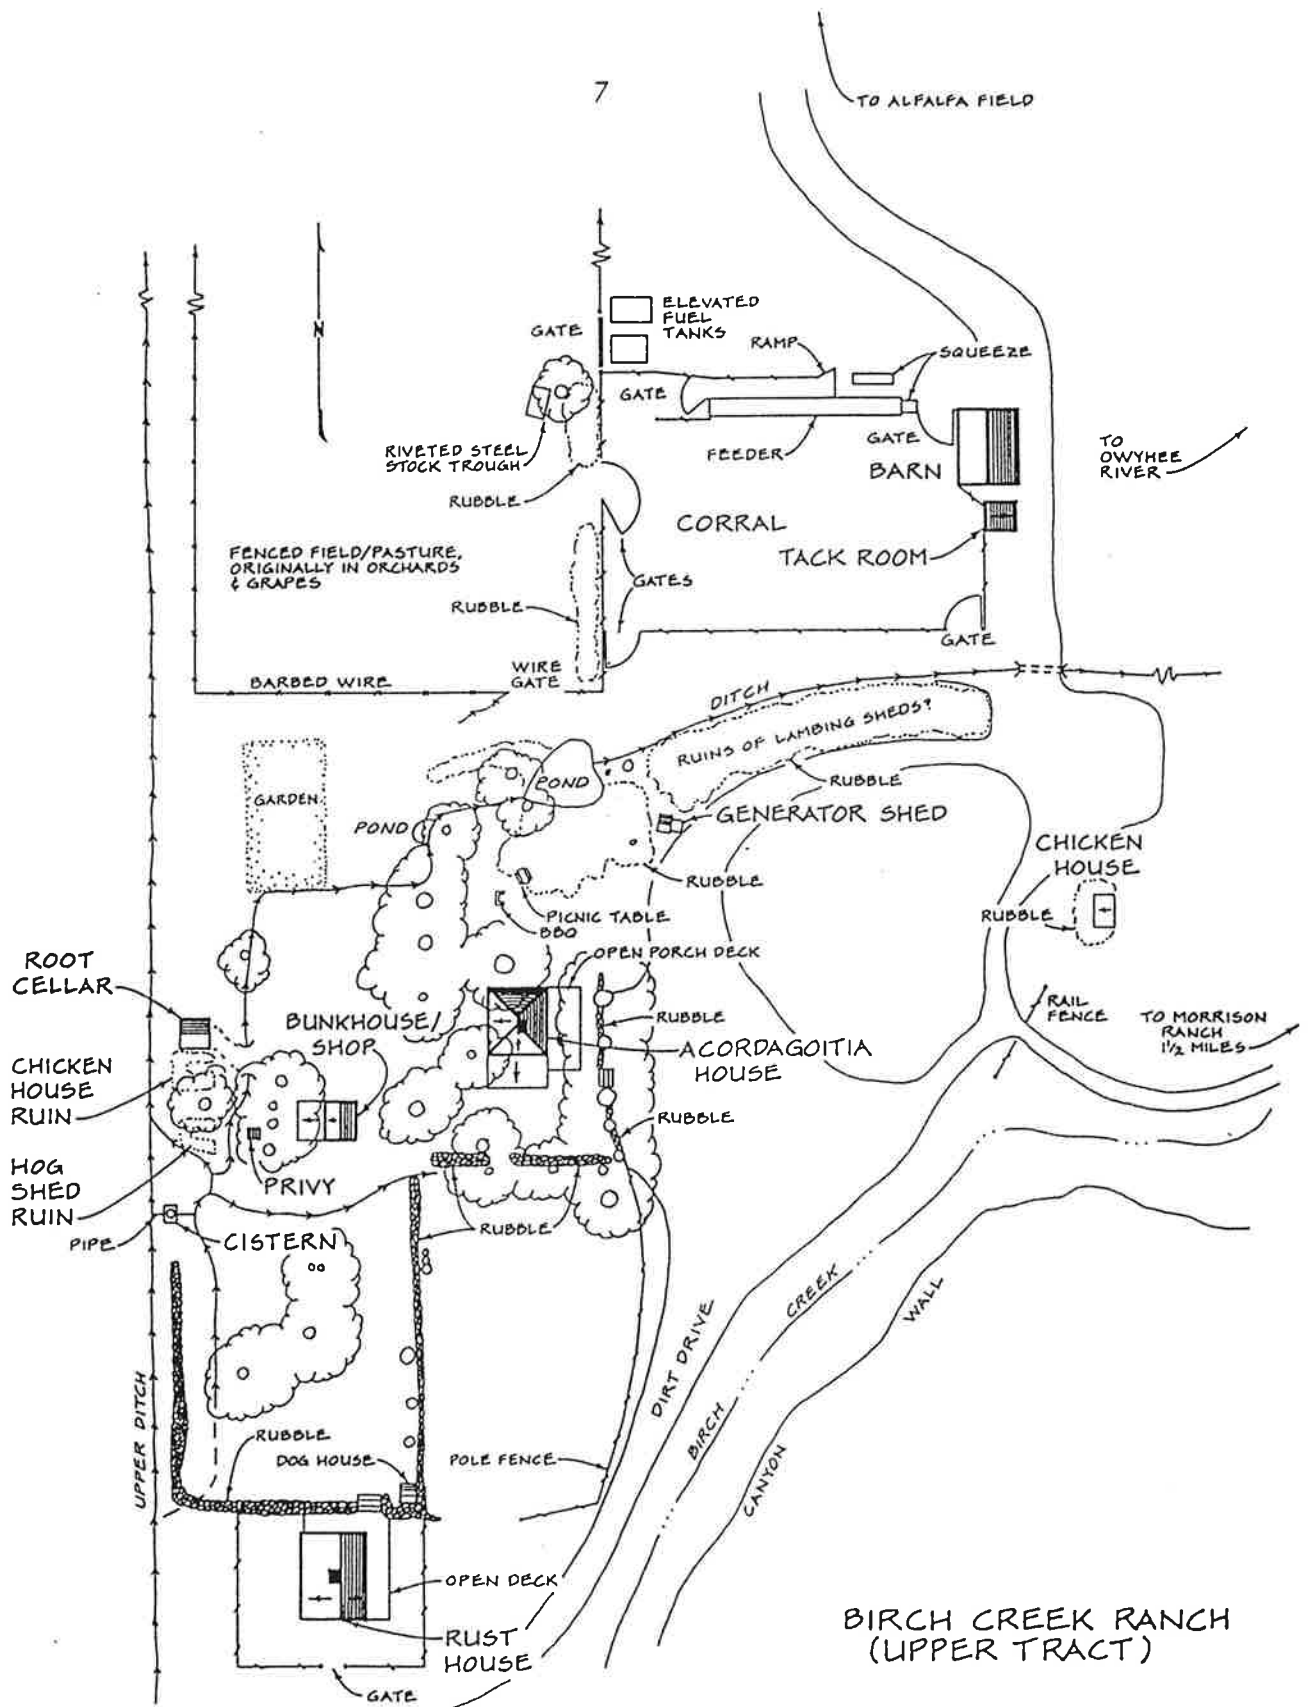
Figure 4. Birch Creek Ranch (Upper Tract) headquarters site plan (September 1995).

*Use*--The chicken house is a later addition to the building group at Birch Creek Ranch and is the second to be constructed on the property. The original chicken house was located to the south of the root cellar (see Figure 4). Only a pile of rubble remains at this site. The BLM caretakers were told by informants that the sill members used in the construction of this building were salvaged from an old "rock boat" that was used to haul the rubble stone to various building sites, particularly the stone fences, around the ranch property (Krause and Krause 1995). They were told that this chicken house was constructed sometime during the 1940s to replace the earlier structure. Currently, the structure is not being used.

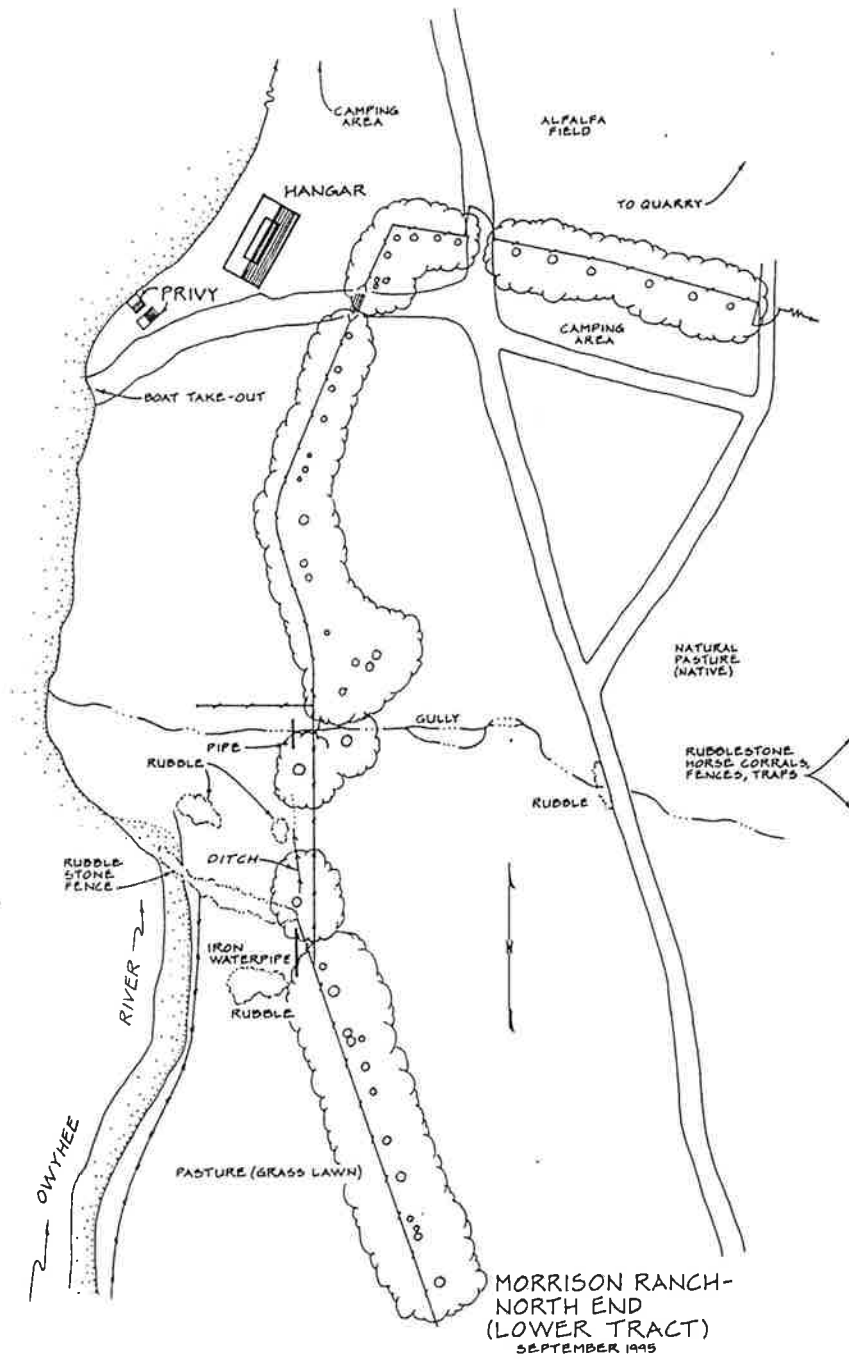
Figure 6. Morrison Ranch (Lower Tract) site plan of north end (September 1995).

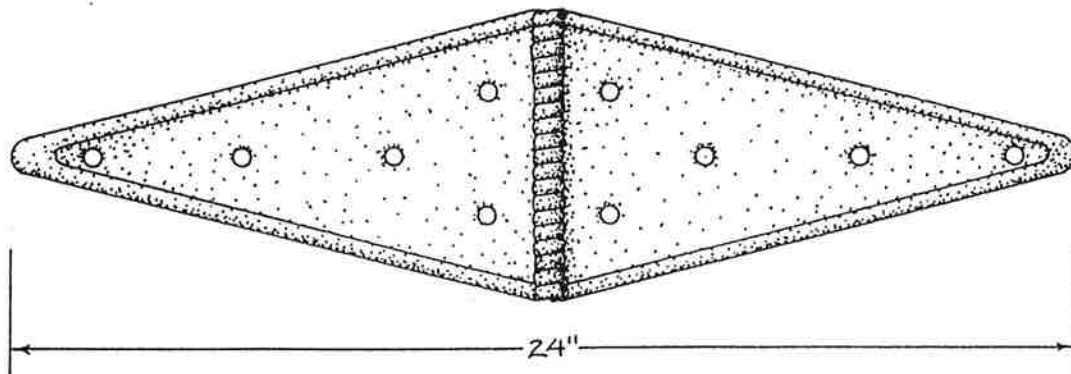
Figure 10. Typical strap hinge used in the construction of the barn.

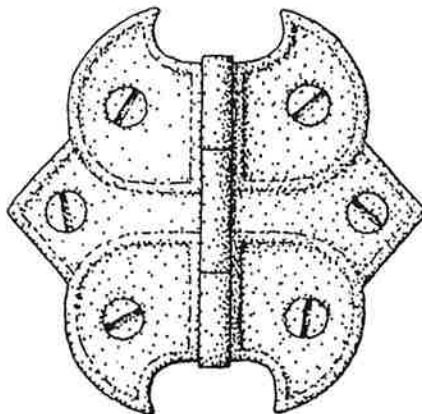
Figure 20. Type of hinge found on chicken house windows and hen doorway (not to scale).

The east elevation (front) of the chicken house is enclosed only with chicken wire attached to 2x4 studs. A single-width board and batten door with a top-hinged chicken door at the bottom exists at the northeast corner. The door is constructed of 1x7 and 1x9 vertical boards with 2x4 cross battens and fastened to the structure with standard, ferrous metal strap hinges. There are window openings on both the south and north walls. The windows are casement, but most of the sash is missing except for the casing where hinges are still attached. These hinges are of the same style as the chicken door hinges (Figure 20).
