Technology and Risk **Implanted Pain Pumps**

An Oregon hospital has reported to the Patient Safety Commission that it has had an incident involving an implanted pain control device. The patient suffered no permanent harm, but the reporting hospital believes underscoring the risk involved in refilling the device is important to prevent future occurrences.

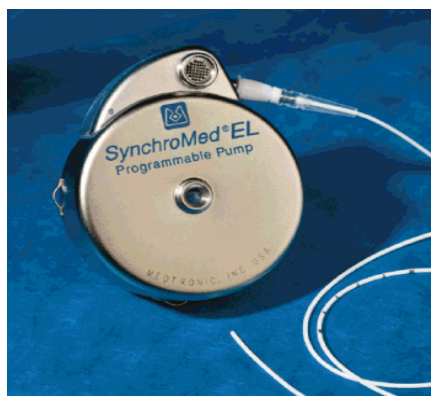
Why we are sharing this information: While this incident was associated with a procedure that is uncommon, the associated risks are very high. Implanted pumps are used to deliver medication into the intrathecal space to treat pain, spasticity, and cancer. Because the pump is inserted below the skin, the port used to refill the pump is not visible and is identified using a template provided by the manufacturer. The pump does not have an internal sensor to indicate the level of fluid in the reservoir, so does not provide feedback. The identified risk is that medication could be instilled into surrounding tissue if the port is not accessed.
