4. Critical and Essential Buildings

Introduction

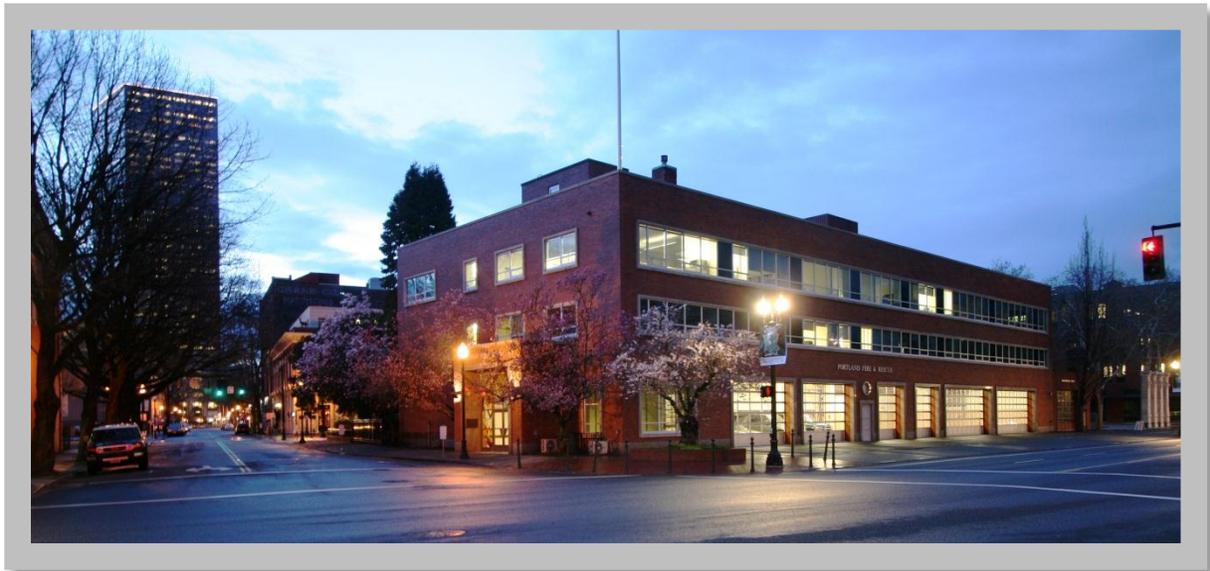
Figure 4.4: Some cities in Oregon have already started seismic rehabilitation program to strengthen the fire stations that are susceptible to serious damage in an earthquake. Fire Station #1, the largest in Portland, was retrofitted in 2009. It should now be in working order after an earthquake, serving downtown Portland. (Source: Peck Smiley Ettlin Architects)

To our knowledge, a mandatory program with a formal mechanism to identify deficient structures and require their upgrade with a firm timeline does not currently exist. ORS 455.400 requires seismic rehabilitation of publicly-operated emergency operations centers, police stations and fire stations by 2022, but with the caveat of being, “subject to available funding.” As a result, it appears to have had only limited effect in this and other essential and critical building sectors. Typically, the impetus to evaluate these types of buildings to determine their seismic-resisting capability is motivated at the local level, often by the public agency itself. Once the evaluation has been completed, a determination can be made about whether a particular building or group of buildings requires seismic rehabilitation. The agency will then submit a request to the voters within that community to support a general obligation bond to accomplish the needed work. This was recently done within the city of Portland, where a general obligation bond was passed in 1998 to rehabilitate the city’s fire stations (See Figure 4.4). The last fire station rehabilitation was completed in 2012.

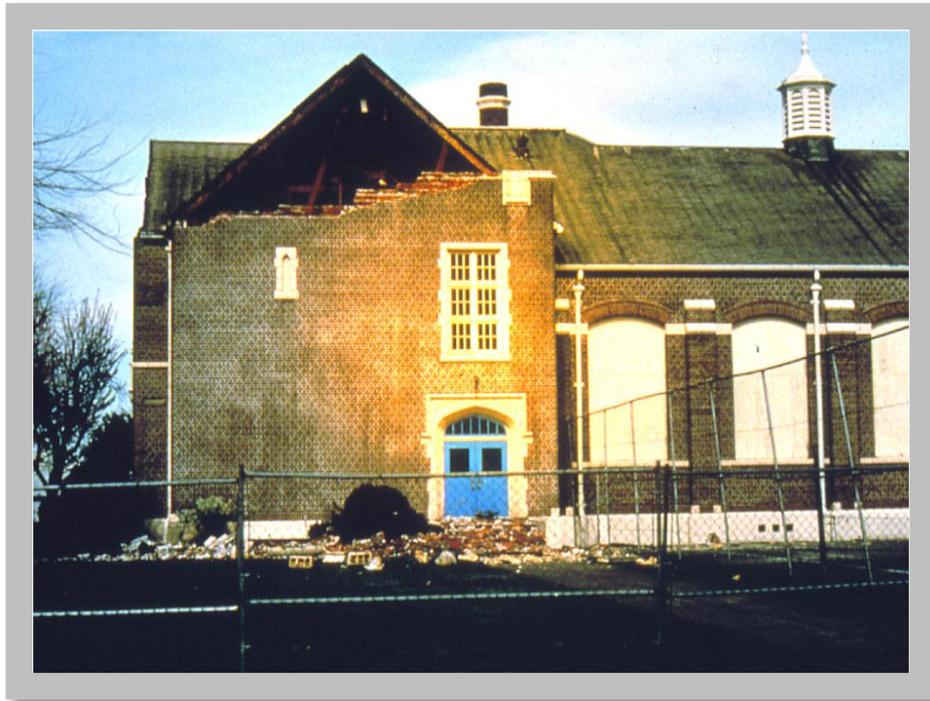
Figure 4.5: The previous Molalla High School building, a three-story unreinforced masonry structure, was damaged from the M5 .6 Scotts Mills, Oregon earthquake in 1993. It happened during spring break, when the school was empty, which prevented serious injuries. The district took the opportunity to forecast future needs and decided not to rebuild at the same location. Molalla High School is now housed on a larger campus with a stronger, more spacious building. Many URM schools and other buildings in Oregon could suffer a similar fate in future earthquakes. Communities can act now to plan how and when to rehabilitate or replace these aging, potentially dangerous facilities. (Source: DOGAMI)

The building stock of Oregon’s K-12 schools possesses seismic vulnerabilities that are common to the specific building types of which it consists. Unreinforced masonry (URM) buildings historically perform poorly in seismic events and are the most dangerous existing building type in the school building stock (See Figure 4.5). Many 1930s-era multistory schools rely on lightly-reinforced concrete shear walls that are historically poor performers as well. Wood framed schools should perform well provided they are well constructed, even though many of them pre-date building codes. These wood buildings may possess deficiencies, including weak or missing roof-to-wall connections, and weak or missing anchorage of walls to foundations—all of which could contribute to poor seismic performance. Concrete tilt-up buildings have also proven to perform poorly in earthquakes. Newer tilt-up buildings have been improved by code changes adopted following the 1994 Northridge earthquake in California, but older tilt-up buildings, and even CMU buildings, may remain vulnerable due to poor connections between heavy rigid walls and flexible roofs. Modular classrooms may also be vulnerable, because they may have insufficient connections to their foundations. In addition, many schools contain unsecured and inadequately braced nonstructural components that may present falling hazards during a seismic event (See Figure 4.6).

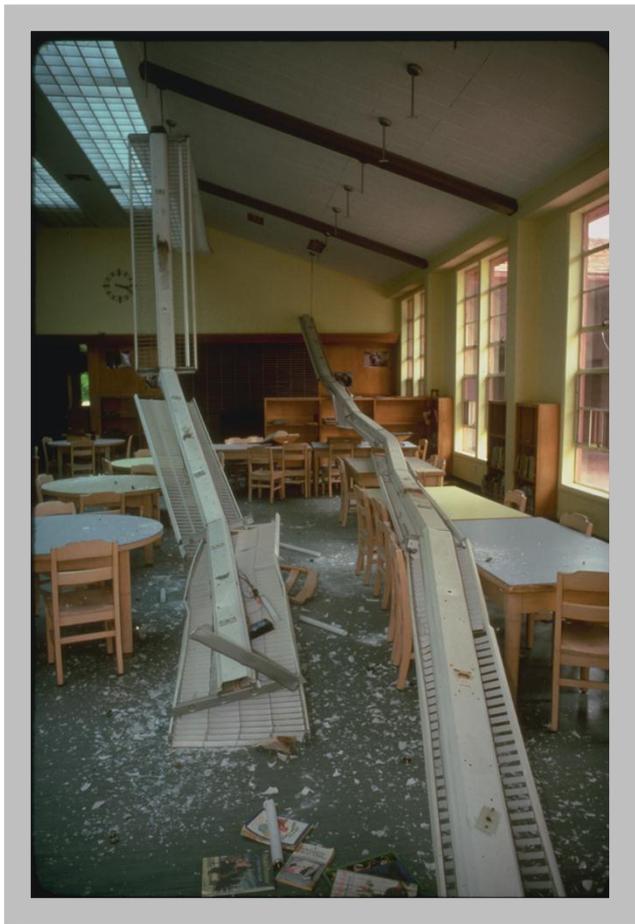
Figure 4.6: Pendant light fixtures failed in this elementary school library during the 1983 M6.5 Coalinga, California earthquake. If the room had been occupied, this could have caused injuries. Bracing nonstructural elements in homes, schools, and offices can often be done easily and relatively inexpensively. (Source: NOAA/NGDC, Earthquake Engineering Research Institute)

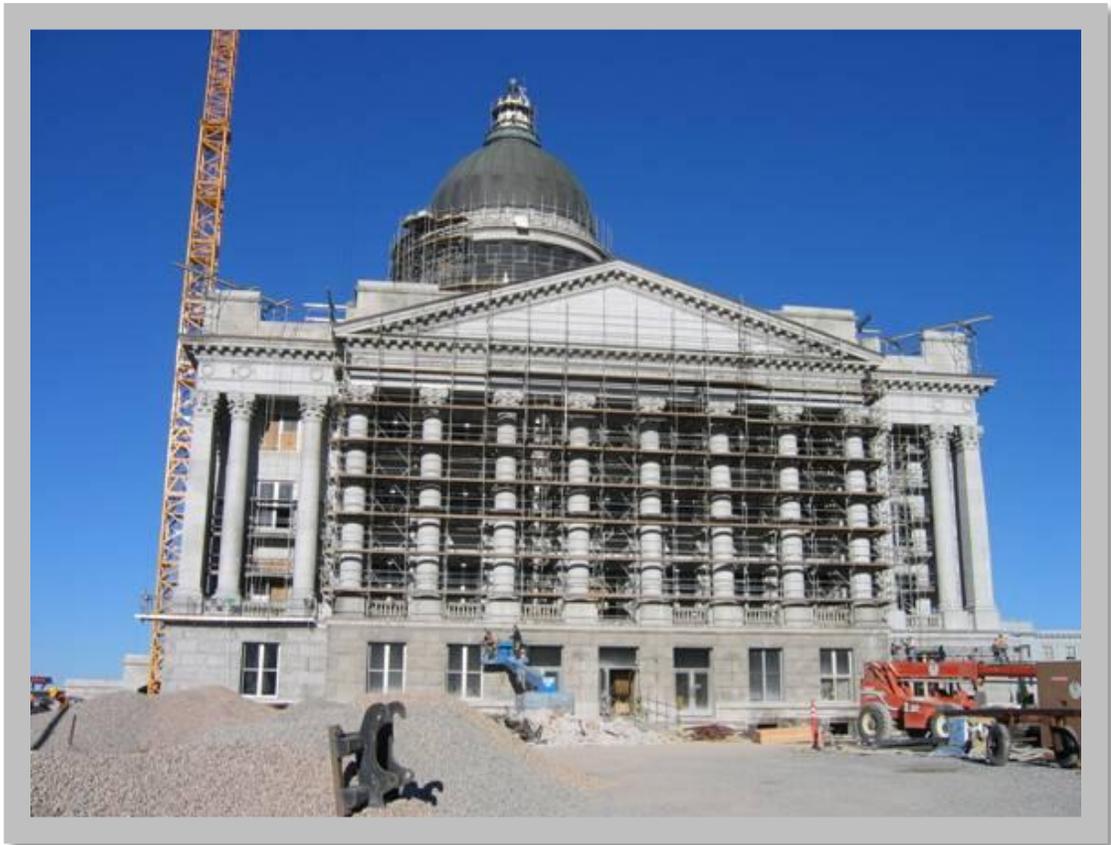
Figure 4.7: Several states have rehabilitated their state capitol buildings. The Utah State Capitol was seismically retrofitted with base isolation to protect visitors and occupants and preserve historic fabric in the building. (Source: State of Utah)

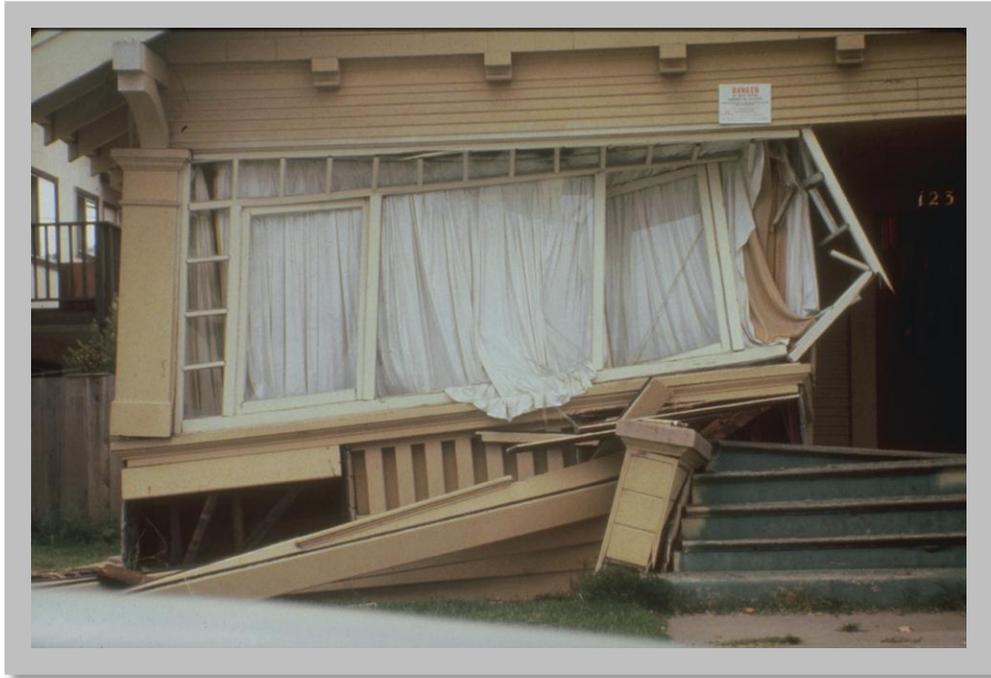
Figure 4.8: This residential building shifted on its foundation after the 1989 M 7.1 Loma Prieta, California earthquake. (Source: NOAA/NGDC, C. Stover, U.S. Geological Survey)

However, the details of a wood frame structure’s construction have a lot to do with its ability to withstand earthquakes, and certain common vulnerabilities make these buildings susceptible to earthquake damage, particularly if they were built before 1976. One of the most common deficiencies is a lack of adequate anchorage between the upper wood frame structure and the concrete foundation or basement walls. Another common deficiency can result in the failure of cripple walls, which are short wood framed wall segments that typically extend from a foundation to the floor above. Frequently, these lack proper connections and can easily rotate in a manner similar to a hinge, allowing the building to shift laterally off of its foundation (see Figure 4.8). In older structures, unreinforced masonry chimneys can fall and cause additional structural damage.

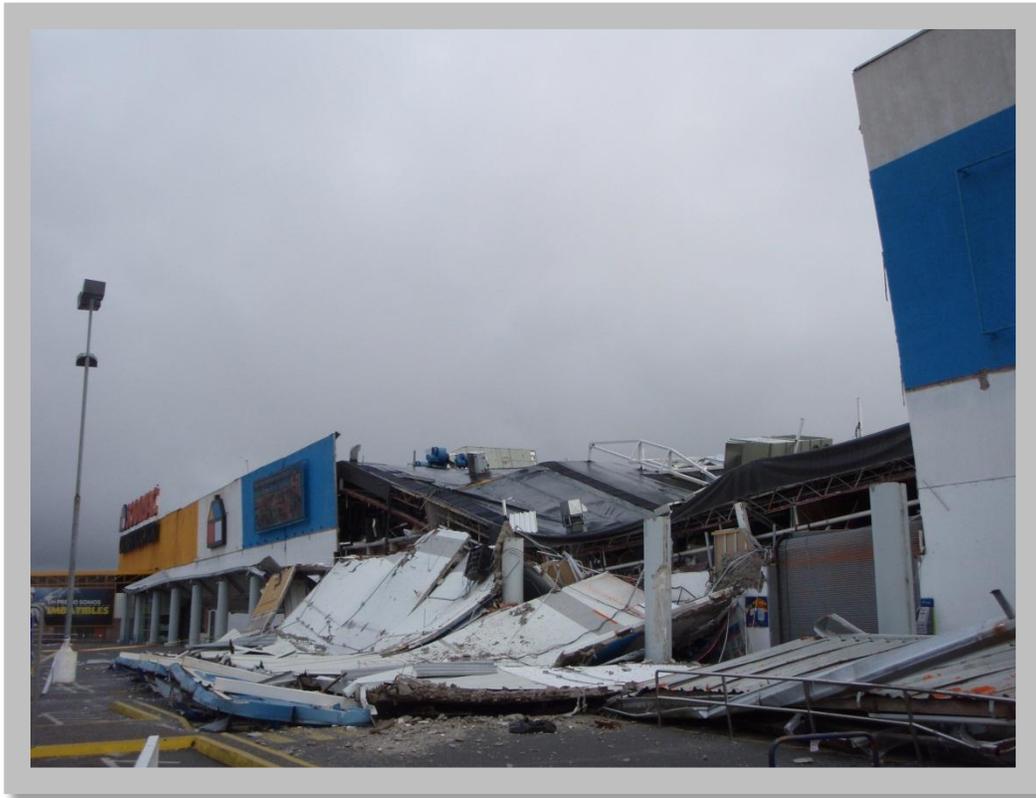
Figure 4.9: Several tilt-up concrete panels of this construction material supply store in Concepcion fell away from the building, causing the roof framing to collapse after the M 8.8 February 27, 2010 Maule Chile earthquake. (Source: Kent Yu, Degenkolb Engineers)

Today, most big-box stores, supermarkets, distribution warehouses, and pharmacies are housed in concrete masonry (CMU) or tilt-up concrete structures with light-framed wood or steel roofs. Buildings of this type that were constructed prior to 1995 have historically not performed well in earthquakes. The seismic vulnerabilities of these buildings were highlighted in the aftermath of the 1994 Northridge earthquake. The most prominent structural failure in this building type has been the connection between the light framed roof and the relatively heavy exterior walls, which led to partial or full roof collapse (see Figure 4.9). Building code provisions for the design and construction of the roof/wall connections were enhanced following the Northridge earthquake, with requirements for a higher degree of resistance being incorporated in the 1997 UBC and subsequent building codes. As a result, buildings of this type that were built after approximately 1995 should have a higher degree of resilience than those built prior to that year.

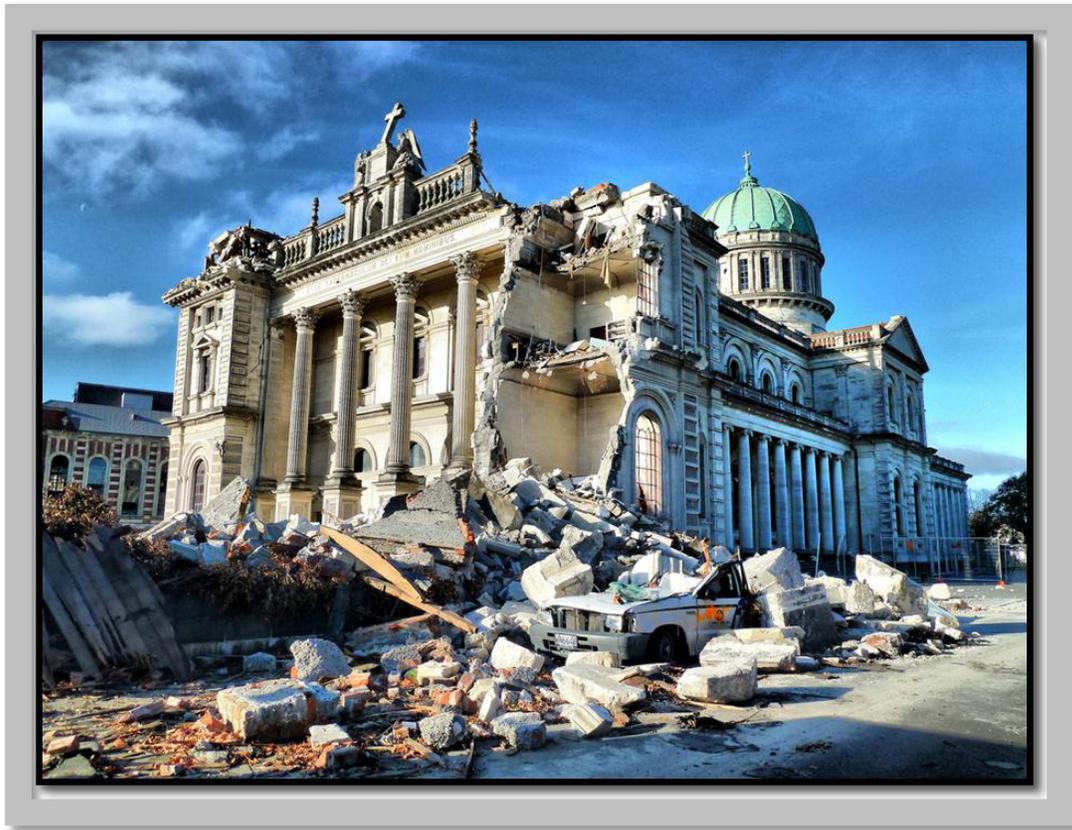
Figure 4.10: Christchurch Cathedral of the Blessed Sacrament, New Zealand after the M 7.0 September 3, 2010 Darfield earthquake [Source: NOAA/NGDC, Steve Taylor (Ray White)]

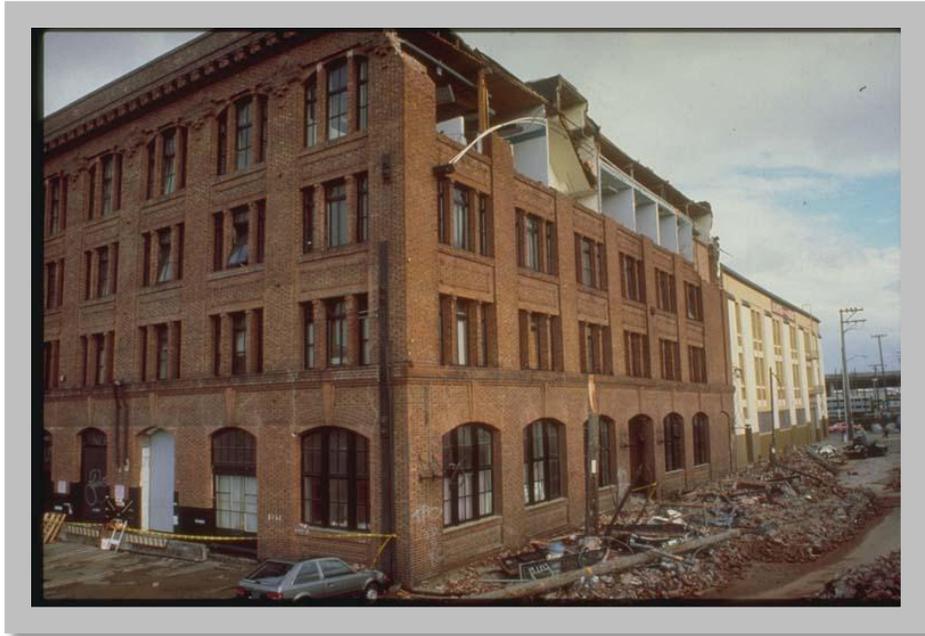
Figure 4.11: The fourth-story wall of this unreinforced masonry building on Bluxome Street in San Francisco collapsed onto the street, killing five people in their cars, during the M7.1 October 18, 1989 Loma Prieta, California earthquake. (Source: NOAA/NGDC, E.V. Leyendecker, U.S. Geological Survey)

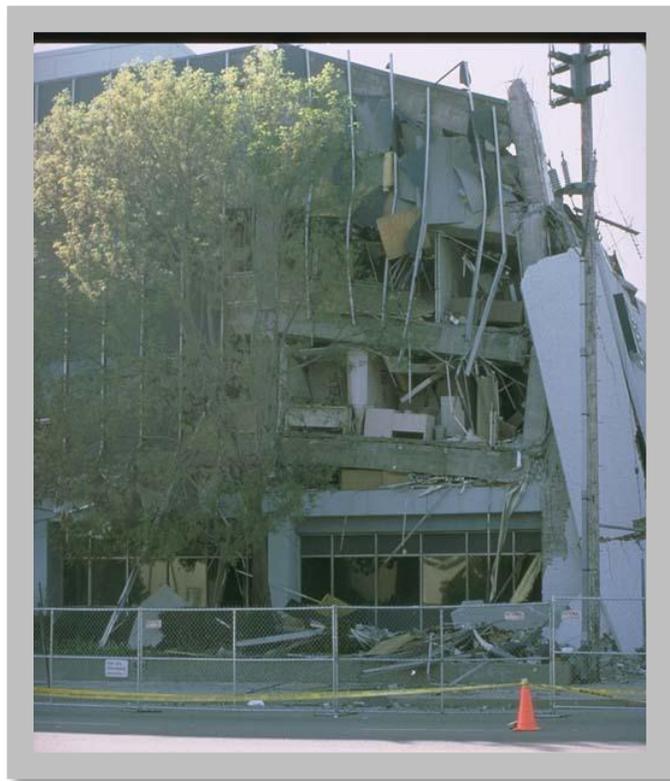
Figure 4.12: This non-ductile concrete frame medical building collapsed during the 1994 M6.8 Northridge, California earthquake. (Source: NOAA/NGDC, J. Dewey, U.S. Geological Survey)
