REAL ESTATE APPRAISAL REPORT

DOME BUILDING & B STREET PARKING LOT

2575 Center Street NE
 Map 07S 03W 24C Tax Lots 200 & 400
 Salem, Oregon 97301
Contract Number: PO-10700-00052500

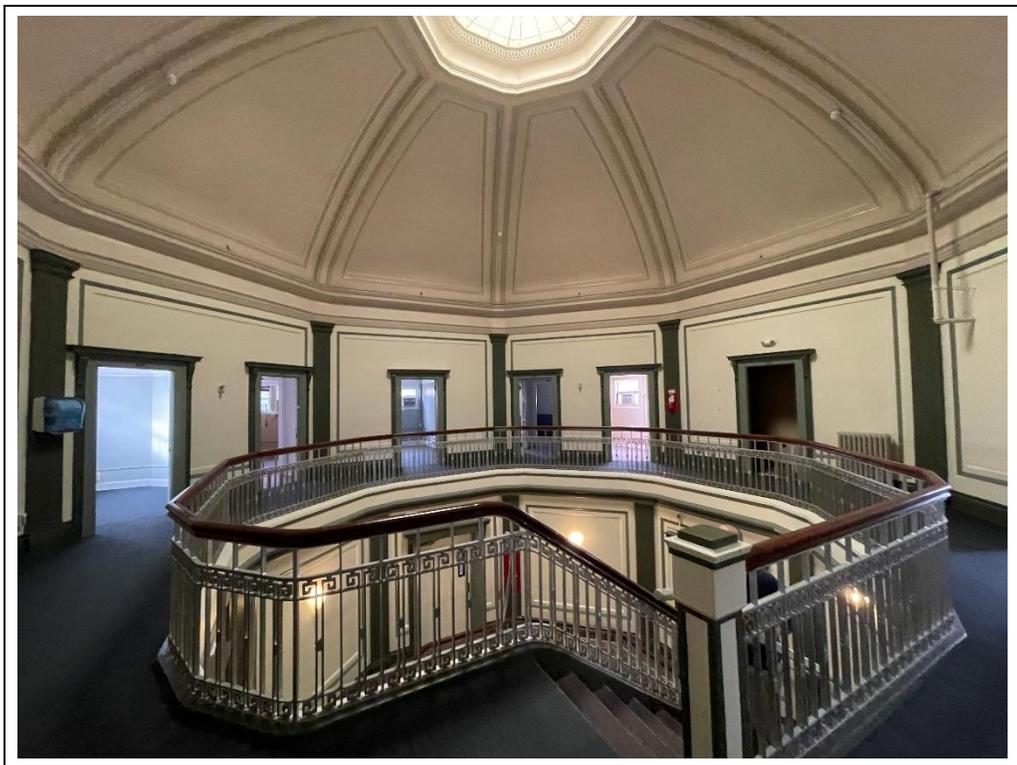
26. View of dome and staircase from 3rd floor, with offices around the perimeter. (13444-175)

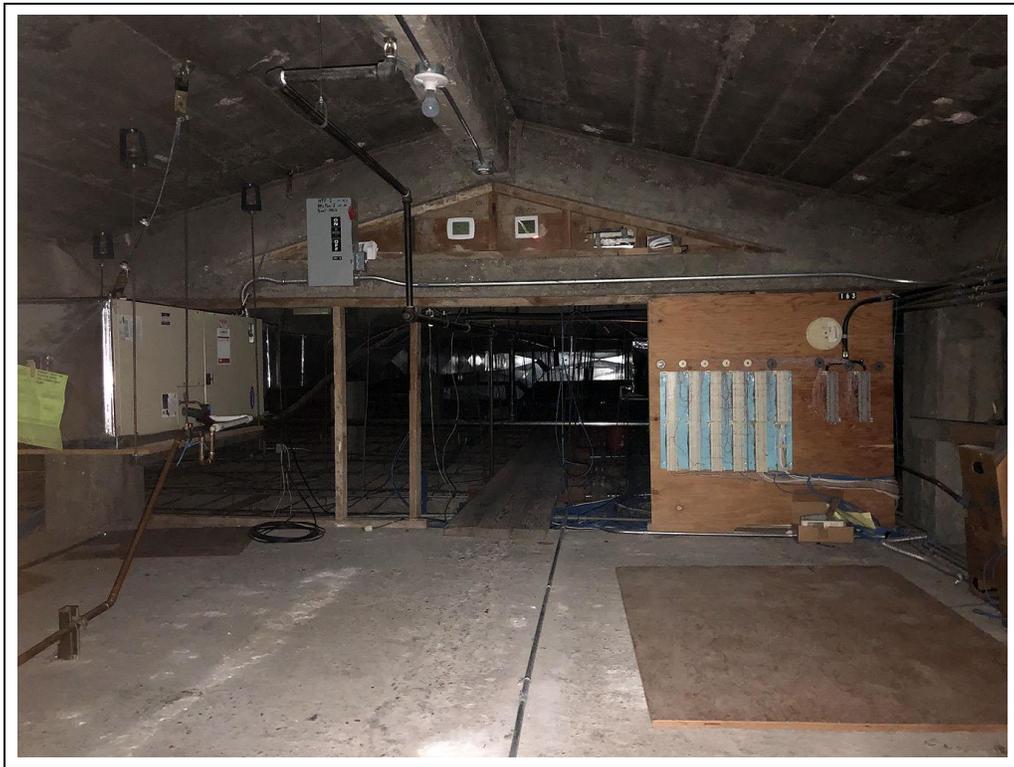
29. View of HVAC system above 3rd floor ceiling. (13444-127)

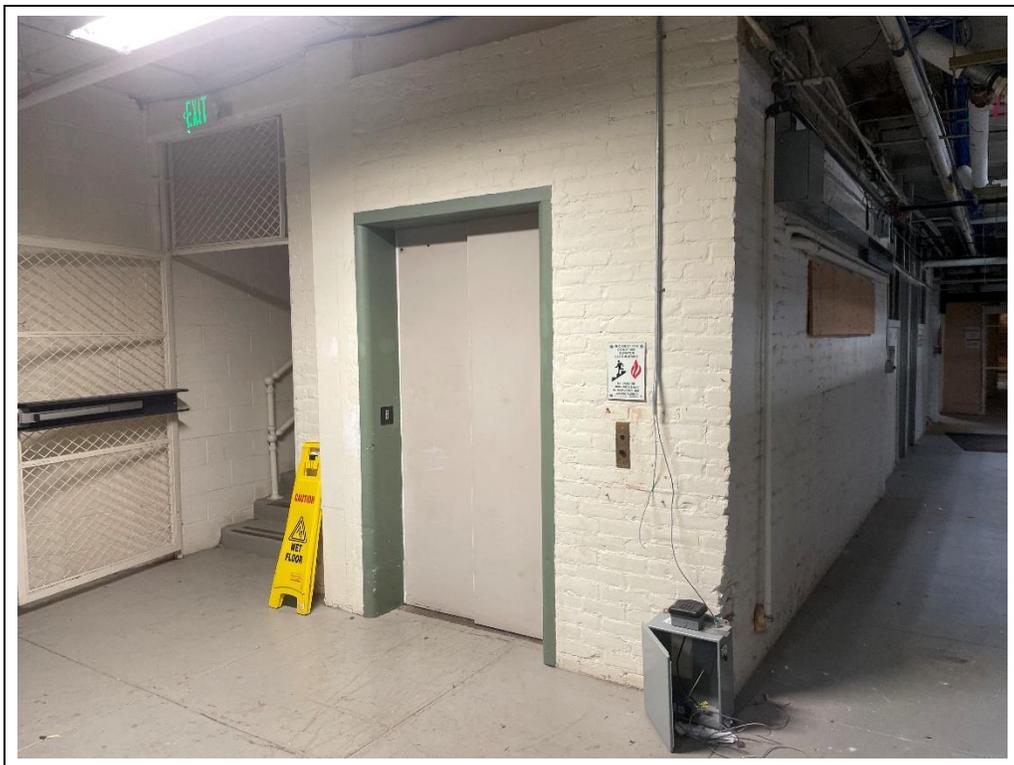
30. View of elevator. (13444-180)

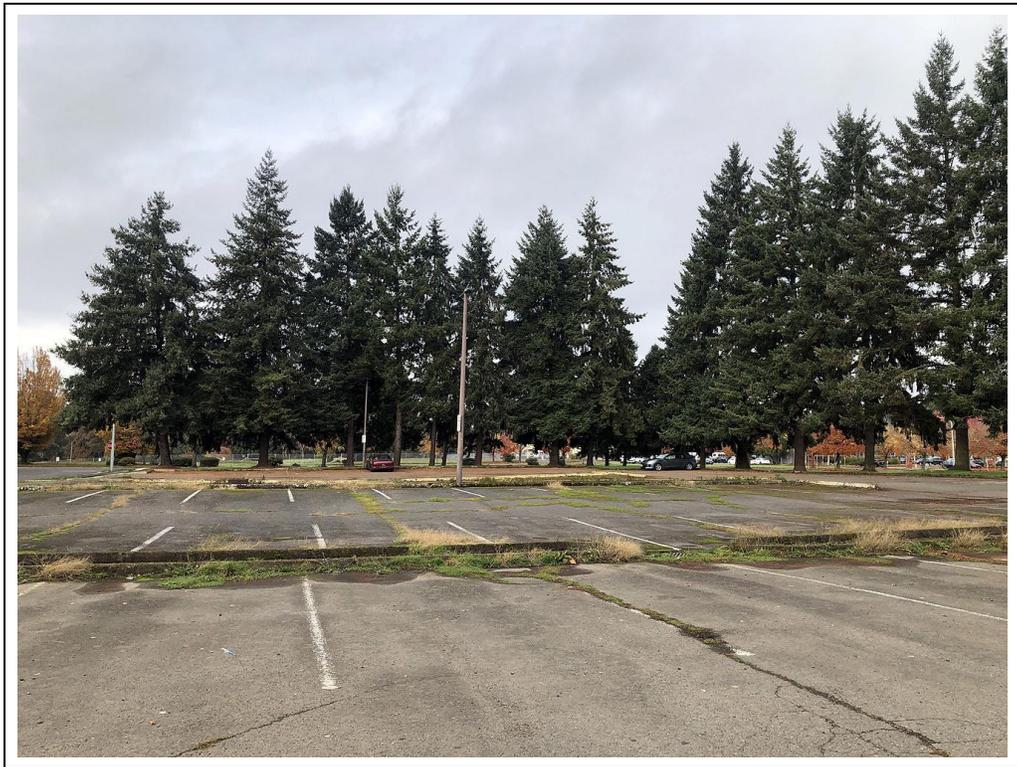
41. View west across B Street Lot's paved parking area. (13444-16)

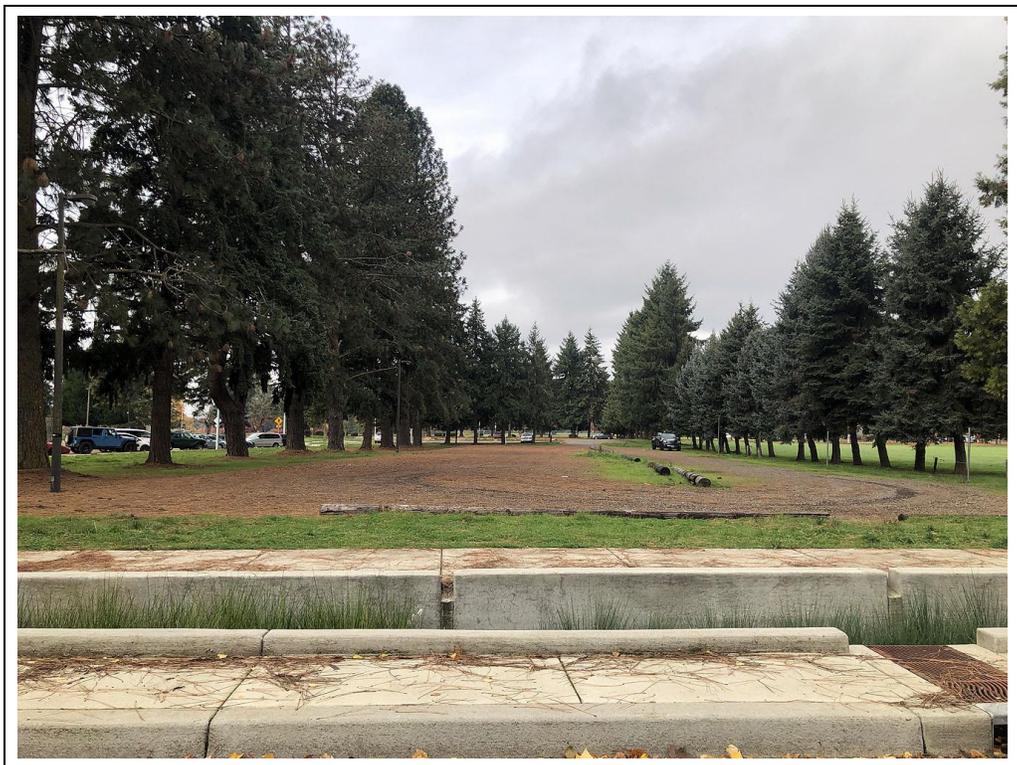
42. View west across B Street Lot's gravelled area from 25th Street NE.
(13444-12)

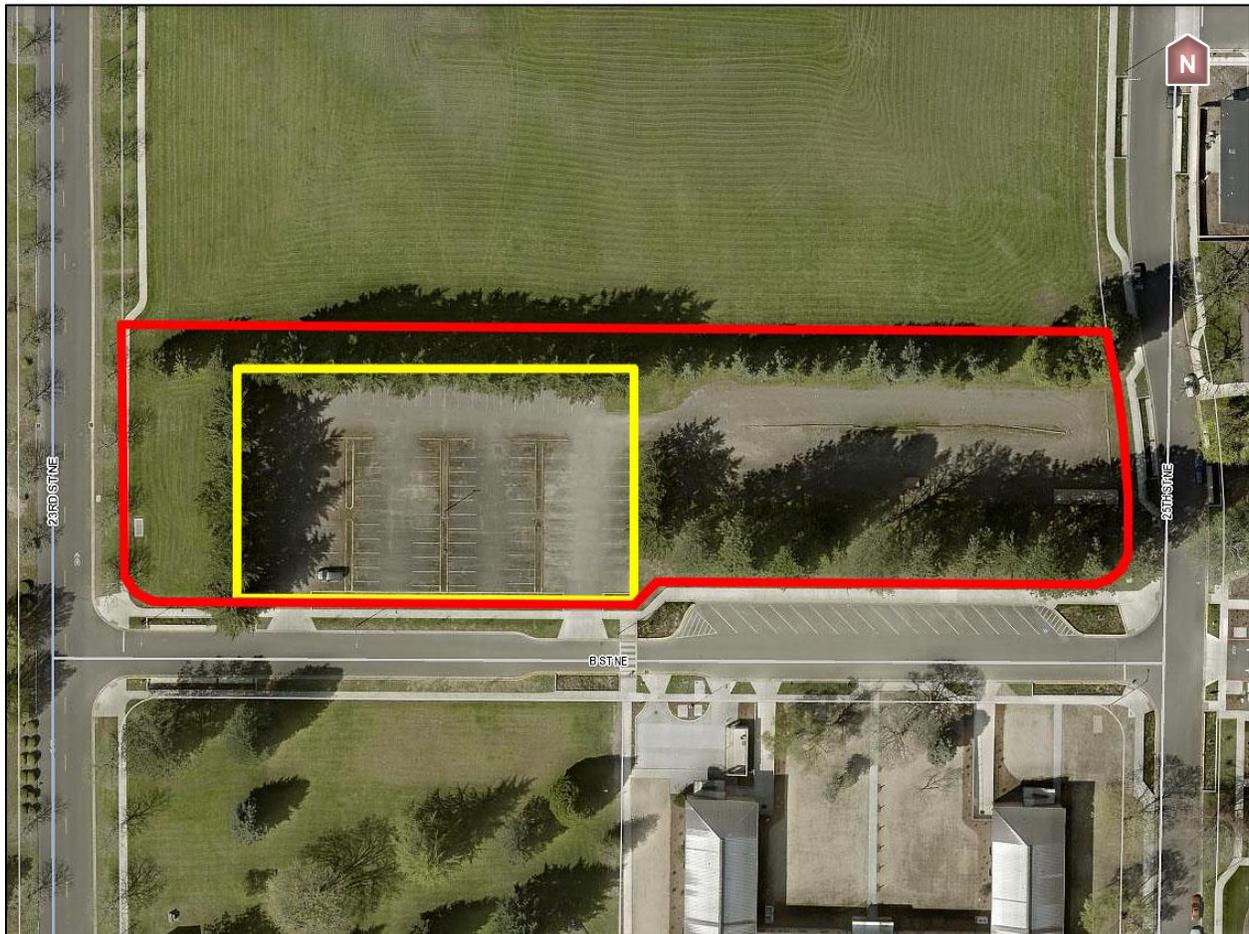
The exhibit above shows the Subject B Street Parking Lot (outlined in red), which is partially improved with a paved, 104-space parking lot (outlined in yellow).

With a paved parking area of 34,848 SF (~0.80 AC), this equates to an average parking space size of 335 SF (34,848 SF ÷ 104 parking spaces). Per parking space metrics outlined in the Marshall Valuation Service (a national, cost-estimating guide), average to good parking spaces (including drives and aisles) range from 315 to 345 SF in size. The existing parking spaces are well-supported by the market.

To meet the conditions of the parking easement, 55 unassigned parking spaces must remain. Utilizing an average parking space size of 335 SF, **this indicates an area of 18,425 SF (335 SF/parking space x 55 parking spaces) must remain as parking.**

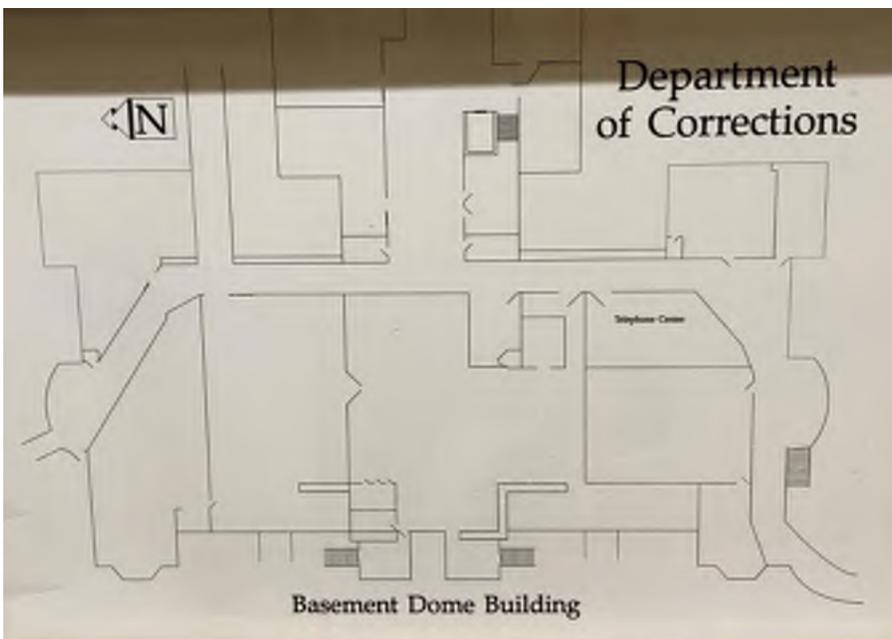
Figure 5.02.1.6 – Basement Evacuation Plan

BASEMENT LEVEL

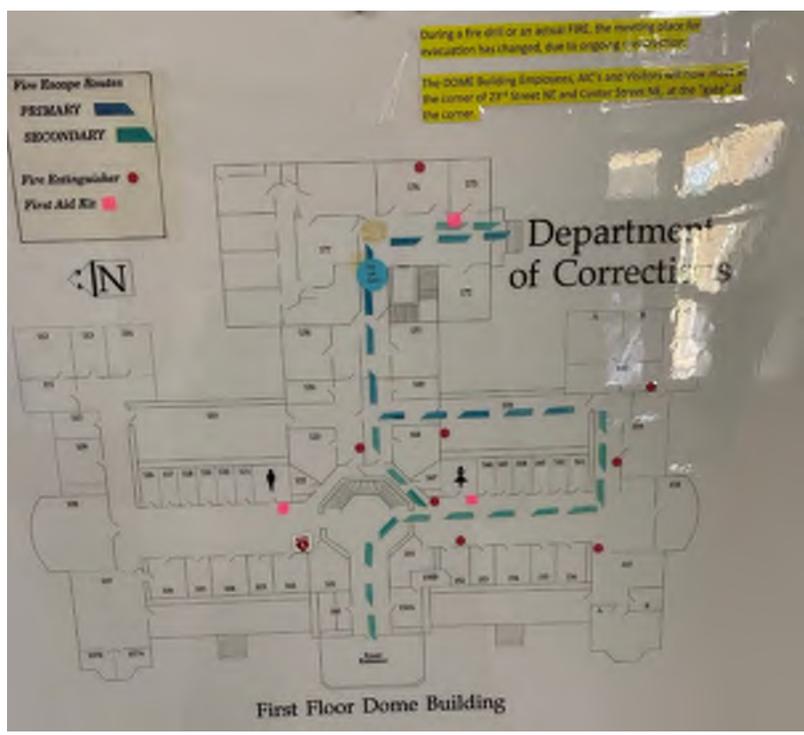
Figure 7.02.1.8 - First Floor Evacuation Plan

FIRST FLOOR LEVEL

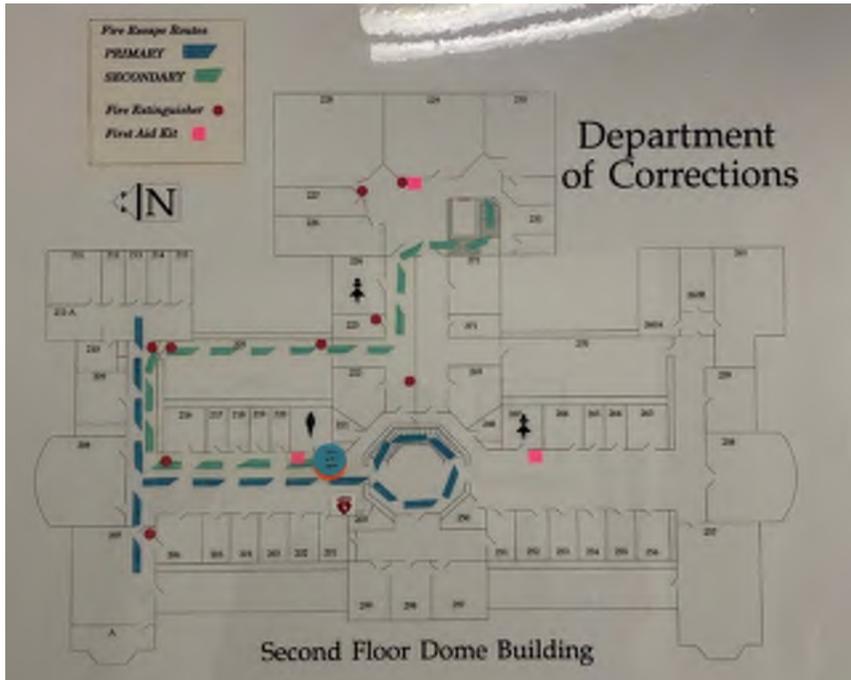
Figure 9.02.1.10 - Second Floor Evacuation

SECOND FLOOR LEVEL

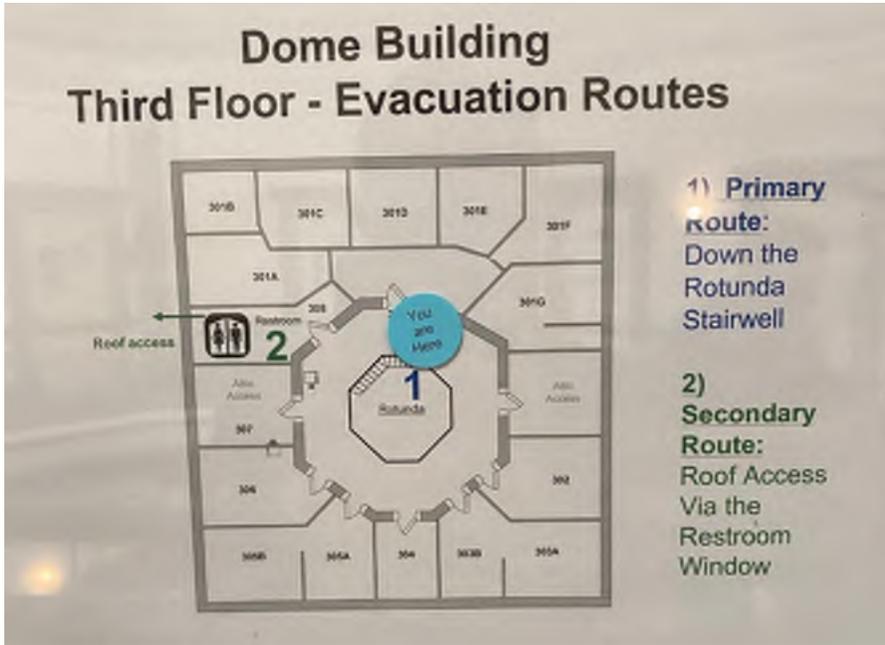
Figure 10.02.1.11– Third Floor Evacuation

THIRD FLOOR PLAN

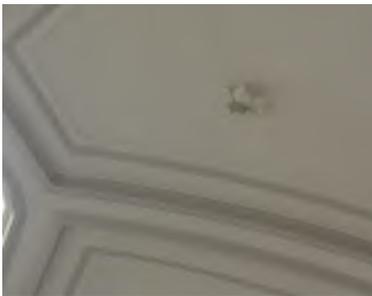
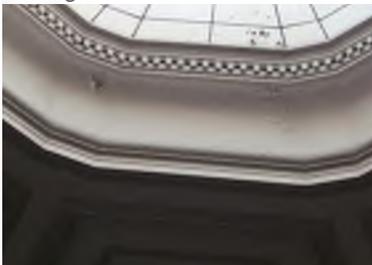
Figure 1.04.1.22 – Dome Plaster Damage

Figure 1.04.1.23 – Dome Plaster Damage

The Third Floor is basically a mezzanine level open to Dome and Rotunda lobby and staircase below. There is no elevator access to this level and primary route to rooms are from the Rotunda stairwell. The only roof access is through the Restroom window. The Third Floor finishes appear in good condition and well maintained. There are some areas of blistering/peeling paint on the underside of dome

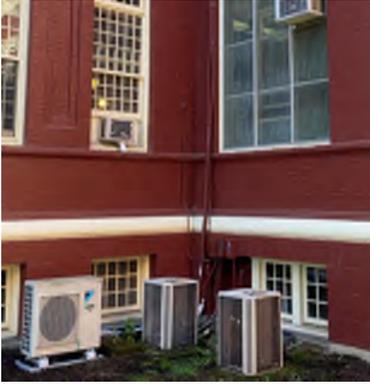
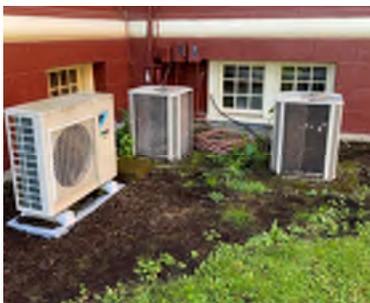
Figure 1.04.3.9 – Typical Condensing Units at Grade

Figure 1.04.3.10 – Typical Condensing Units at Grade

The multiple small condensing units installed at grade around the building are in poor condition and no should be replaced. They range between 10-30 years old. These units typically have a 15 year life expectancy.

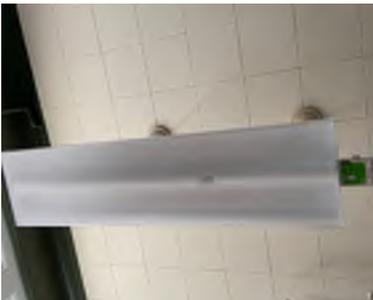
The majority of lighting in the facility appeared to have been replaced as part of the 1993 remodel. Much of the interior spaces are served by pendant and/or surface mounted, fluorescent T8-lamp wraparound luminaires. Lighting in the rotunda consists of porcelain A-lamp luminaires with LED bulbs.

Figure 1.04.4.6 - Pendant Wrap-around

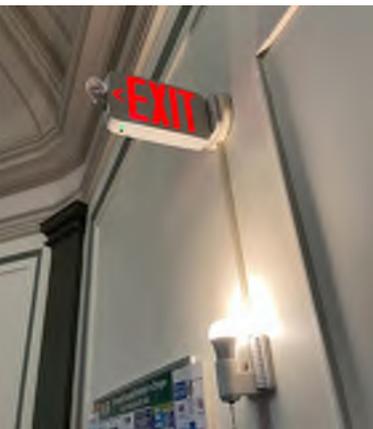
Figure 1.04.4.7 - Rotunda Lighting

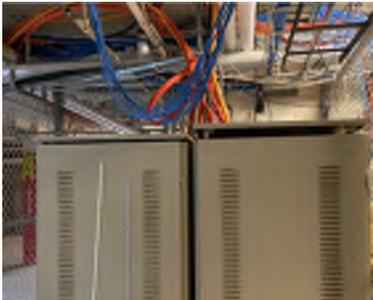
Figure 1.04.4.8 – Fiber Entrance

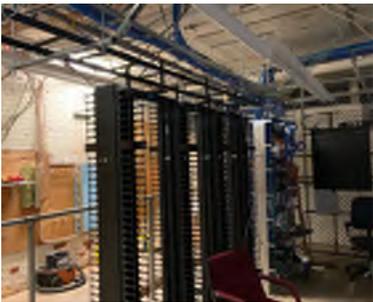
Figure 1.04.4.9 – MDF Racking

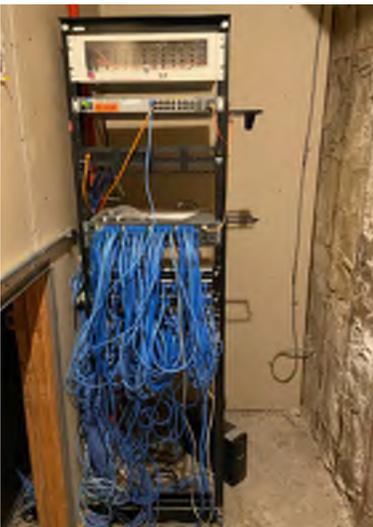
Figure 1.04.4.10 – Third Floor IDF

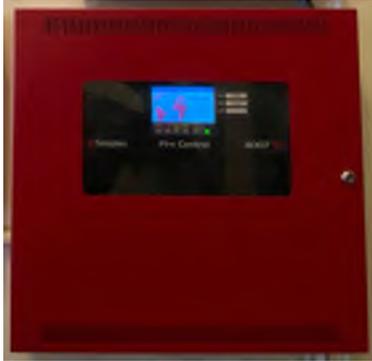
Figure 1.04.4.11 – FACP

The fire alarm system currently installed in the building is an addressable system manufactured by Simplex. The fire alarm control panel, a Simplex 4007, is located in the main lobby. Horn/strobe notification devices were observed in corridors, and manual pull stations had been provided at stair landings and building exit doors. Ceiling mounted smoke detectors were also observed.

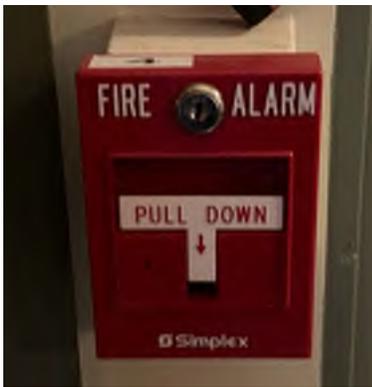
Figure 1.04.4.12– FA Pull station

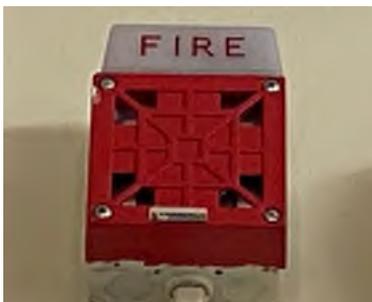
Figure 1.04.4.13– FA Notification Device

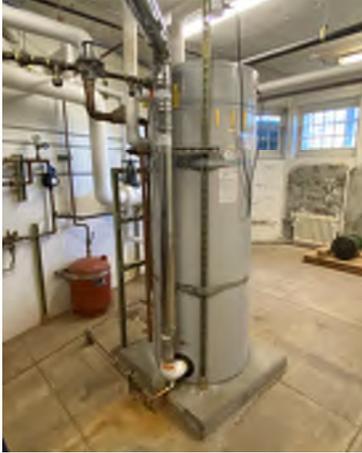
Figure 1.04.5.1 – Gas Water Heater

The gas water heater and recirc pump were installed in 2010 and are in good condition. It should last another 5-10 years. The water heater has a 100 gallon capacity and 300,000 BTUH input. A temperature gage was not installed to verify water temperature.

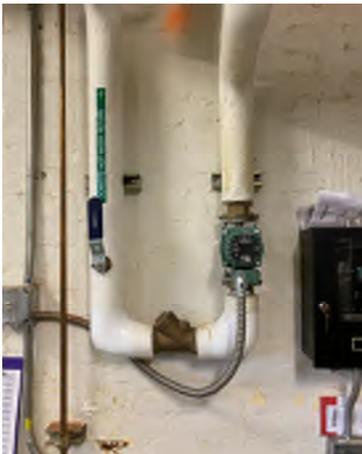
Figure 1.04.5.2 – Hot Water Re-Circulation Pump

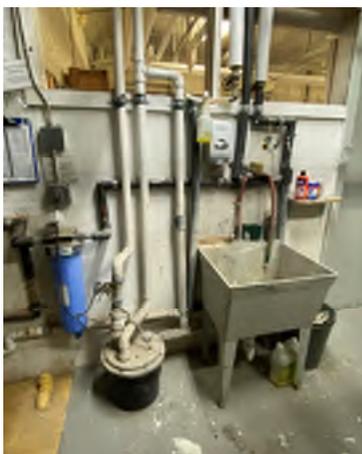
Figure 1.04.5.3 – Basement Service Sink and Sump Pump

Several waste sump pumps were observed around the basement to accommodate drainage at that level. These pumped up to the sanitary piping overhead.

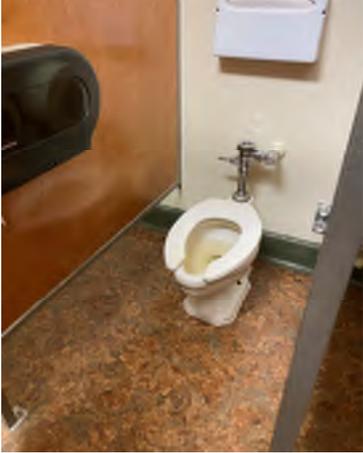
Figure 1.04.5.4– Typical Water Closet

The plumbing fixtures are in poor to fair condition. Several toilets have automatic sensor style flush valves installed but most have manual flush valves. The flow of the lavatory faucets could not be verified and were not tested at the time of the visit.

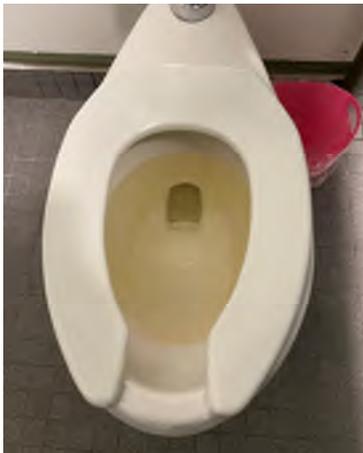
Figure 1.04.5.5– Toilet with Yellowed Water

The cause of the water quality issues is the age of the galvanized steel piping. It should be replaced due to its age and condition.

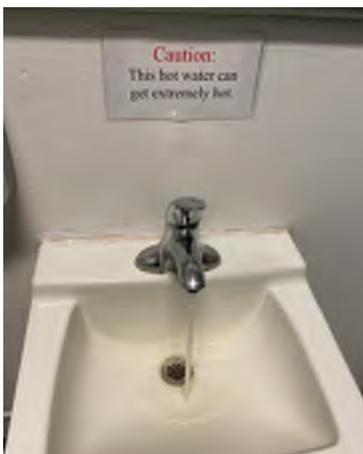
Figure 1.04.5.6– Lavatory and Hot Water Warning Sign

- Code requires water delivered to public lavatories to be no hotter than 110 degrees Fahrenheit but must be stored at 140 degrees Fahrenheit to prevent legionella's from growing in the tank. There is no means of regulating this temperature
- Plumbing fixtures currently exceed code requirements for water flow volume.

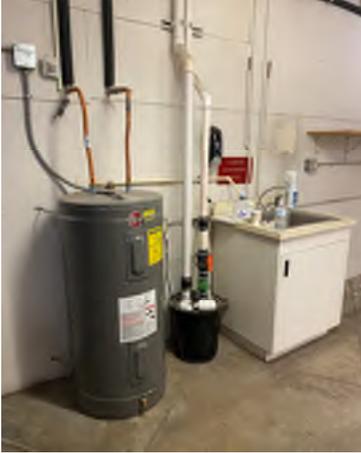
Figure 1.04.5.7– Auxiliary Water Heater and Sink

The domestic water service enters the building in the basement and is distributed to plumbing fixtures throughout the building. Also located in the basement is the primary gas fired domestic water heater and hot water recirculation pump. A secondary electric water heater was also observed in another part of the basement. It was unclear the extent of the fixtures this serves.

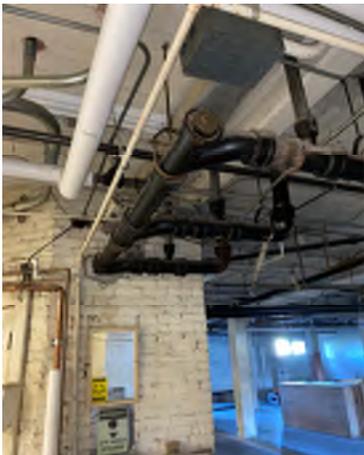
Figure 1.04.5.8– Cast Iron Sanitary Waste Piping in Basement

Waste piping was visually inspected where exposed and visible in the basement and chases. There was evidence of past leaks and most of the piping observed was original to the building. The interior condition of the pipe was unknown but there were no reports of clogged piping. It is common in cast iron piping this old to have erosion in the horizontal runs. The galvanized piping is also prone to interior corrosion and blockage and should be further inspected.

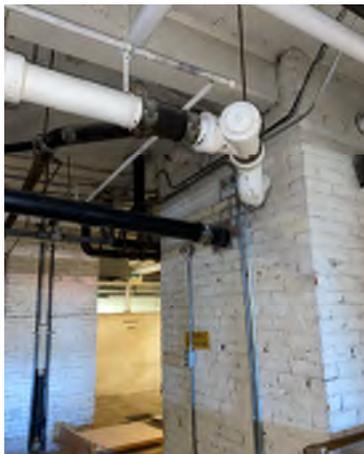
Figure 1.04.5.9 – Cast Iron Sanitary Waste Piping in Basement with new ABS Tie-Ins

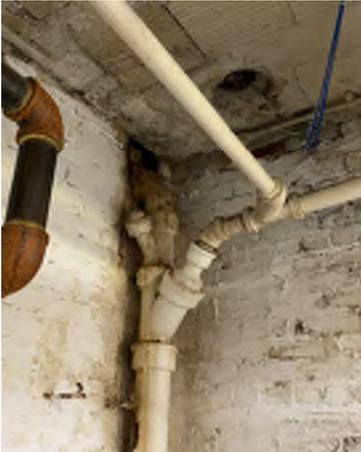
Figure 1.04.5.10 – Cast Iron and Galvanized Waste Piping

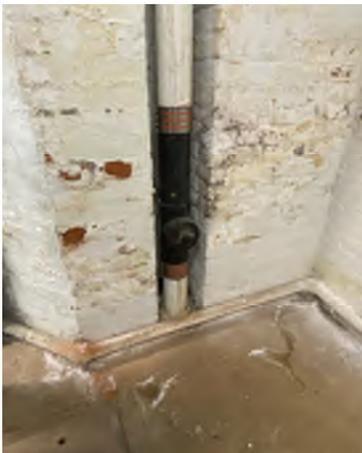
Figure 1.04.5.11 – Storm Drain Piping at Basement with New Cleanouts

Piping where observed in the basement was cast iron hub and spigot pipe original to the building. PVC pipe sections with cleanouts had been added to the storm drains to facilitate cleaning.

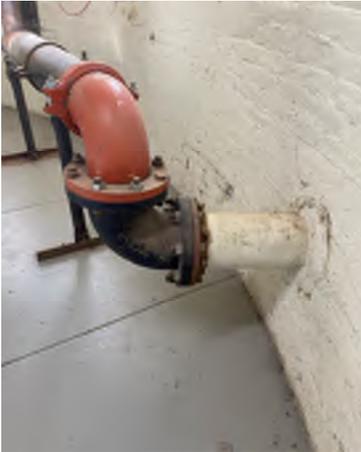
Figure 1.04.5.12– Incoming Fire Water Service

A 6" fire water service enters the building at the basement level. The backflow device was not observed in the basement and is located in a vault on the site. The building is protected by a wet pipe automatic sprinkler system with two zones: one zone serves the basement, and one serves the upper floors.

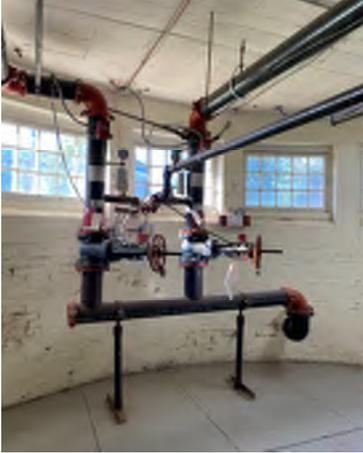
Figure 1.04.5.13– Automatic Sprinkler Head

Sprinkler piping throughout the building is exposed in almost all areas. Some areas with ceilings have concealed piping with flush heads.

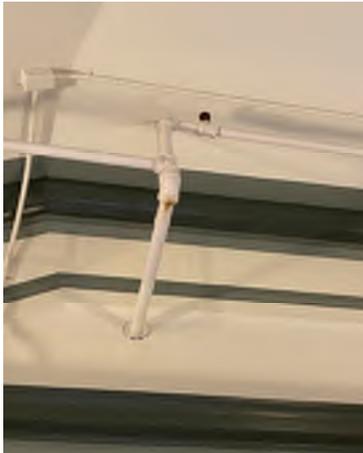
Figure 1.04.5.14 – Exposed Sprinkler Piping

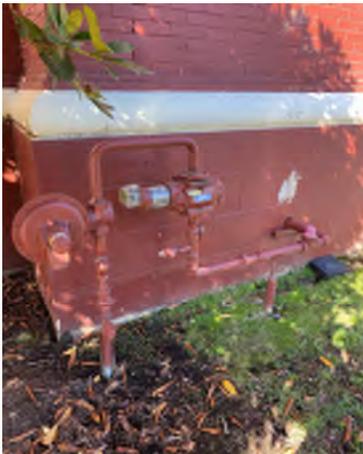
Figure 1.04.5.15 – Gas Meter and Earthquake Valve

After the gas piping enters the building it runs across the basement and is connected to the water heater and boiler. Ventless gas regulators are installed at the appliance connections. No other equipment connections were observed on the gas system.

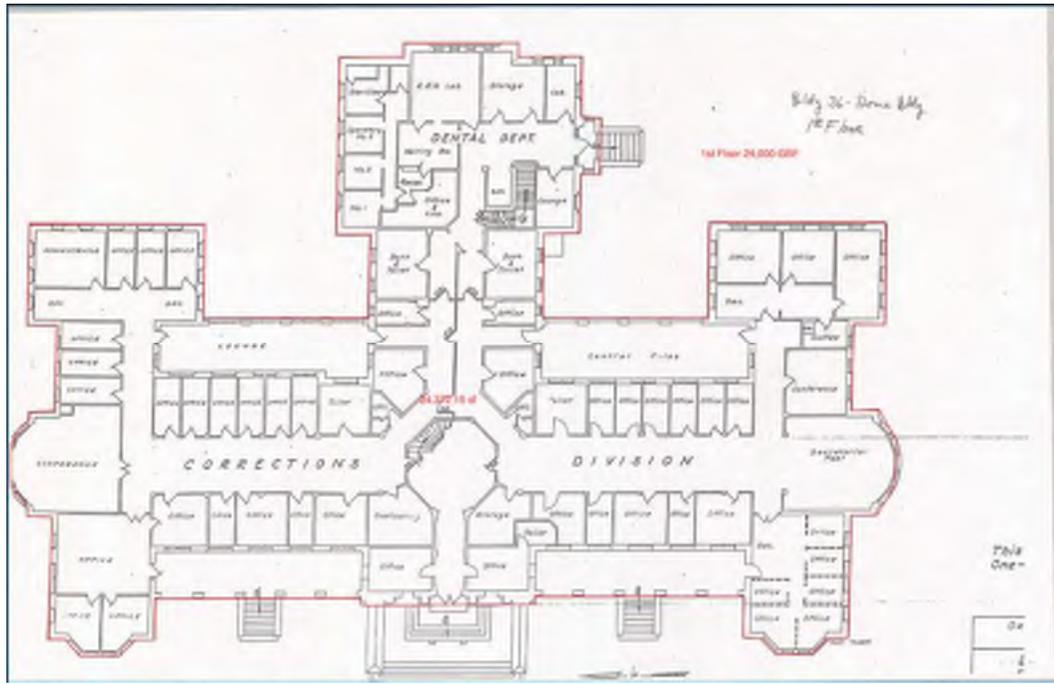
The Building Plan illustrates the plan configuration. The basement, 1st and 2nd floors are of similar configuration. The 3rd floor is a partial plan, only present at the core area.

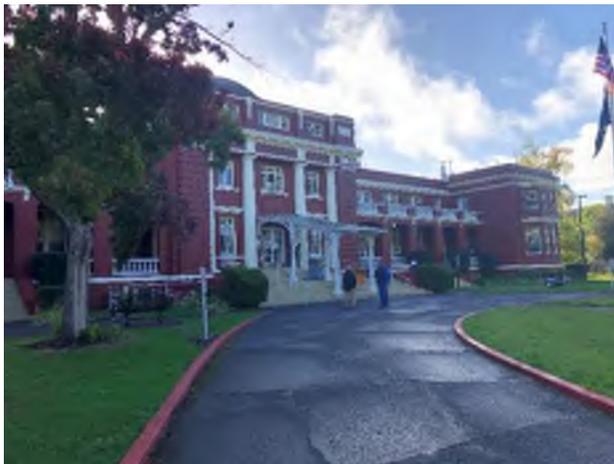
Figure 2 – West Elevation

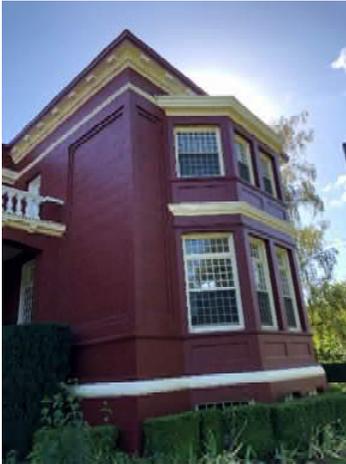
Figure 11 – South Wall

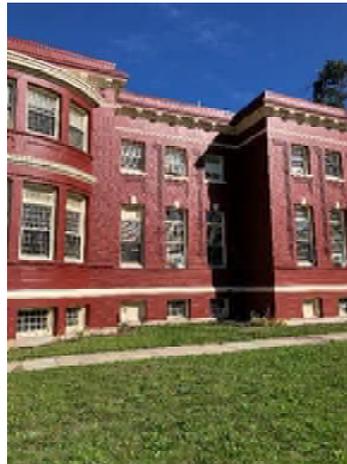
Figure 12 – South Elevation

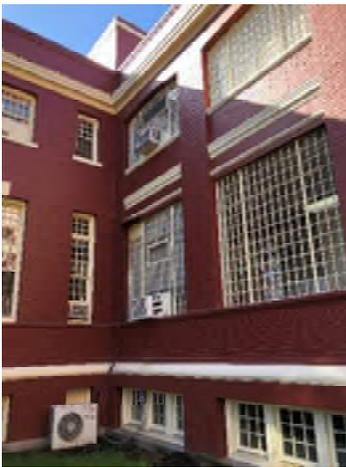
Figure 13 – East Elevation at Enclosed Porch

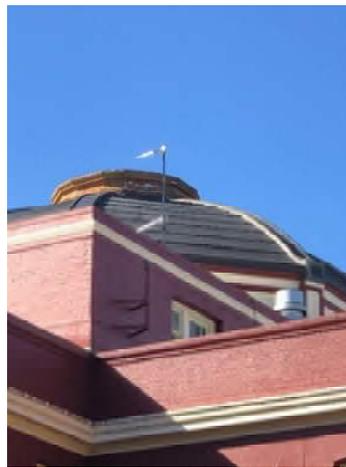
Figure 14 – Dome

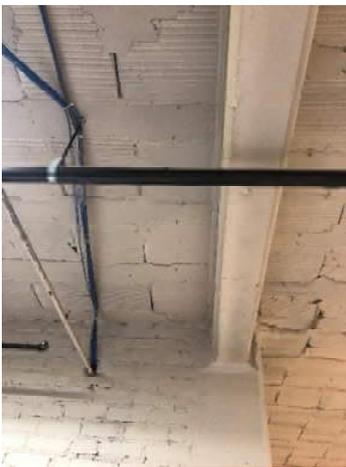
Figure 15 – 1st Floor Construction (1912 from below)

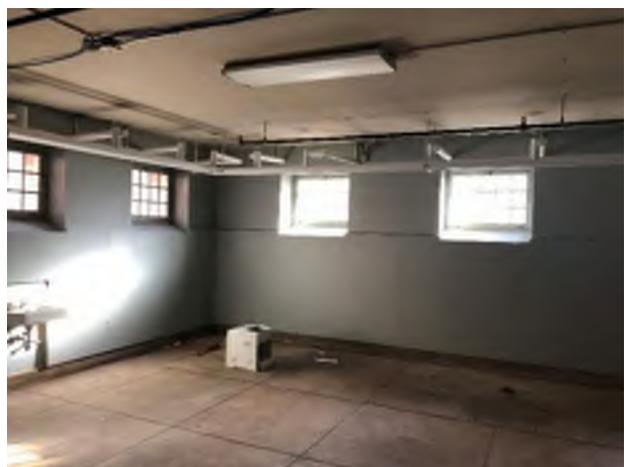
Figure 16 – Basement Wall

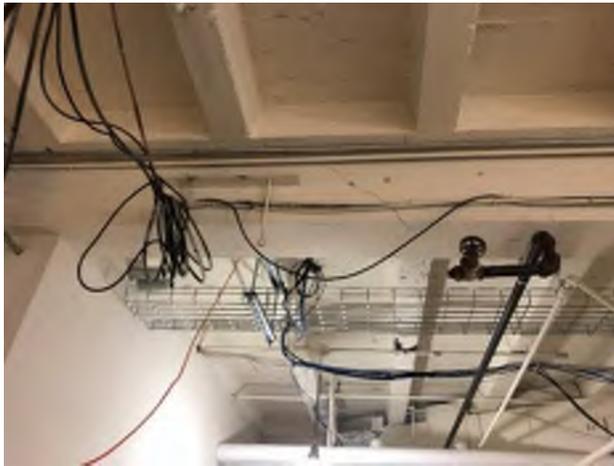
Figure 17 – 1st Floor Construction (1917 from below)

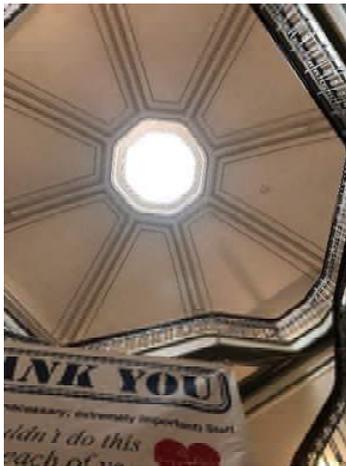
Figure 19 – Dome from below

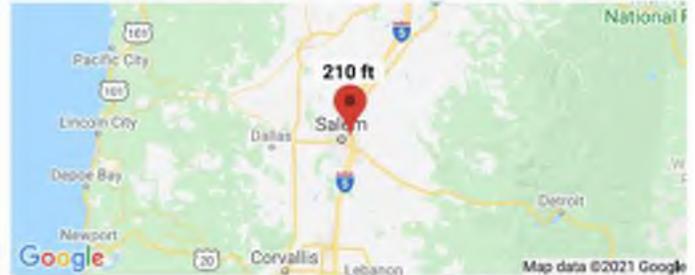
Address: 2575 Center St NE, Salem, OR 97301, USA
Coordinates: -123.00 5033
Elevation: 210 ft
Timestamp: 2021-10-25T11:10:51.2-12
Hazard Type: Seismic
Reference Document: ASCE 1-17
Site Class: D-default
Custom Probability:

Site Class D-default. No available geotechnical report.

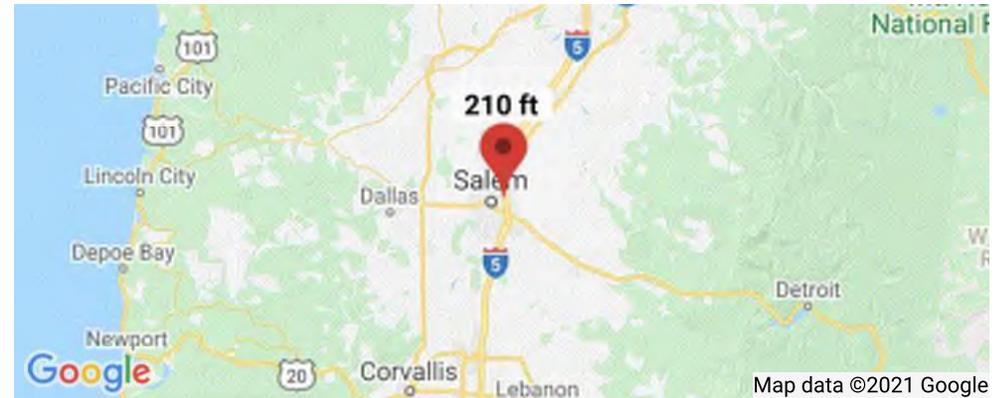
Address: 2575 Center St NE, Salem, OR 97301, USA
Coordinates: 44.9406322, -123.0045033
Elevation: 210 ft
Timestamp: 2021-10-25T16:10:51.241Z
Hazard Type: Seismic
Reference Document: ASCE41-17
Site Class: D-default

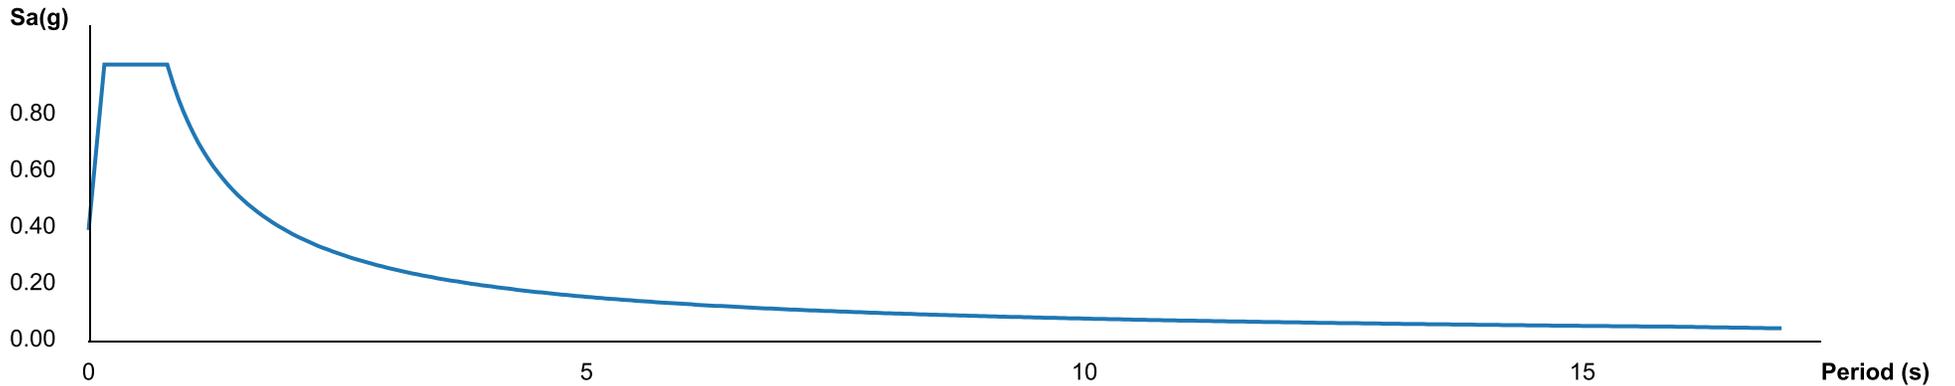
Horizontal Response Spectrum - Hazard Level BSE-2N

Name	Value	Description
SsUH	0.925	Factored uniform-hazard spectral acceleration (2% probability of exceedance in 50 years)
CR _S	0.879	Coefficient of risk (0.2s)
SsRT	0.814	Probabilistic risk-targeted ground motion (0.2s)

SsD	1.5	Factored deterministic acceleration value (0.2s)
S _S	0.814	MCE _R ground motion (period=0.2s)
F _a	1.2	Site amplification factor at 0.2s
S _{Xs}	0.977	Site modified spectral response (0.2s)
S1UH	0.472	Factored uniform-hazard spectral acceleration (2% probability of exceedance in 50 years)
CR ₁	0.864	Coefficient of risk (1.0s)
S1RT	0.408	Probabilistic risk-targeted ground motion (1.0s)
S1D	0.646	Factored deterministic acceleration value (1.0s)
S ₁	0.408	MCE _R ground motion (period=1.0s)
F _v	1.892	Site amplification factor at 1.0s
S _{X1}	0.772	Site modified spectral response (1.0s)

SEISMIC HAZARD	S_{XS}	S_{X1}
BSE-2N;	$S_{XS_2N} = 0.977$;	$S_{X1_2N} = 0.772$;
BSE-1N;	$S_{XS_1N} = 0.651$;	$S_{X1_1N} = 0.578$;
BSE-2E;	$S_{XS_2E} = 0.772$;	$S_{X1_2E} = 0.578$;
BSE-1E;	$S_{XS_1E} = 0.311$;	$S_{X1_1E} = 0.179$;
