LOWER COLUMBIA SLOUGH REFUGIA PROJECT

Final Grant Report

Oregon Department of Environmental Quality's
Columbia Slough Natural Resources Damages Fund

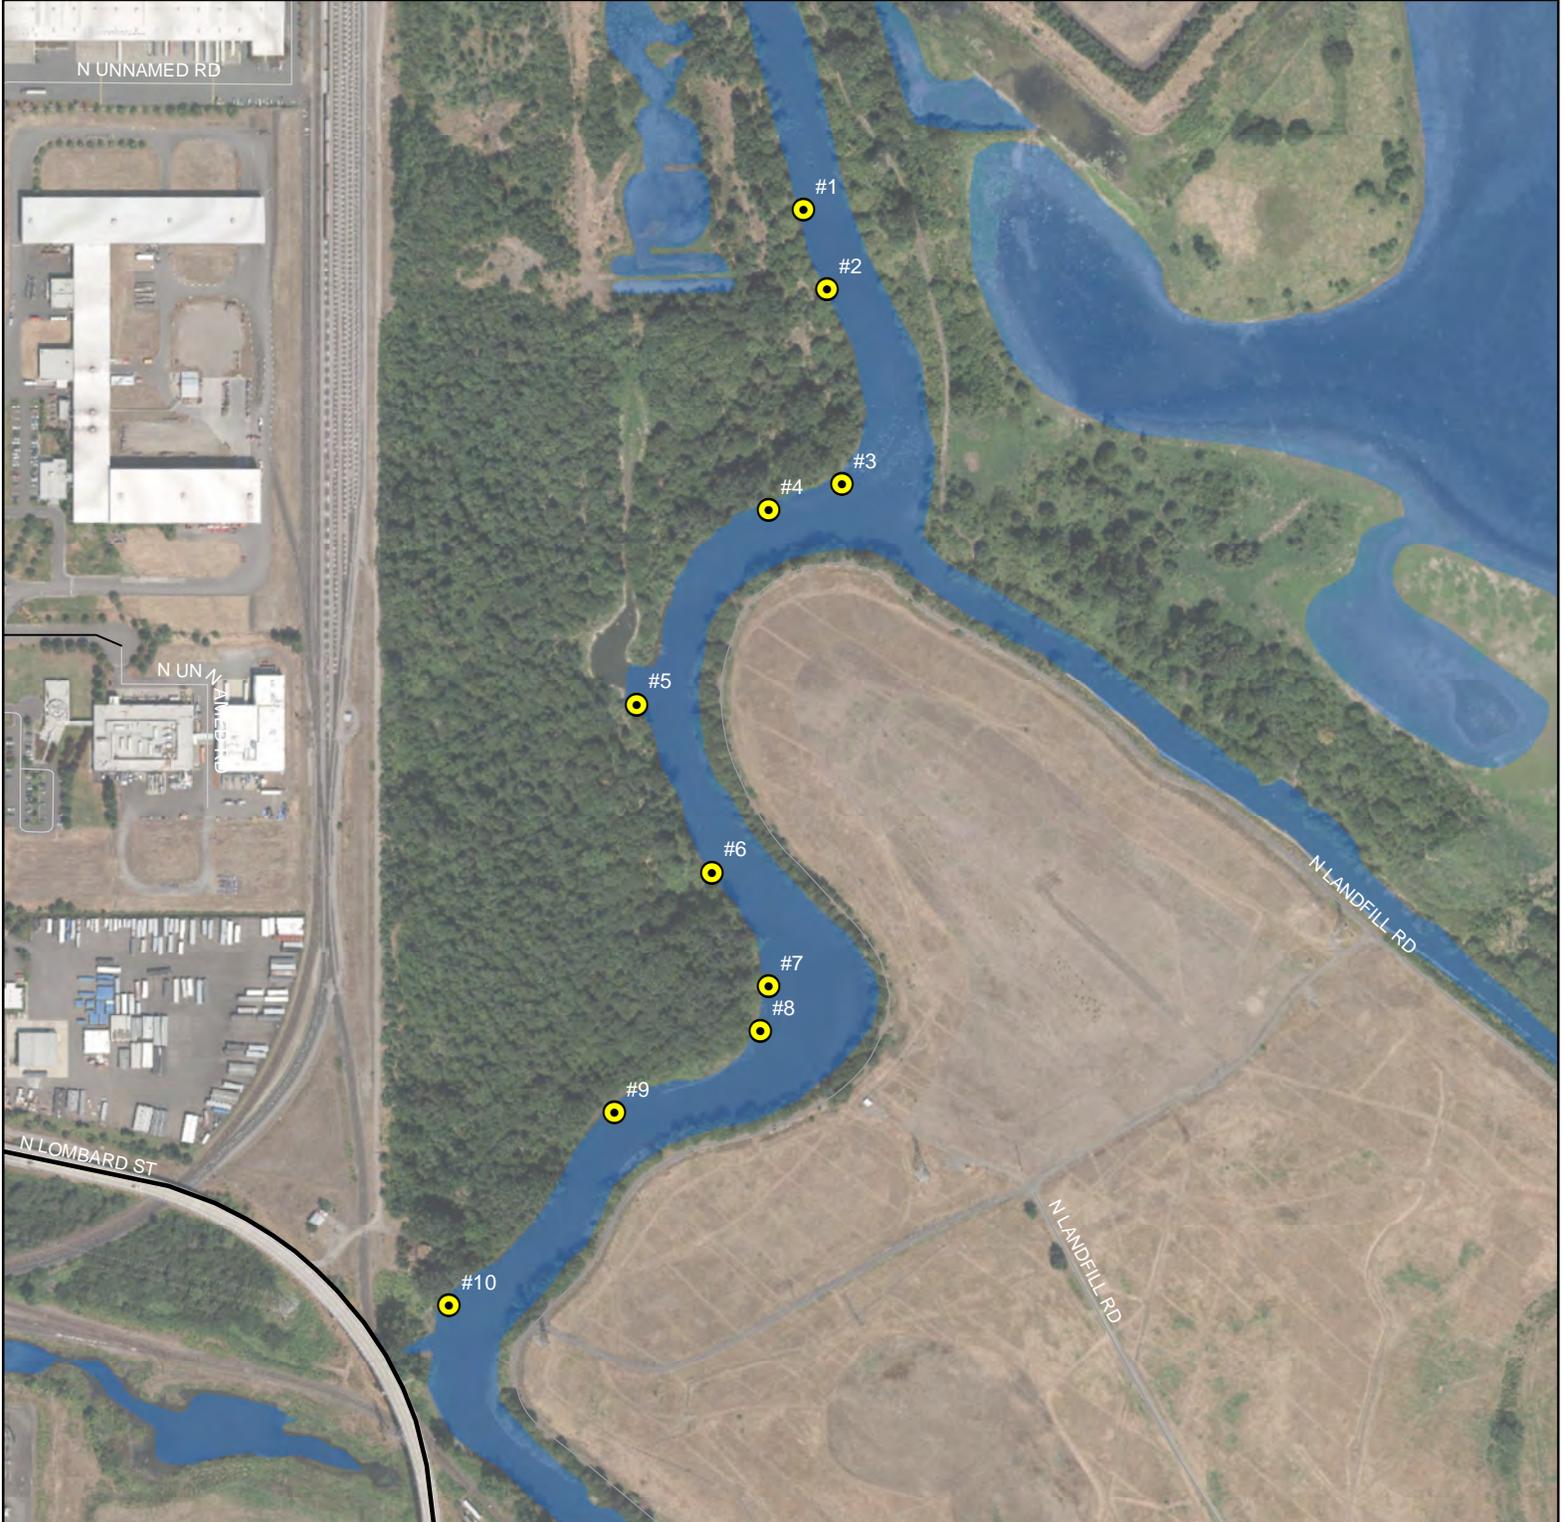
Log Jam Locations in Ramsey Reach

- Engineered Log Jams

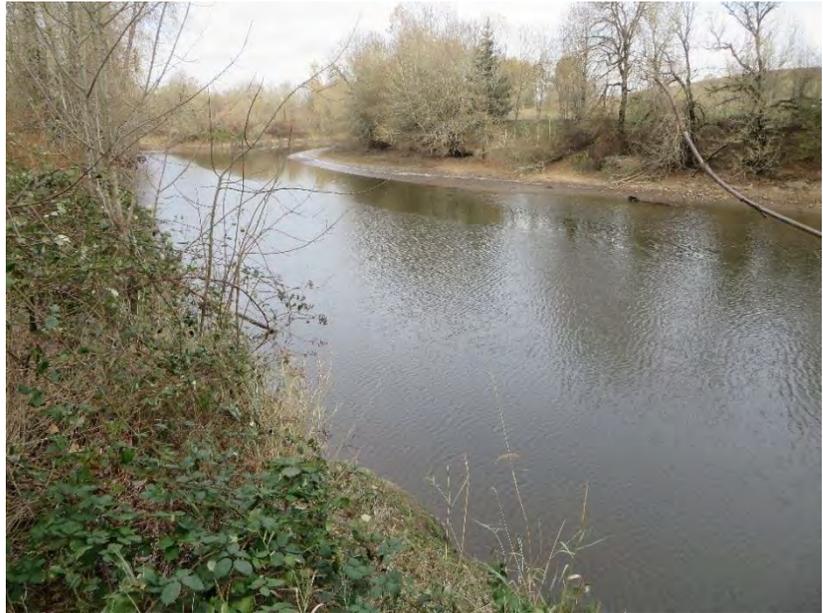
Preconstruction. Looking north, downstream, in the Ramsey Reach. The Saint John's Landfill is visible in the upper right. Water surface elevation: 5.8 feet (COP datum).

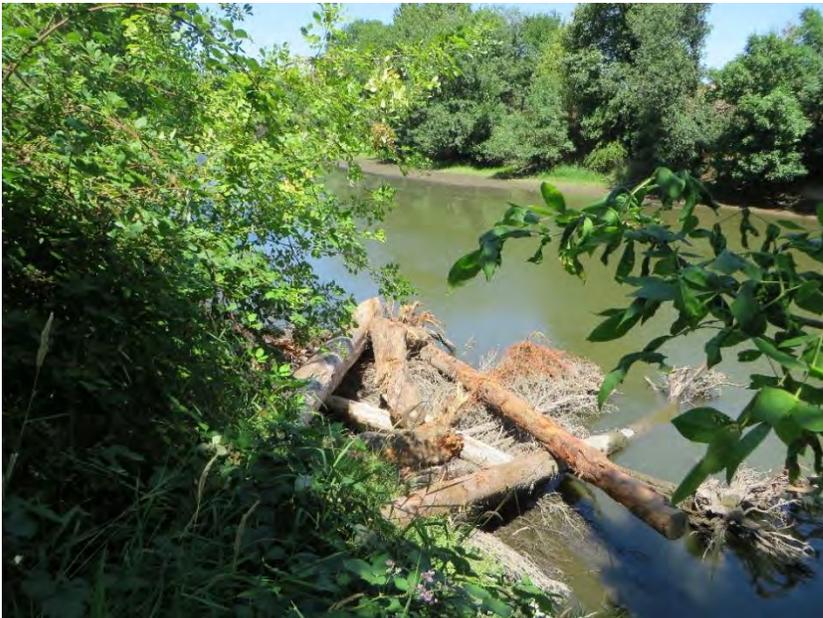
Photo Point 31

ELJ # 6, one of the smallest ELJ types, with 2 anchors at the upper end. This style of structure is designed to float up some, in high water. Water surface elevation: 5.9 (COP datum).

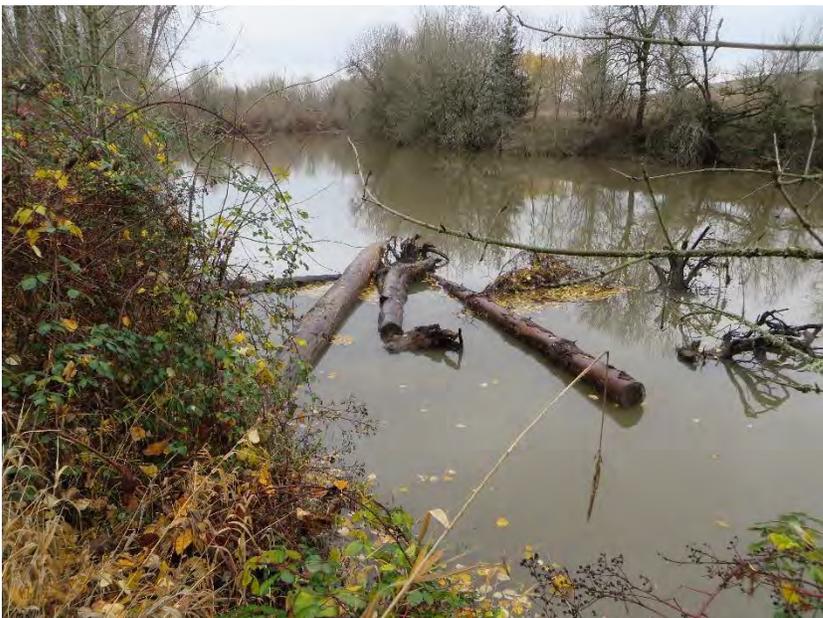
Photo Point 31

High water event in early December. Water surface elevation: 14.2 feet (COP datum).

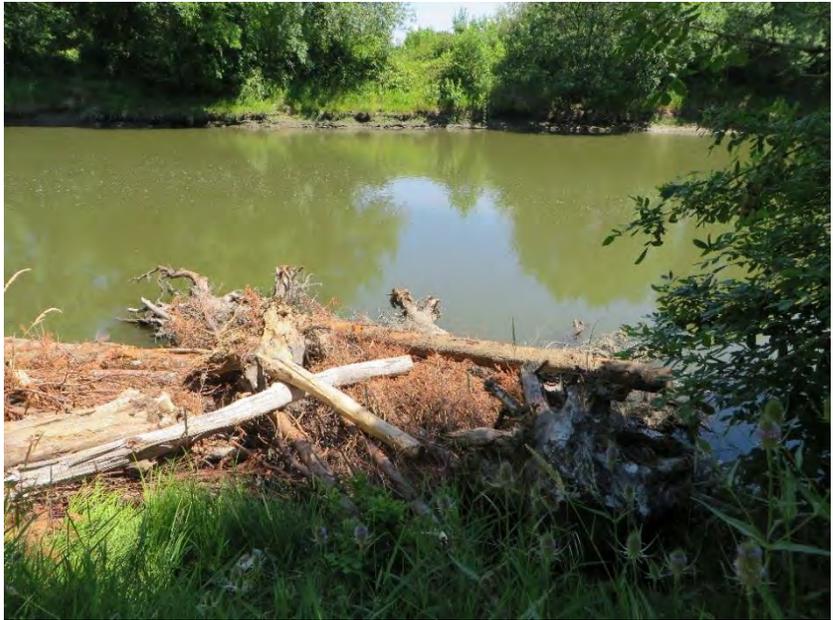
Photo Point 25A

ELJ #2, approximately one month after construction. Water surface elevation: 5.9 feet (COP datum).

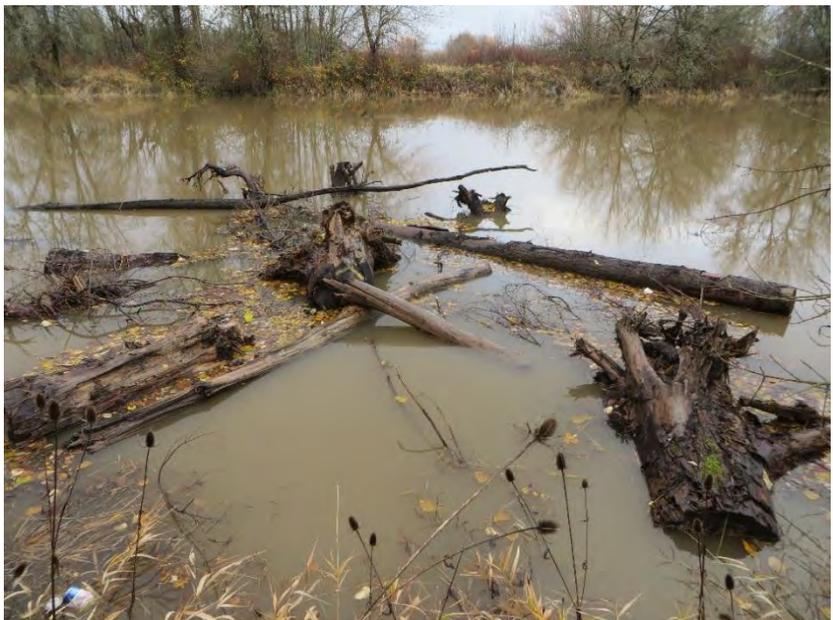
Photo Point 25A

This is the smallest ELJ type; it is designed for a steep bank and will float up in high water conditions (as in this photo). Water surface elevation: 14.2 feet (COP datum).

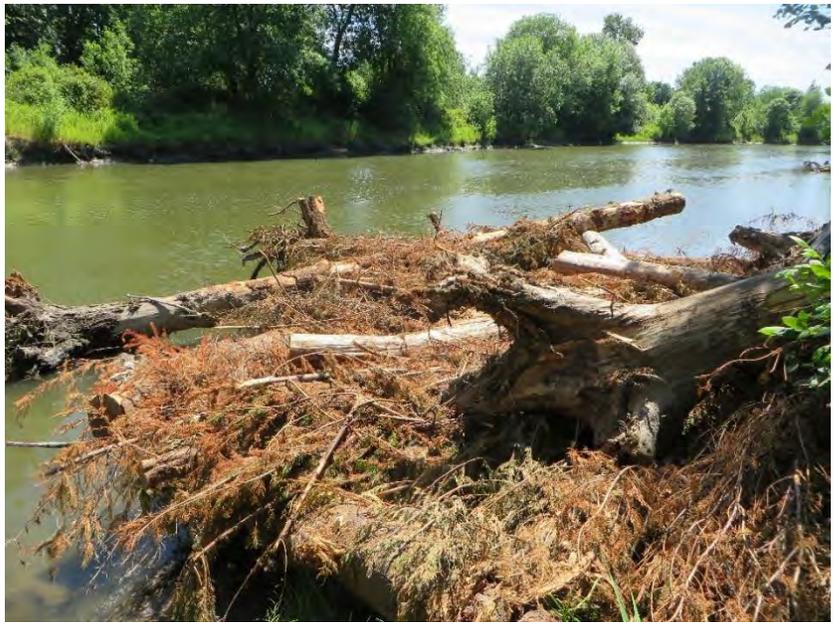
Photo Point 23

ELJ # 1, approximately one month after construction. Water surface elevation: 5.9 feet (COP datum).

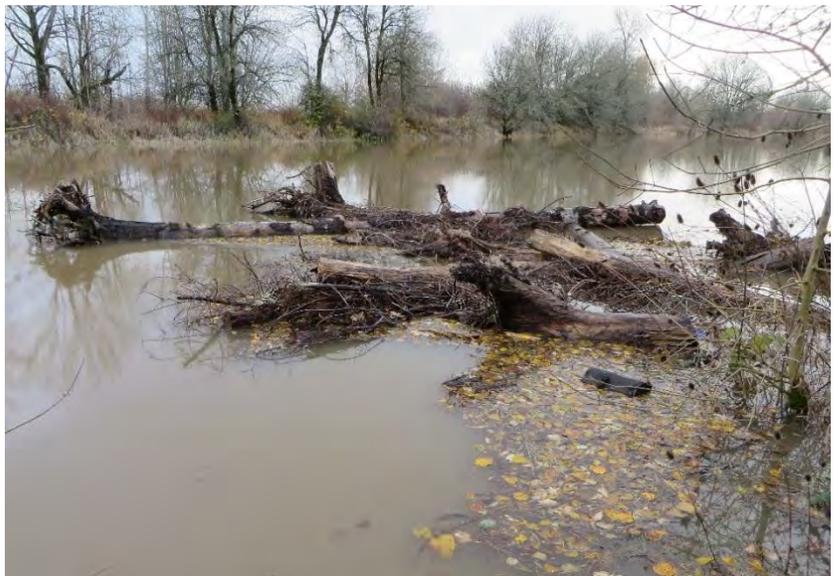
Photo Point 23

This is the smallest ELJ type. It is designed for a steep bank and will float in high water conditions (as in this photo). Water surface elevation: 14.2 feet (COP datum).

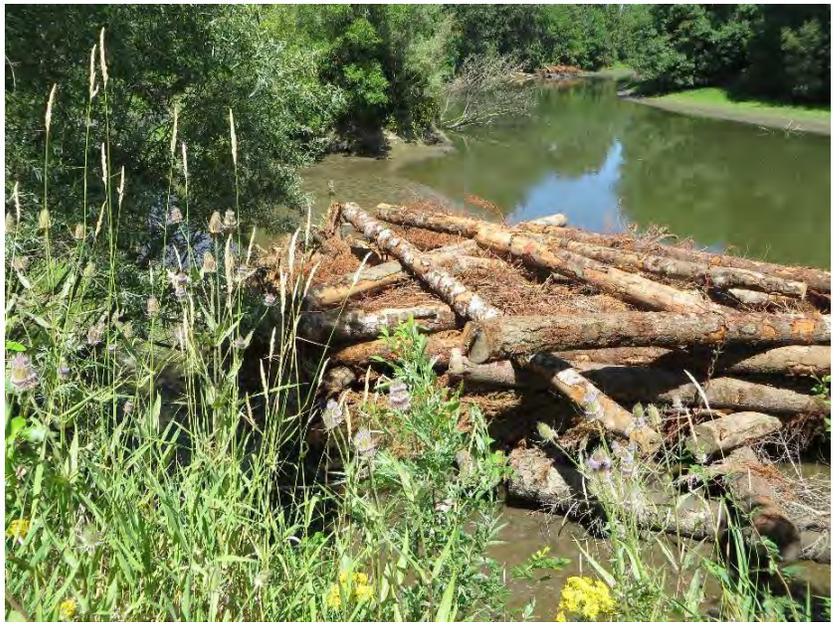
Photo Point 26

ELJ # 5, approximately one month after construction. This is the largest of the five ELJ designs with 28 logs/rootwads and 12 anchors. It does not float. Water surface elevation: 5.9 feet (COP datum).

Five different types of ELJs were installed on the project: the smallest had two anchors and five logs while the largest had 12 anchors and 28 logs. On some installations, additional loose, un-anchored logs were placed between the ELJ and the bank. The loose logs were stripped cottonwoods trees obtained from Trimet. Since they were not anchored, we anticipated some would eventually float away to "seed" the Slough with additional wood. In fact, one of these

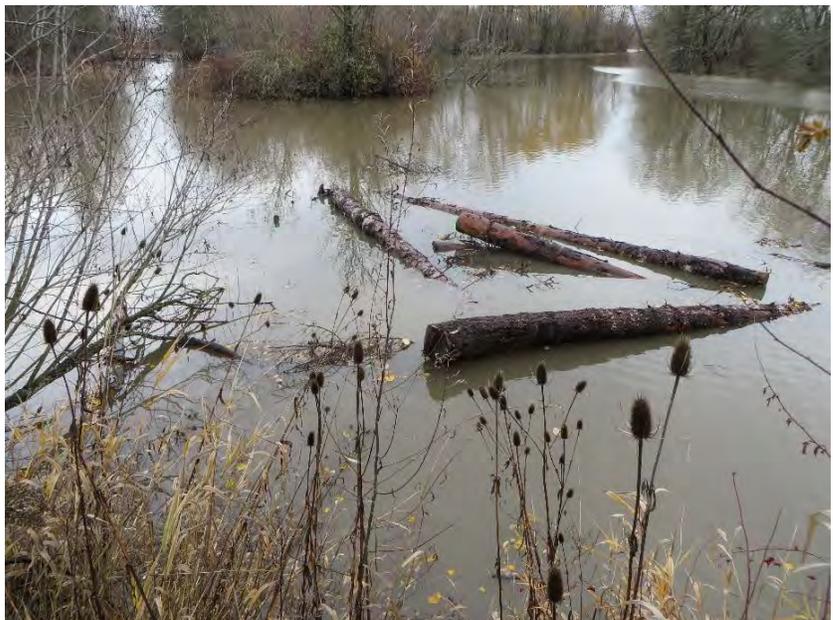
Photo Point 26

The ELJ is functioning as designed for this water level, with the entire structure inundated, except for the top layer of logs. Water surface elevation: 14.4 feet (COP datum).

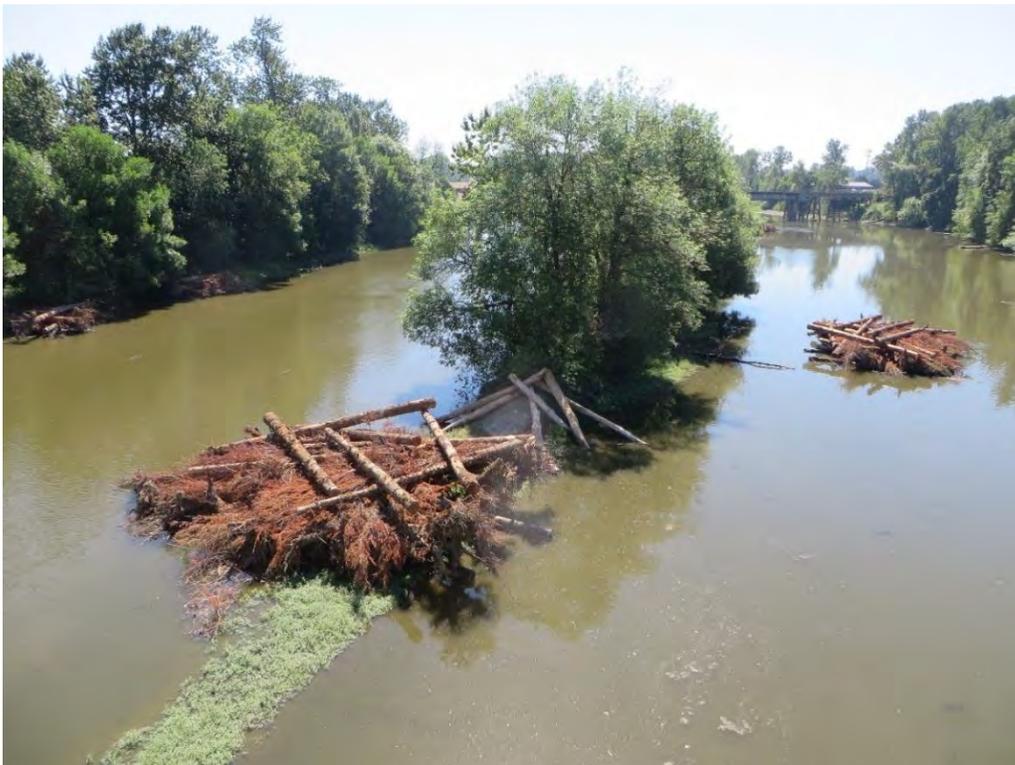
Photo Point 9 July 2, 2015
Recently constructed ELJs on Wright Island (11 and 12) and the north bank (14 and 16). Water surface elevation: 7.8 feet (COP datum).

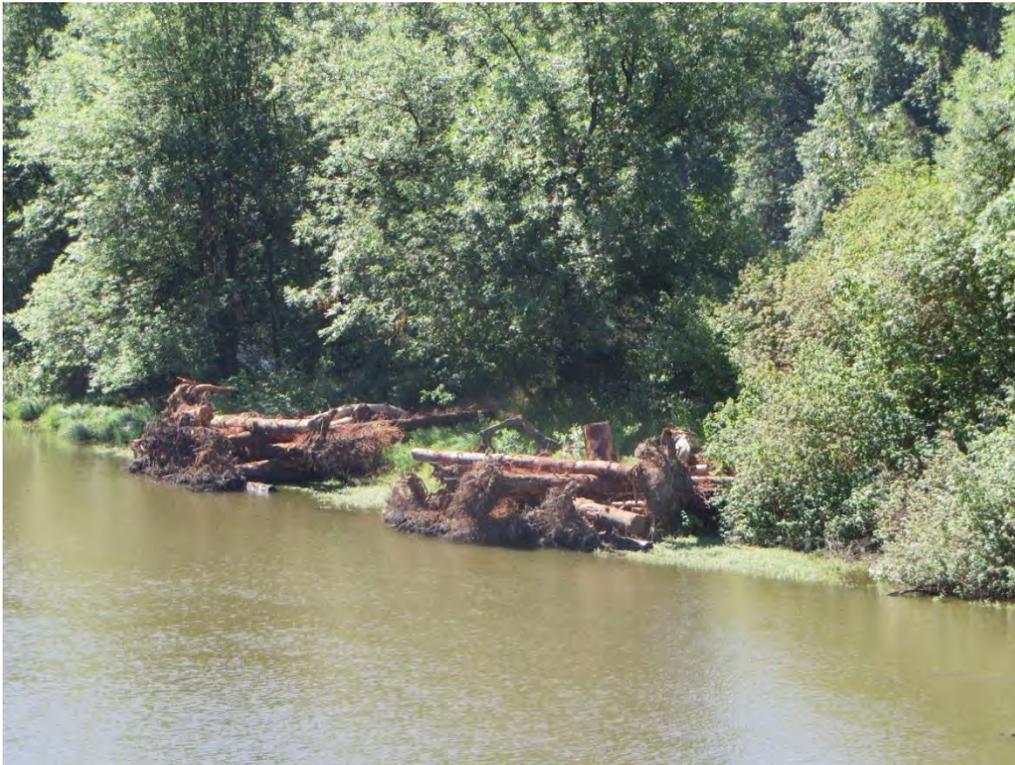
Photo Point 10z July 2, 2015

ELJ # 13 and 15. These are smaller ELJs with four anchors that do not float. Water surface elevation: 7.8 feet; functional ordinary high water is about 13 feet (COP datum).

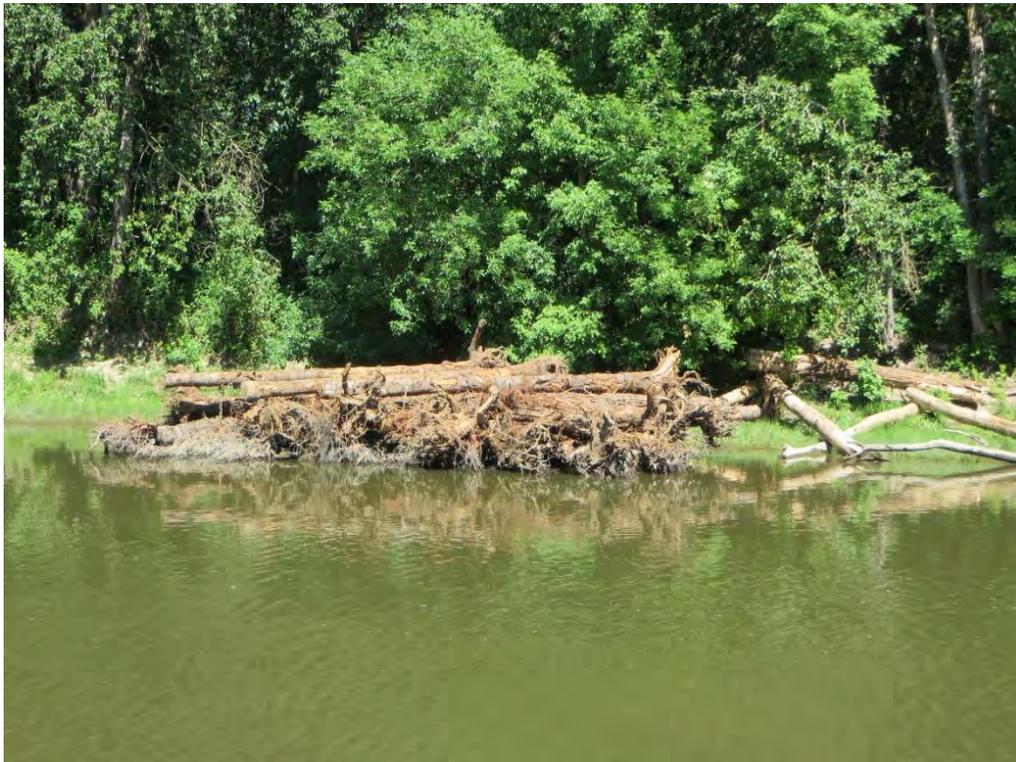
Photo Point 20z July 1, 2015
ELJ # 9. The second largest of the ELJ design types with 18 logs/rootwads and 8 anchors. Supplemental, un-anchored wood is visible to the right of the ELJ.
Water surface elevation: 7.3 feet (COP datum.)

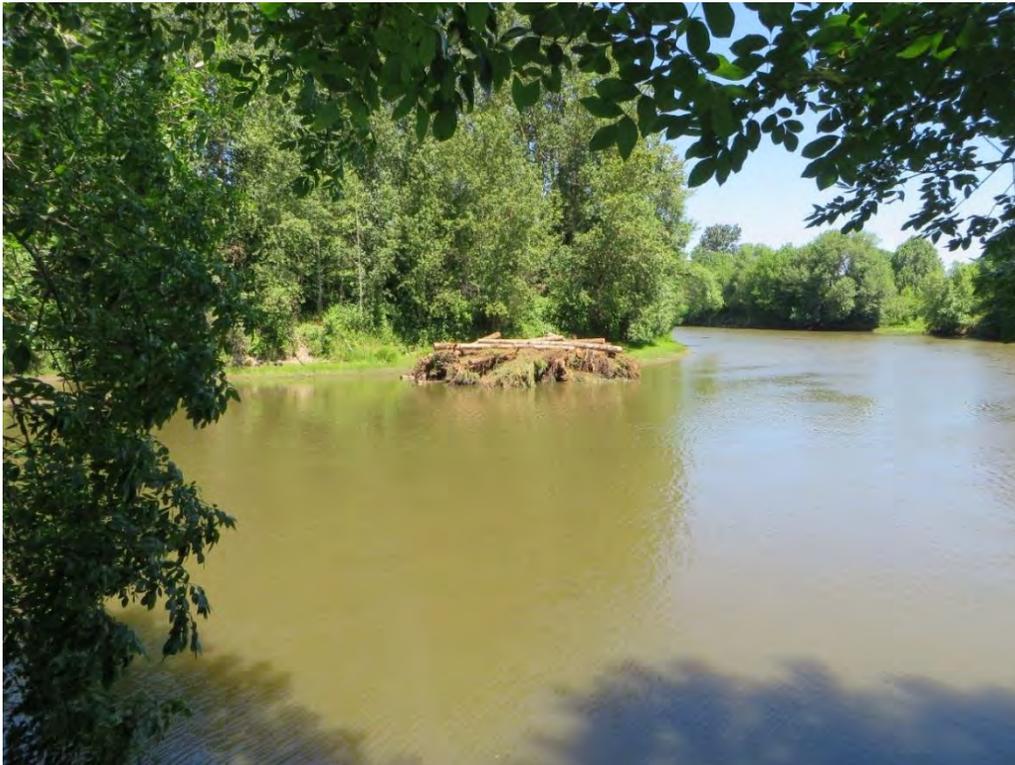
Photo Point 22 July 1, 2015
ELJ # 3. Water surface elevation: 7.3 feet; functional ordinary high water is about 13 feet (COP datum).

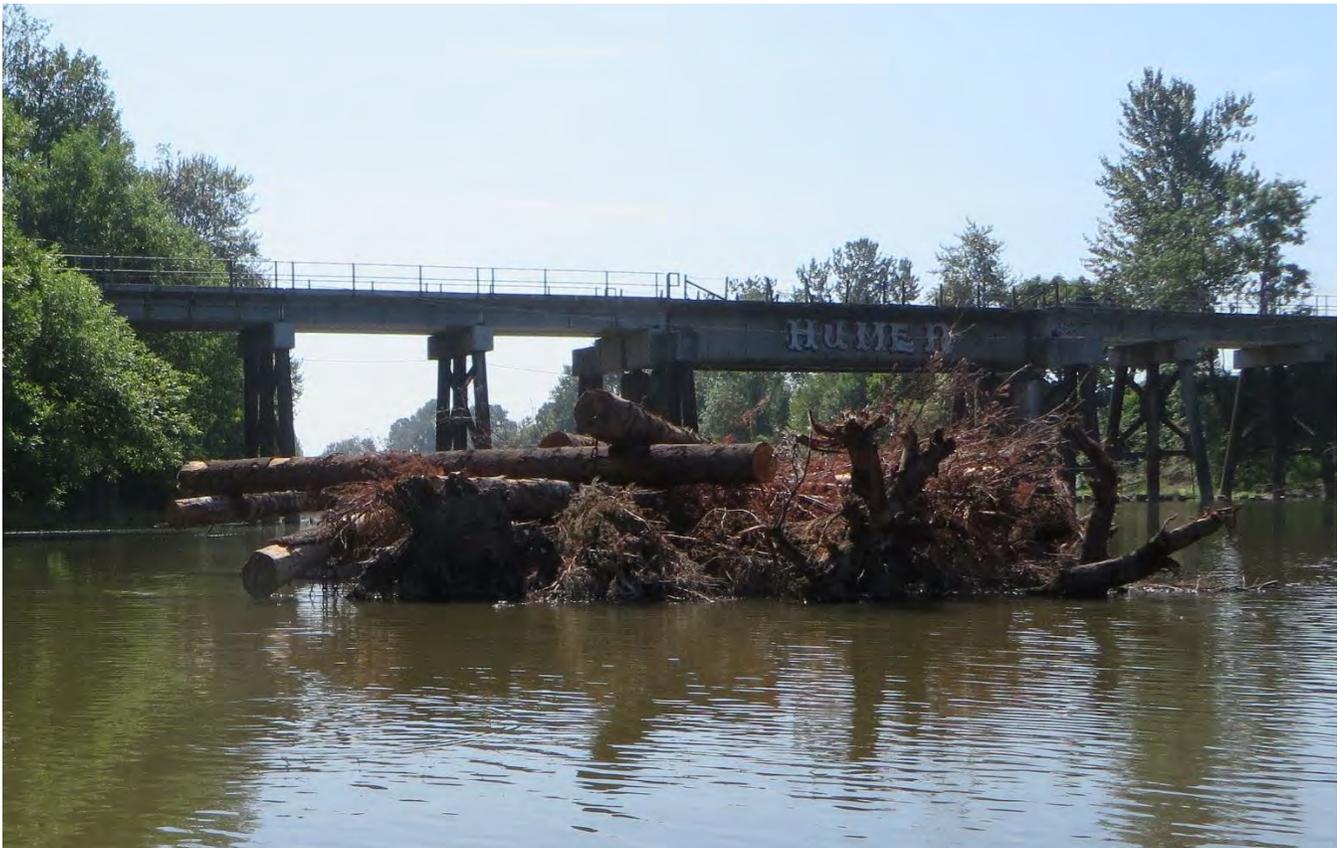
Photo Point 27 July 6, 2015
ELJ # 18. The second largest of the ELJ design types, with 18 logs and 8 anchors. Water surface elevation: 8.0 feet, functional ordinary high water is 13 feet (COP datum).

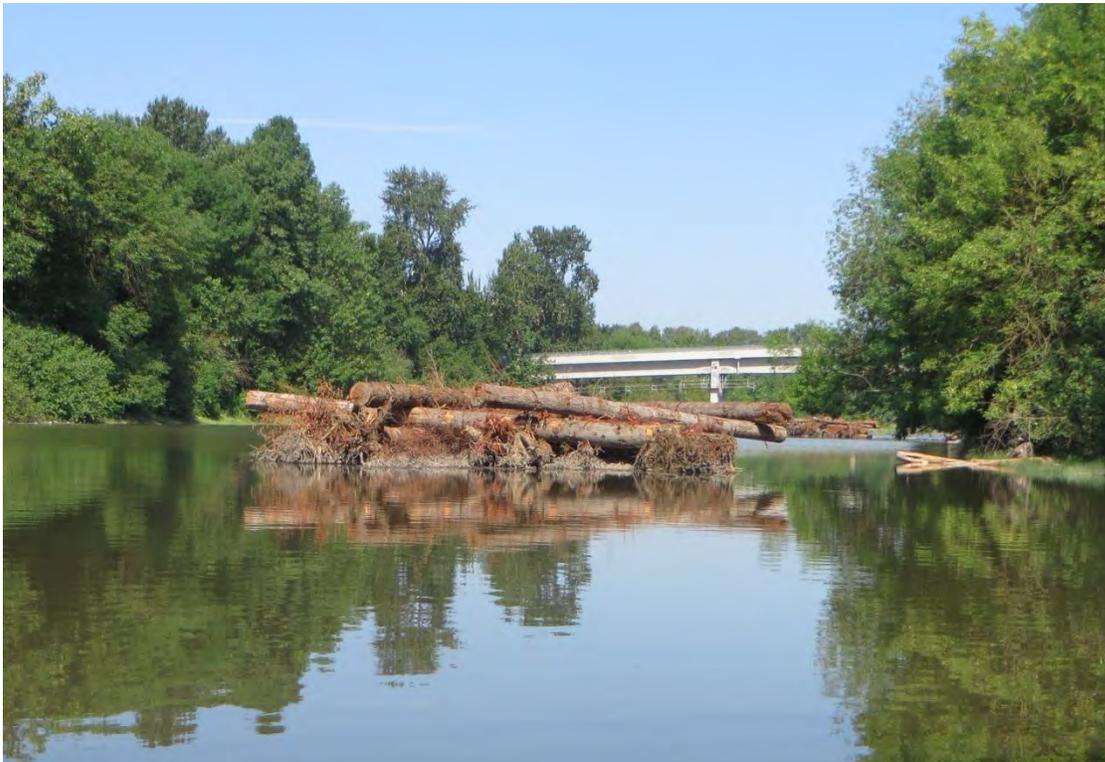
ELJ # 18 (ELJ # 12 in background). Water surface elevation: 6.9 feet, functional ordinary high water is 13 feet (COP datum).

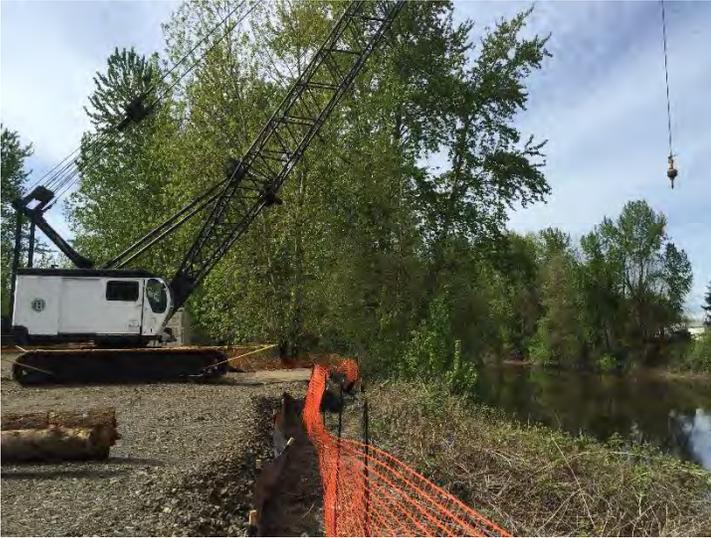
Crane at staging area off North Portland Road. The crane was used to load wood and slash onto the materials barge.

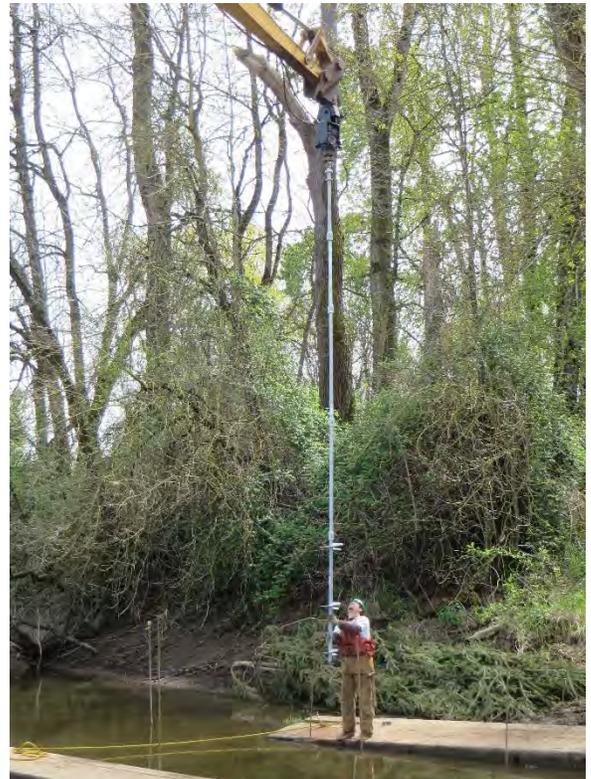
Preparing to install one of the helical anchors. The anchor is slowly rotated by a torque motor on the excavator head as it drives into the Slough bed.

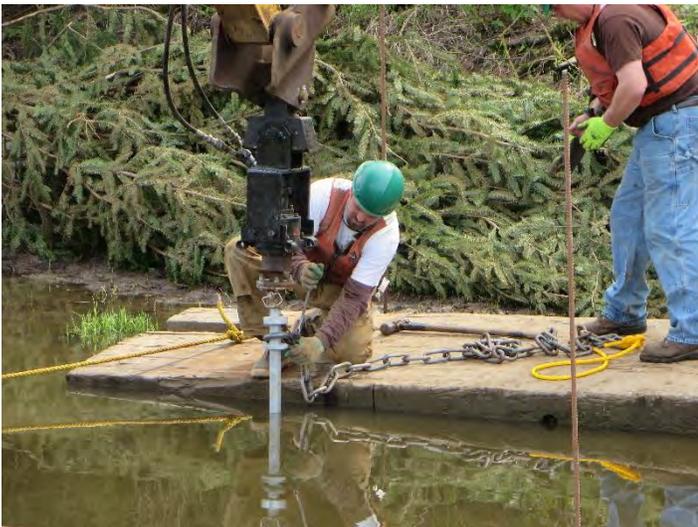
Attaching the anchor chain to the mooring head at the top of the helical anchor.

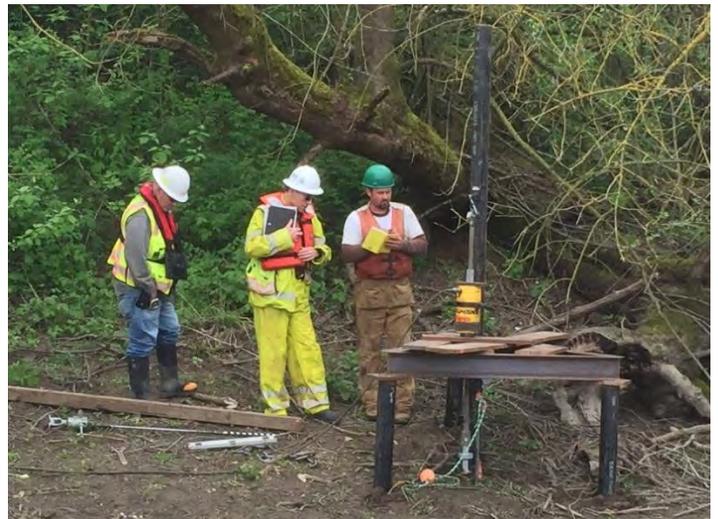
The set up for helical anchor strength testing. All tested anchors passed.

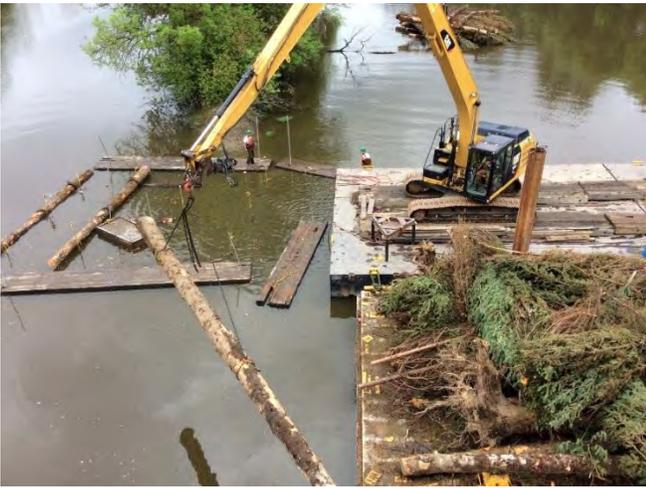
Moving base layer of logs into place after anchors have been installed.

The construction barge was positioned and stabilized at each ELJ location; the crew constructed one ELJ a time and then moved to the next installation site. The general construction sequence was: install helical anchors, build base layer of logs, add slash, add logs for middle layer, add slash, place tops logs and secure structures to anchors with chains. Anchors were installed at depths of 17 to 27 feet below the bed surface. Installed anchors were strength tested at prescribed intervals throughout the project and all passed. Overlapping logs were pinned together at one or both ends for additional stability.

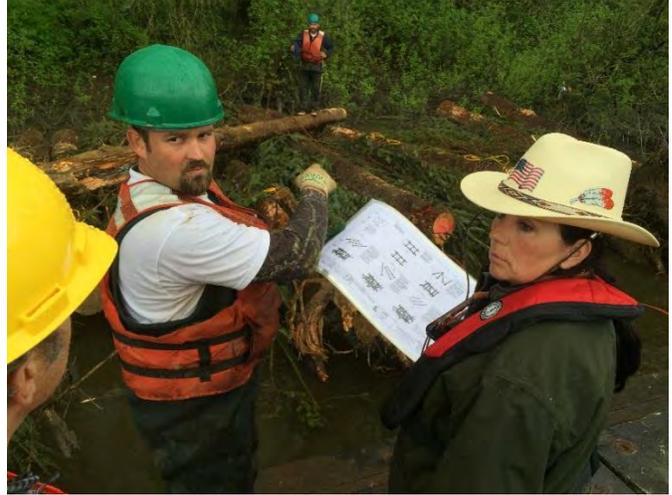
Close and regular communication between the contractor and BES inspectors and designers was a key element of success.

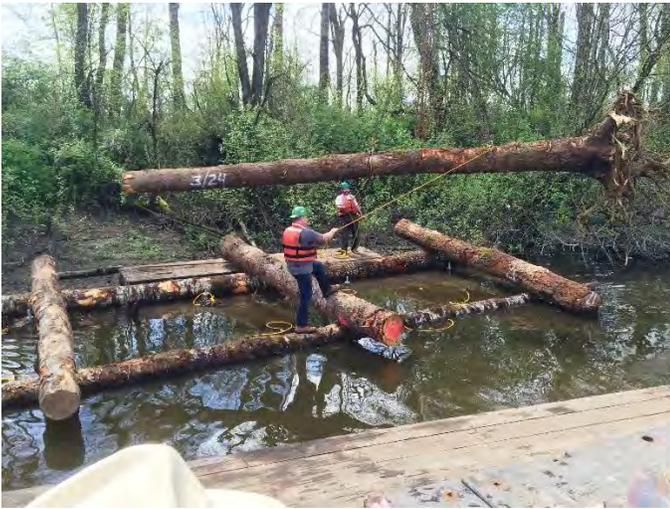
Moving a rootwad log into place to start building the next layer of the ELJ.

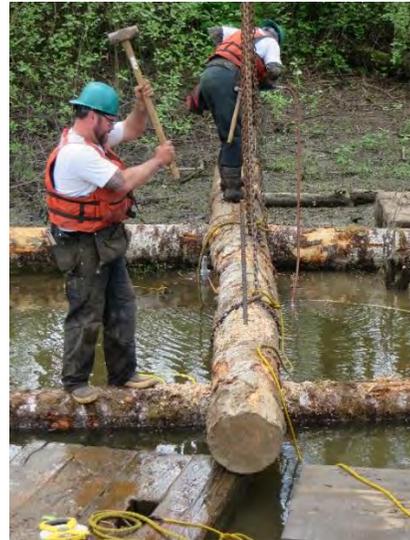
Driving a pin to secure logs to each other.

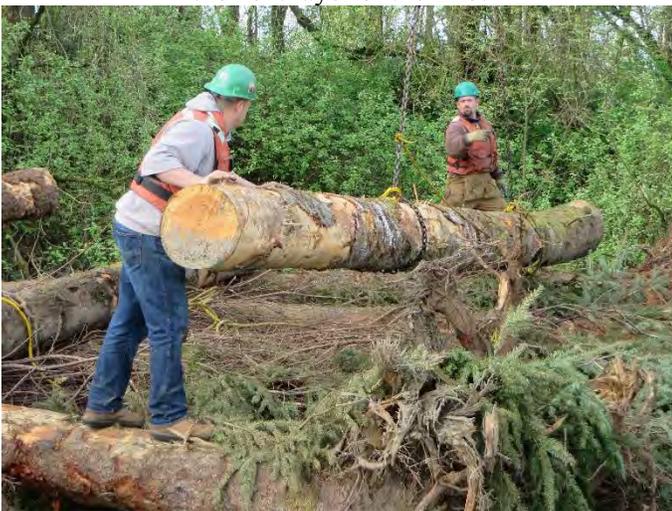
Each log was carefully placed to match design and accommodate natural variation in size and shape.

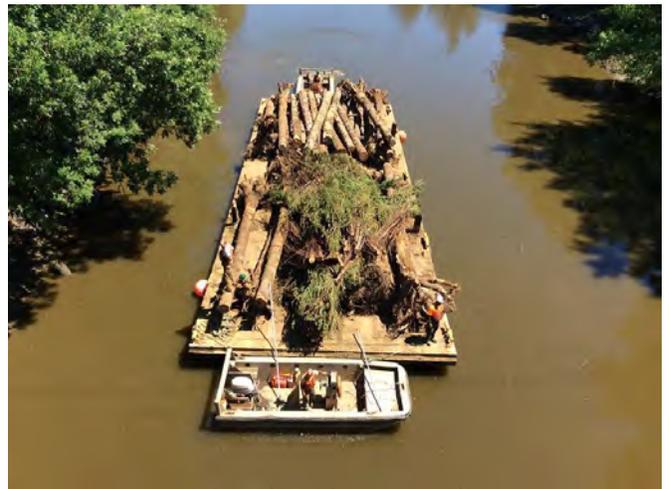
The materials barge in transit.

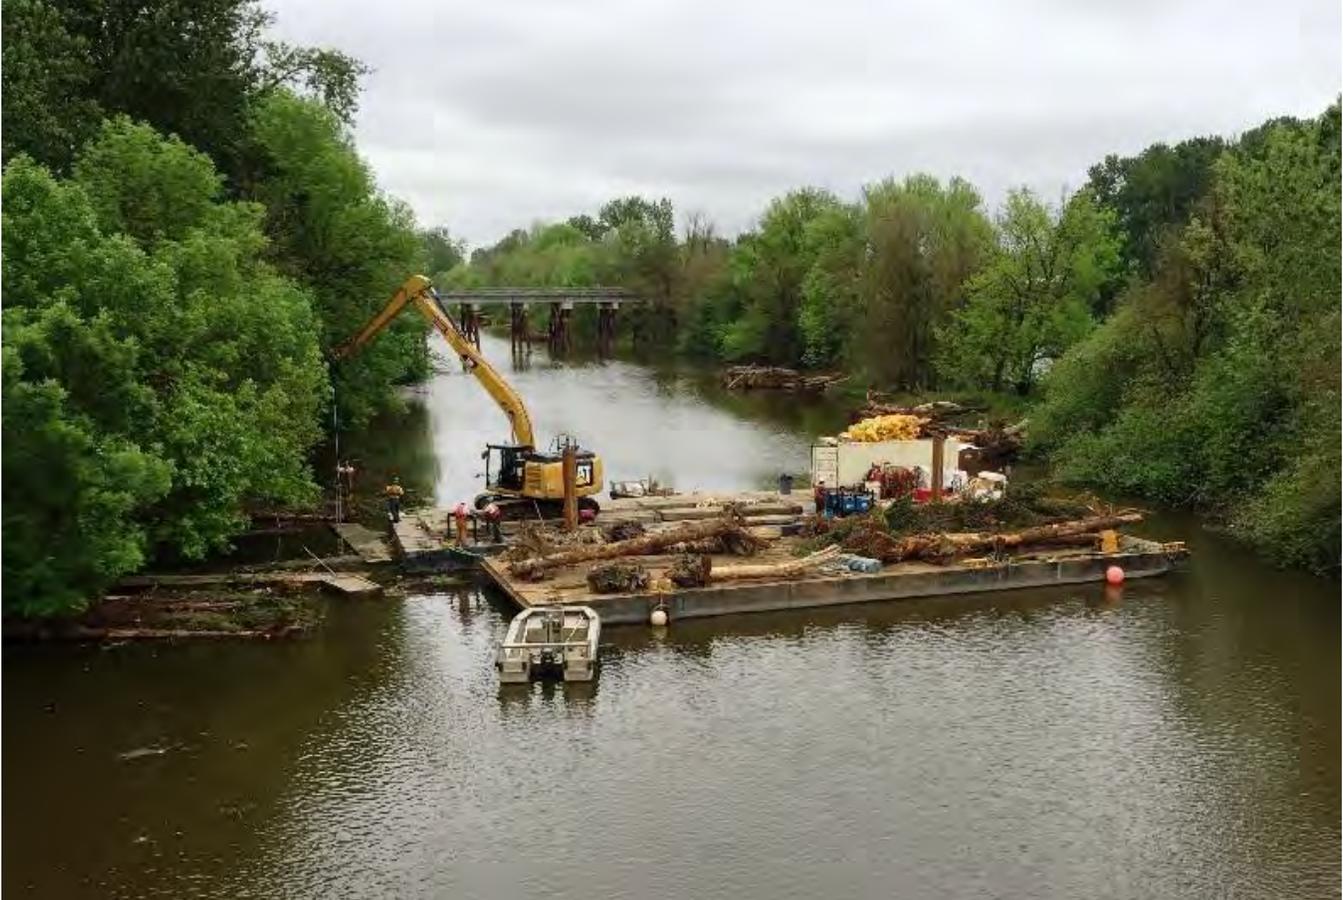
Constructing ELJs on the north bank of Columbia Slough. The materials barge is in the foreground with the construction barge behind it. Completed ELJs are visible in the top right, on the north shoreline of Wright Island.

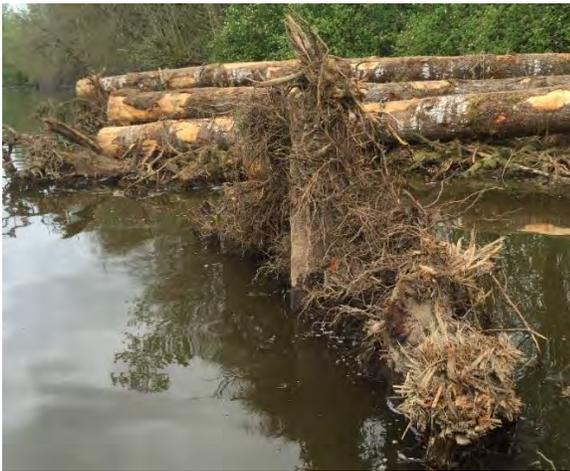
Ensuring rootwads met specifications was a key element of success: they are at least 6 feet in diameter and untrimmed with ample fine root structure.

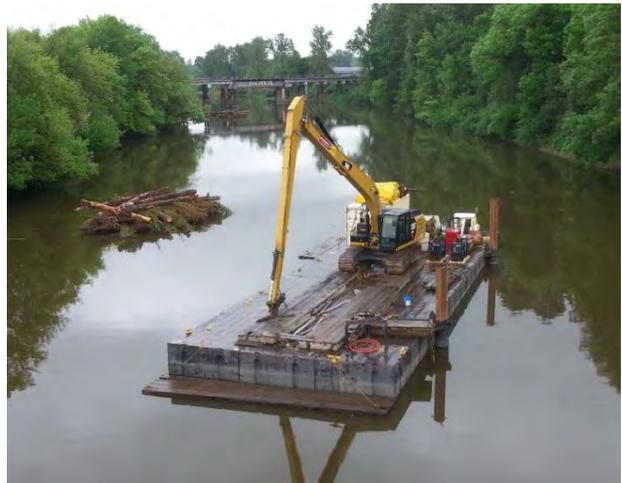
Construction barge in Slough near completed ELJ.

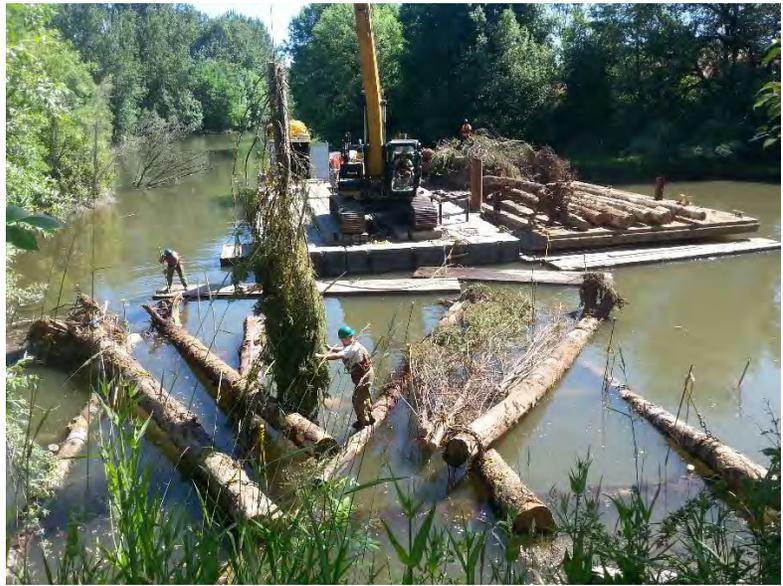
ELJ #5

1st photo in series of 3

Placing slash between logs in first of the rootwad layers. The base layer of logs is already installed and visible, but mostly submerged. The base logs do not have rootwads.

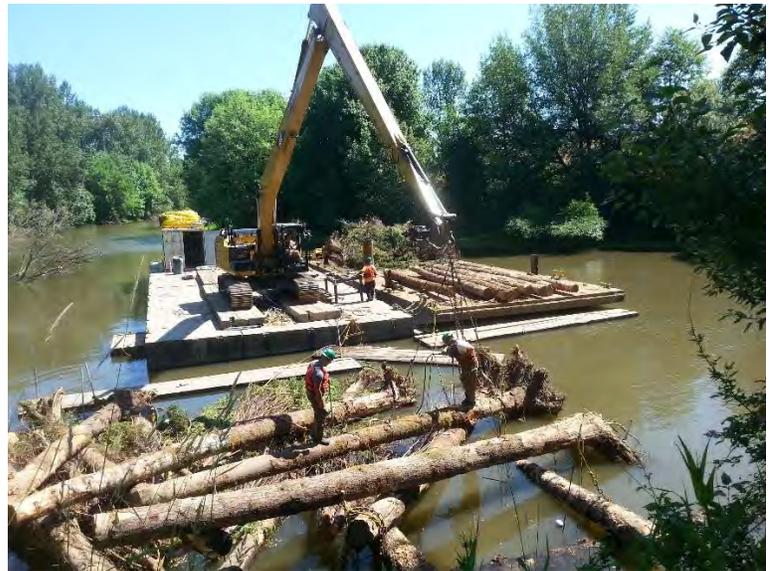
ELJ # 5

2nd photo in series of 3

Adding a second layer of rootwad logs. Slash was then packed between these.

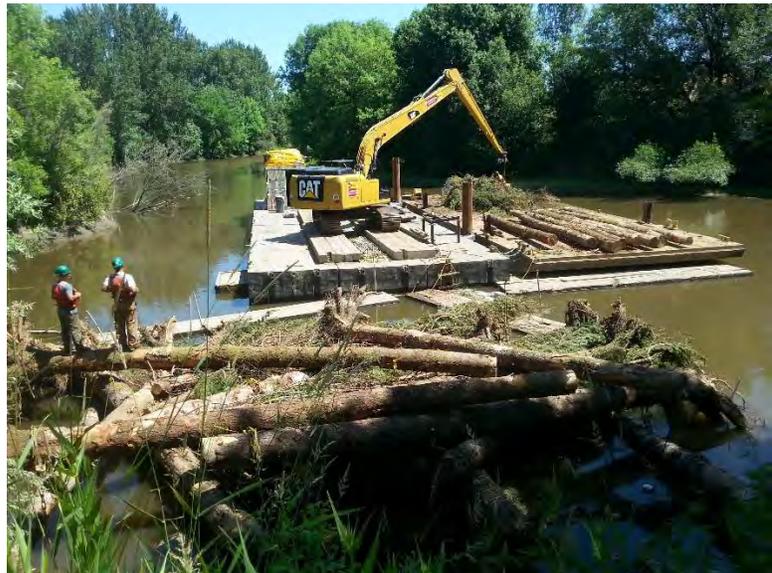
ELJ # 5

3rd photo in series of 3

A third layer of rootwad logs has been added with slash again packed between each log. A final layer of top logs were added and anchoring chains were attached to the ends of the top logs.
