MADDEN MINE REPORT

H. F. Byram  
375 Edgecliff Road  
Portland, Ore.  
Sept. 20, 1931.

The Madden Mine is situated twenty-two miles south of Bandon, Oregon, in Township 32 South, Range 15 West. It consists of forty acres patented homestead land and seventy acres held by mineral location. It is four miles east of Cape Blanco and the Pacific Ocean and crossed by the Roosevelt Highway. The climate is excellent and suitable for all year mining operations. An electric power line follows the highway and is available for power.

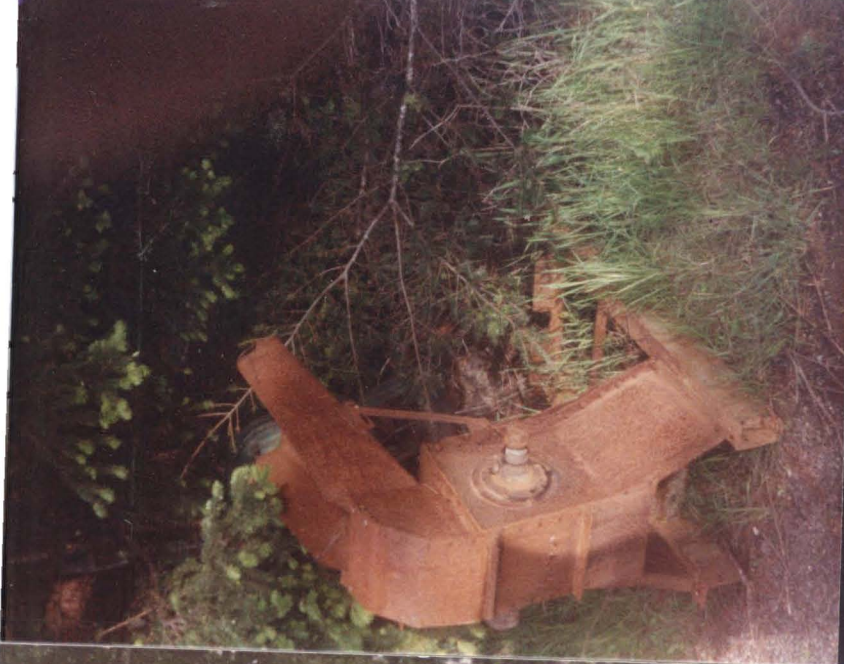
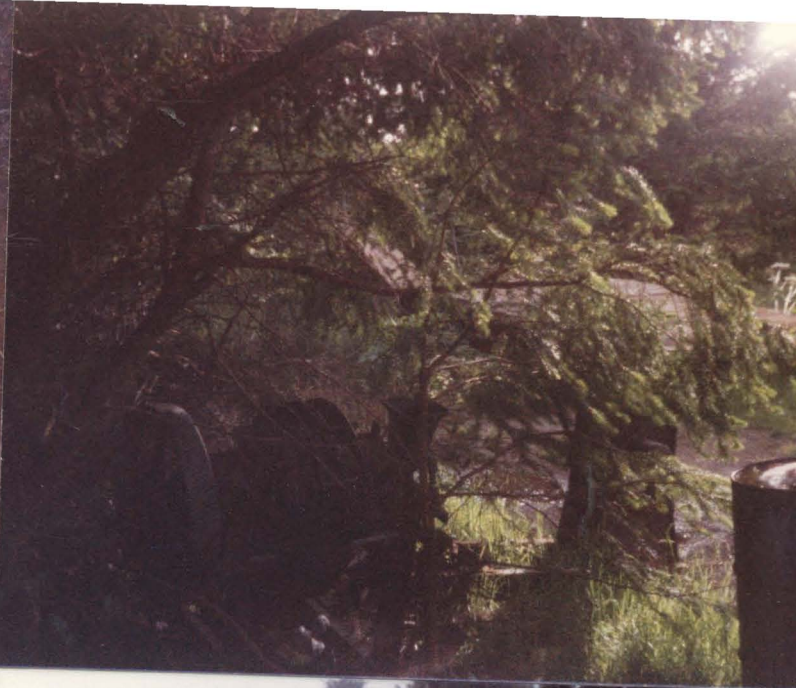
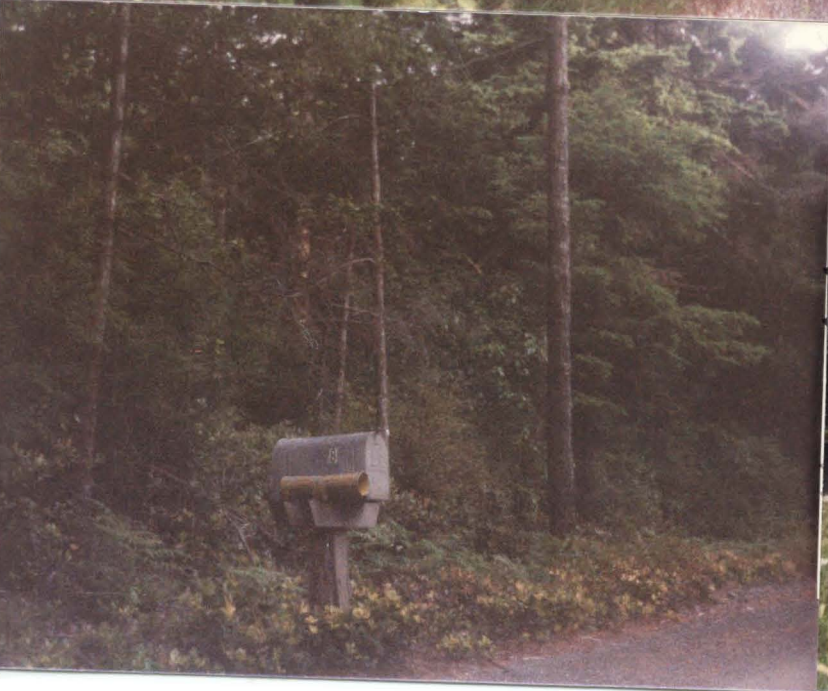
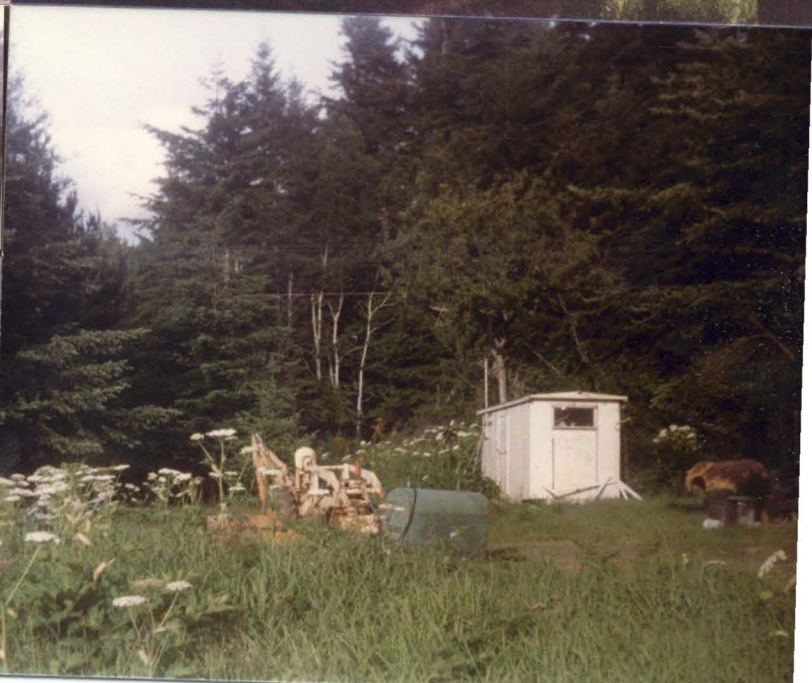
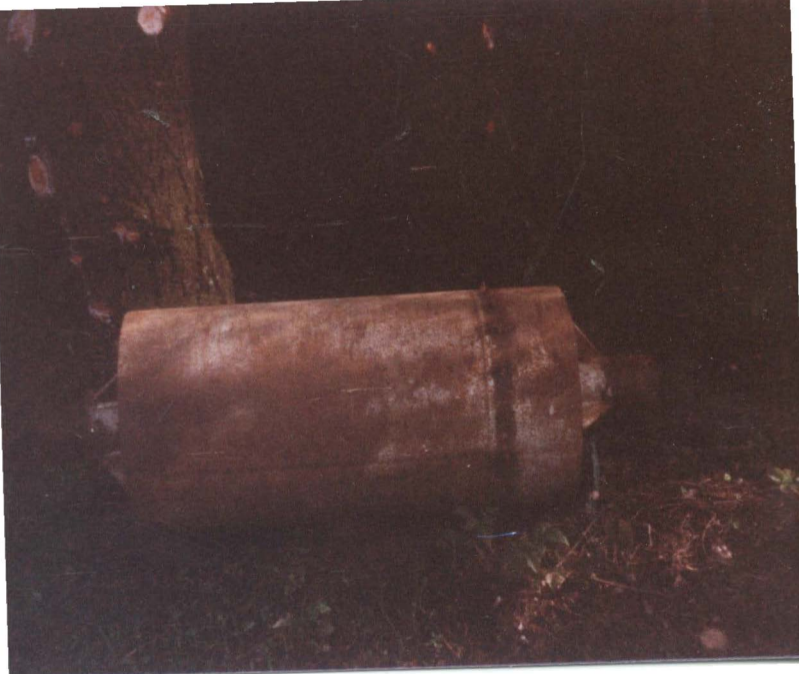
(Photos in envelop)

Here's some snaps  
of the Madden Operation,  
missing ~~is~~ the development

The Madden black sand is  
a seam of thick rusted botte  
hematite & limonite with large  
sharp pieces of brecciated matter  
in a east trending dip and  
a N-S strike, it is very  
old and about 2"-6" thick.  
The old ditch and rock walls  
drained it out under the  
old highway now Coast Road, 101?  
The mill site was about 50'  
from the road, the workers  
cabins close to road and the  
sand seam is overlain with  
about 10-20 ft of blonde  
sand. The old horse and Fresno  
dug ditch 6' deep 8' wide  
goes for miles back up onto  
Madden Butte, yours - James  
Mason
