North Lincoln Fire & Rescue - Otis Fire Dept.

FEMA 154 Rapid Visual Screening Score Card

Rapid Visual Screening - Senate Bill #2 - Seismic Needs Assessment
Oregon Department of Geology and Mineral Industries

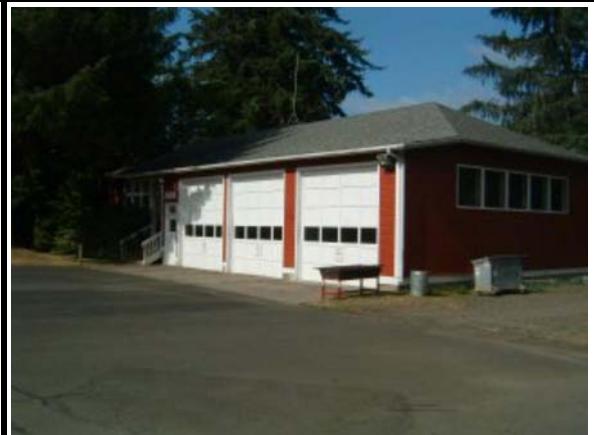
Building Type	County	
Fire - RFPD	Lincoln	
Street		
381 Old Scenic Hwy		
City	State	Zip
Otis	OR	97368
Latitude	Longitude	
45.02448	123.94713	
Tracking Code	Inspection Date	
RVS in 2006	8/8/2006

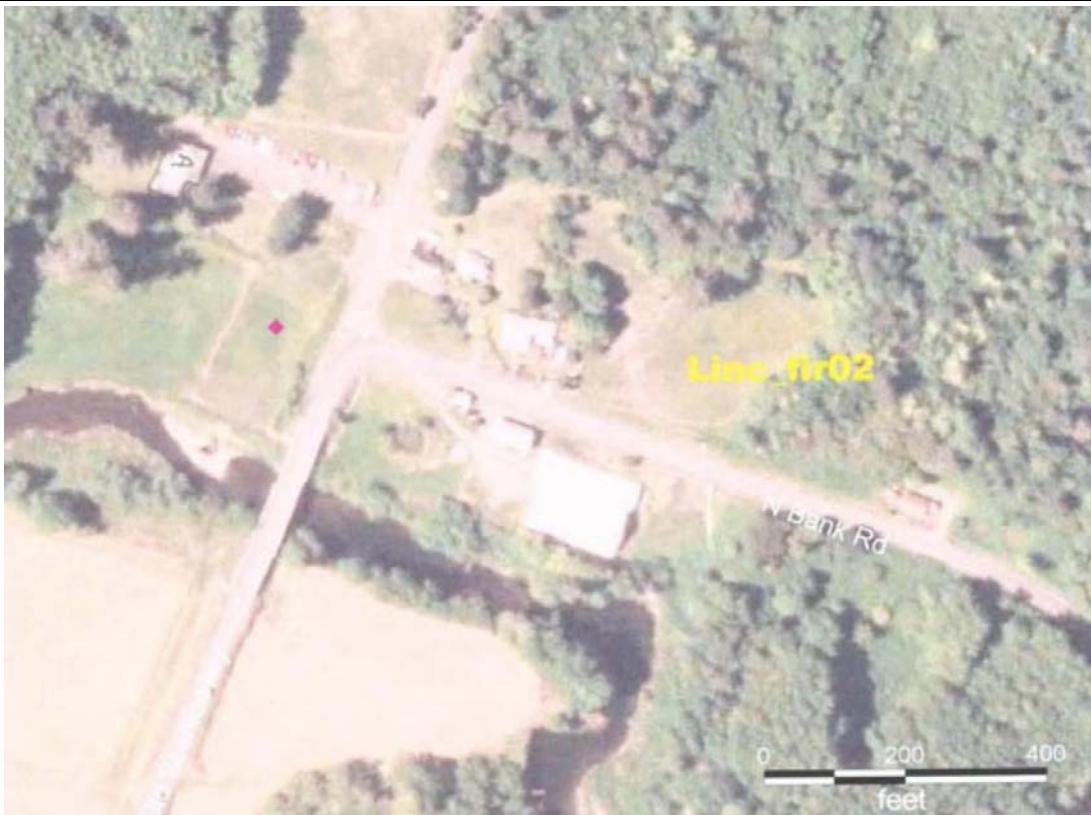
Enrollment	Year Built (Field Verified)	Year Built (Alt. Source)	Est. Decade Built
			1970
Total Area (square ft)	Number of Stories	Basement	Pounding Potential
	1	Yes	No
Plan Irregularities		Vertical Irregularities	
Out of Plane Lateral-Force-Resistance Elements		None	
Torsion: Eccentric Stiffness		None	
None		None	
Falling Hazards		Poor Conditions	
None		None	
None		None	
None		None	
NW Primary Structural Type		SE Plan Irregularity Primary
