Takena Hall

Linn-Benton CC

FEMA 154 Rapid Visual Screening Score Card

Rapid Visual Screening - Senate Bill #2 - Seismic Needs Assessment
Oregon Department of Geology and Mineral Industries

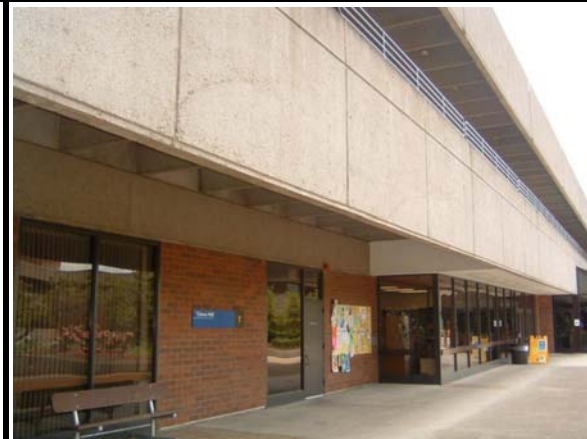
Type	Basic Score	Vert Irreg	Plan Irreg	Pre-Code	Post-Bench	Soil C	Soil D	Soil E	RVS Score
Primary	PC2	2.4	-1	-0.5	0	0	0	-0.6	0	0.3
Secondary		0	0	0	0	0	0	0	0	0
Tertiary		0	0	0	0	0	0	0	0	0

Takena Hall
