OR 126 EAST MCKENZIE HIGHWAY SAFETY STUDY

JANUARY 2024

THE GOAL OF THE OR 126 EAST MCKENZIE HIGHWAY SAFETY STUDY IS TO IDENTIFY LOW-COST, HIGH-BENEFIT SAFETY SOLUTIONS ON THE OR HIGHWAY 126 EAST CORRIDOR BETWEEN THE SPRINGFIELD CITY LIMITS (IN LANE COUNTY) AND US 20 (IN LINN COUNTY).

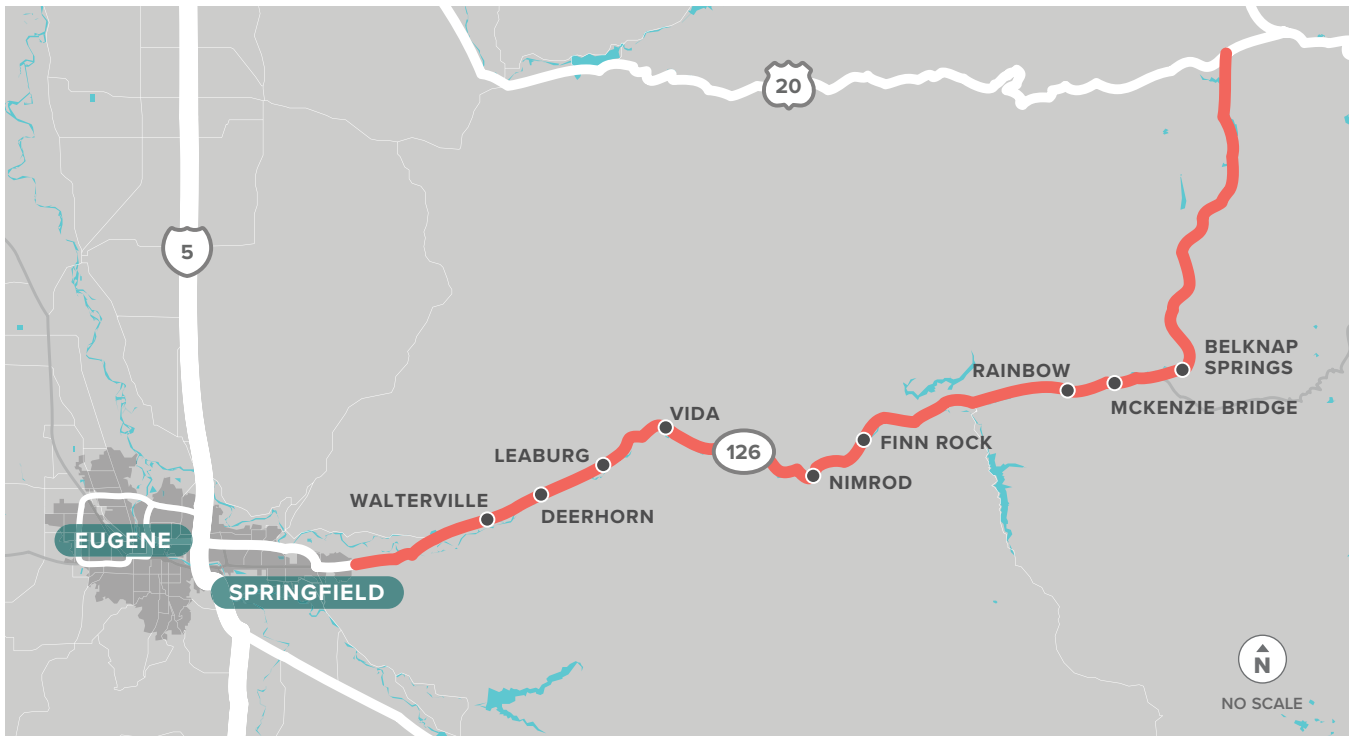
FIGURE 1. OR 126 EAST STUDY AREA

As shown in Figure 1, the study area spans these two Oregon Department of Transportation (ODOT) highways (from west to east):

1 McKenzie Highway #15
 MP 8.81 (Springfield City limits) to MP 55.00 (Junction with OR 242)

2 Clear Lake-Belknap Springs Highway #215
 MP 19.81 (Junction with OR 242) to MP 0.00 (Junction with US 20)

highway carrying approximately 12,000 vehicles per day (vpd) on the west end and 3,000 vpd at the east end. There are many small rural communities located along the McKenzie Highway segment (shown in Figure 1). Along the Clear Lake-Belknap Springs segment, there are no small communities, but the highway provides access to several campgrounds and popular trailheads.

There are nine small unincorporated communities along the corridor. (Refer to Figure 1.) These communities have a higher density of homes and businesses compared to the rest of the corridor. There is a high level of public concern for safety in these small communities. On the rural segments of the highway, safety concerns are mostly focused on drivers leaving their lane or the roadway, as well as potential conflicts at major intersections. Within these small communities, however, the safety challenges are more complex as regional traffic on the highway mixes with local residents driving, walking, and biking to their homes, work places, schools, and other local destinations. Identifying solutions for small communities is a top priority.

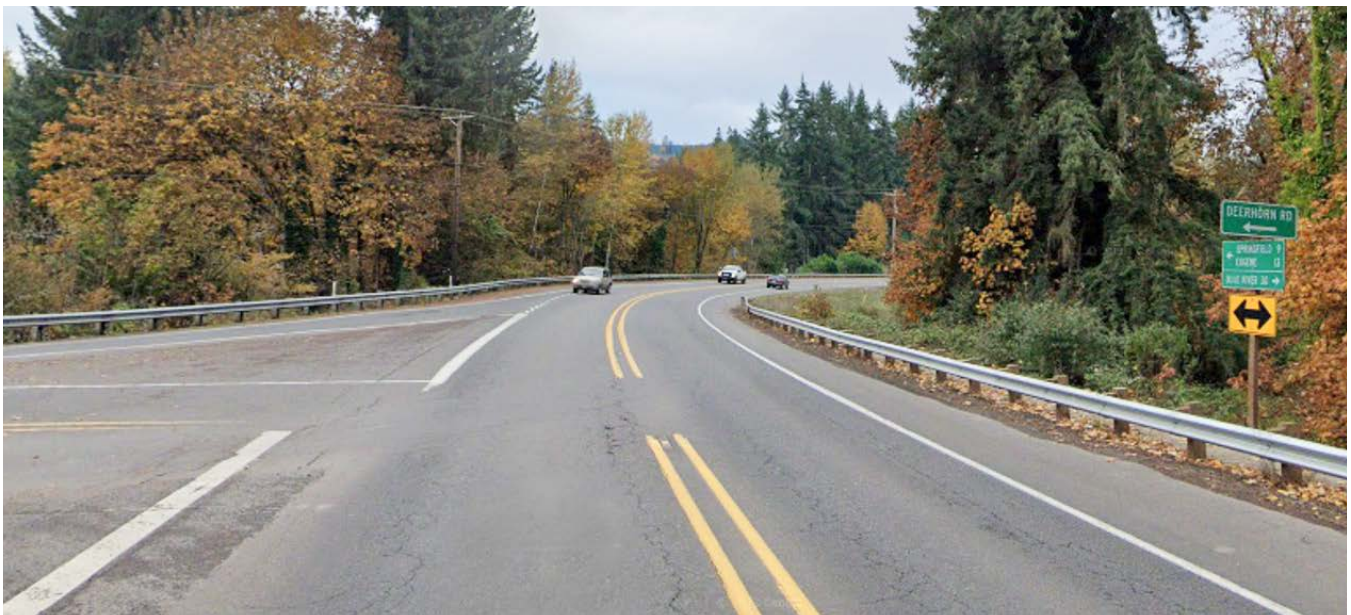
FIGURE 3. OR 126 EAST AT DEERHORN ROAD, LOOKING WEST

- » *Install systemic stop-controlled intersection visibility upgrades*
- » *Increase sight triangle by removing vegetation*
- » *Upgrade to high-visibility striping*
- » *Install/upgrade signs with high visibility sheeting*
- » *Install retroreflective tape on sign posts at non-intersection locations*
- » *Install delineation on centerlines and edgelines*
- » Modify drainage areas to create flatter slopes on road shoulders
- » Install eastbound right turn lane
- » Install single lane roundabout

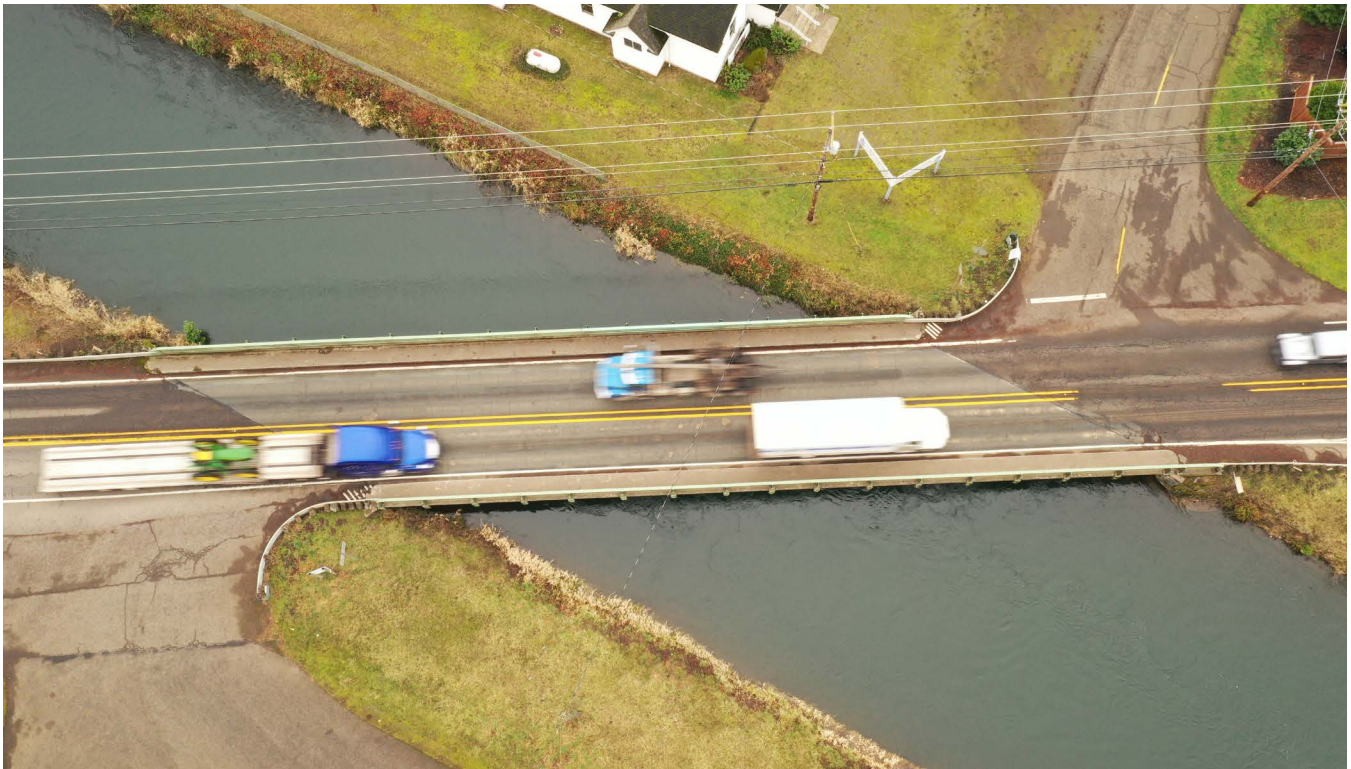
FIGURE 4. AERIAL VIEW OF THE WALTERVILLE CANAL BRIDGE

- » *Install wider edge lines and upgrade to high-visibility striping*
- » *Install/upgrade signs with high visibility sheeting*
- » *Install “Narrow Bridge” warning signs*
- » *Install retroreflective tape on sign posts at non-intersection locations*
- » *Install delineation on centerlines and edgelines*
- » Install centerline rumble strips
- » Widen shoulders and install profiled edgeline markings

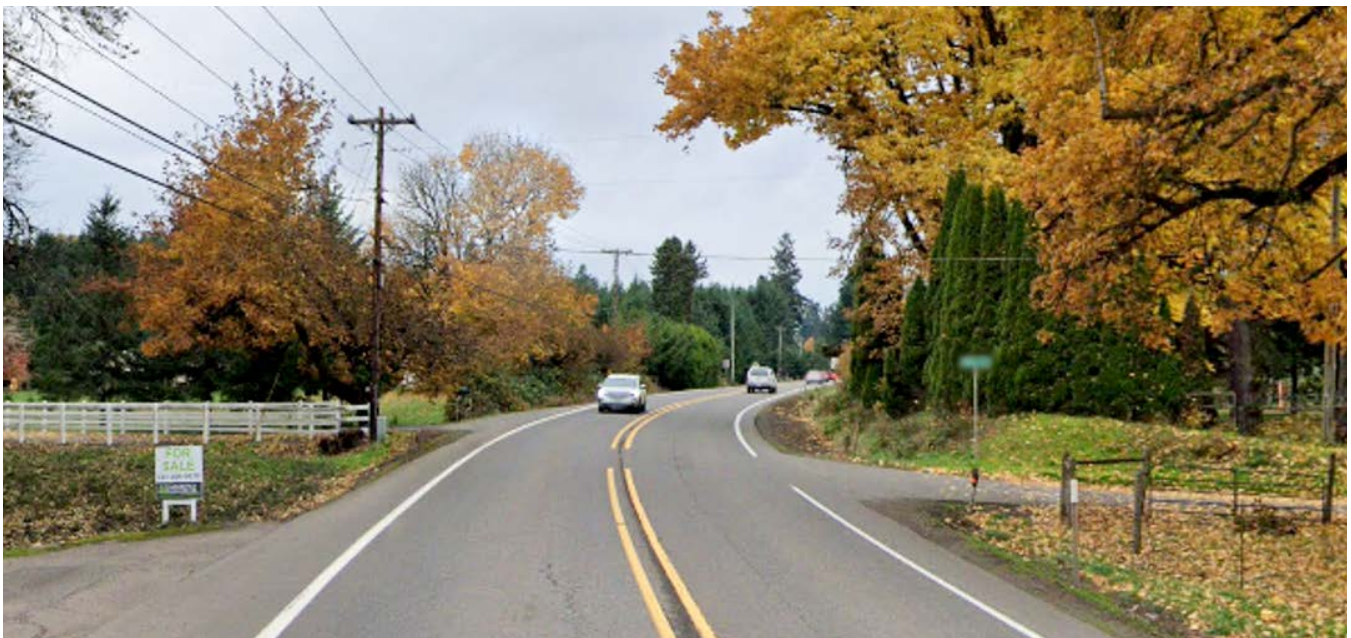
FIGURE 5. OR 126 EAST AT ROSS LANE, LOOKING WEST

- » *Install systemic stop-controlled intersection visibility upgrades*
- » *Increase sight triangle by removing vegetation*
- » *Install delineators at driveways and intersections*
- » *Upgrade to high-visibility striping*
- » *Install/upgrade signs with high visibility sheeting*
- » *Install retroreflective tape on sign posts at non-intersection locations*
- » *Install delineation on centerlines and edgelines*
- » Remove or relocate fixed objects such as utility poles outside of clear recovery zone

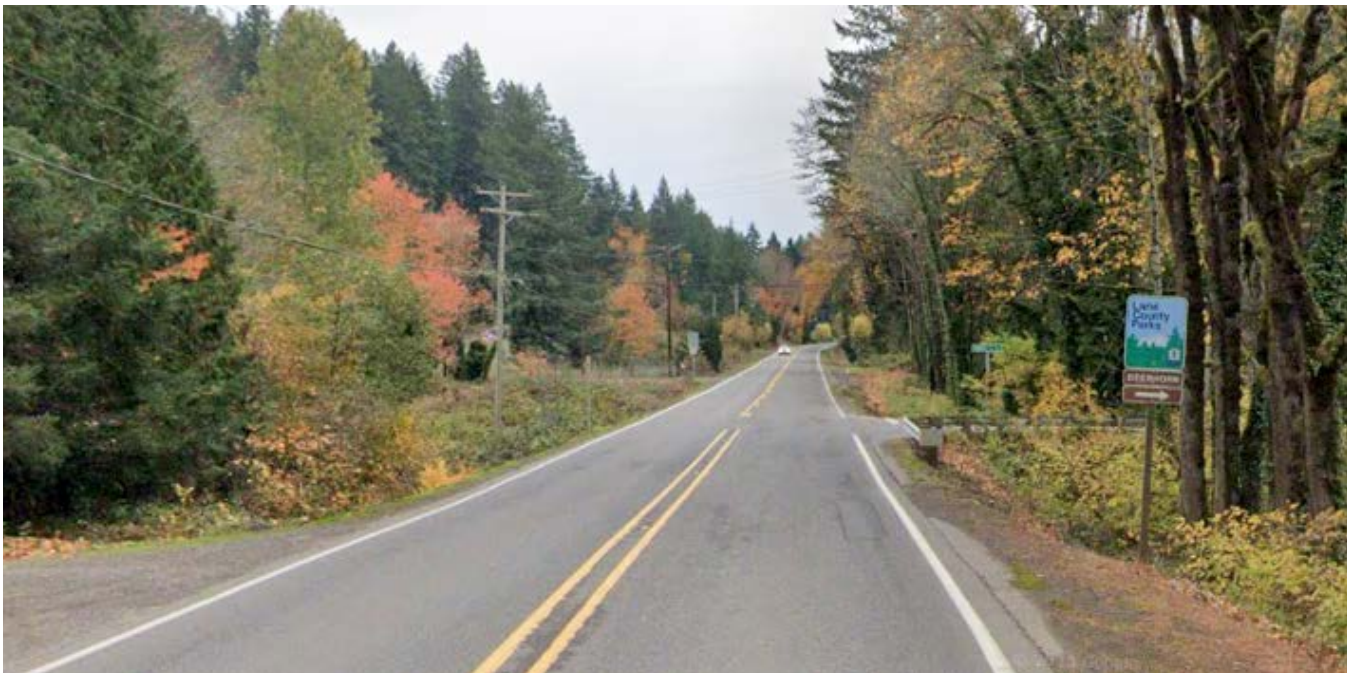
FIGURE 6. OR 126 EAST AT HOLDEN CREEK LANE (WEST), LOOKING EAST

- » *Install systemic stop-controlled intersection visibility upgrades*
- » *Increase sight triangle by removing vegetation*
- » *Upgrade to high-visibility striping*
- » *Install/upgrade signs with high visibility sheeting*
- » *Install retroreflective tape on sign posts at non-intersection locations*
- » *Install delineation on centerlines and edgelines*
- » Modify drainage areas to create flatter slopes on road shoulders
- » Install eastbound right turn lane

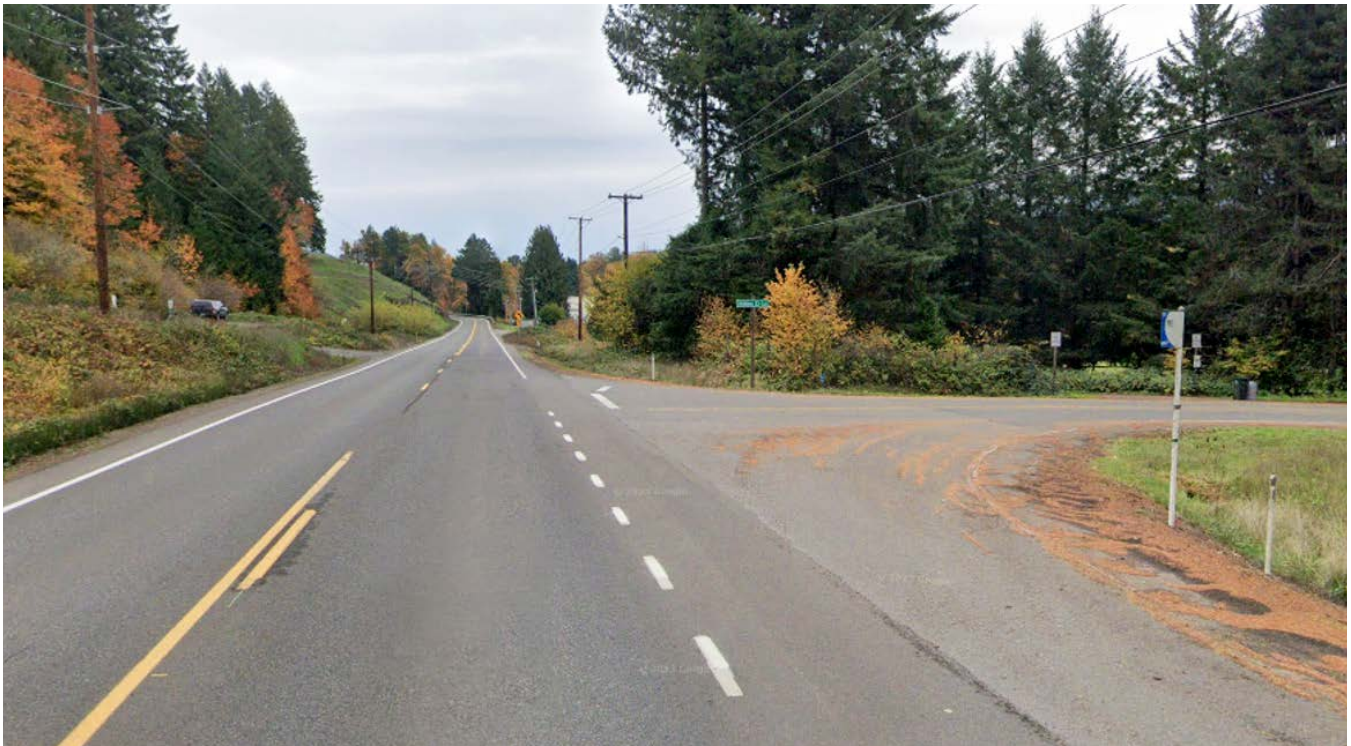
FIGURE 7. OR 126 EAST AT HOLDEN CREEK LANE (EAST), LOOKING EAST

- » *Install systemic stop-controlled intersection visibility upgrades*
- » *Upgrade to high-visibility striping*
- » *Install/upgrade signs with high visibility sheeting*
- » *Install retroreflective tape on sign posts at non-intersection locations*
- » *Install delineation on centerlines and edgelines*
- » Install intersection lighting

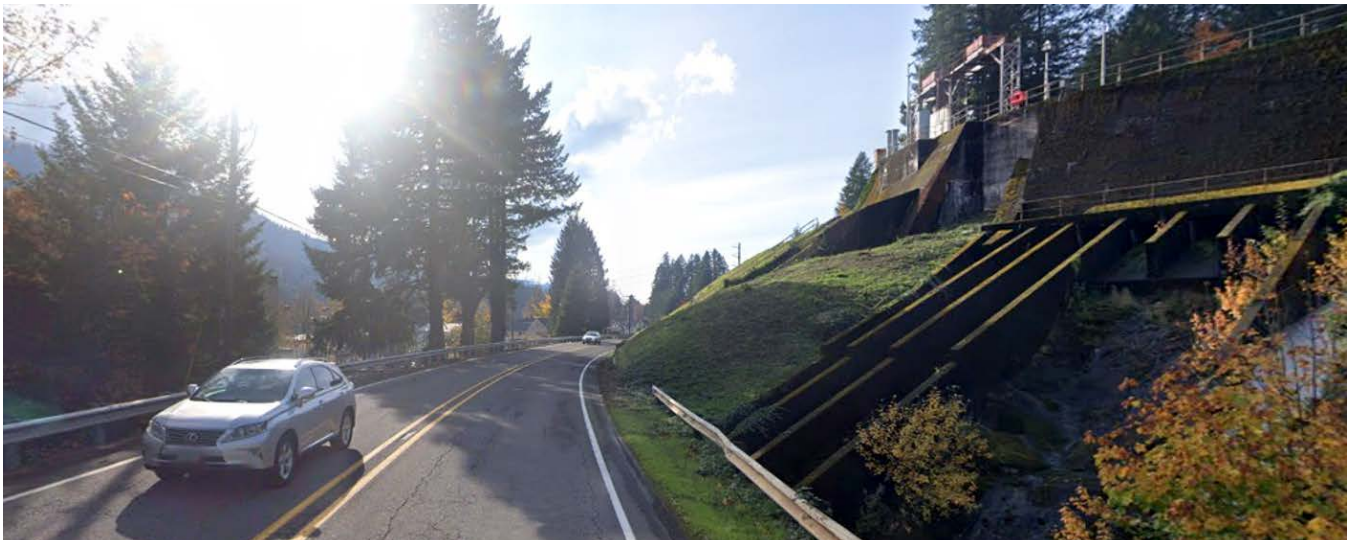
FIGURE 8. OR 126 EAST AT LEABURG DAM SPILLWAY, LOOKING WEST

- » *Install wider edge lines and upgrade to high-visibility striping*
- » *Install post mounted or guardrail-mounted delineators where the shoulder and/or clear zone are particularly narrow*
- » *Install/upgrade signs with high visibility sheeting*
- » *Install retroreflective tape on sign posts at non-intersection locations*
- » *Install delineation on centerlines and edgelines*
- » Install Safety Edge on shoulders
- » Install centerline rumble strips
- » Install recommended chevron curve signs
- » Install flashing beacons on warning signs
- » Widen shoulders and install edge line rumble strips

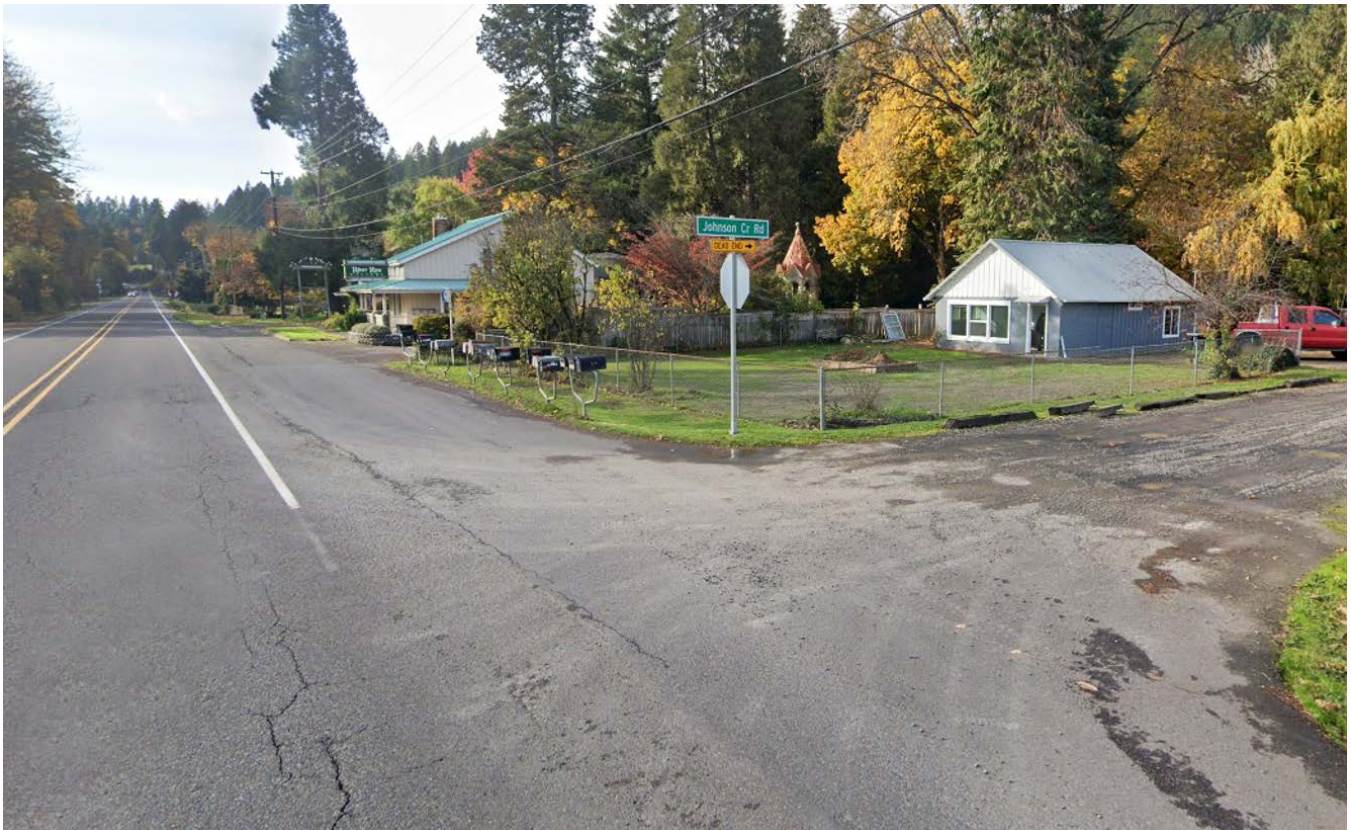
FIGURE 9. OR 126 EAST AT JOHNSON CREEK ROAD

- » *Install systemic stop-controlled intersection visibility upgrades*
- » *Upgrade to high-visibility striping*
- » *Install/upgrade signs with high visibility sheeting*
- » *Install retroreflective tape on sign posts at non-intersection locations*
- » *Install delineation on centerlines and edgelines*
- » *Install intersection lighting*

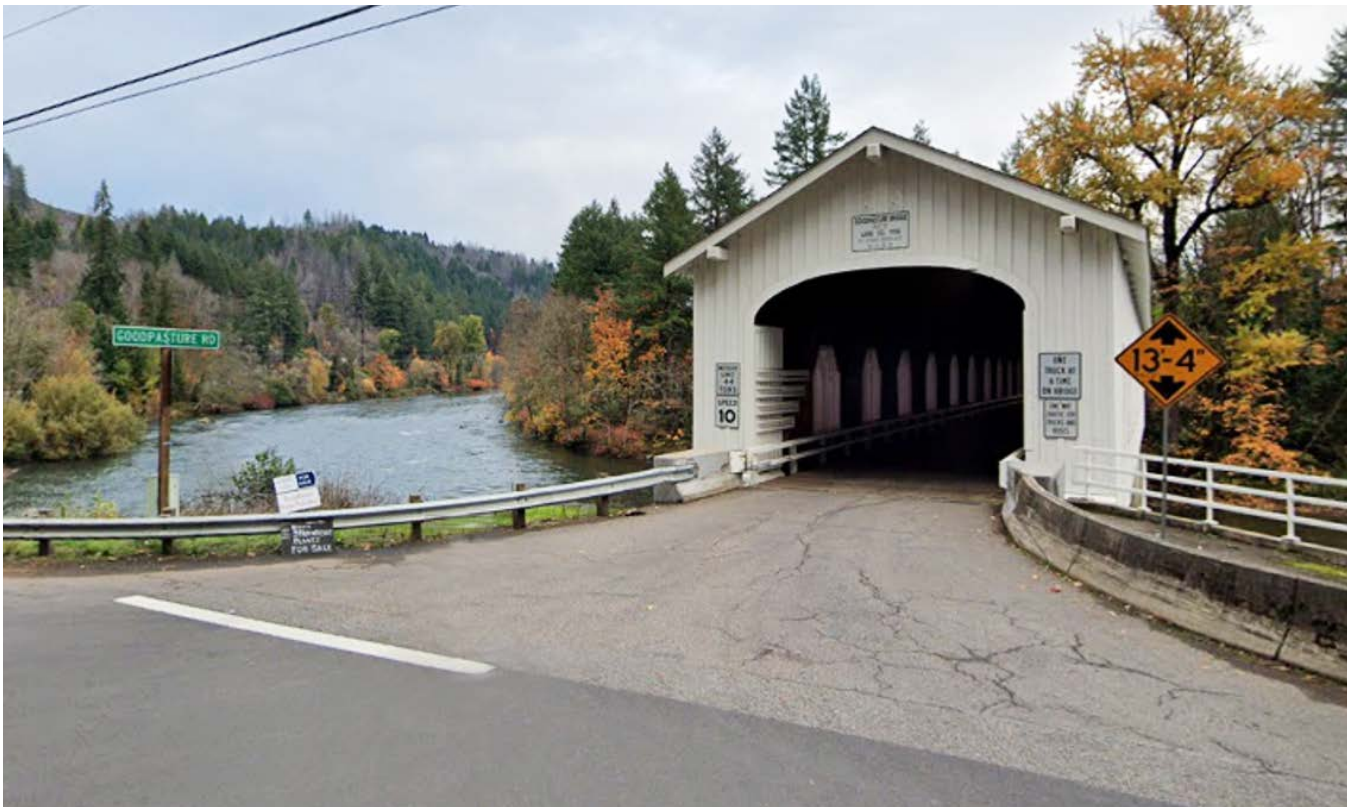
FIGURE 10. OR 126 EAST AT GOODPASTURE ROAD

- » *Install actuated flashing beacons triggered by approaching vehicles*
- » *Install systemic stop-controlled intersection visibility upgrades*
- » *Upgrade to high-visibility striping*
- » *Install/upgrade signs with high visibility sheeting*
- » *Install retroreflective tape on sign posts at non-intersection locations*
- » *Install delineation on centerlines and edgelines*

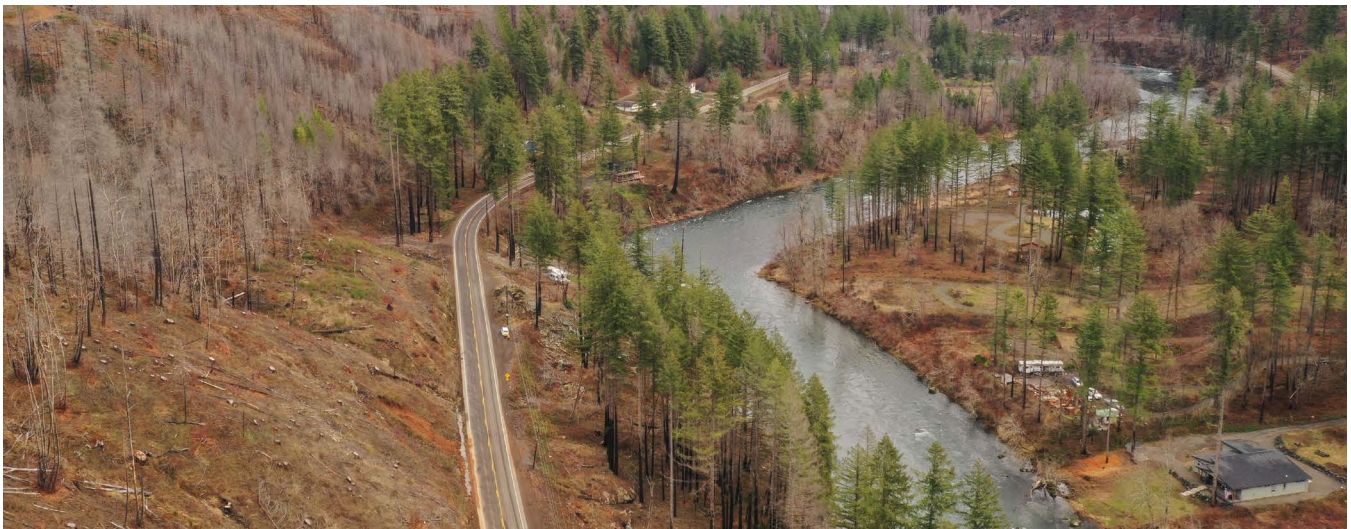
FIGURE 11. AERIAL VIEW OF THE SEGMENT OF OR 126 EAST NEAR BEN AND KAY DORRIS COUNTY PARK

This location has an increased risk of high-severity road departure crashes due to horizontal curves, steep slopes and narrow shoulders. The Holiday Farm Fire drastically changed the roadside and burned many of the trees that used to provide physical and visual barriers along the highway. Community members note feeling particularly unsafe and uncomfortable driving in this area.

- » *Install wider edge lines and upgrade to high-visibility striping*
- » *Install warning signs at Ben and Kay Dorris Park access*
- » *Install/upgrade signs with high visibility sheeting*
- » *Install retroreflective tape on sign posts at non-intersection locations*
- » *Install delineation on centerlines and edgelines*
- » *Install recommended chevron curve signs*
- » Install guardrail
- » Widen shoulders and install edge line rumble strips
- » Install Safety Edge on shoulders
- » Flatten side slopes
- » Install flashing beacons on warning signs

- » **Ben and Kay Dorris County Park:** This location has a high risk of run-off-the-road crashes because the shoulder is very narrow. In addition, there is a steep drop-off on the eastbound shoulder and no guardrail. This segment of OR 126 East was especially altered by the Holiday Farm Fire because numerous trees were removed. Many people suggested adding guardrail on this segment of the highway.

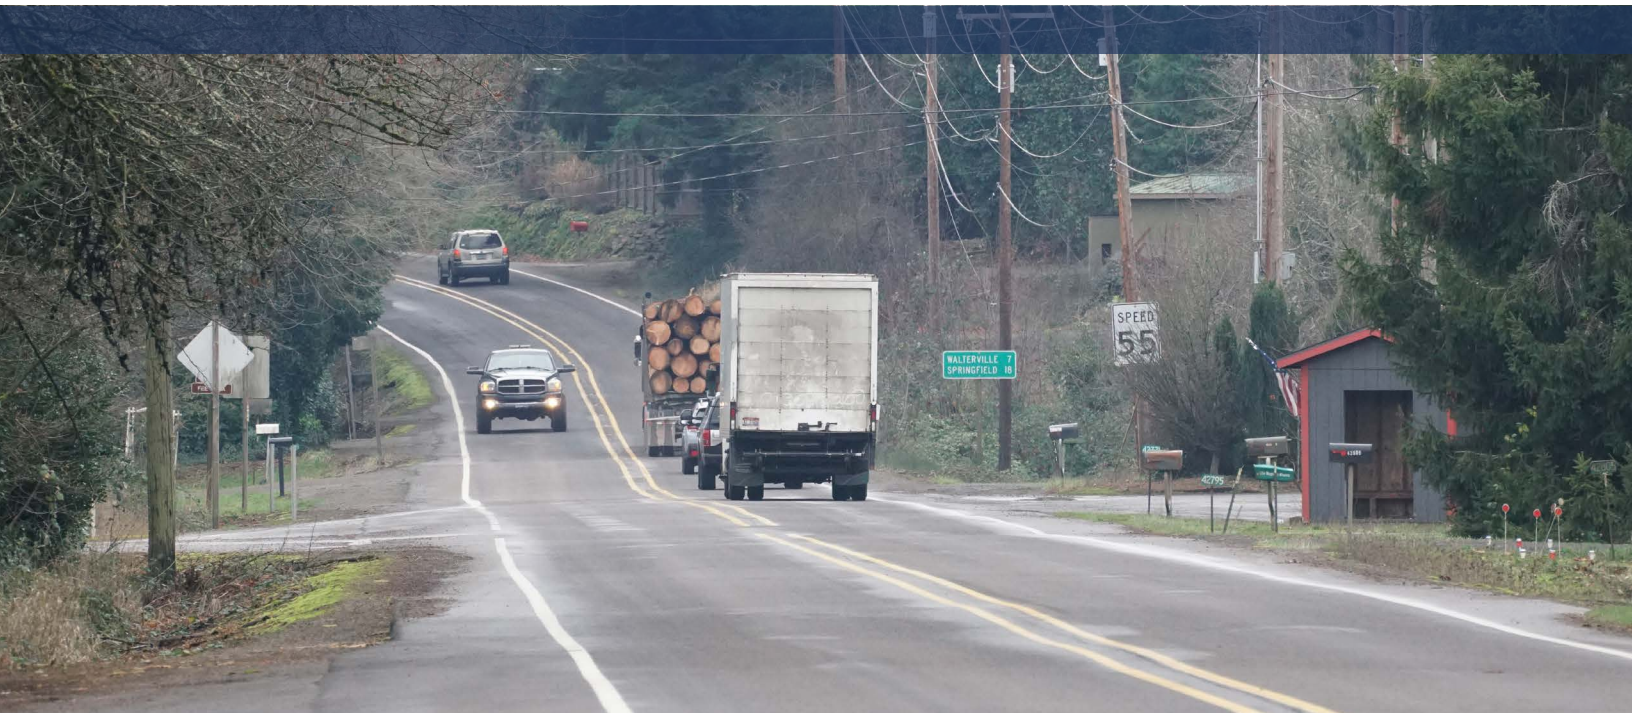
LEFT-TURN LANE AT DEERHORN ROAD

Planning-level concept designs and cost estimates have been developed for each of three options. The designs shown in the figures below are conceptual only. The dimensions and estimated costs are based on similar projects ODOT has constructed at other locations. The design concepts do not account for all the constraints that exist at these specific locations along OR 126 East.

Building a left-turn lane would require widening or replacing the bridge to meet ODOT design standards. This project could impact the nearby wetland and floodplain areas. It could also, at least temporarily, impact the parking lot and access to Hendricks Bridge County Park during construction.

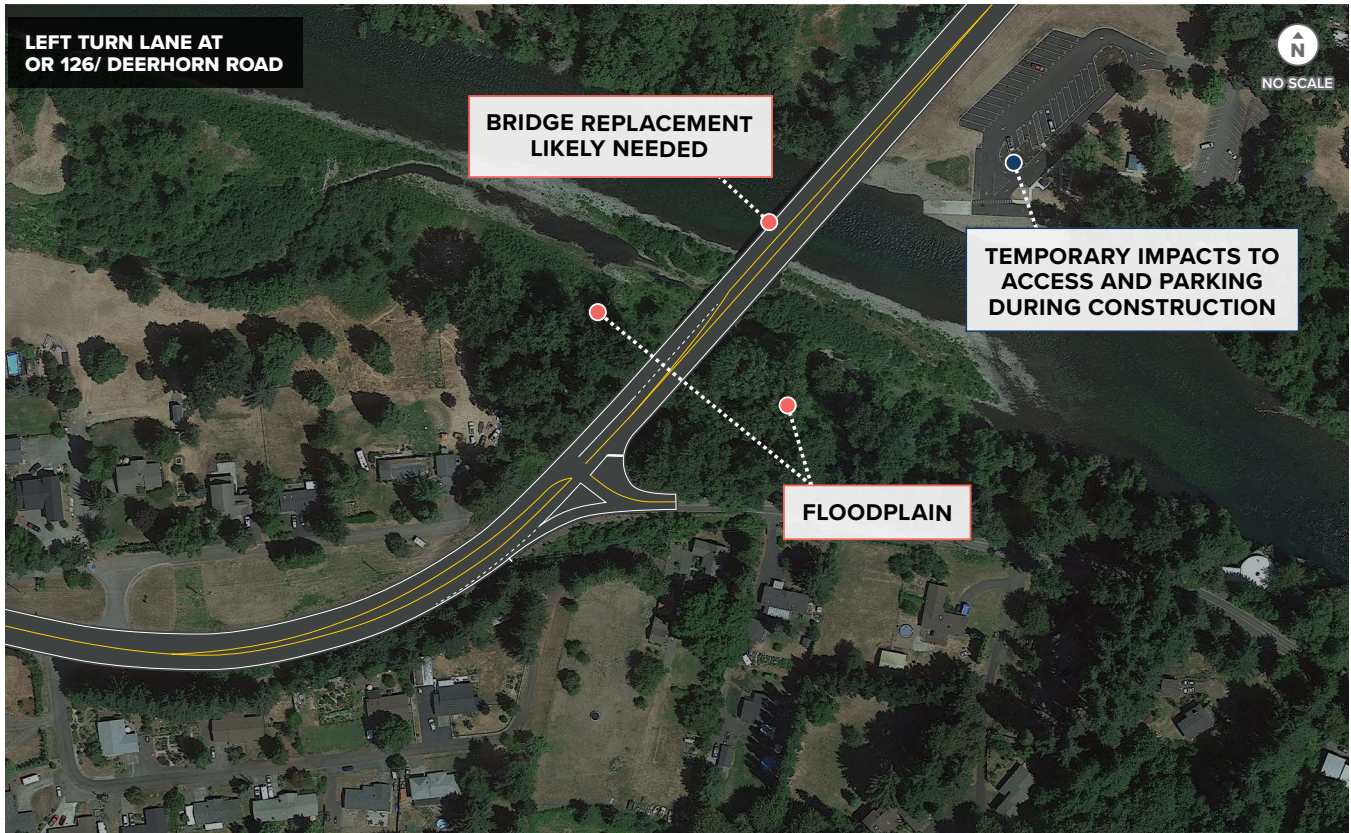
FIGURE 12. LEFT-TURN LANE CONCEPT DESIGN

Estimated cost: \$18-20 million

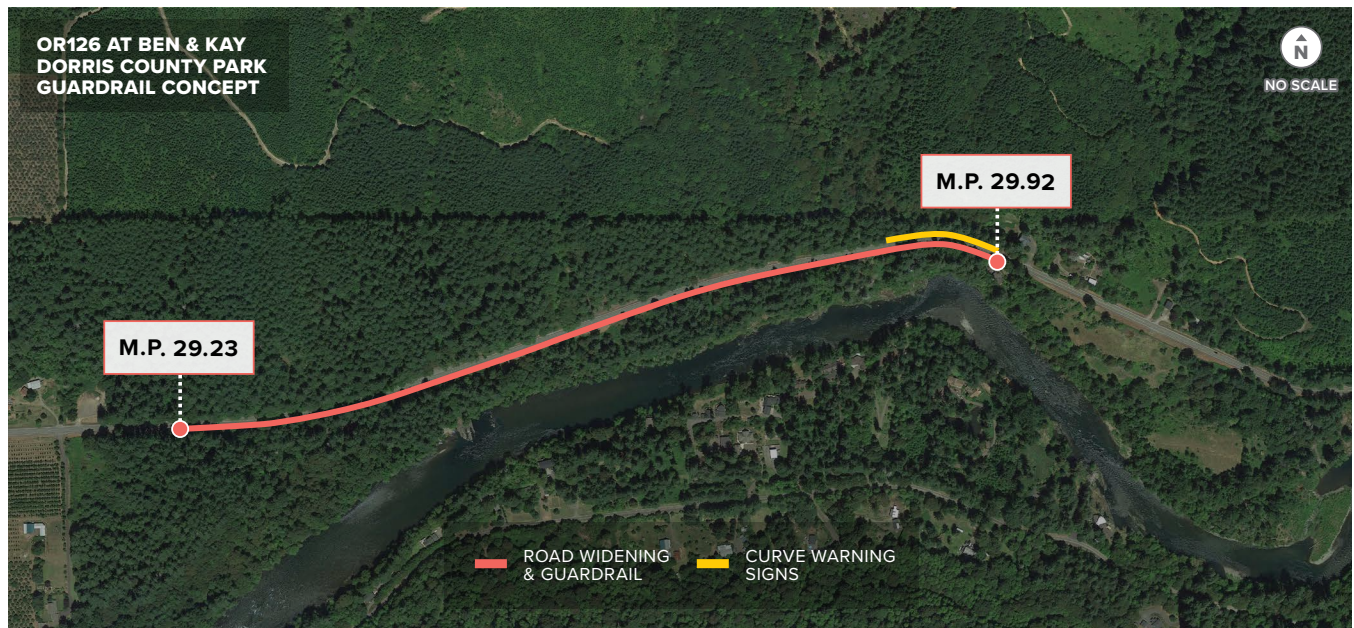
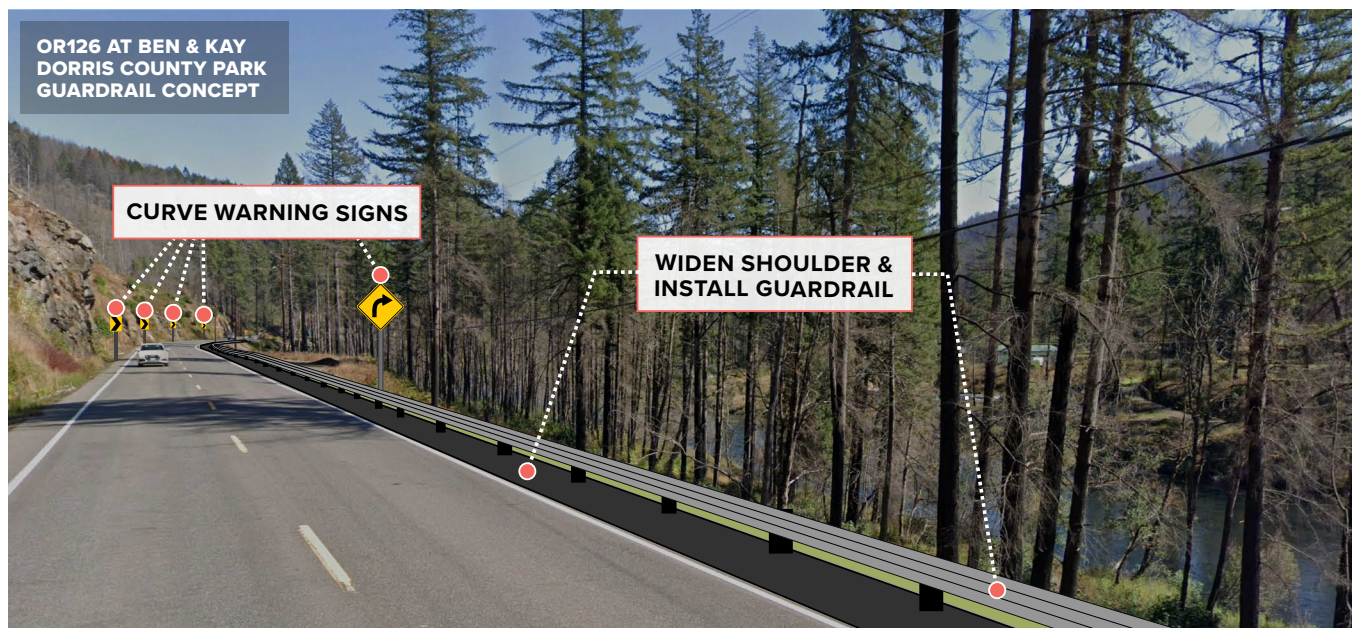
FIGURE 14. GUARDRAIL CONCEPT DESIGN

This solution includes the installation of guardrail on the south side of OR 126 East, which require the shoulder to be widened to meet ODOT design standards. Additionally, upgraded curve warning signs would be installed along the curve on the east end of the guardrail section.

Estimated cost: \$3-4 million
