US26 from the Willamette River going east through the City of Portland is one of these routes – known as Powell Boulevard. The highway does not fulfill the statewide need that it was originally constructed for – as the urban areas has built-up around it, the users of the highway are different, and with different needs. Funding for improvements are always in high demand and the 2017 Oregon Legislature recognized the need to address this section of Powell Boulevard and ultimately transfer it to the City of Portland.

House Bill 2017 Section 27e requires the Oregon Transportation Commission (OTC) to study the costs to upgrade and transfer the portion of SE Powell Boulevard from the intersection with SE 9th Avenue to the I-205 interchange in Portland, Oregon. This segment of SE Powell Boulevard is referred to as Inner Powell. The OTC directed ODOT to prepare the Inner Powell: SE 9th to I-205 State of Good Repair Study. The study establishes a state of good repair threshold for various roadway elements to help ODOT determine the cost to upgrade existing assets and to inform continuing efforts to transfer ownership of Inner Powell from ODOT to the City of Portland. The OTC

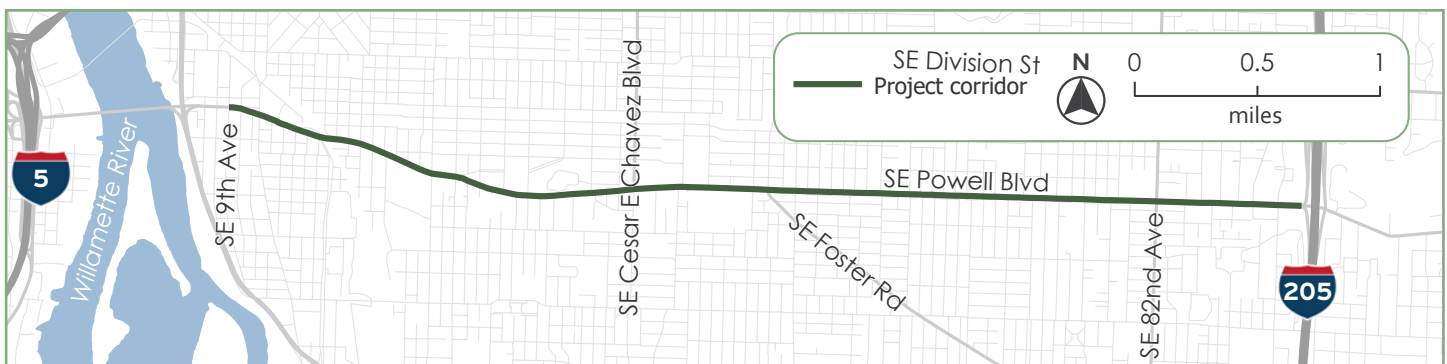
The study area is SE Powell Boulevard from the intersection with SE 9th Ave to the I-205 interchange in Portland. The segment is approximately 4.5 miles long and correlates roughly to mileposts 1.2 to 5.7. ODOT owns curb-to-curb for most of the corridor.

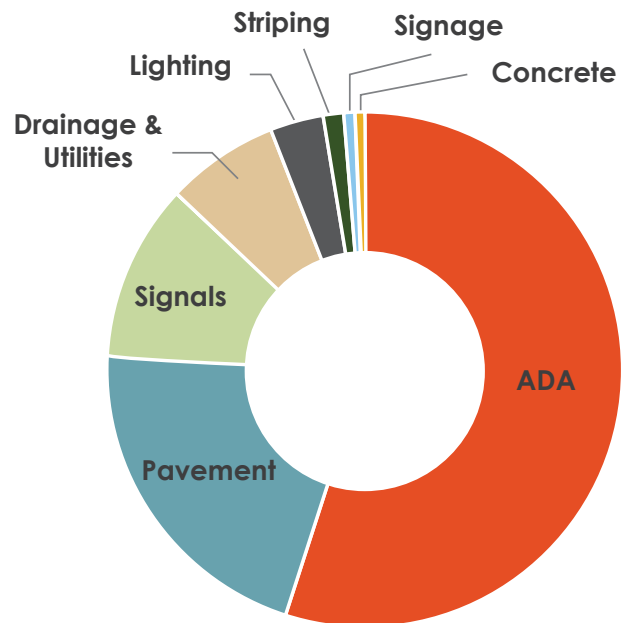
Breakdown of estimated costs by corridor element. ADA costs are approximately 57% of the total base cost estimate.

The cost to upgrade Inner Powell to a state of good repair would be about \$31 million. This cost is subject to change depending on construction year. The breakdown of costs is shown to the right.
