MEMORANDUM

Re: Preliminary Hazards Assessment
ODOT: OR 42-US 101 Passing Lanes Study
TM4: Geotechnical Tech Memorandum
Various Counties, Oregon

VICINITY MAP

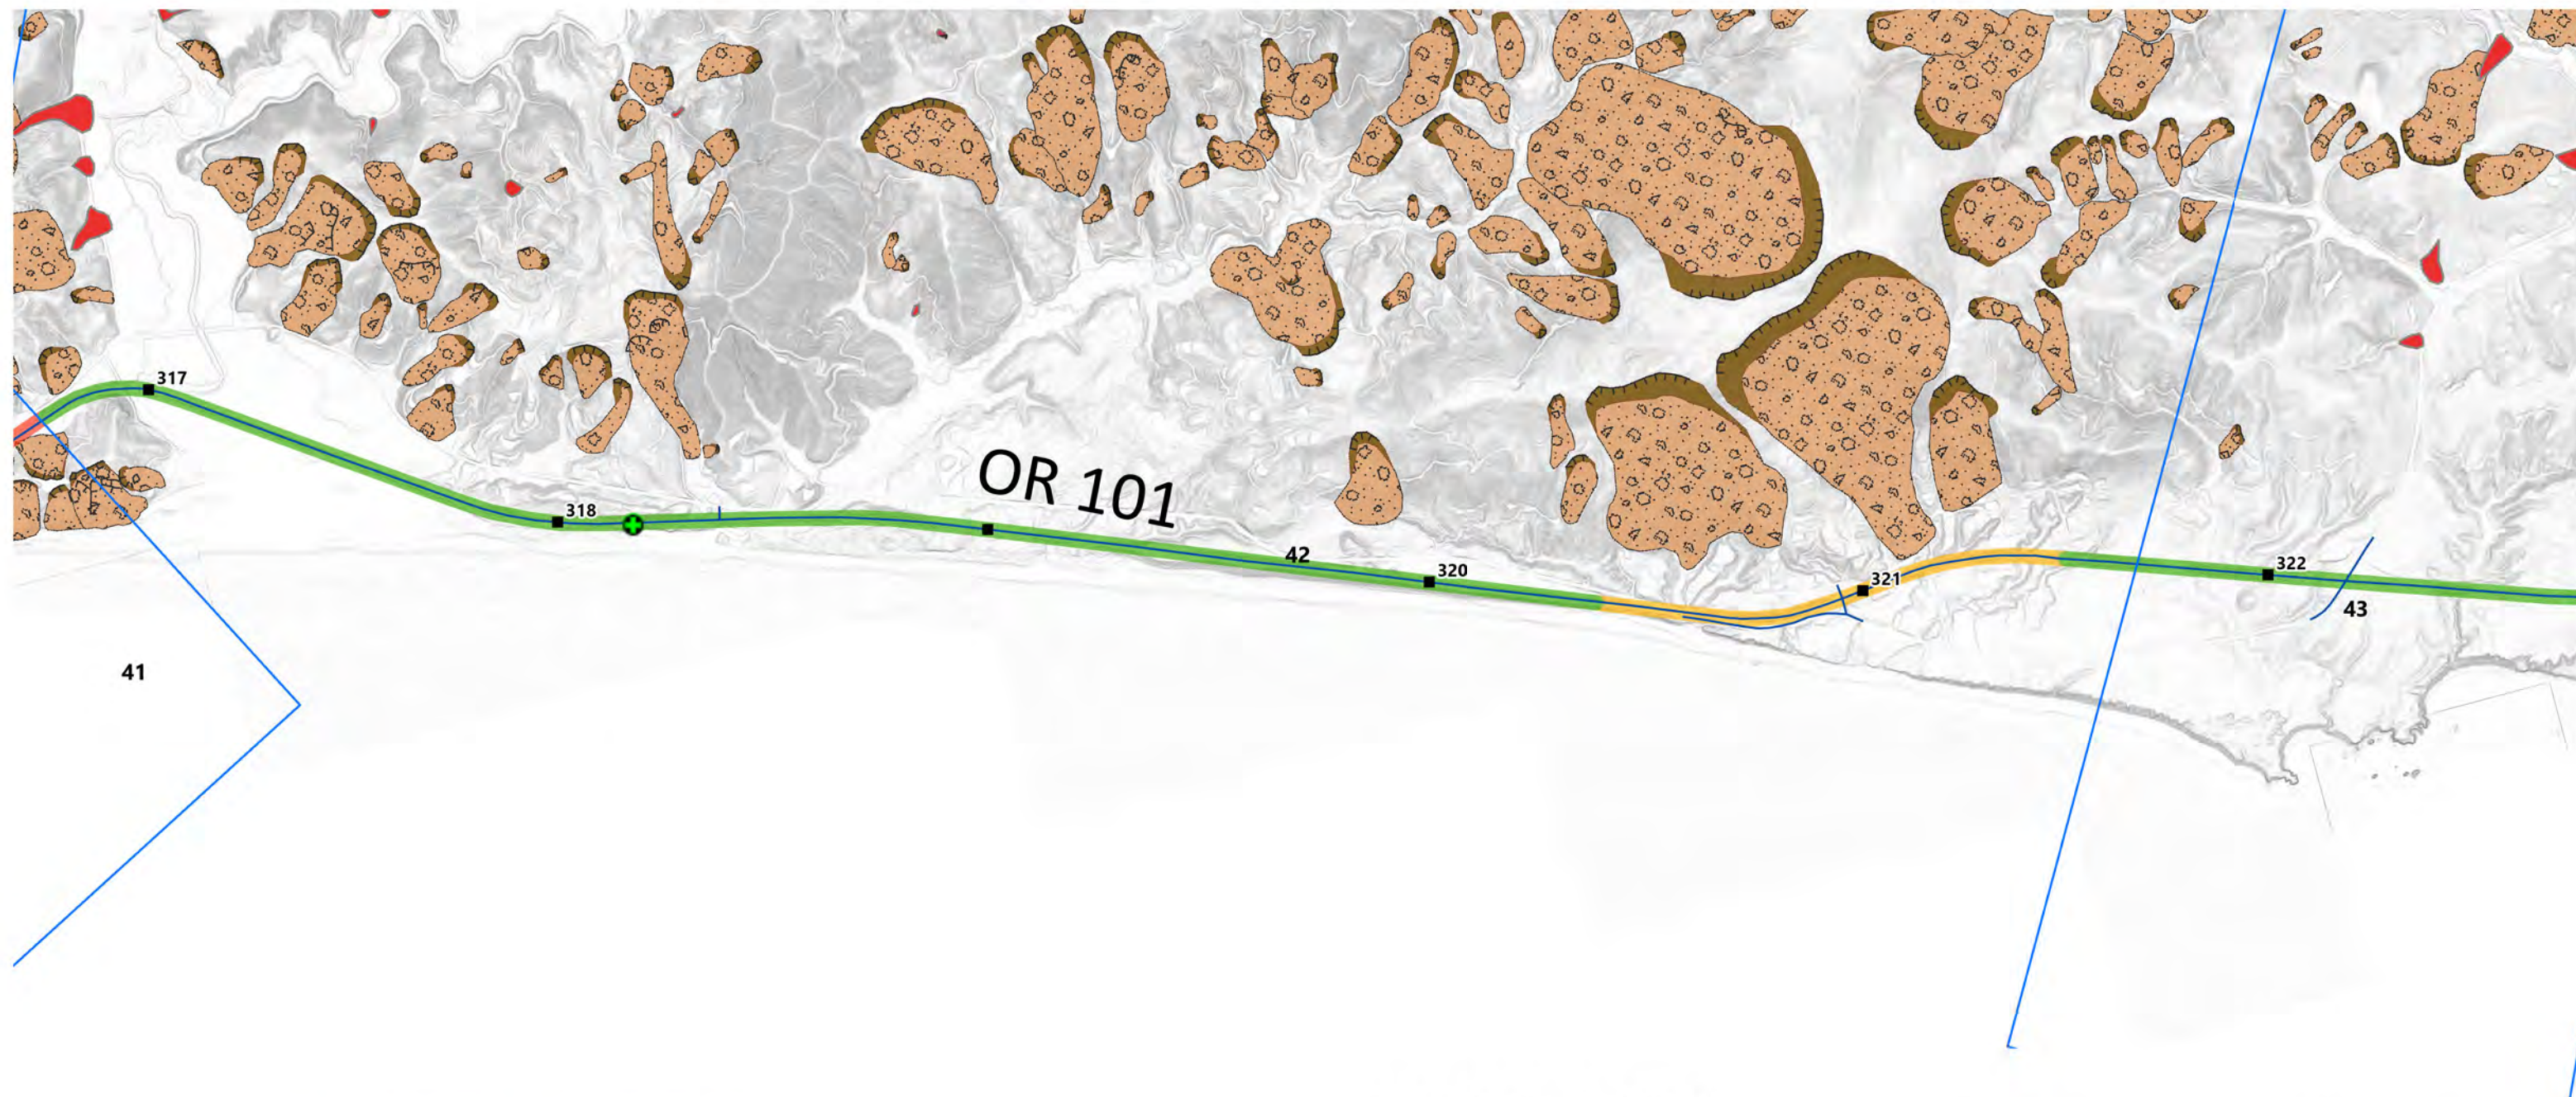
(101-F) PORT ORFORD TO GOLD BEACH

Relative Hazard Assessment

- High Hazard
- Moderate Hazard
- Low Hazard
