# Memorandum 1.10

To: Lisa Cornutt and Anna Henson, ODOT Region 3  
CC: Marc Butorac, PE, PTOE, and Susie Wright, PE, Kittelson & Associates  
From: Andrew Fortner, OBEC and Zachary Horowitz, Kittelson & Associates  
Date: January 5, 2017  
Subject: **Task 1.10 Existing Structure Maintenance Deficiencies and No-Build Maintenance Costs of Existing Structure**

The purpose of this memorandum and the other early anchoring activity memorandums in Phase 1A of the project is to inform the Draft Problem Statement and guide further development of the project.

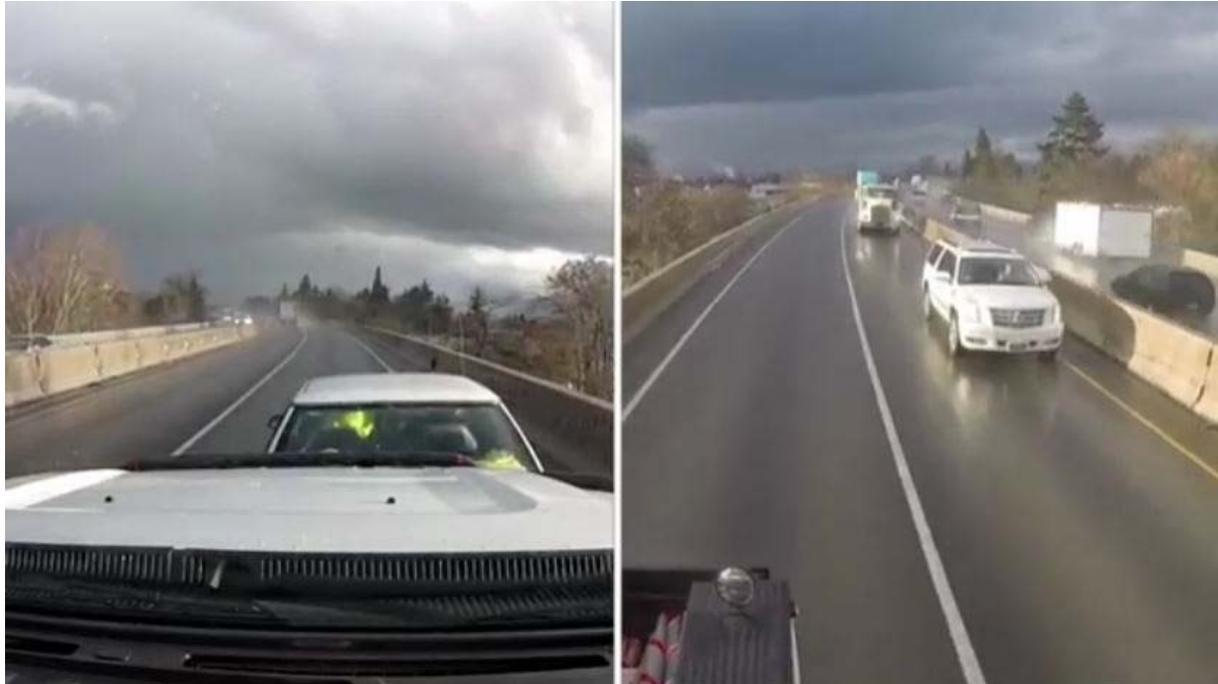
Figure 1: ODOT Incident Responders “Pushing” a Stalled Vehicle Off the Viaduct

- Stalls can cause traffic backups and it can be difficult for tow trucks, ODOT, and emergency responders to access the area and remove vehicles from the Viaduct to restore traffic flow. An example showing how ODOT incident responders “push” a vehicle off the Viaduct can be seen in **Figure 1** on the following page.

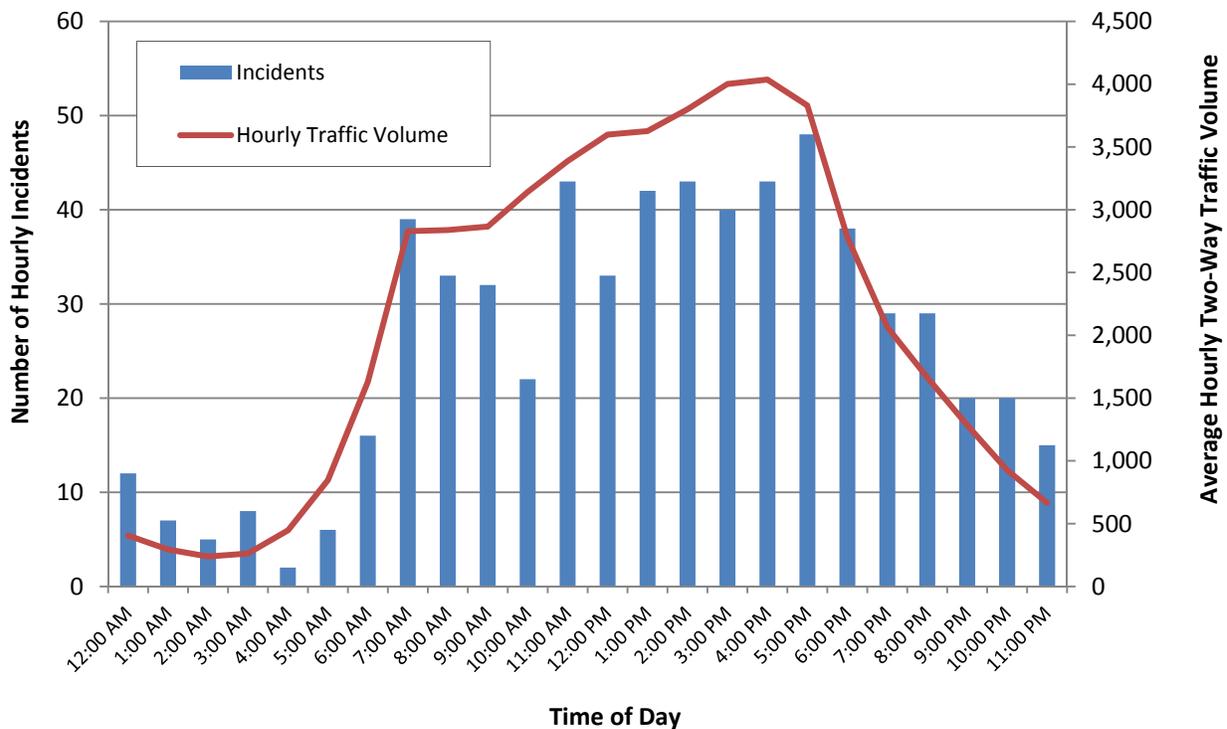
**Figure 2: Reported Incidents and Average Hourly Two-Way Traffic Volume**

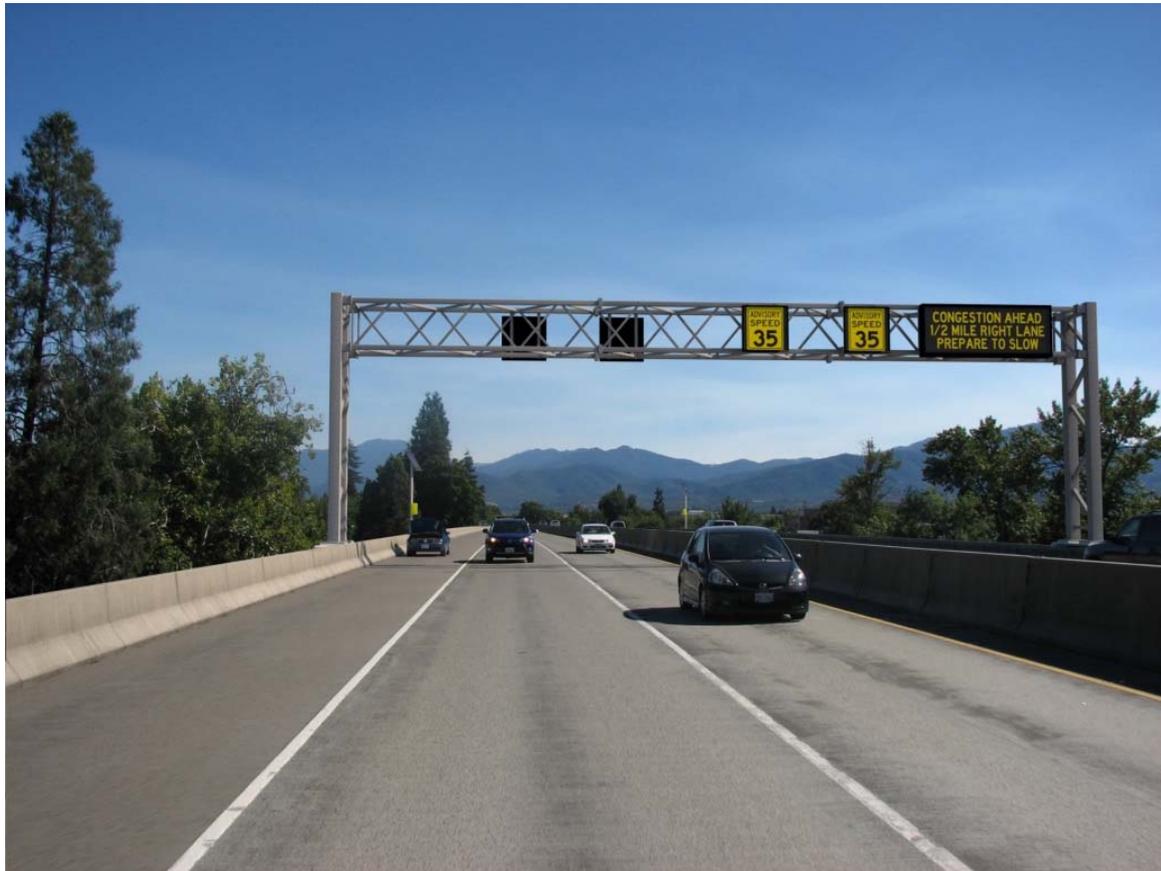
**Figure 3. Potential Variable Speed Limit Implementation**

- **Variable Message Signs (VMS)/Variable Speed Limits (VSL)** – VMS and VSL (shown in **Figure 3** on the following page) implementation between and at the north and south Medford interchanges would provide safety and traffic management benefits by addressing the safety issues identified by emergency responders and maintenance workers.
