# Sitka Sedge Tidal Wetland Restoration: Alternatives Analysis & Hydraulic Modeling

Sitka Sedge Tidal Wetland Restoration Project – Townhall Meeting

June 17, 2023

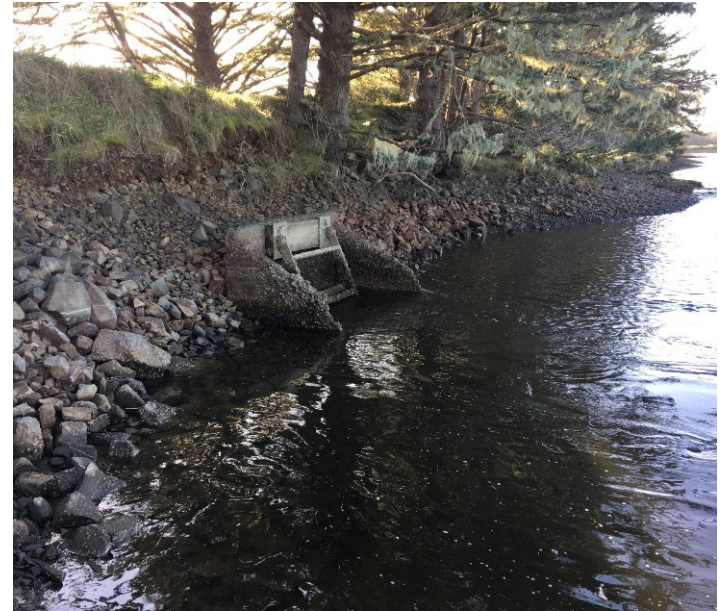
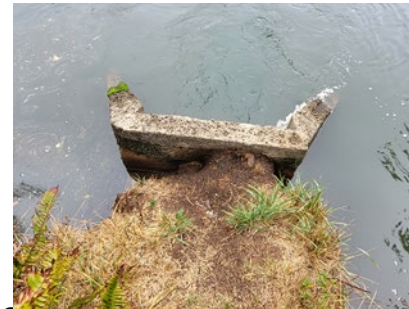
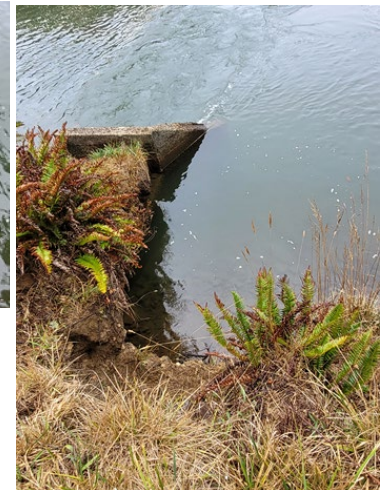
- **Current tide gate is failing**
  - Boards on the flap are missing
  - The dike is eroded around the box culvert and wing walls
  - The box culvert itself appears to be compromised
  - The amount of work that would need to be done to repair and stabilize the existing gate would trigger fish passage regulations that would not allow the use of the current old-model structure
- **Current tide gate is undersized**
  - The opening is too small to efficiently drain - backs up water and acts like an hourglass
  - “firehose” water velocity
- **Current tide gate restricts fish passage to Reneke, Beltz, and No-name Creeks as well as to the marsh behind the dike**
- **The current dike is only barely above current king tides and will soon be at risk of overtopping from sea-level rise**

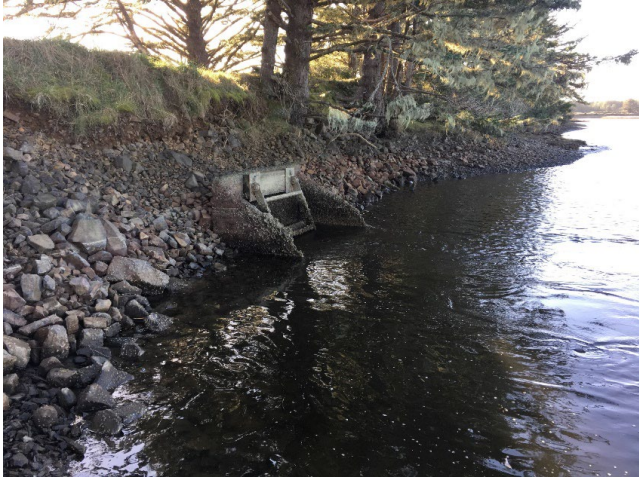
**No action/ existing condition** – reference condition

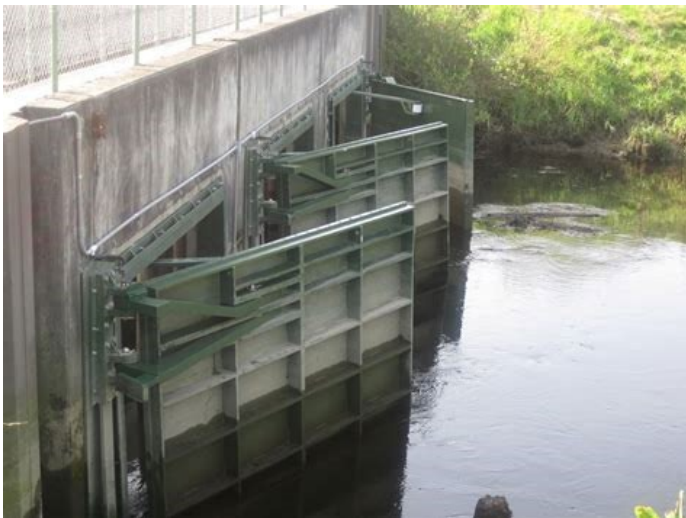
**Replace existing tide gate with modern muted tidal regulator**– two 10' wide by 8ft' tall gates with 7 or 8' closure valve... Reneke inside or outside... location...

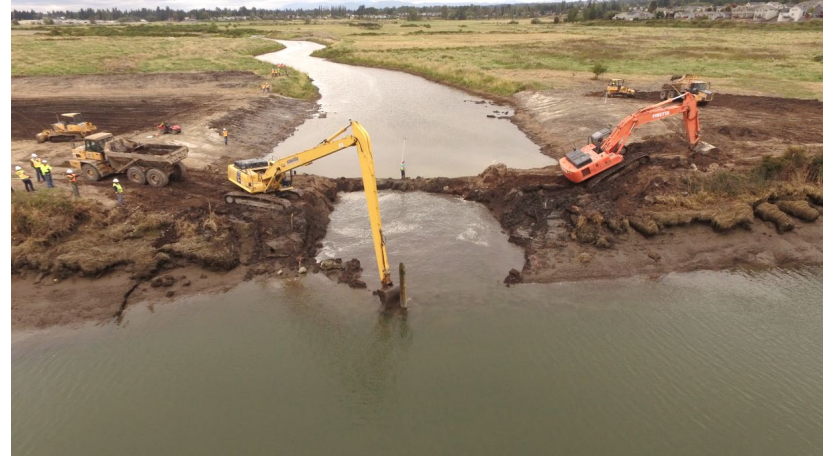
**Dike breach** – 40' bottom width, 80' top width, or larger

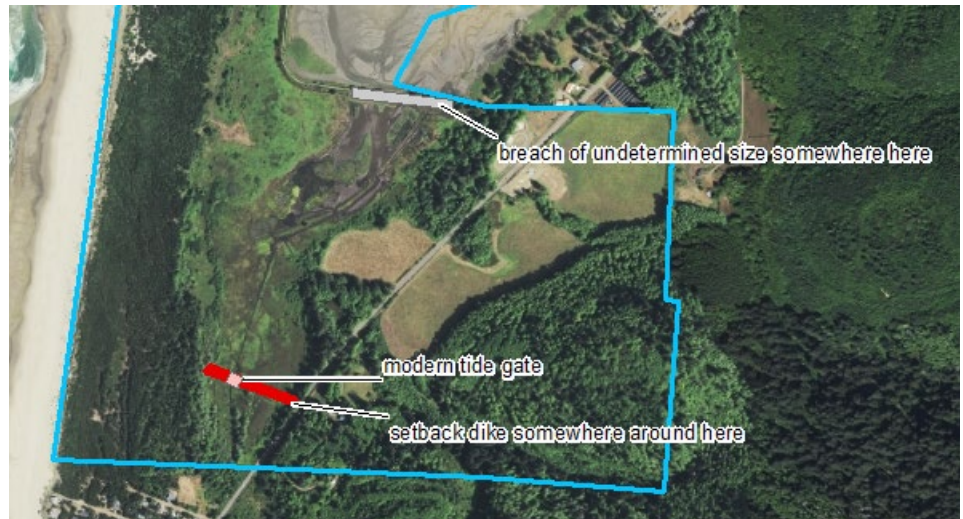
**Setback dike**- construct new dike closer to TDM that includes a modern tide gate, then breach the old dike... tide gate style/sizing/closure settings... location...

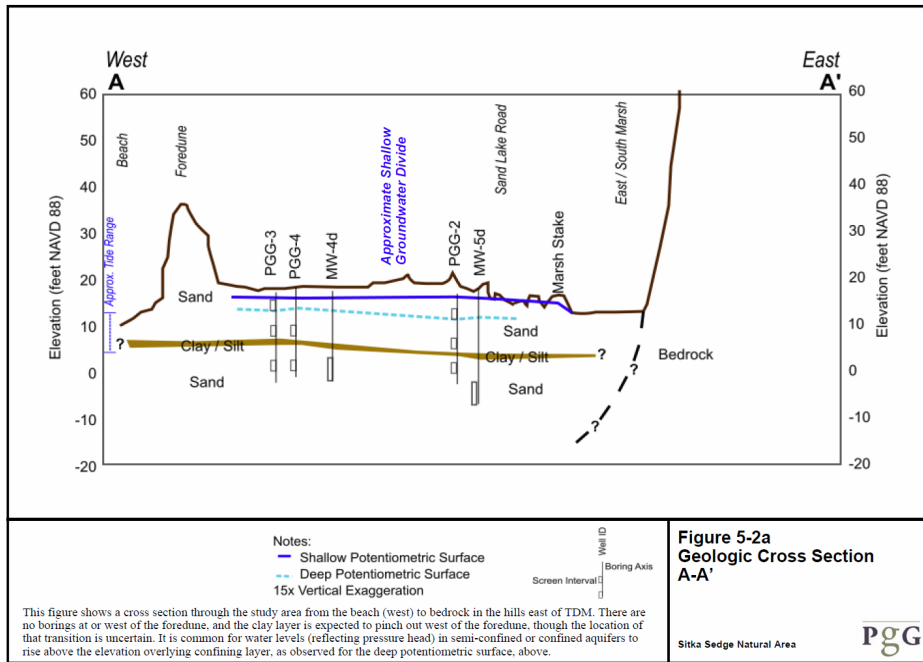
East-west cross section

- 2 aquifers separated by a clay layer
- The surface aquifer is the primary interest due to its effect on septic systems and stormwater issues

- BREACH: a breach might result in up to  $\frac{1}{4}$  inch increase in water table elevation relative to the existing condition
- MODERN TIDE GATE OR SETBACK DIKE: likely a small decrease in water table elevation relative to the existing condition

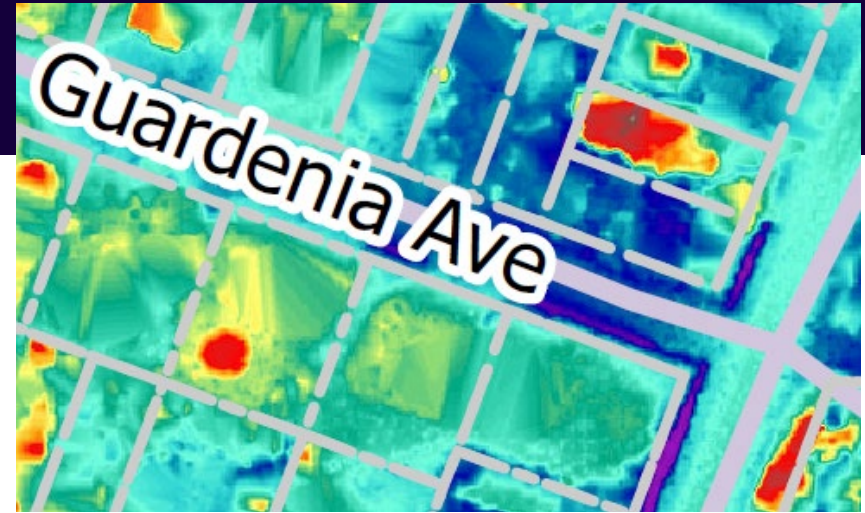
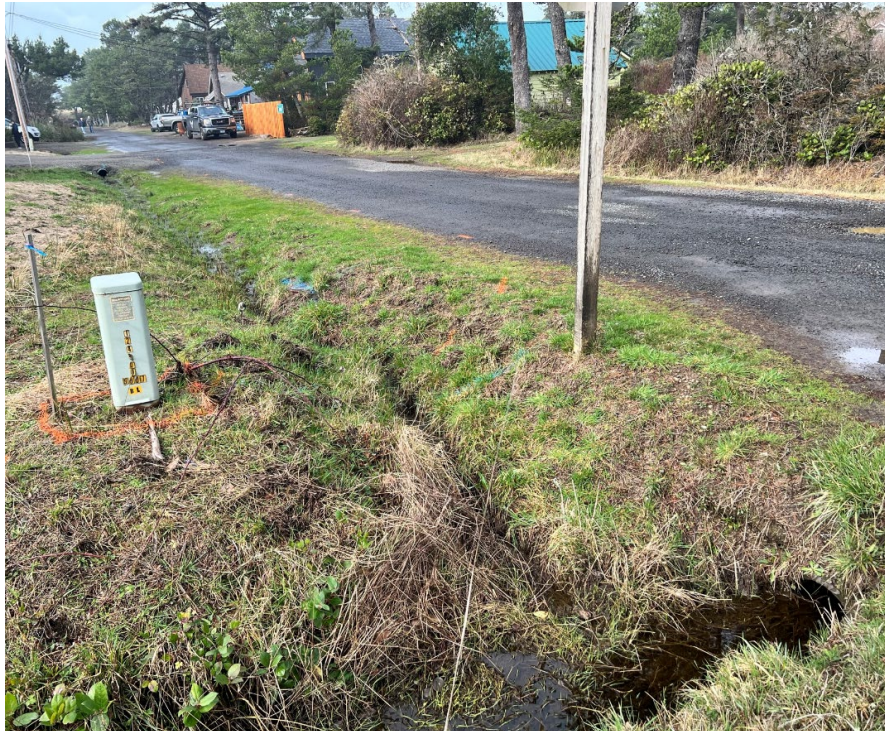
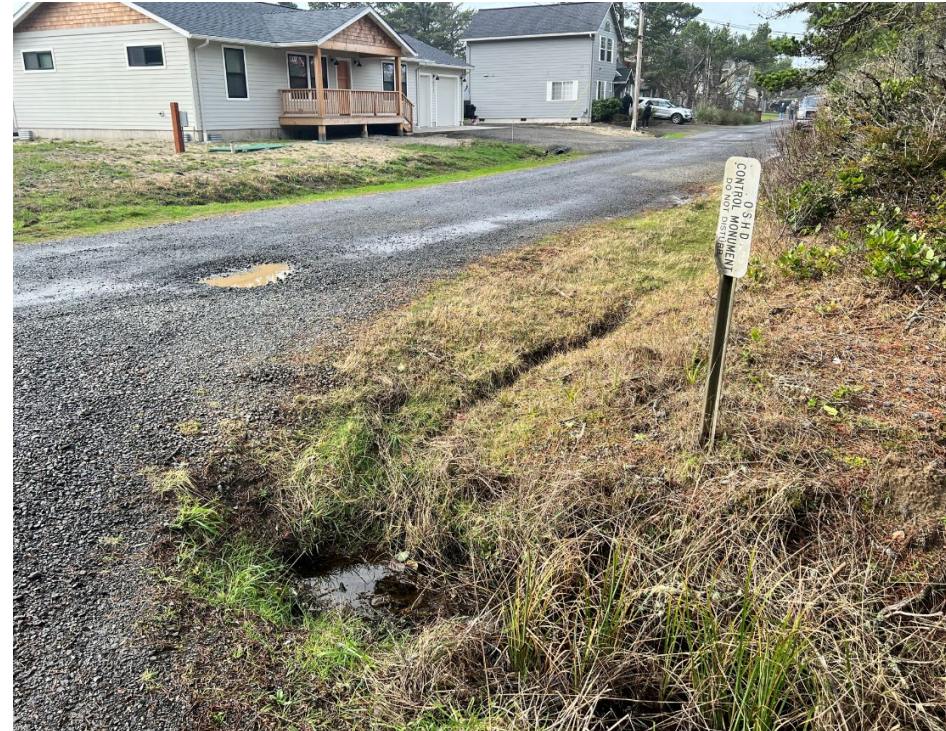
Guardenia Ave/Sand Lake Rd

- Example of side street ditch/swale connections to SLR Ditch
- Raised driveway over culvert

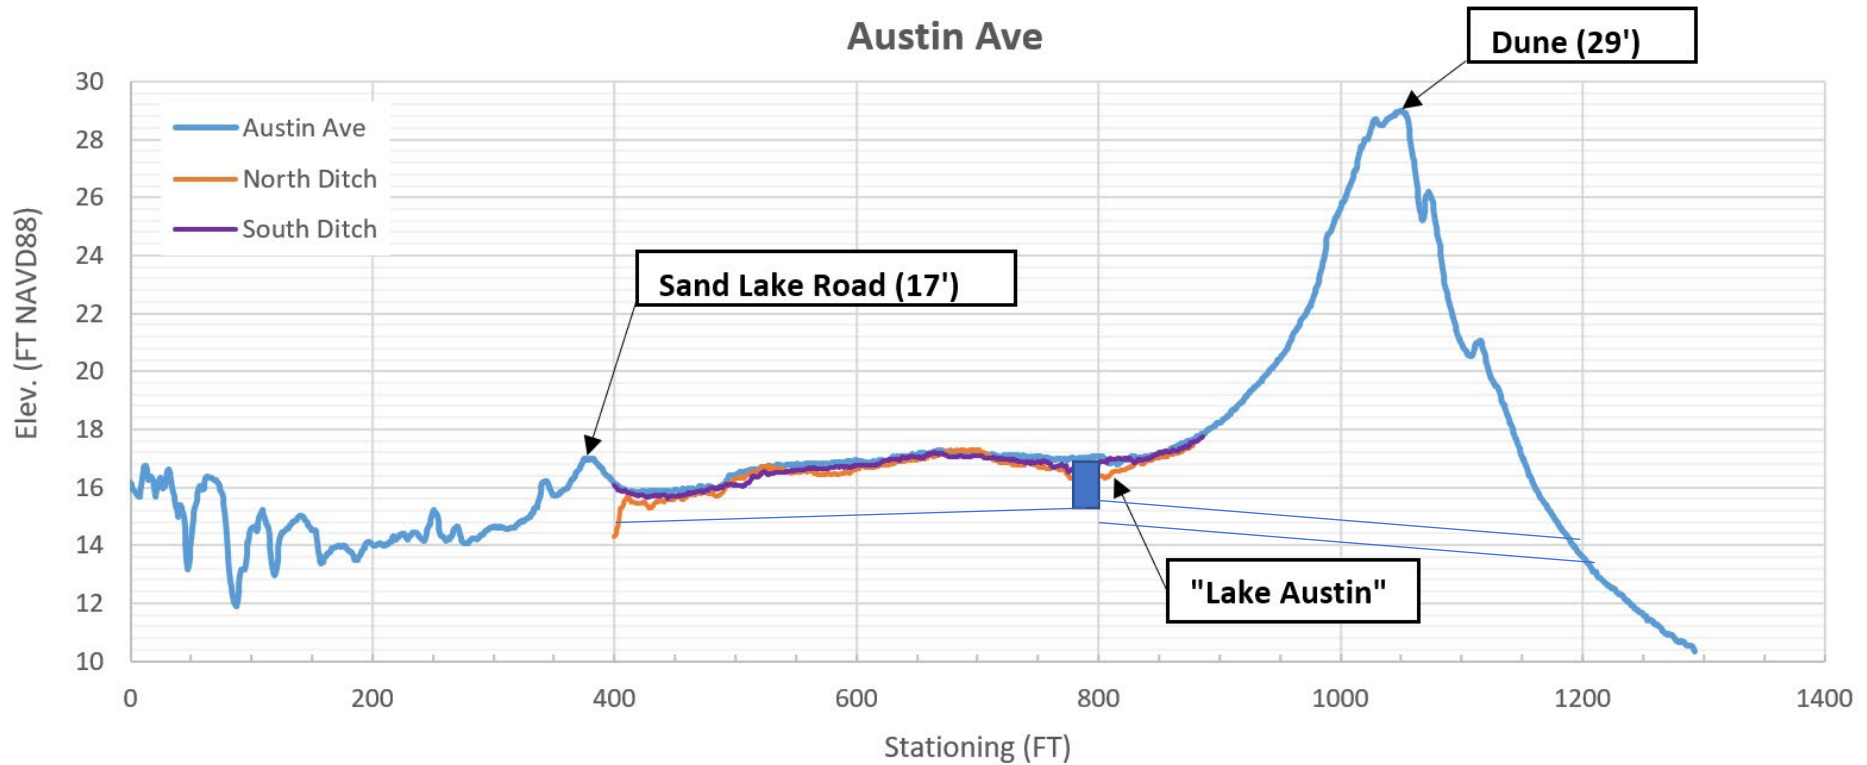
# Tierra Del Mar Drainage System Assessment – Side Street Centerline Profiles

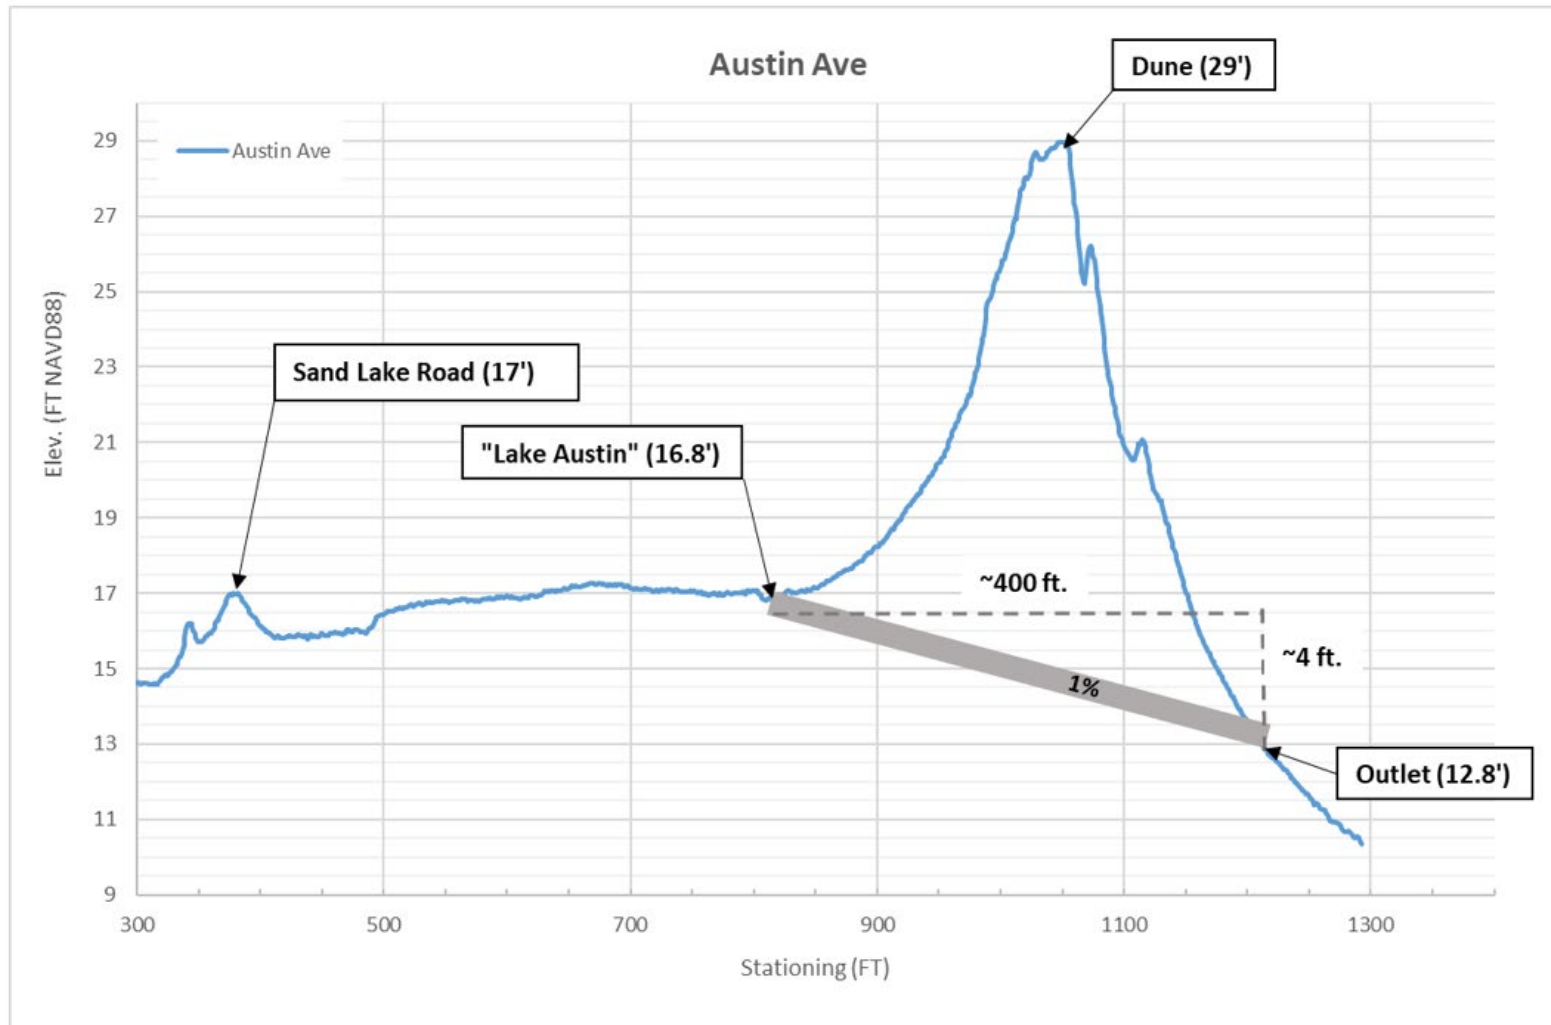
Figure 7. Proposed Beach Outfall Concept

# Relief drainage outfall to beach - concept

- Replace/Upsize Culverts at Pollock and Jasmine Ave/NW Ditch to increase conveyance (also deteriorating)
- Enlarge ditch/swale in select locations, remove fill and blockages in specific locations
- Consider catch basins and new outfall pipes to beach to drain areas that are not feasible to connect to Sandlake Rd Ditch (such as Austin Ave)
- Enhance flow paths that have been lost due to infill developments, potentially with subsurface drain system

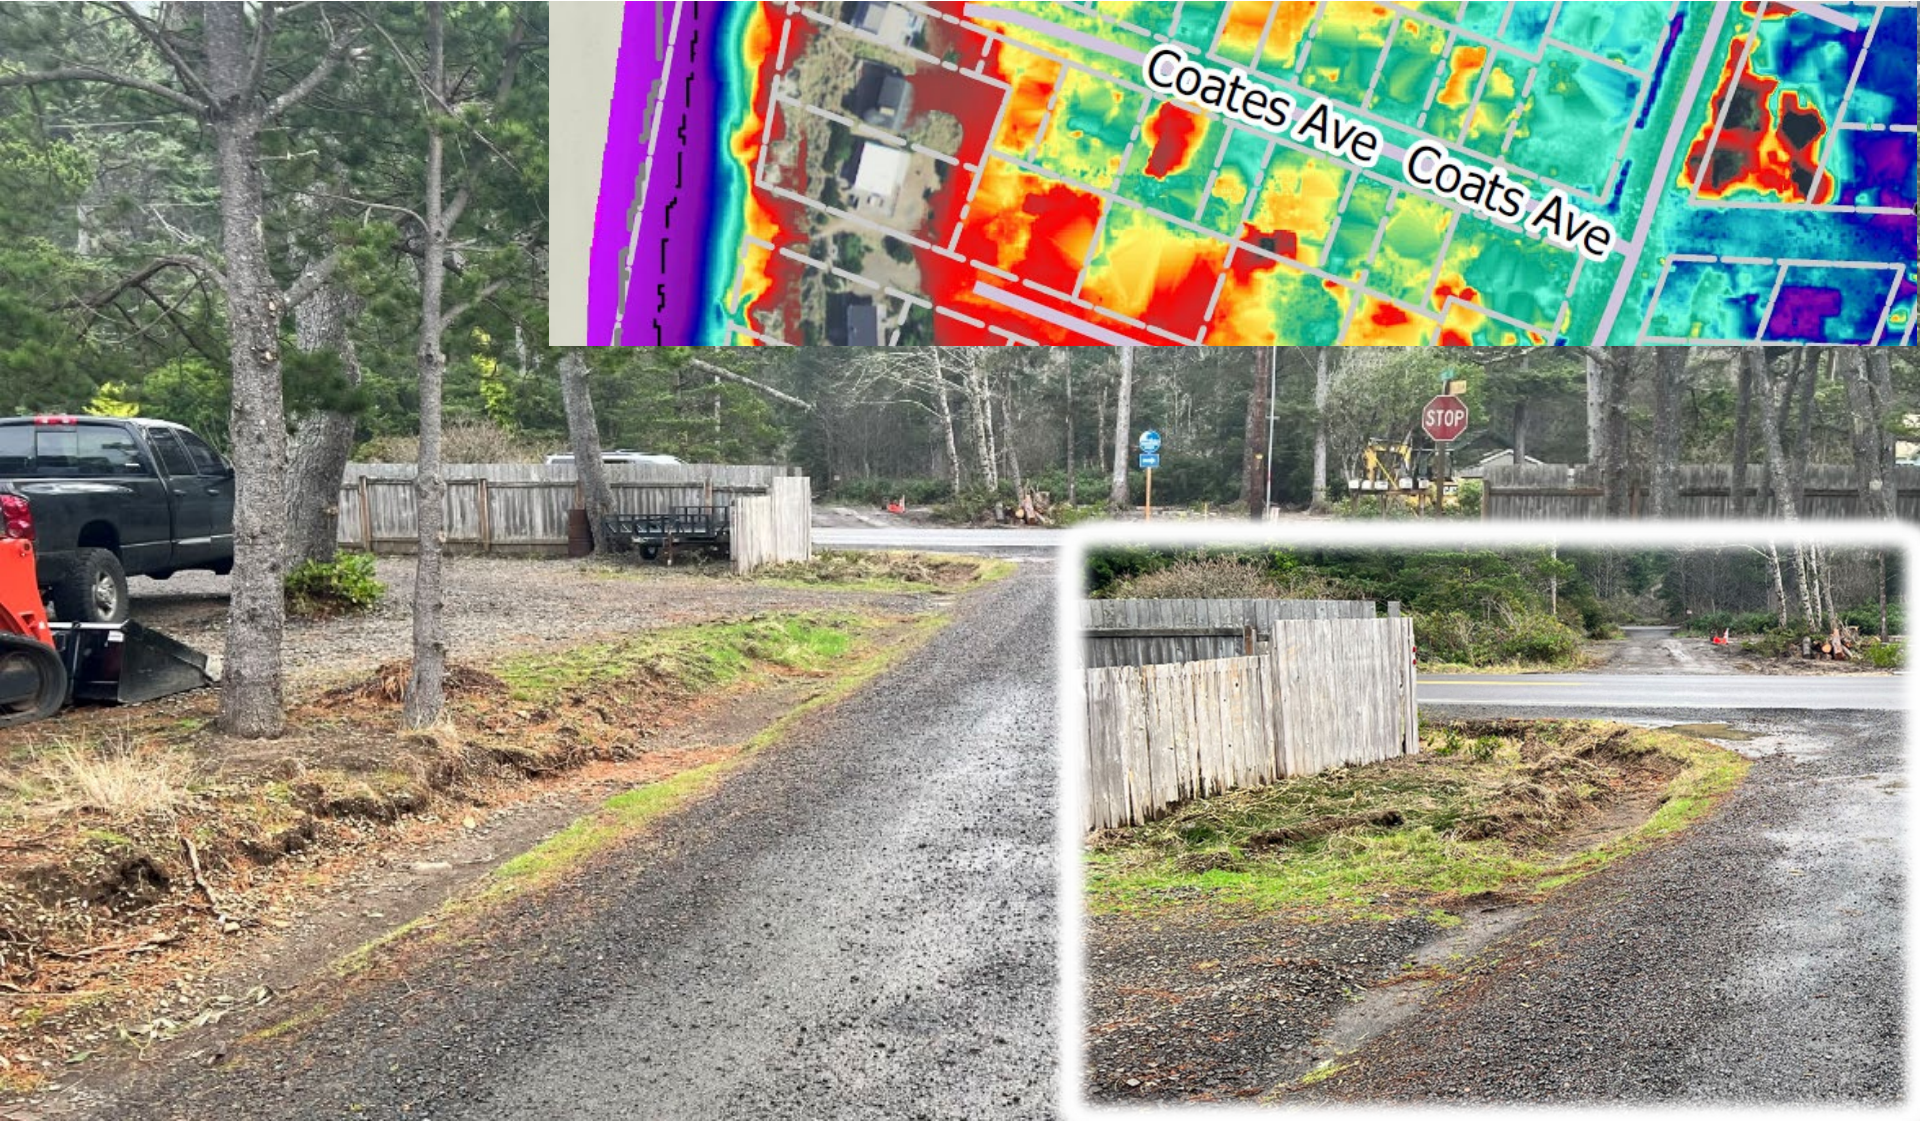
# TDM Drainage System Assessment

## Coats Ave – example of recent ditch improvement

- Frequently maintain culverts and ditches to clear blockages
- Upsize culverts along Sandlake Rd ditch for increased drainage capacity (especially at Roma Ave)
- Excavate swales/ditches along side streets to drain to Sandlake Rd ditch (similar to recent improvements at Guardenia/Coats)
  - Range from subtle grading/hand excavation to more extensive/deeper ditching
  - Requires driveway culverts/raising driveways in some locations
  - Consider/manage conflicts with existing utilities (water, telecom, OH poles) – adjust/deepen/protect lines
  - Catch basins/Inlets and storm pipes to collect and convey water from low points
  - Perforated pipe underdrain/'French Drains' option to intercept groundwater
- Daylight sections of Sandlake Rd ditch where long culverts prevent side street drainage (Holly Ave). Longer culverts also susceptible to plugging

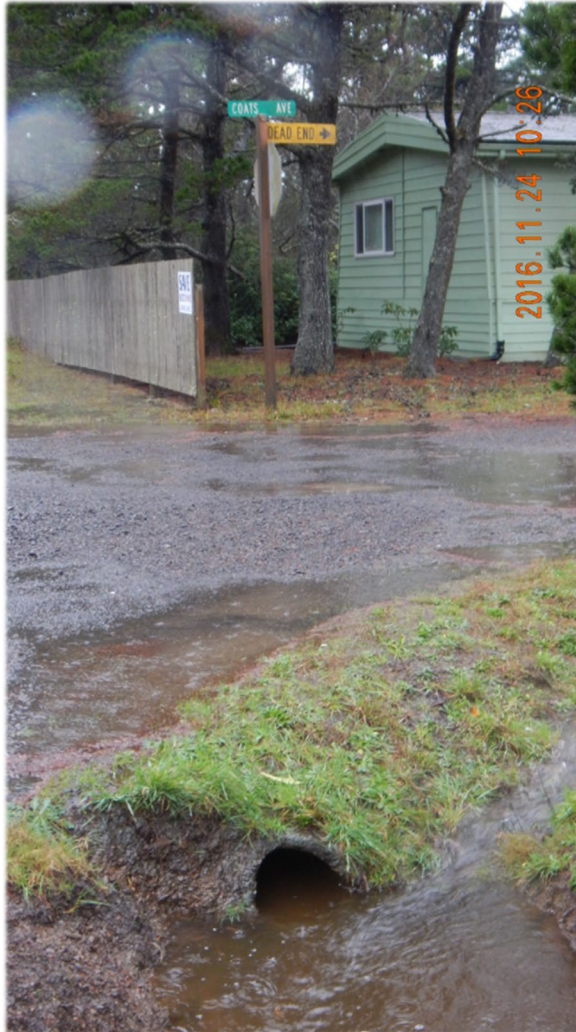
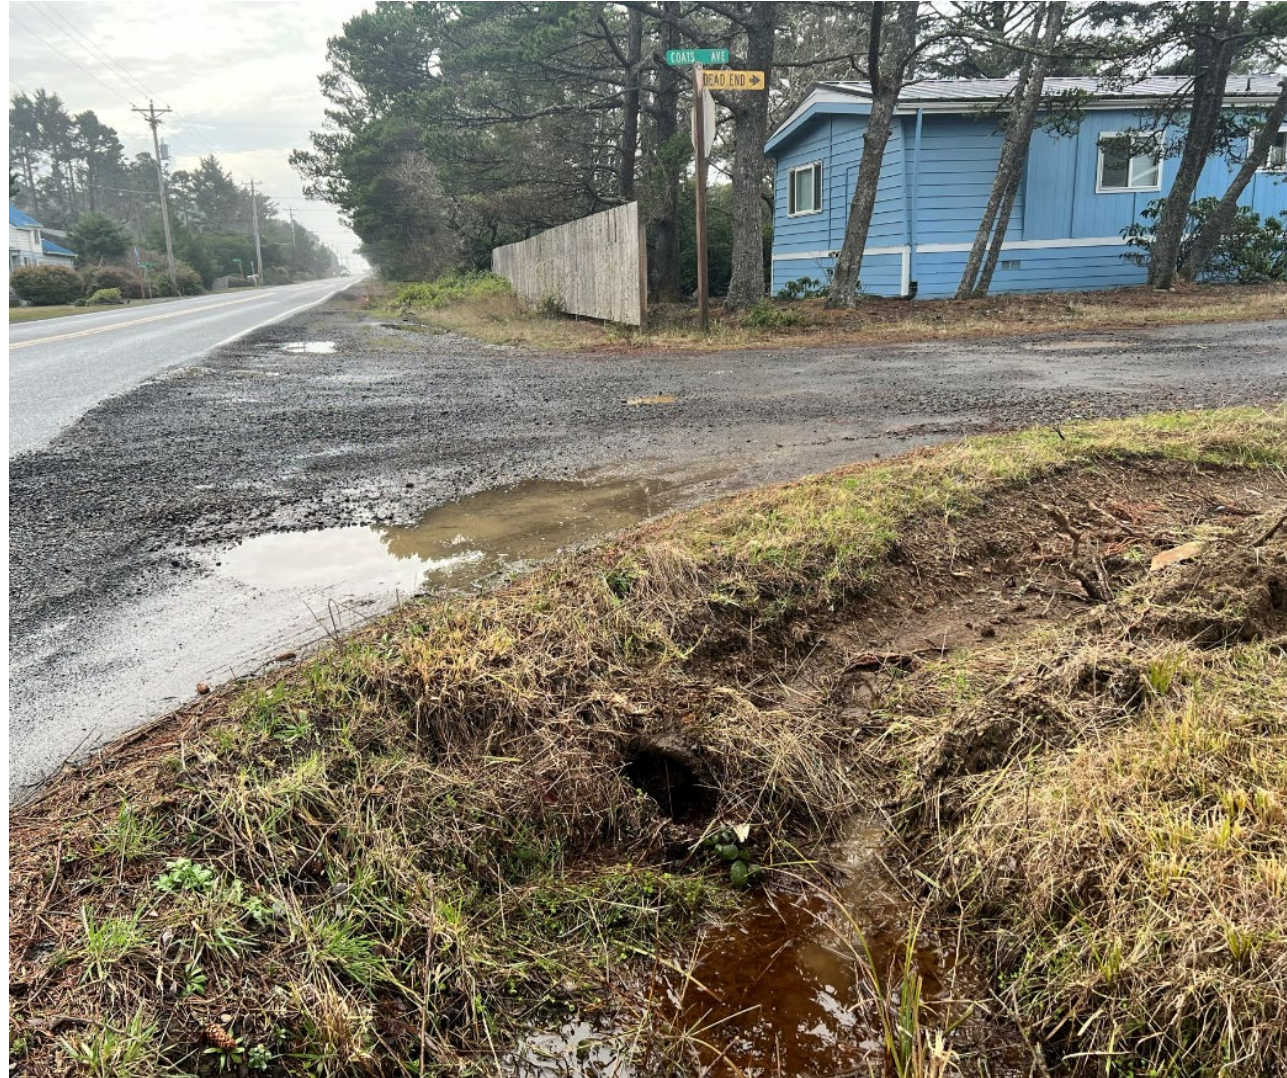
# TDM Drainage System Assessment

## Coats Ave – example of recent ditch improvement

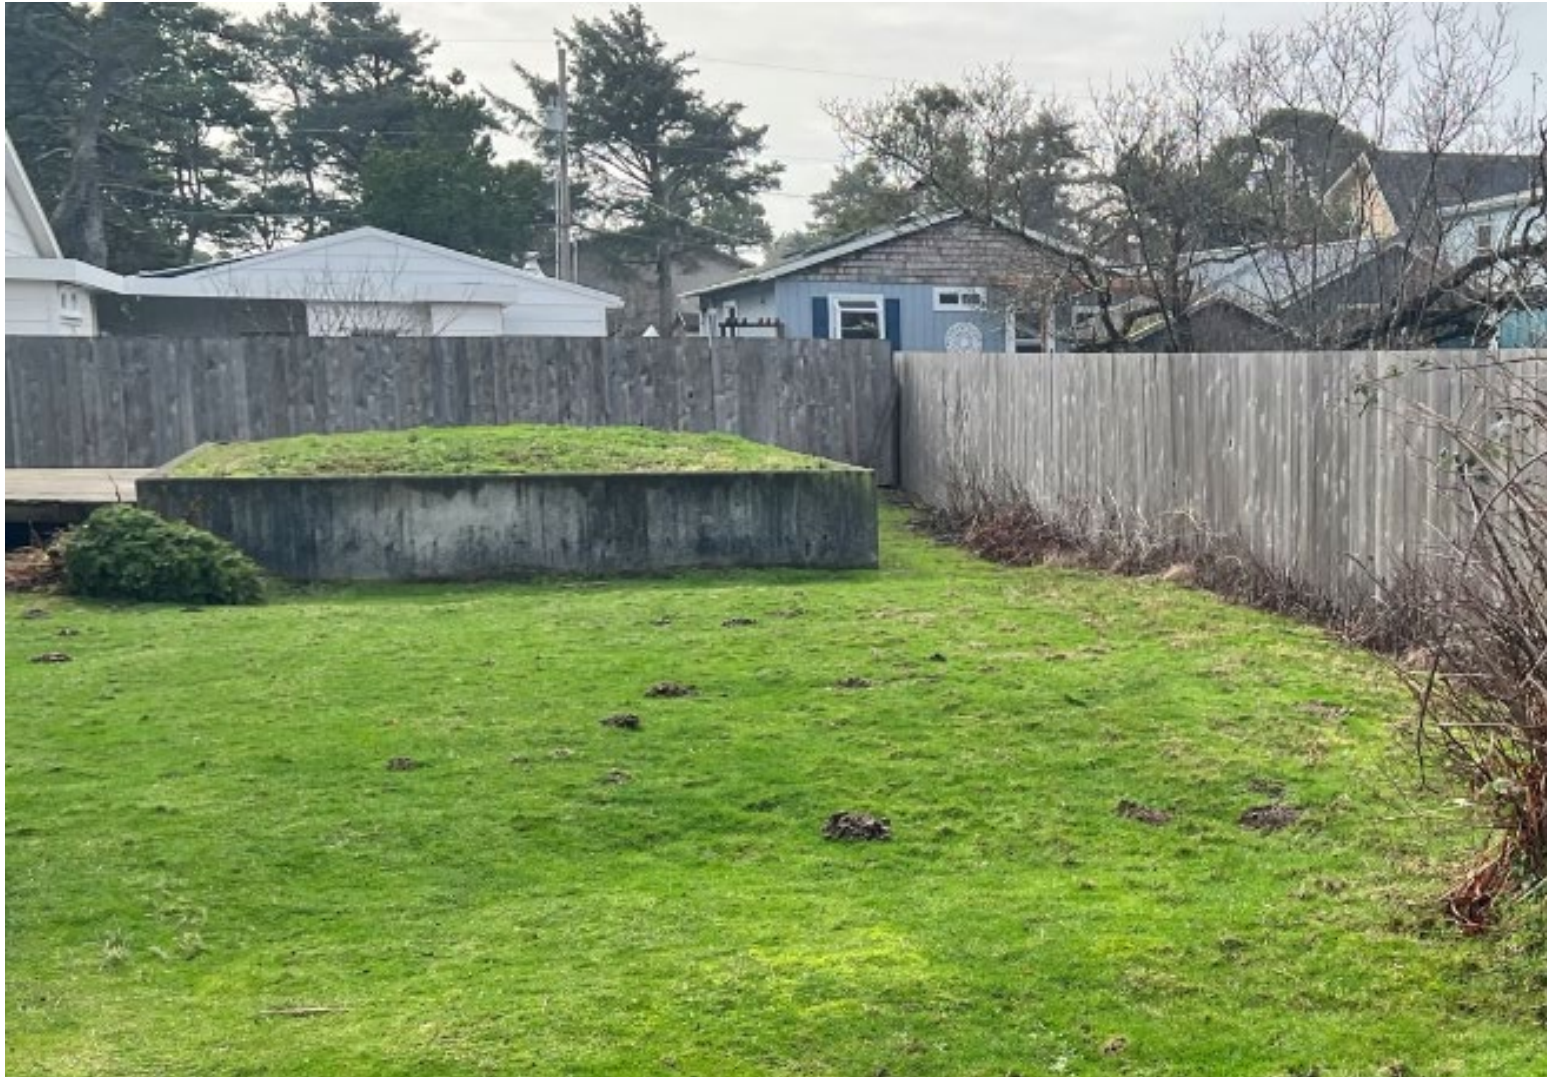
# Septic System – elevated drain field/sand filter

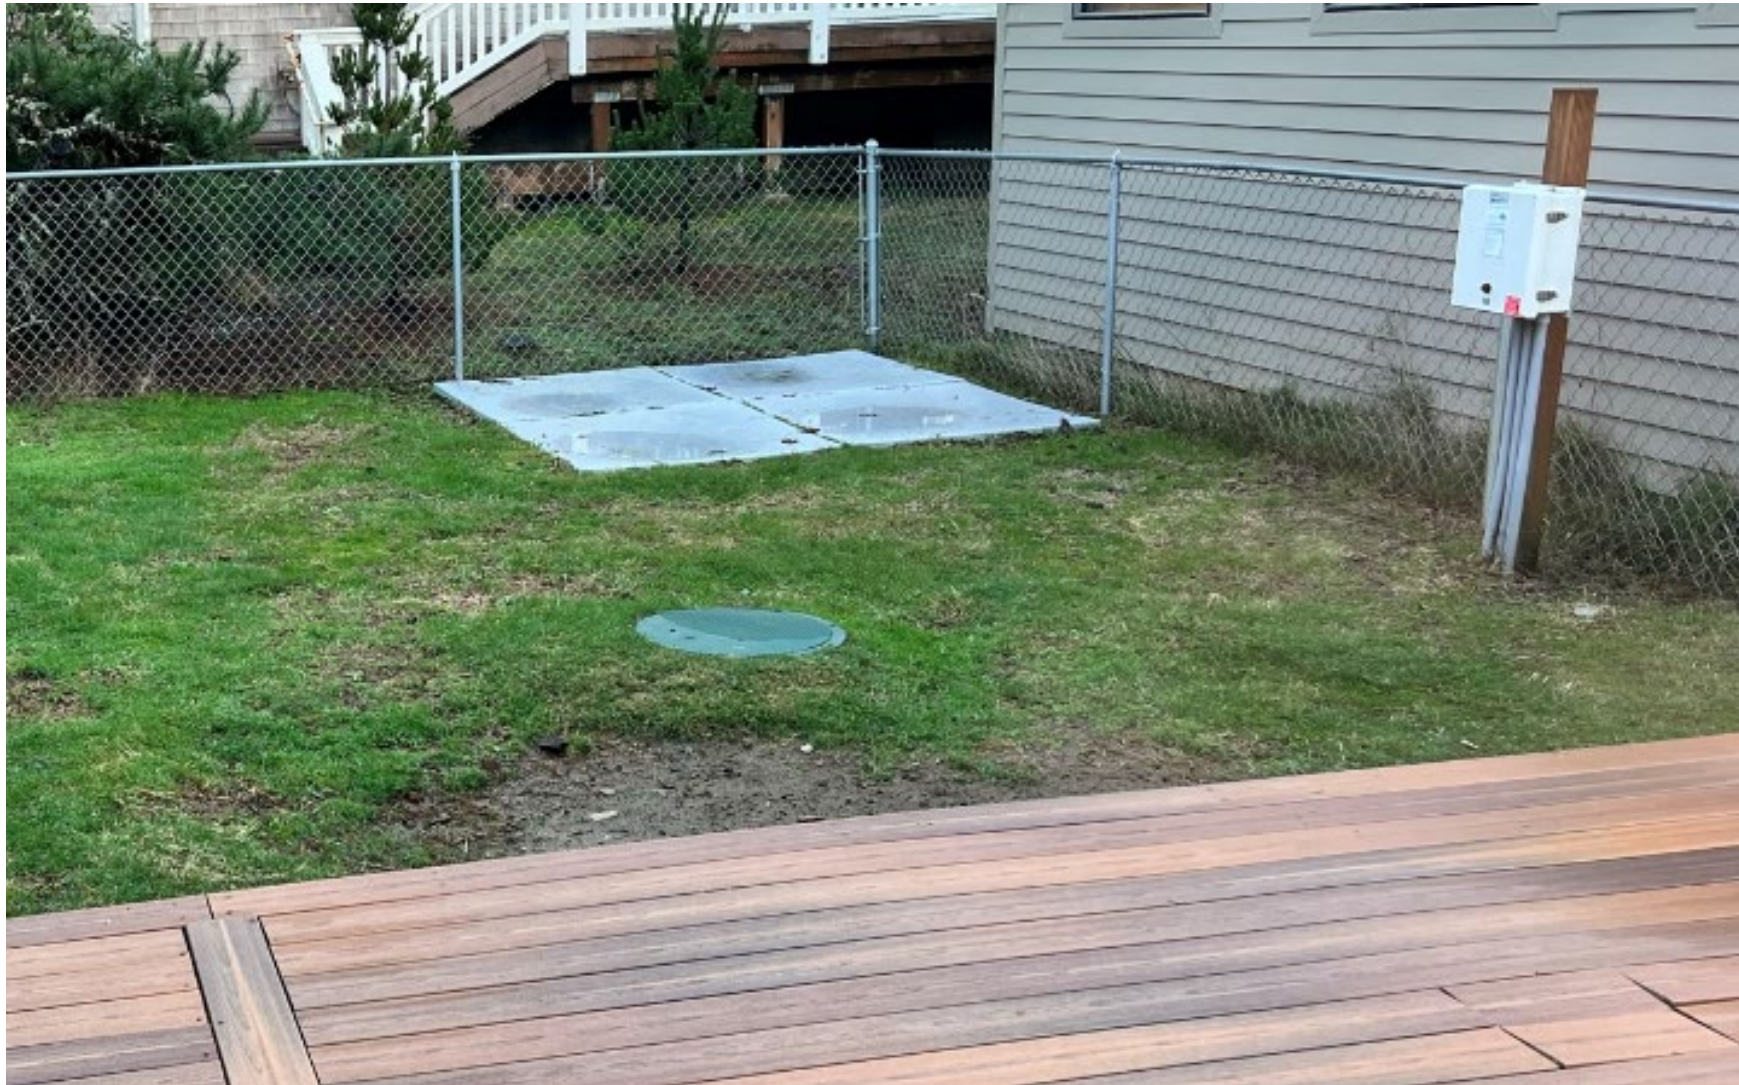
# Septic System – Advanced Treatment System

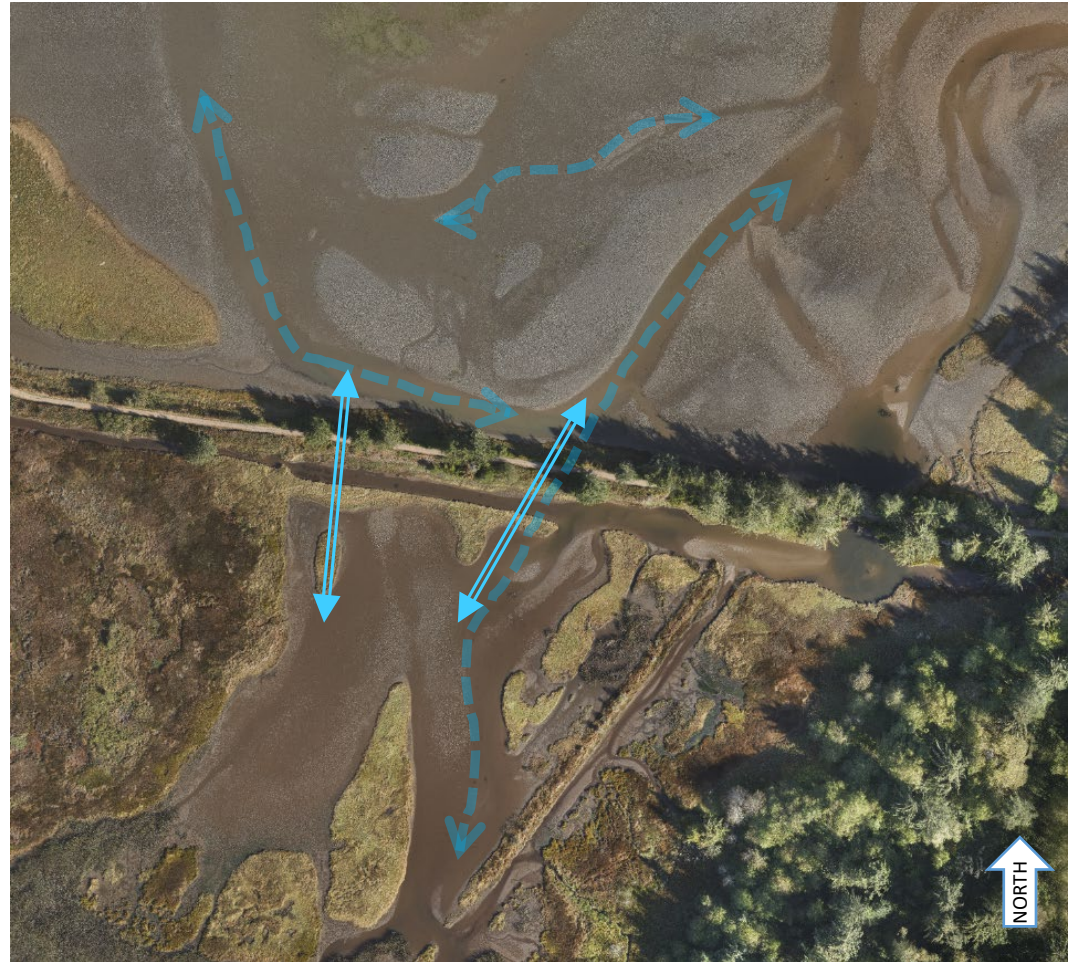
# Consider Two or More Breaches aligned with prominent historical channels?

- Would two breaches be beneficial?
  - If allowed for less expensive bridges
- Would two breaches be risky/less predictable?
  - Two equally sized breaches?
  - **One could dominate as preferential primary channel and adjust/scour**
- Cost of additional breach/bridge if sized to allow either to dominate

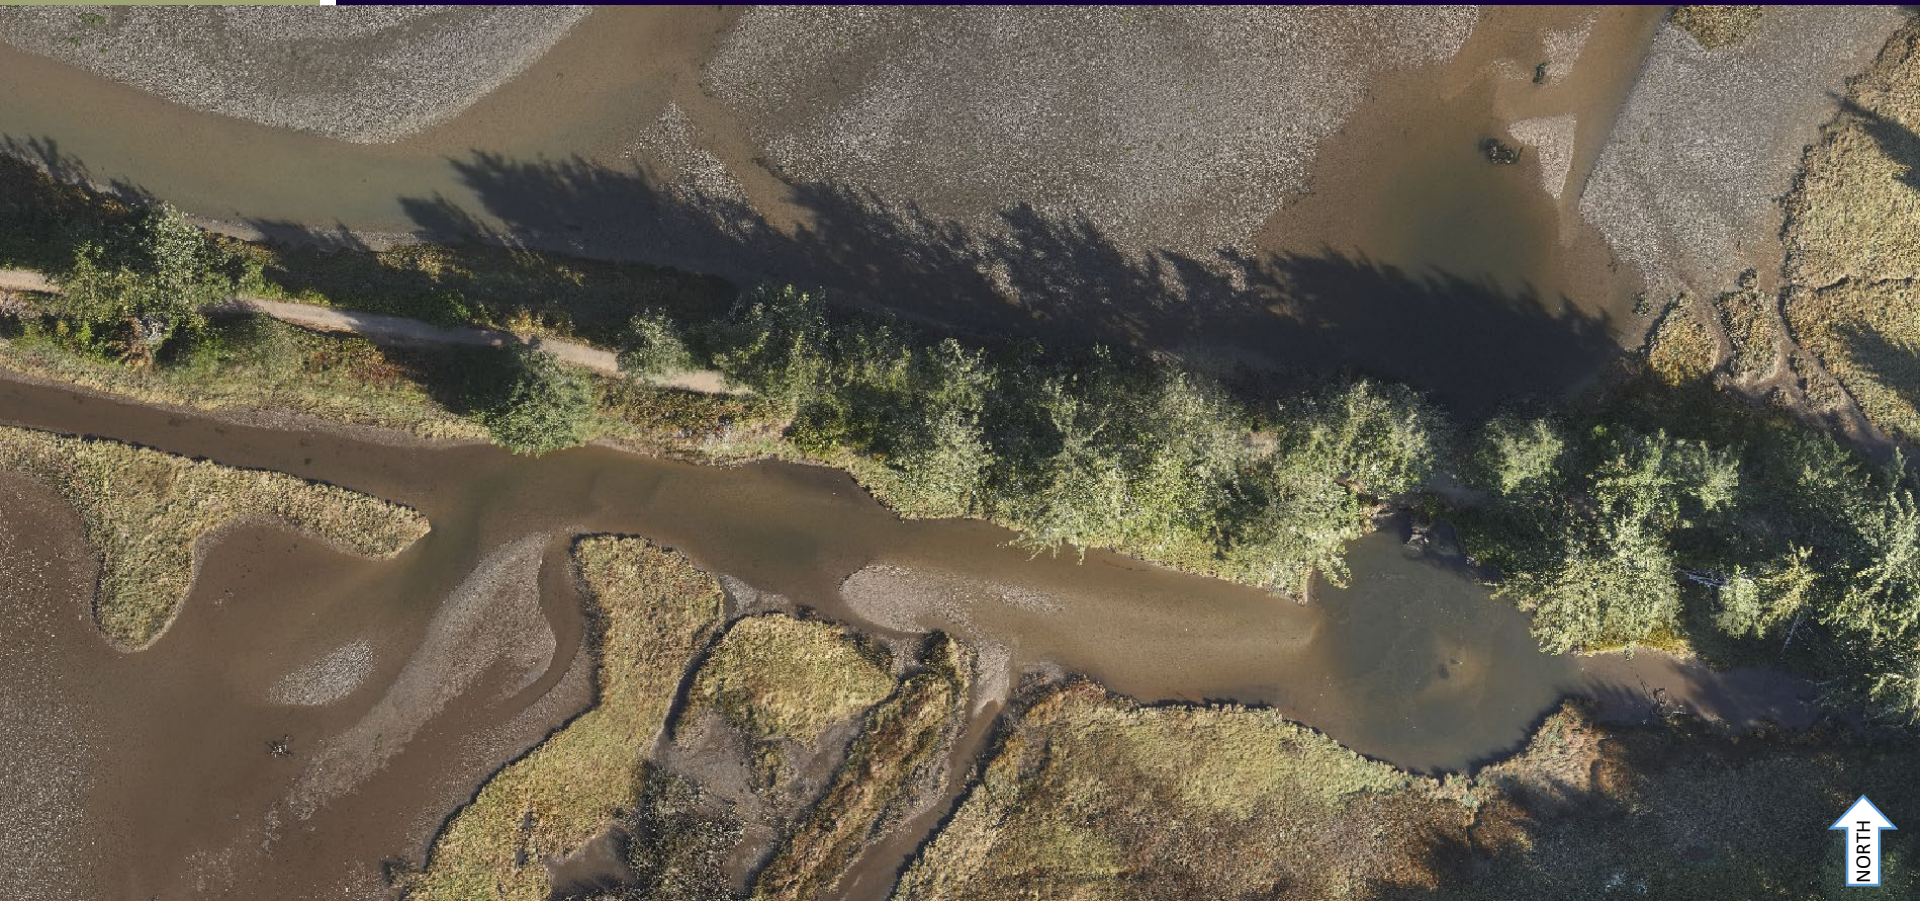
# 100' DIKE BREACH, SPANNED BY 100-150' PEDESTRIAN BRIDGE

- Appropriate Breach/Inlet size based on tidal channel design guidelines
  - Analyzed Marsh Area, Tidal Prism Volume vs. Inlet Size
    - Hydraulic Geometry
  - 40' bottom width (80' top width) minimum
- Minimum size for fish passage – review model velocities
  - 2 ft/sec threshold for fishways (ODFW criteria)
- Maximum reasonable bridge span?
  - 150-foot-span is reasonable. Larger spans become more expensive and higher profile (deeper substructure)
- Minimize Constriction for scour/erosion

- Single beach would be much more predictable than multiple breaches
- 100-foot breach is a 'constriction' compared to historical conditions, but peak modeled velocity (and shear stress) are modest ~3 ft/sec (0.19 lb/sf) within the breach (much lower on marsh plain)

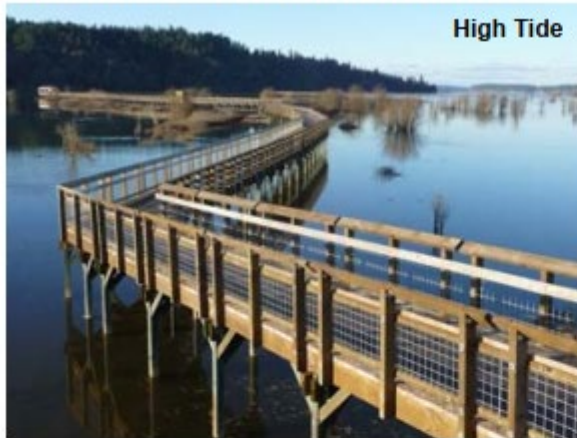
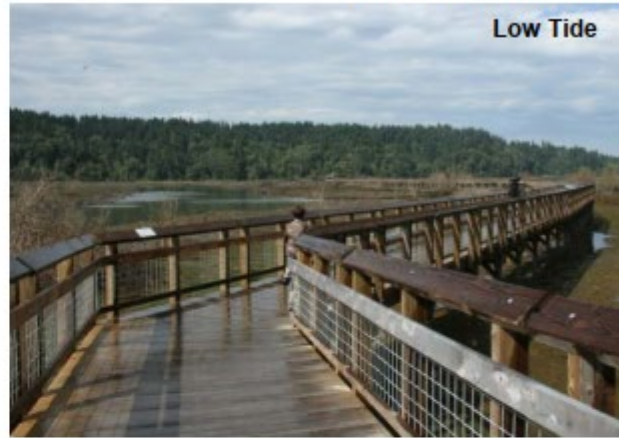
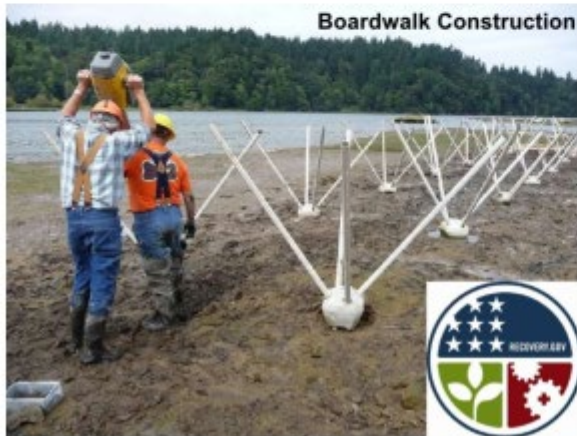
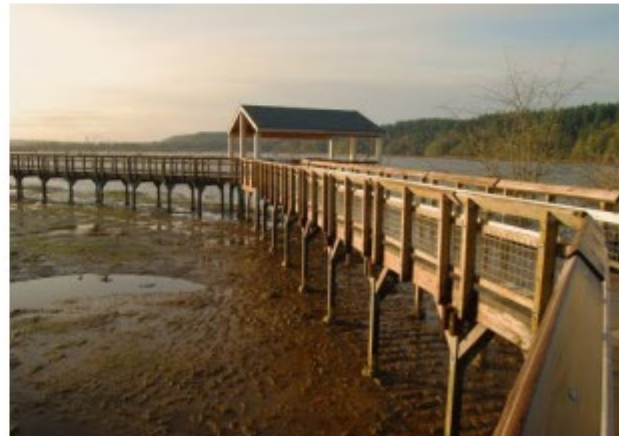
Nisqually NWR, WA

# Boardwalk Example – Nisqually NWR

- 8' wide
- 8-13' height
- Pressure Treated structural members
- Laminate decking
- Diamond Pier Foundations
- \$68/SF (1 mile)
- \$2.8 Million
- Built in 2010

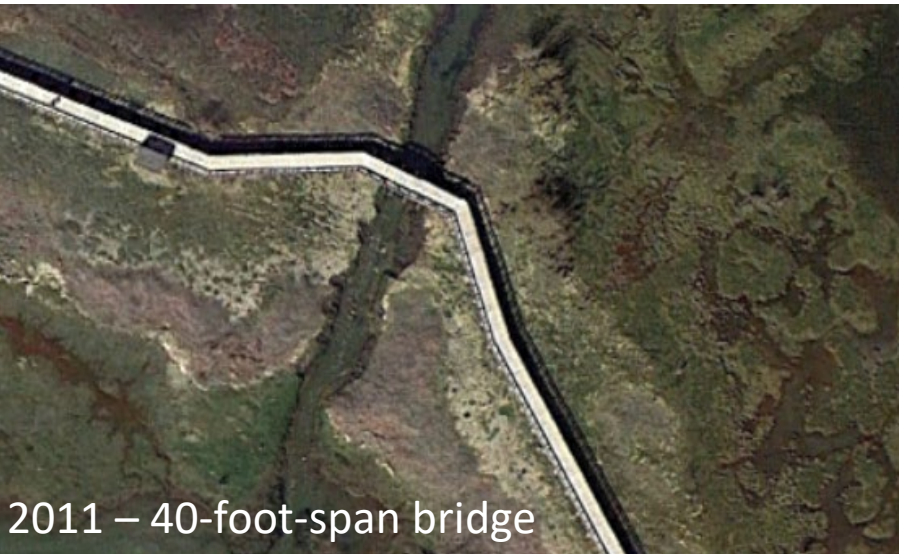
2011 – 40-foot-span bridge

# Boardwalk/Bridge Example – Nisqually NWR lesson learned

2020 – replaced with 90-foot span

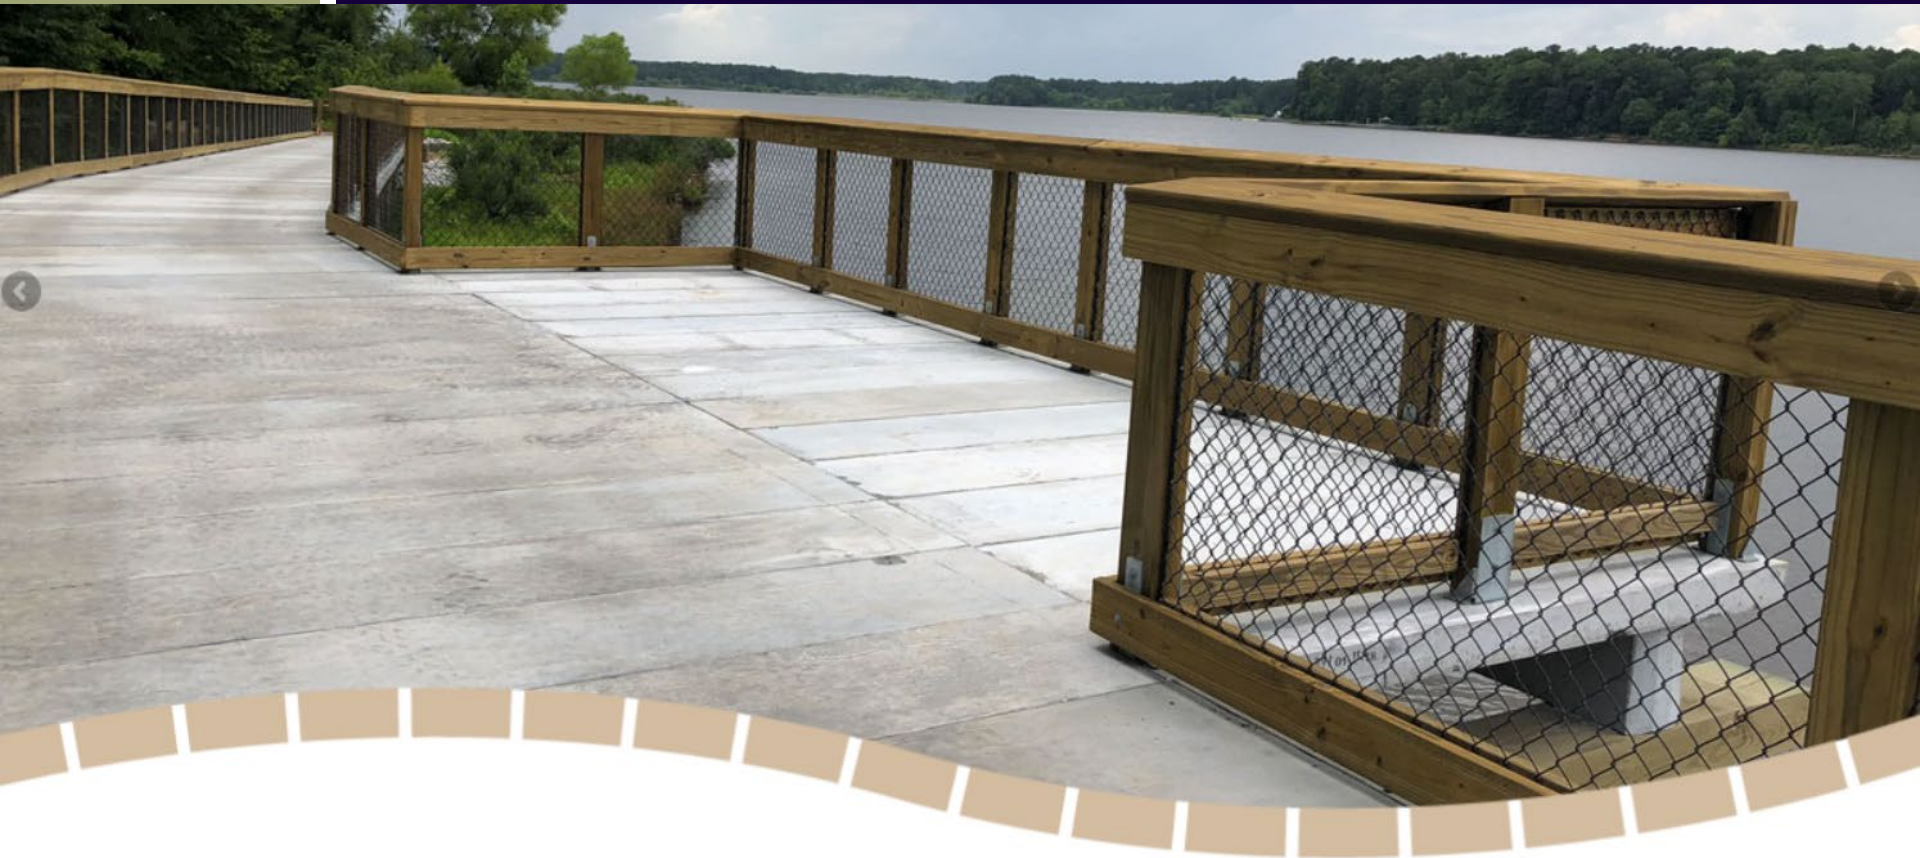
# Concrete Boardwalk option (less maintenance, higher cost)

- PermaTrak – precast concrete boardwalk system
