# Sitka Sedge Tidal Wetland Restoration: Alternatives Analysis & Hydraulic Modeling

Sitka Sedge Tidal Wetland Restoration Project – Townhall Meeting

June 17, 2023

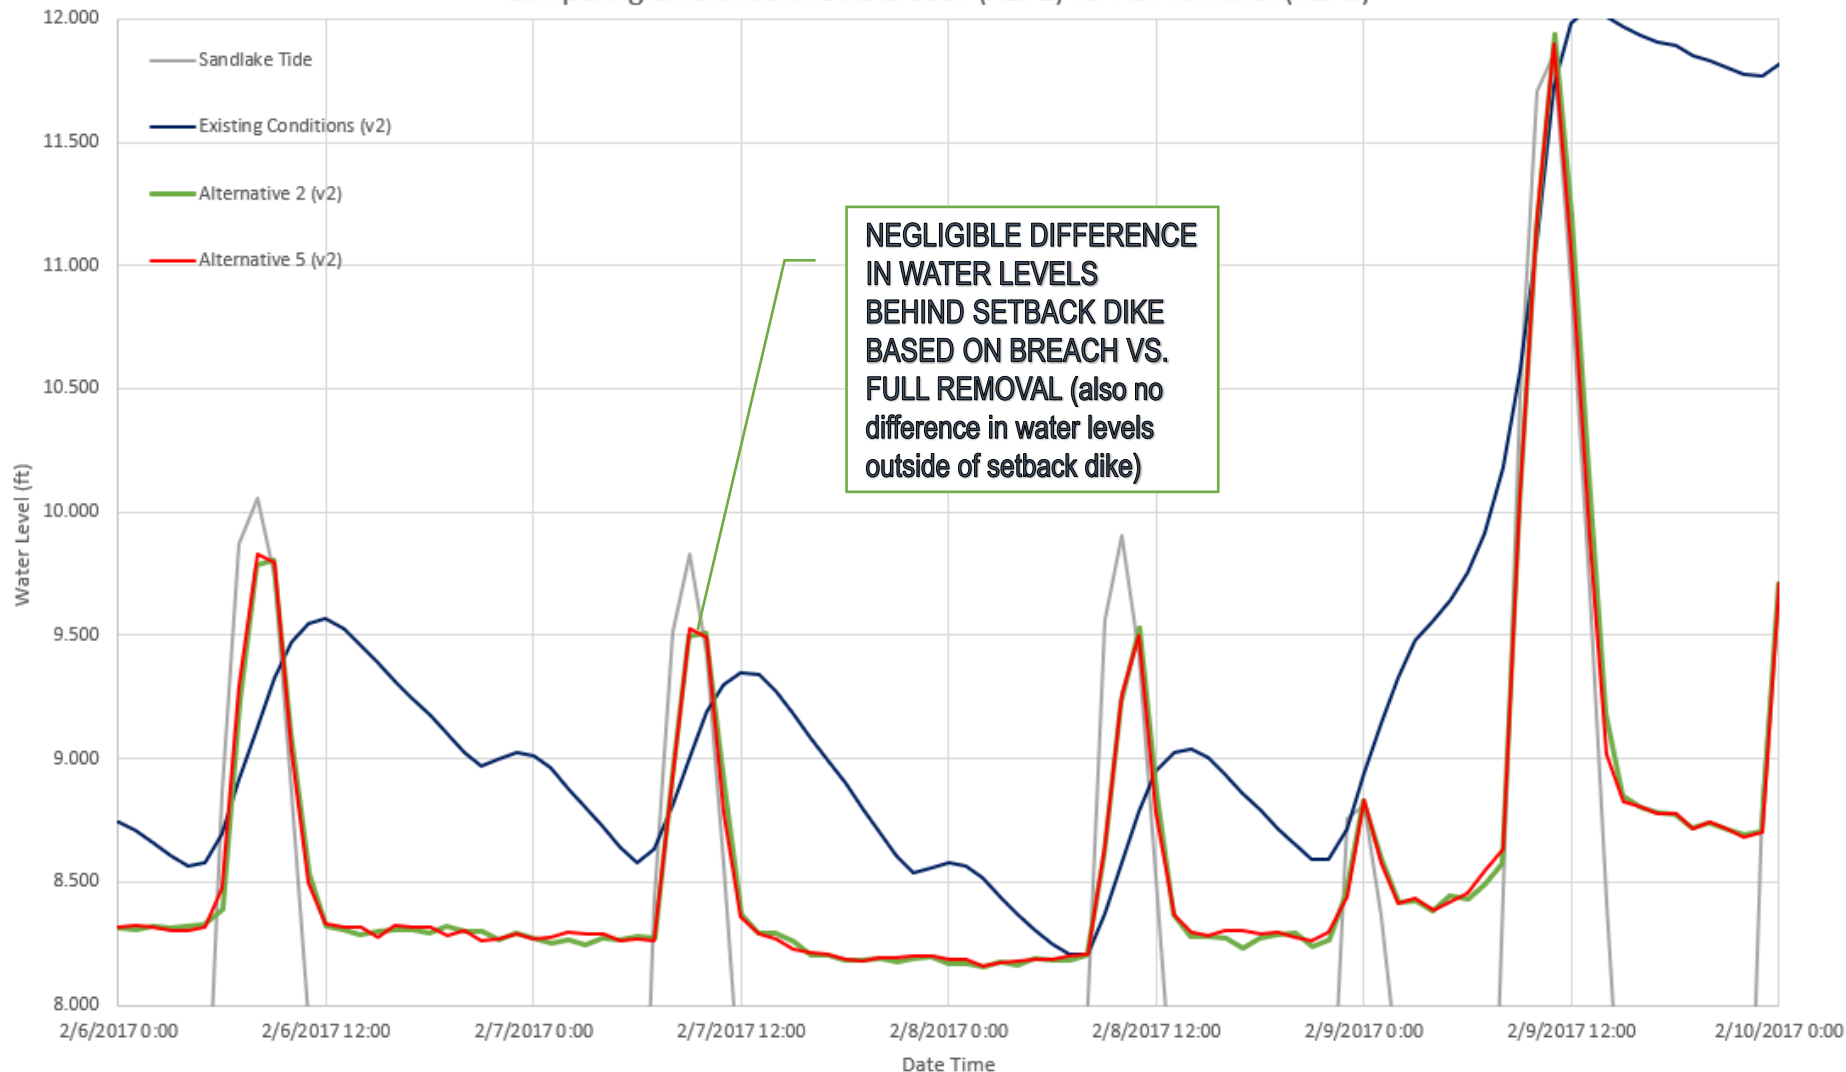
# Comparing Marsh Water Levels Under Dike Breach vs. Full Removal

100 year with Feb 2017 Tides - South End of Marsh  
Comparing difference in Dike Breach (ALT 2) vs. Full Removal (ALT 5)

- 150-foot bridge span is reasonable, but larger span gets much more expensive
- No difference in water levels in marsh between 100'/200' Dike Breach vs. Full Removal

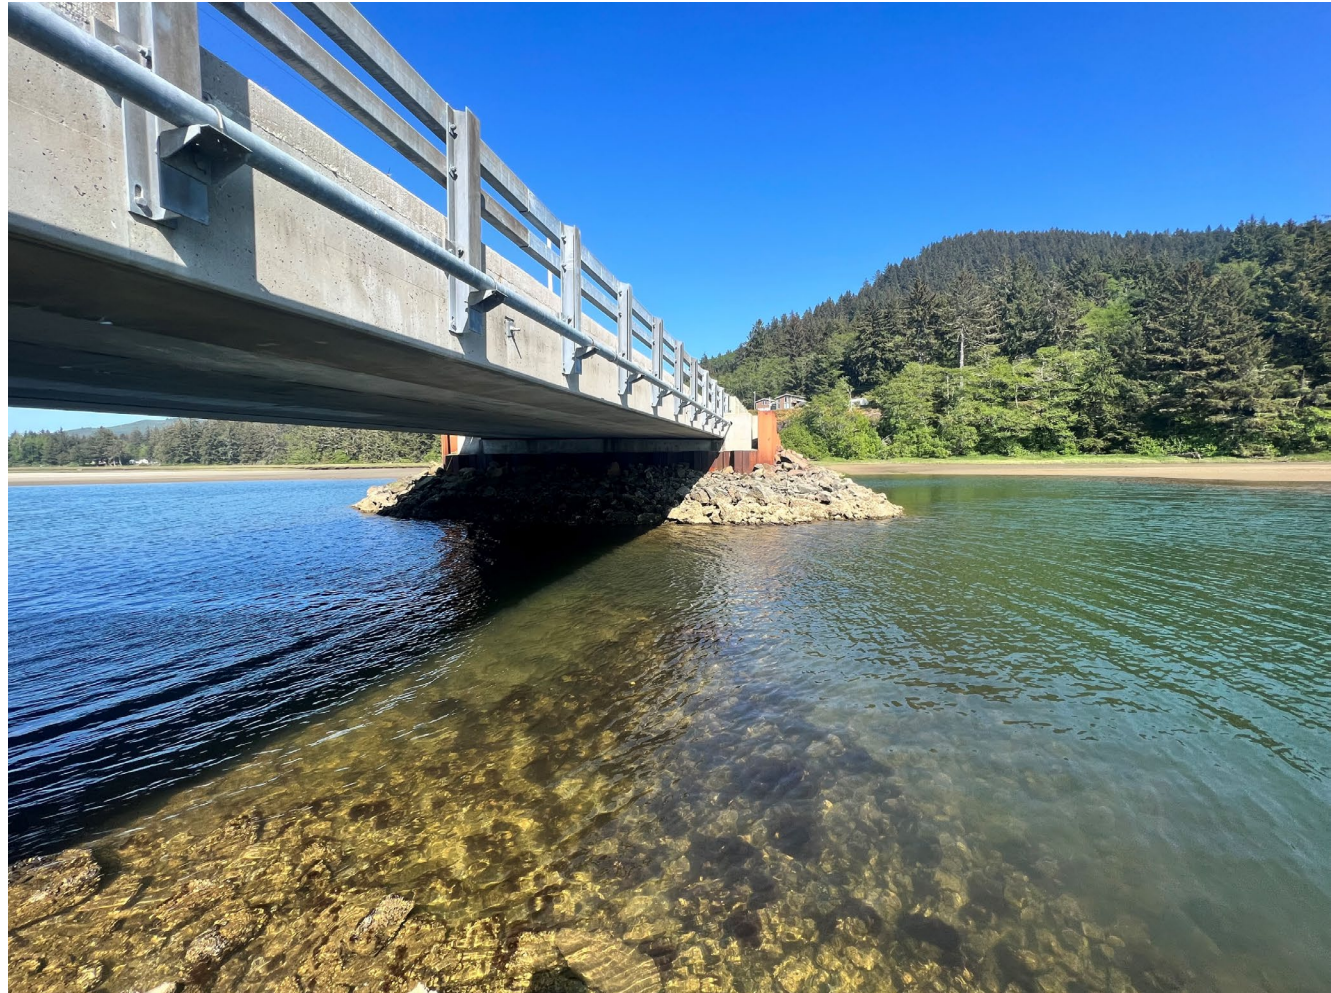
## Whalen Island Rd Bridge

- 180-acre contributing marsh area (80 acres at Sitka Sedge)
- 80-foot span
- Heavily armored opening/banks with riprap

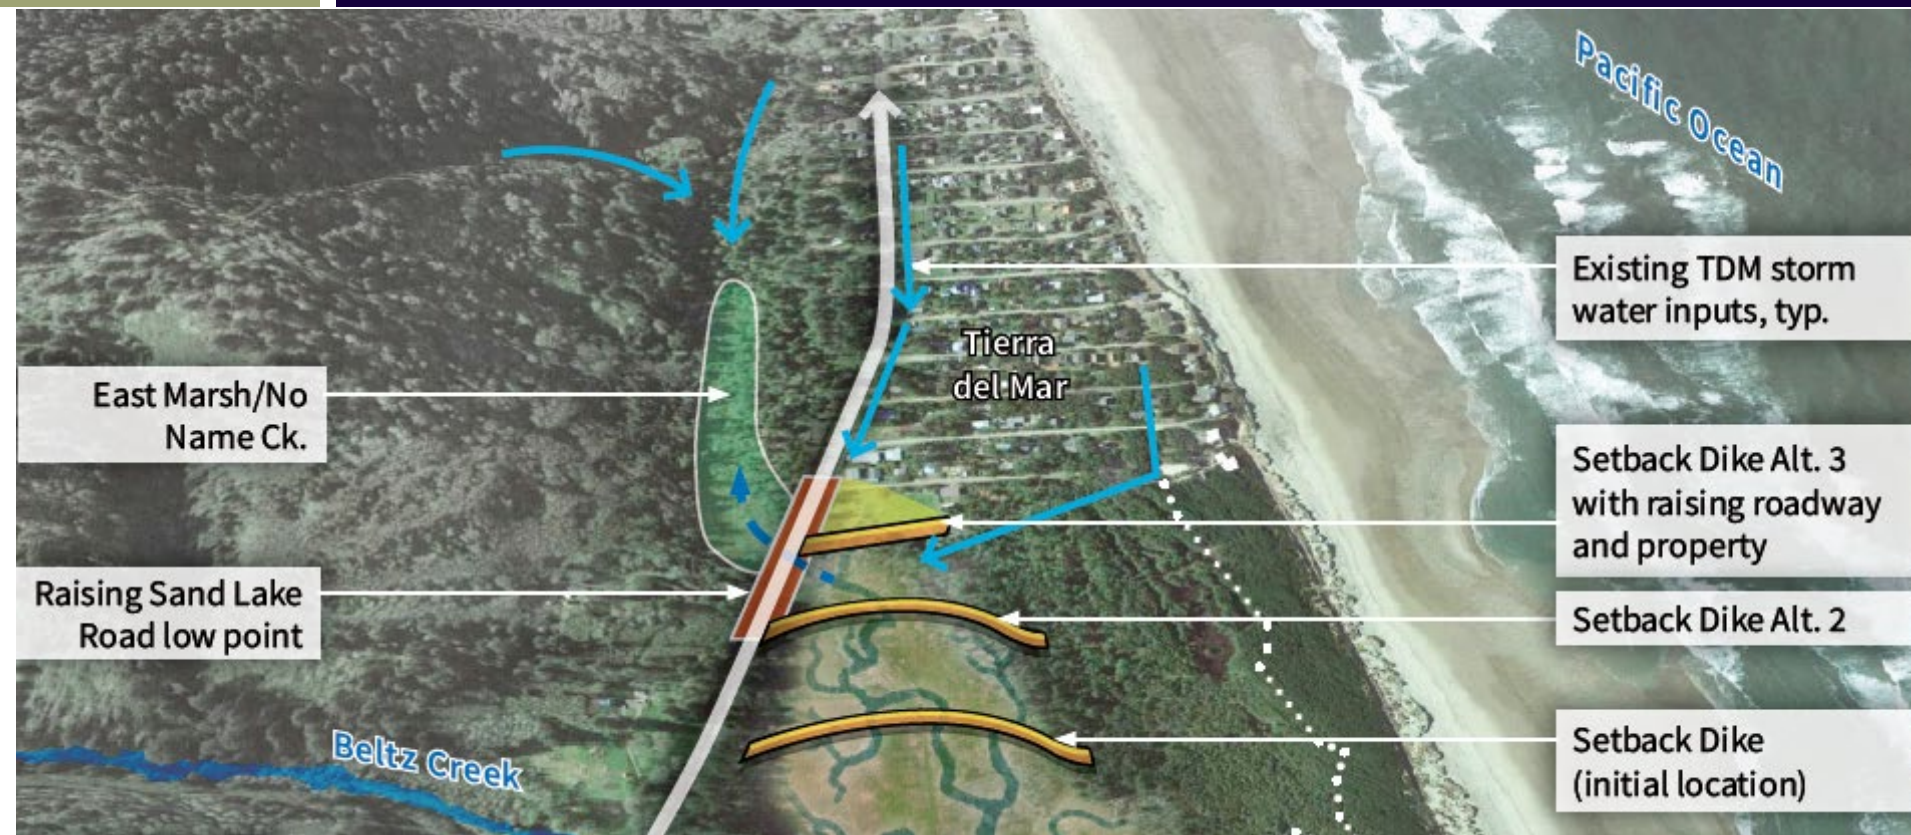
# Optimizing Setback Dike Location and Functionality

- Prior study: high-level feasibility assessment of Initial Location
- Estimated storm inflows under 100-year storm event vs. storage volume
- Initial location feasible from a storage capacity standpoint. Need to consider other factors (logistics, maintenance, long-term function)

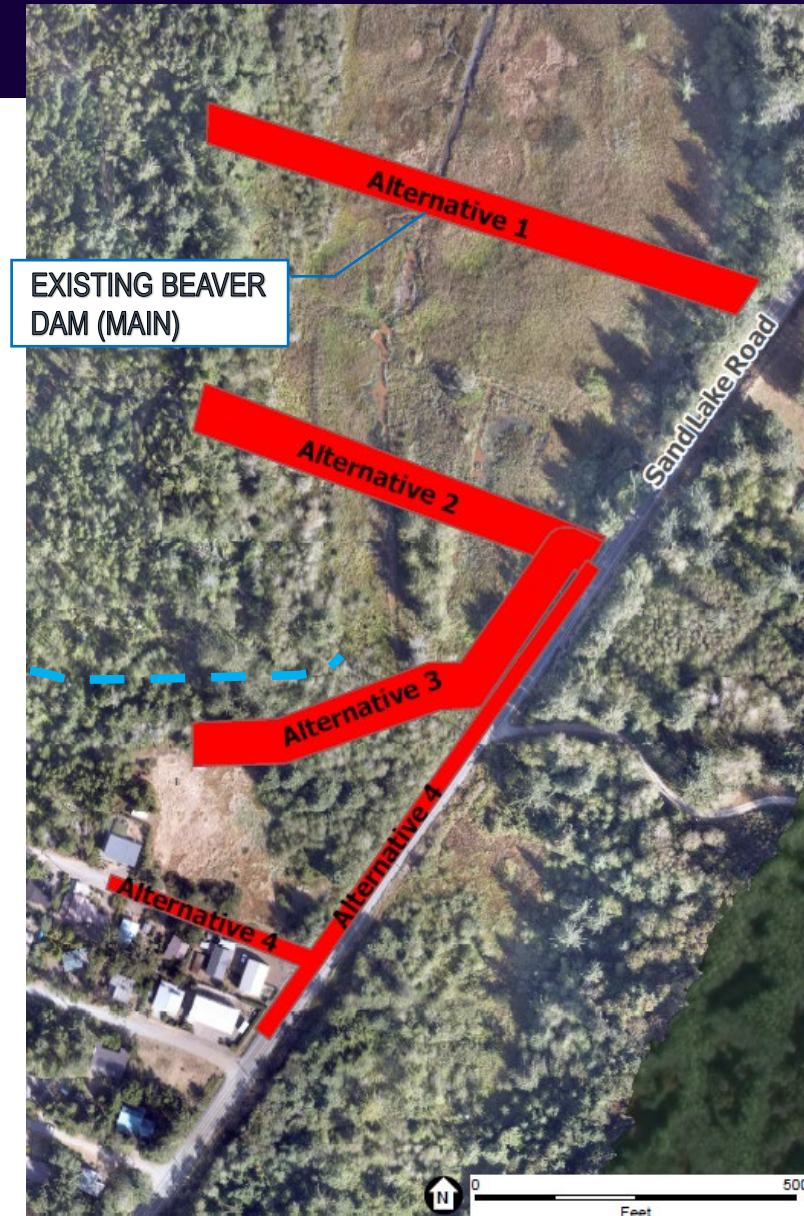
# Setback Dike Alternatives –

- Evaluated 4 potential setback dike locations
  - Alt 1 – at/near existing beaver dam
  - Alt 2 – 300 feet south of existing beaver dam
  - Alt 3 – at Park boundary (configured to allow NW Ditch to flow outside of dike)
  - Alt 4A – raise Sandlake Rd and Roma Ave to 15' as the setback dike (with tide gate to East Marsh)
  - Alt 4B – no tide gate at Sandlake Rd setback dike (free flowing connection to East Marsh)

*Alt 4B is full tidal reconnection while raising Sandlake Rd and east end of Roma Ave to 2-3' above maximum water levels.*

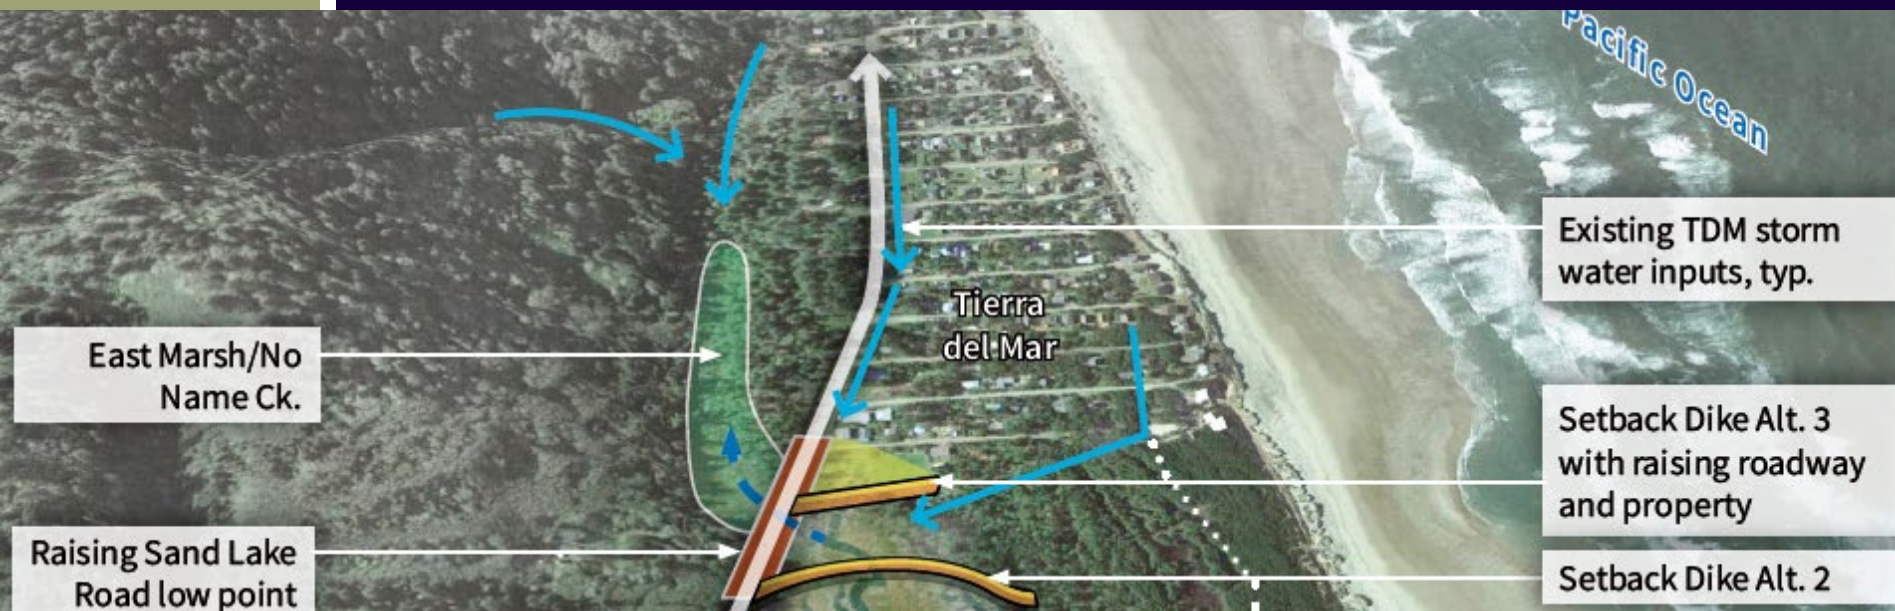
# Flow inputs to area behind a setback dike

- East Marsh drainage is the largest contribution of runoff/flow
- Sand Lake Rd Ditch drains more than 2/3 of TDM west of Sandlake Rd
- NW Ditch drains ~1/3 of TDM to Beltz Marsh

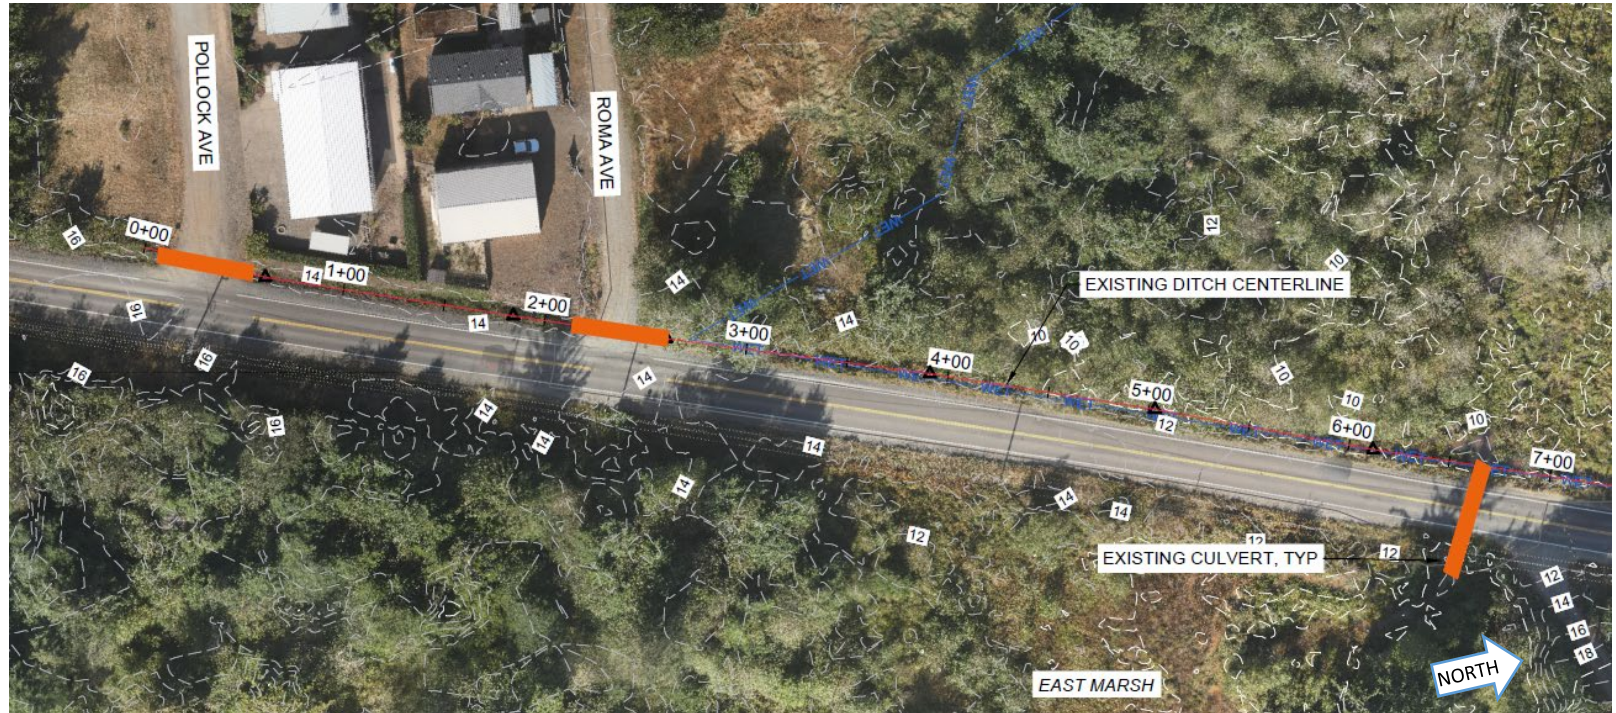
# Sandlake Rd Ditch Profile relative to 12' and 13' water levels

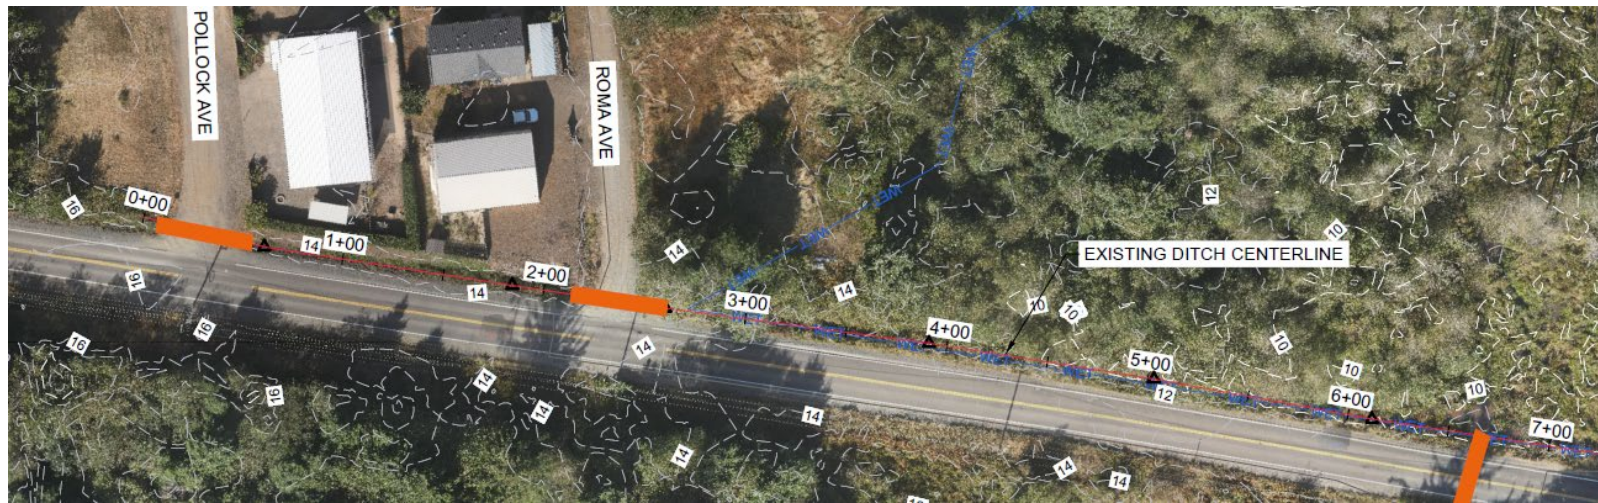
# Sandlake Rd Ditch Profile w/ Alt 4 Improvements

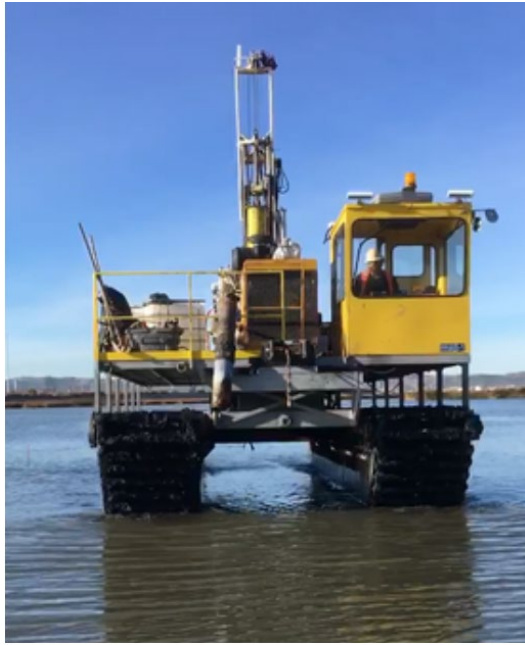
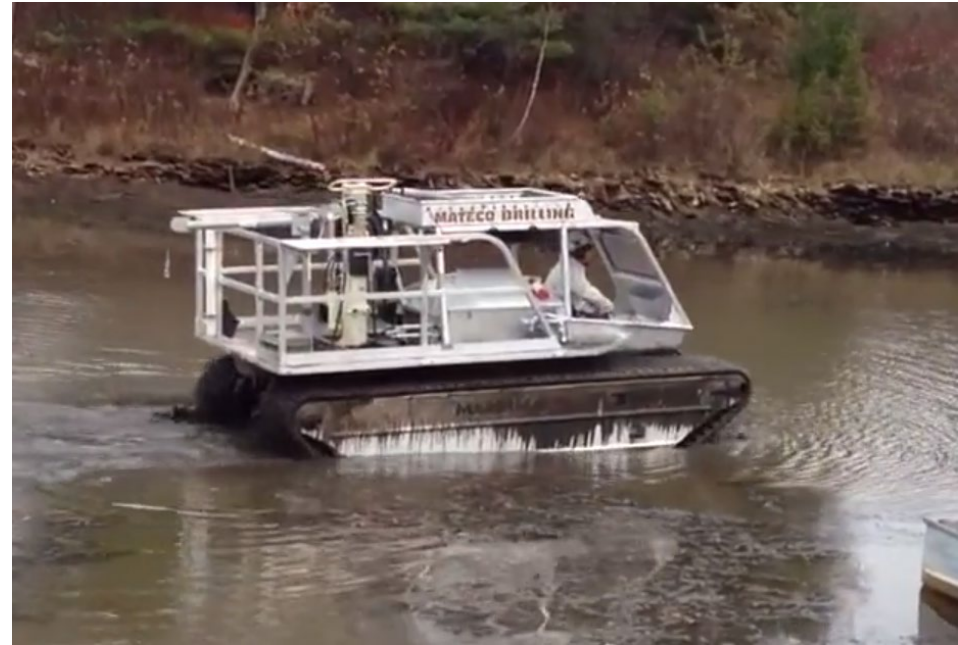
- Challenging to collect geotechnical borings along setback dike and tide gate location
- Specialized amphibious drill rig, expensive to mobilize from out of state and would impact vegetation/marsh surface to access
- Hand auger borings difficult, holes would collapse with very wet soils
- First steps would be to collect additional borings at existing dike, Sandlake Rd, and possibly edge of marsh using traditional drilling equipment
  - While collecting useful data for culvert replacements and bridge design

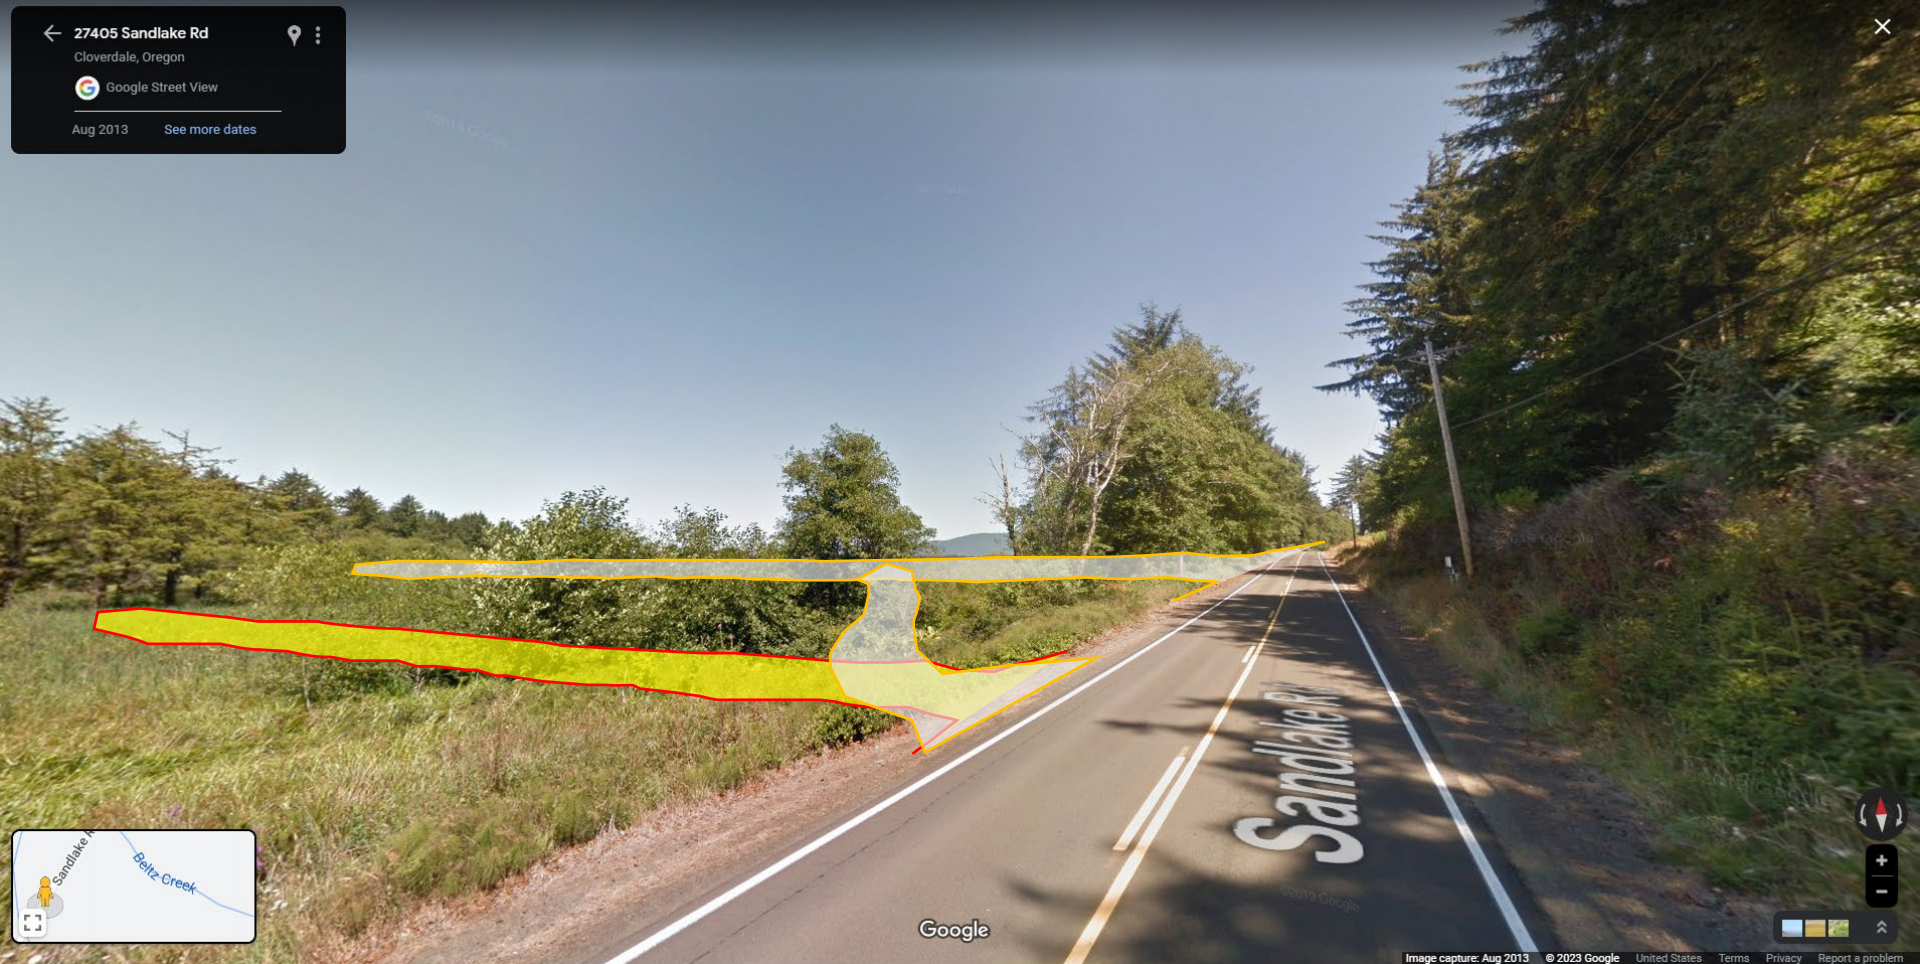
# Setback Dike tie-in point to Sandlake Rd

- Setback Dike Tie-in points to Sandlake Rd Embankment (min elev = 15')

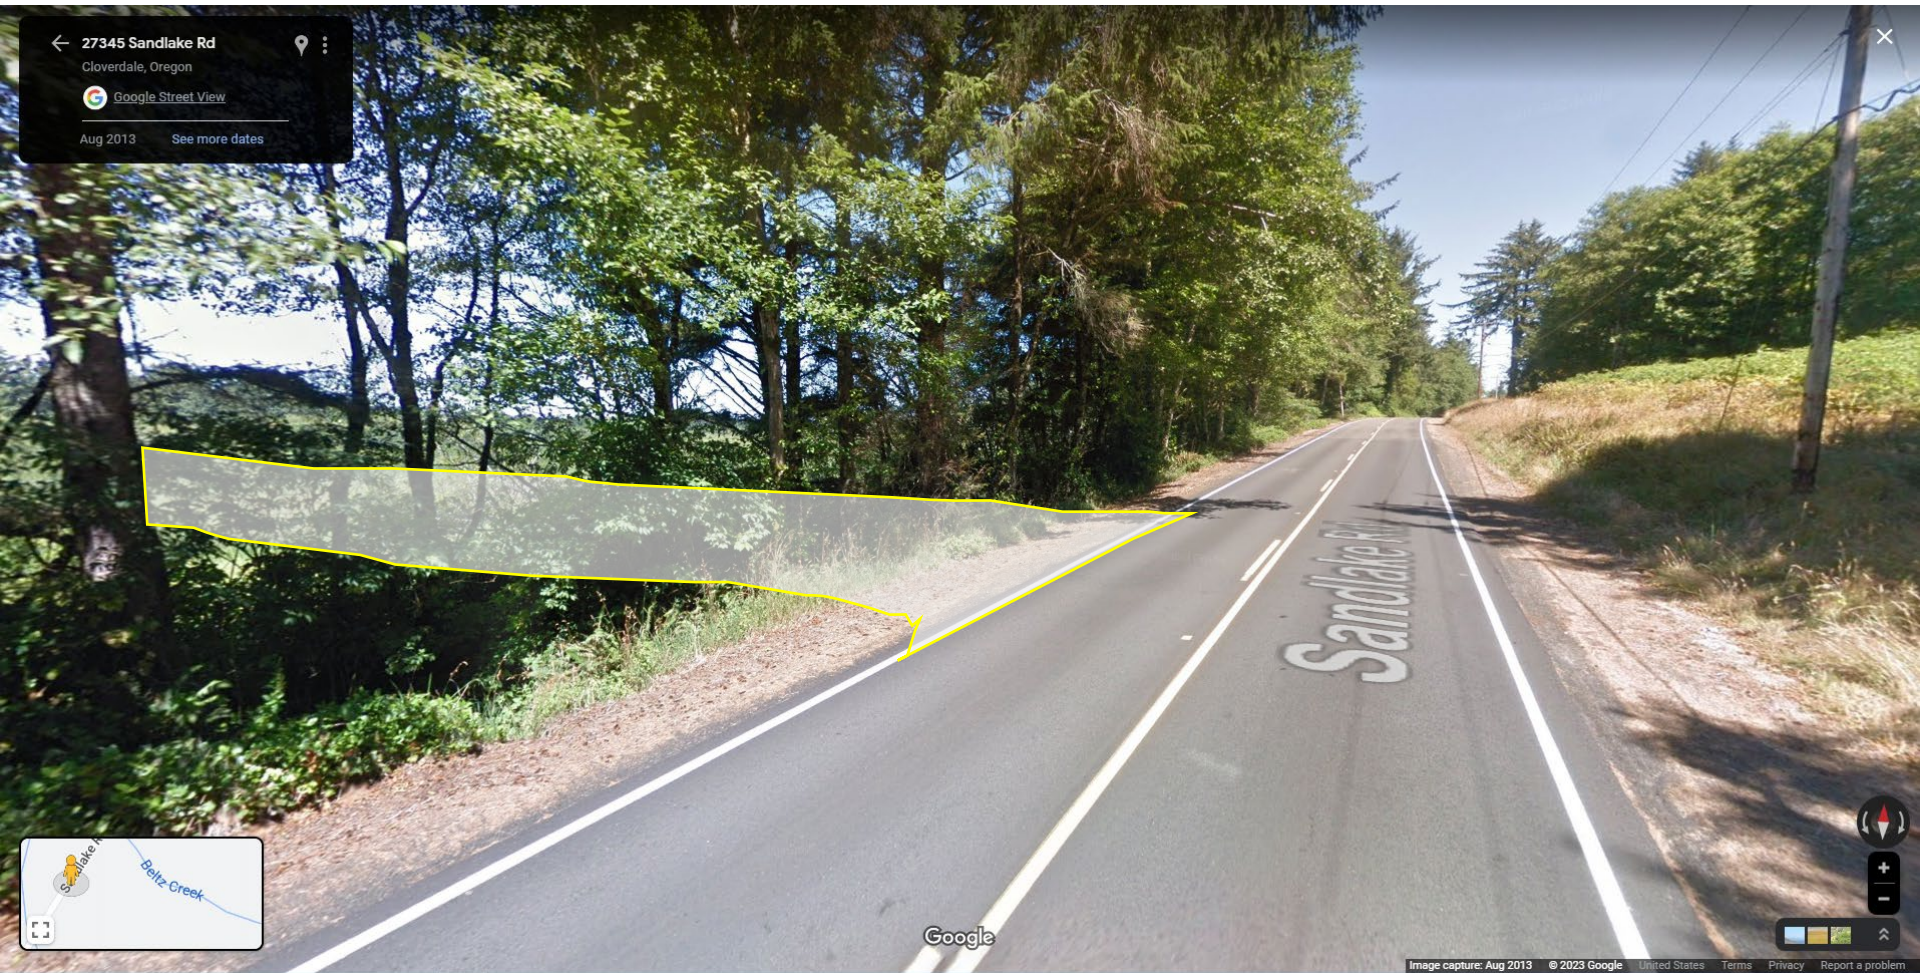
# Setback Dike tie-in point to Sandlake Rd

- Setback Dike Tie-in points to Sandlake Rd Embankment (min elev = 15')

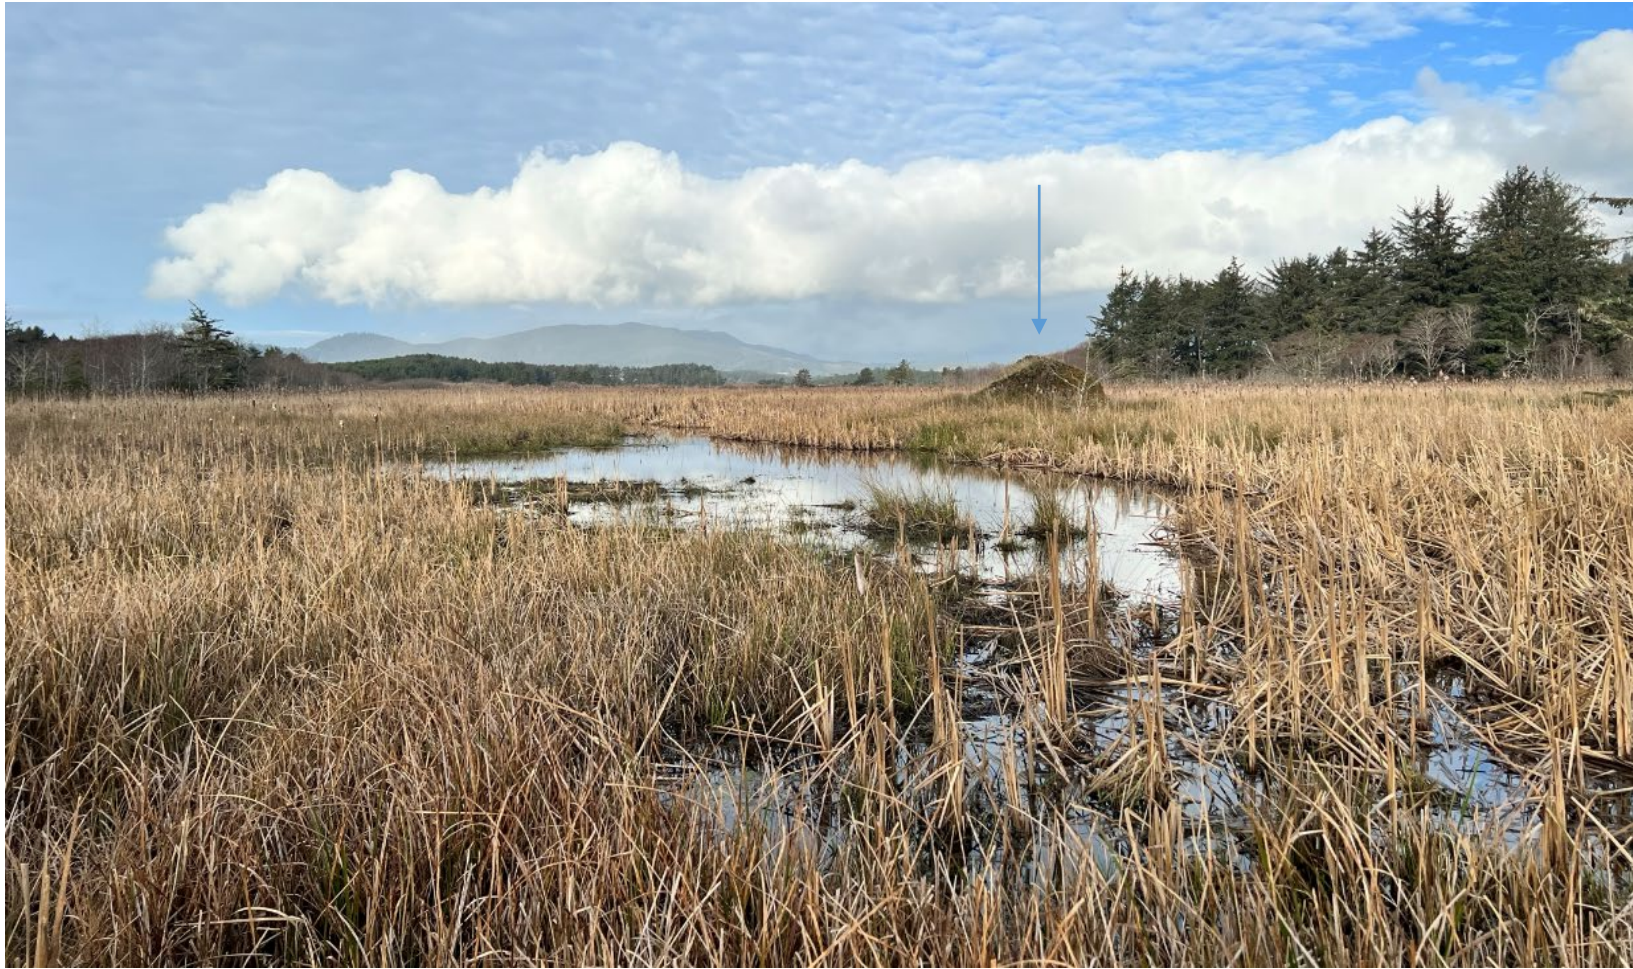
- Facing north, looking at beaver pond (beaver dam impounding water). Note, bedrock outcropping just SE of beaver dam.

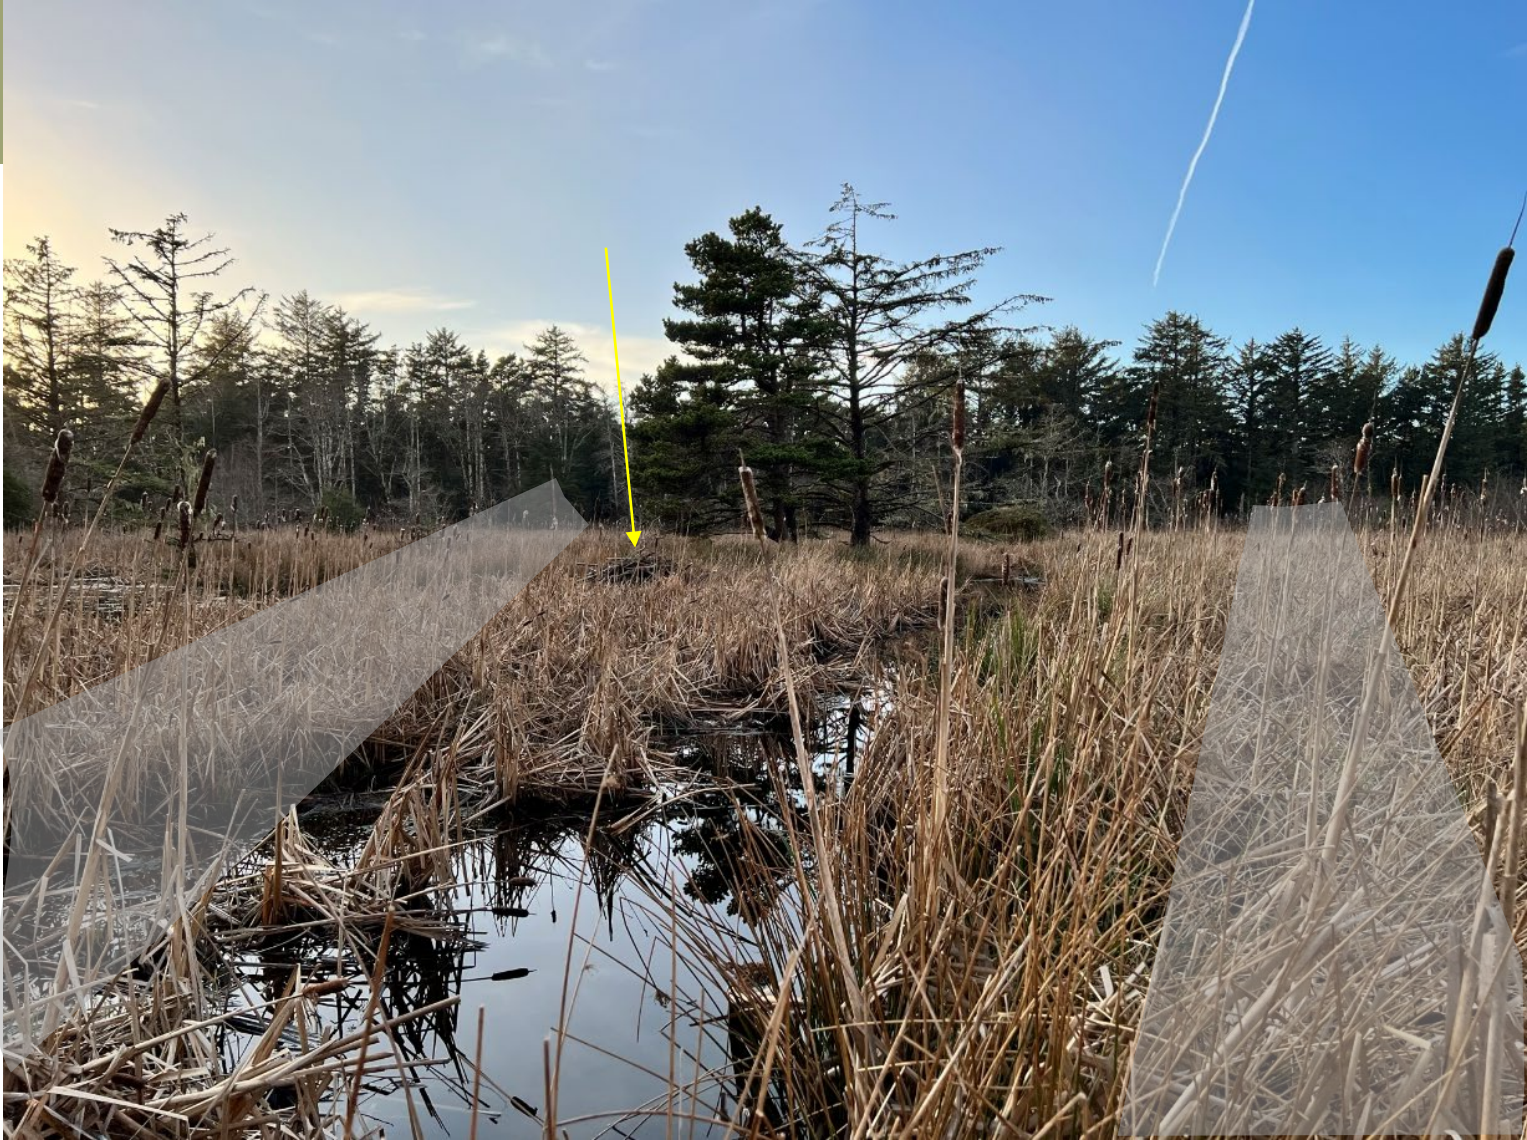
- Facing west, looking at East-to-west ditch. Potential setback dike alignment area. Active beaver lodge to the south of ditch

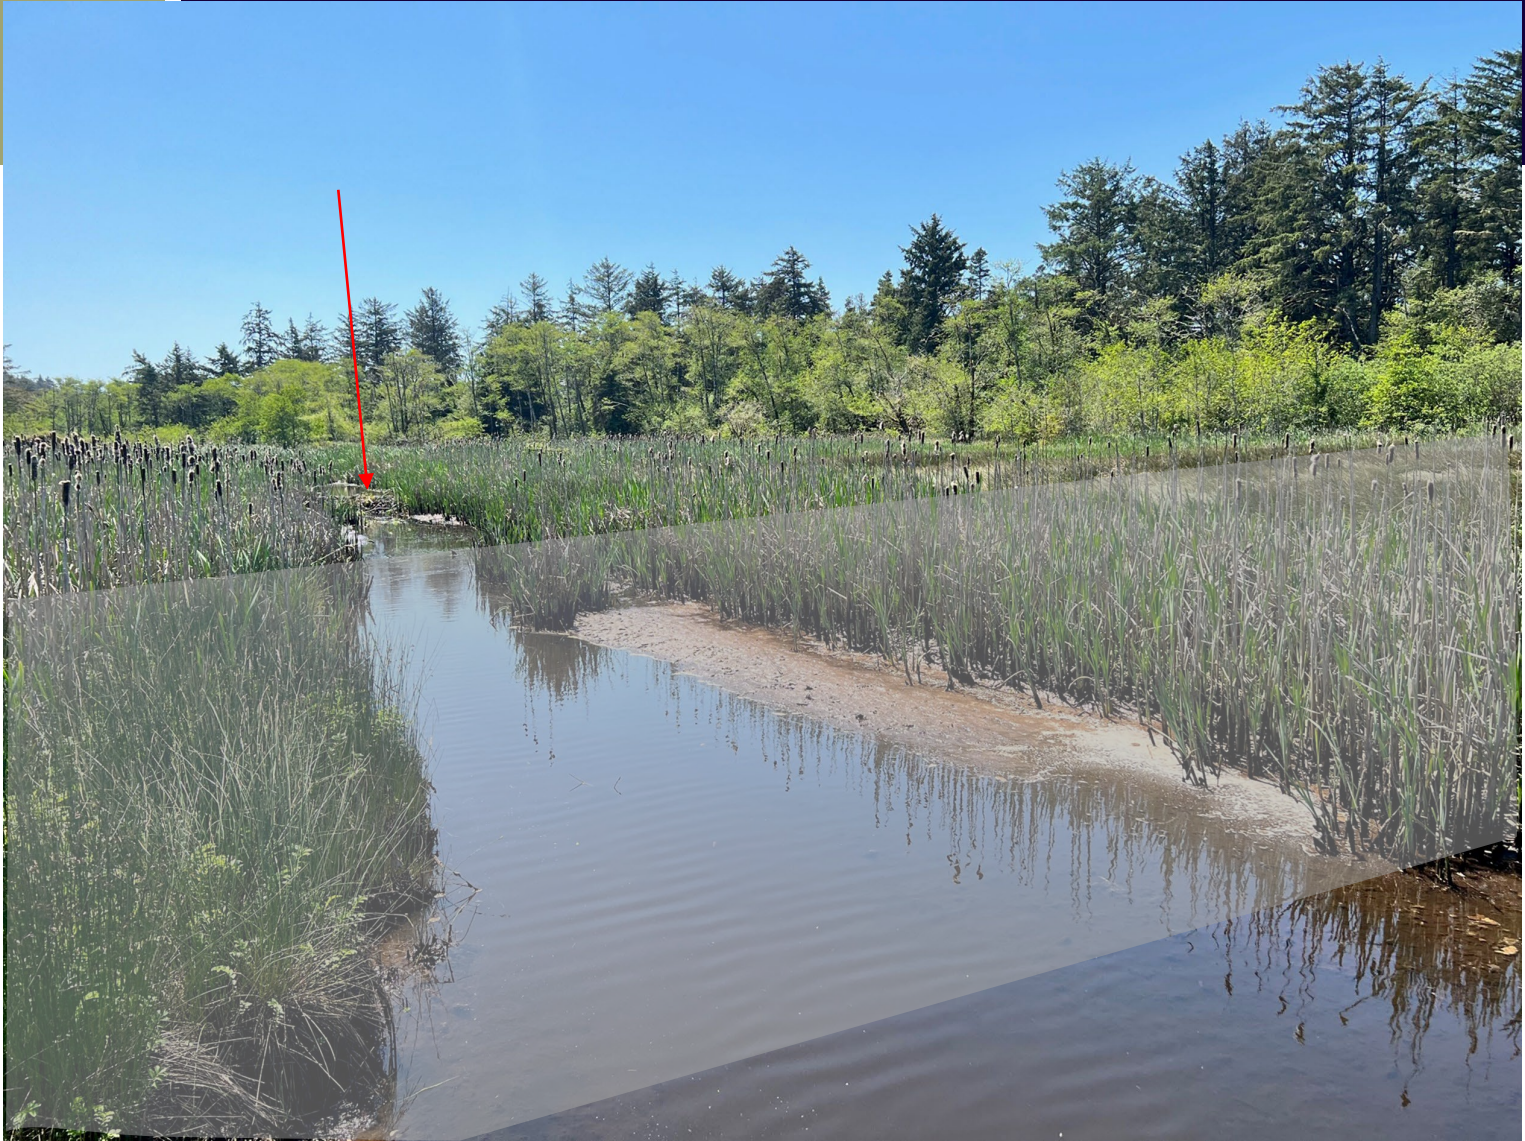
- Facing west, looking at East-to-west ditch. Potential setback dike alignment area. Active beaver lodge to the south of ditch

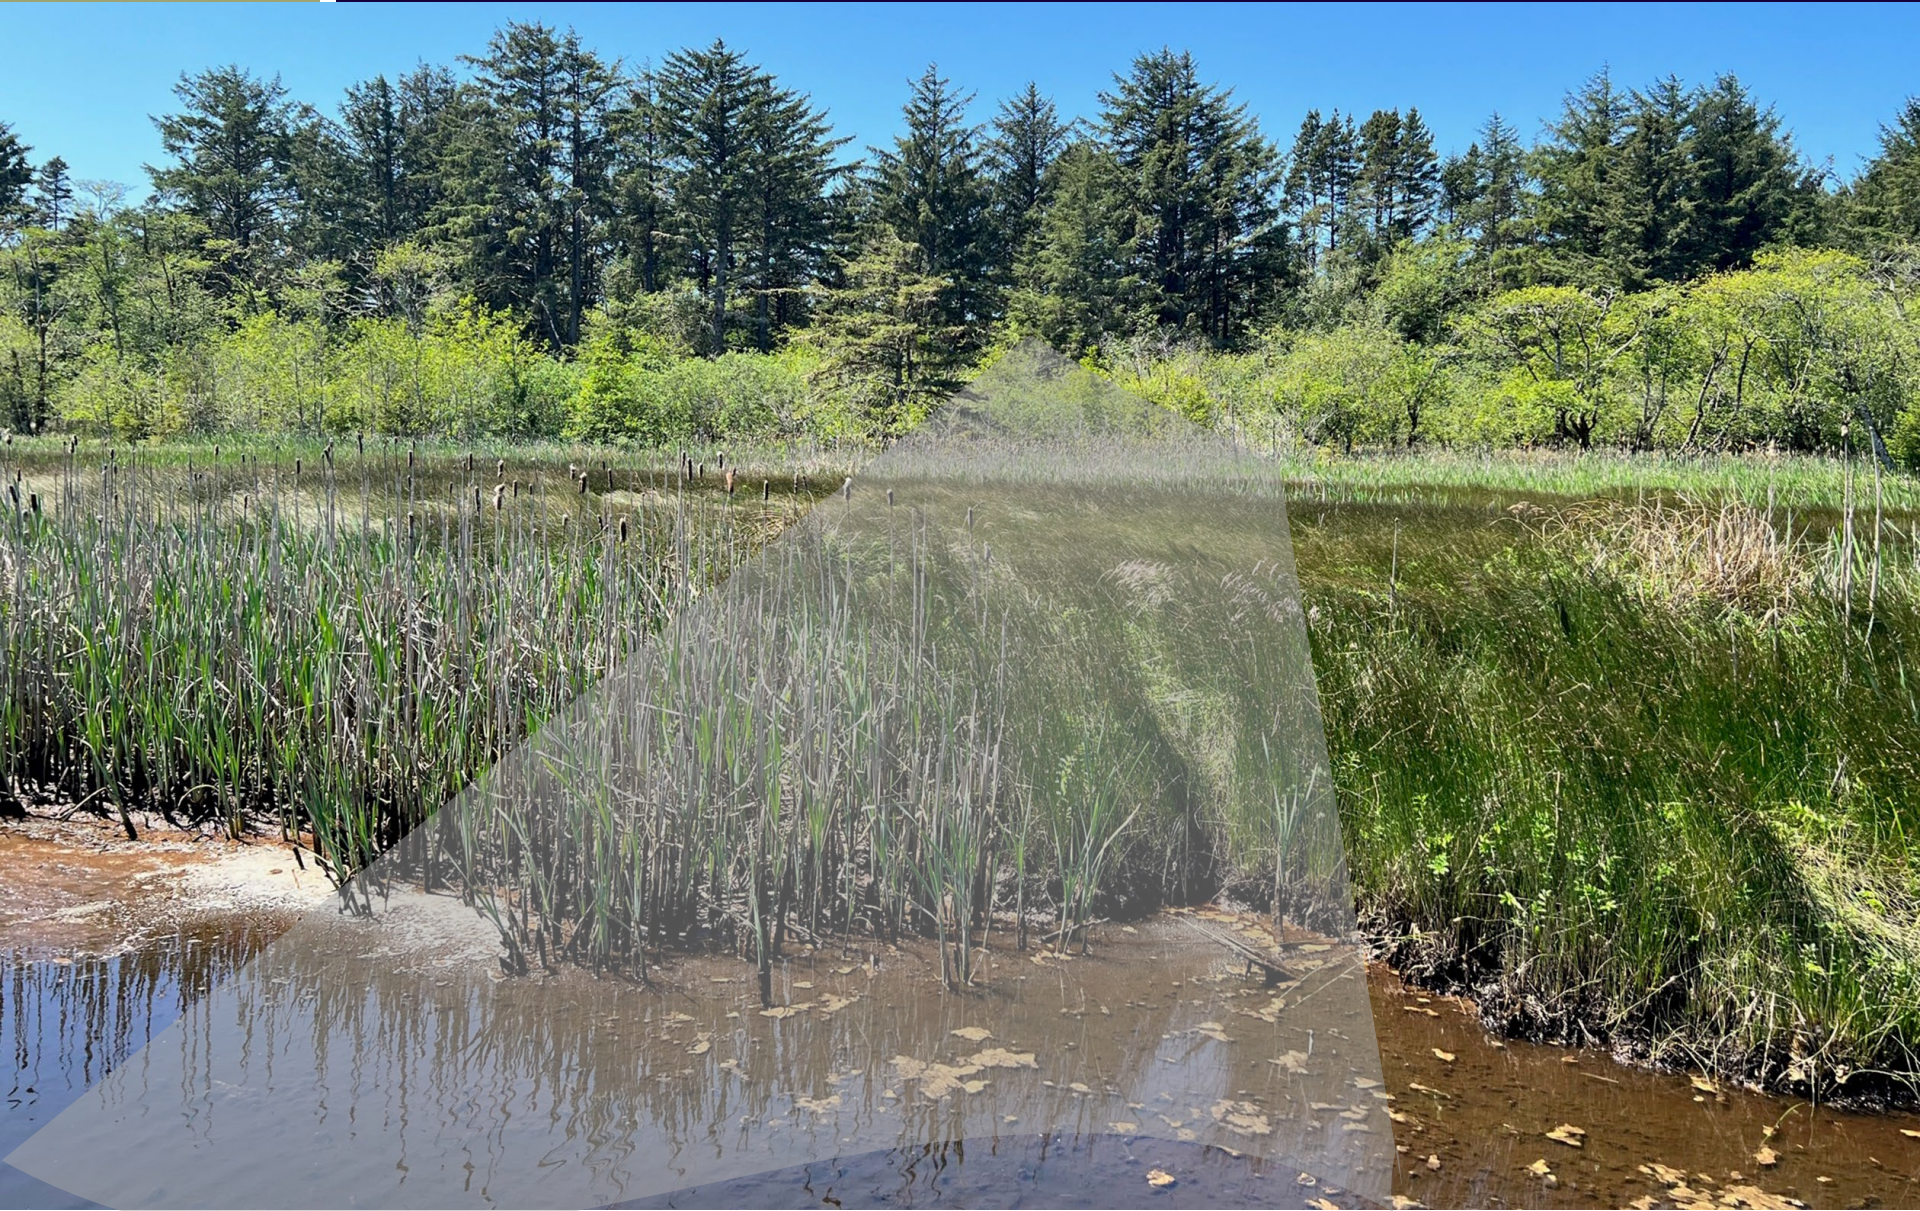
■ Facing west towards forested dune to tie into
