# Sitka Sedge Tidal Wetland Restoration: Alternatives Analysis & Hydraulic Modeling

Sitka Sedge Tidal Wetland Restoration Project – Townhall Meeting

June 17, 2023

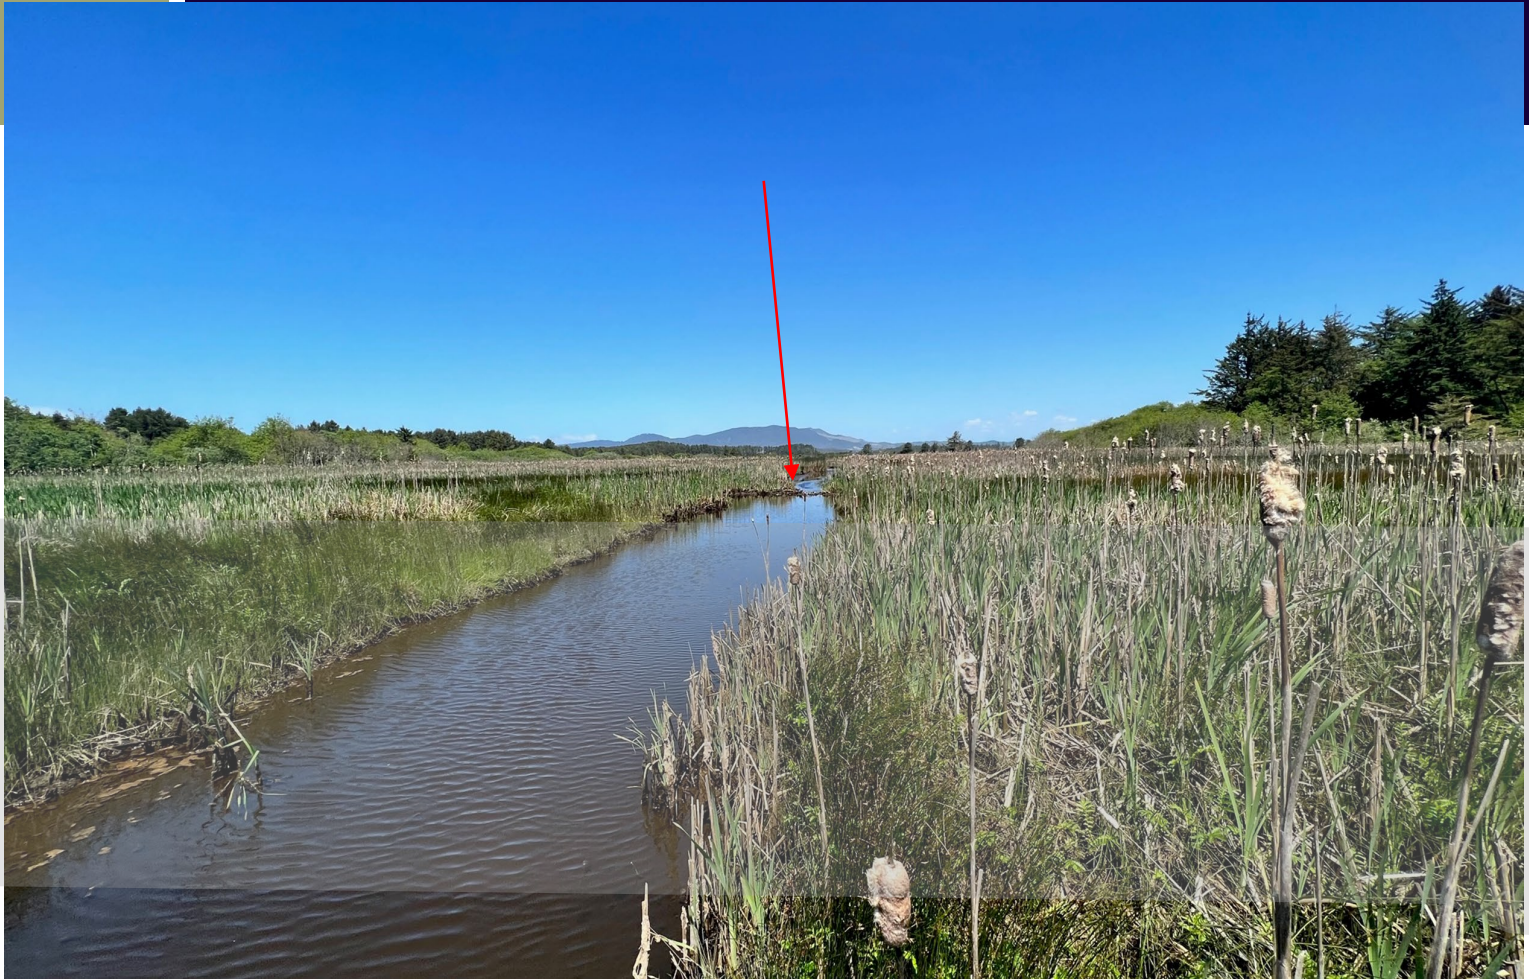
- Facing north along primary ditch. Smaller existing beaver dam downstream. Potential setback dike located between two existing dams

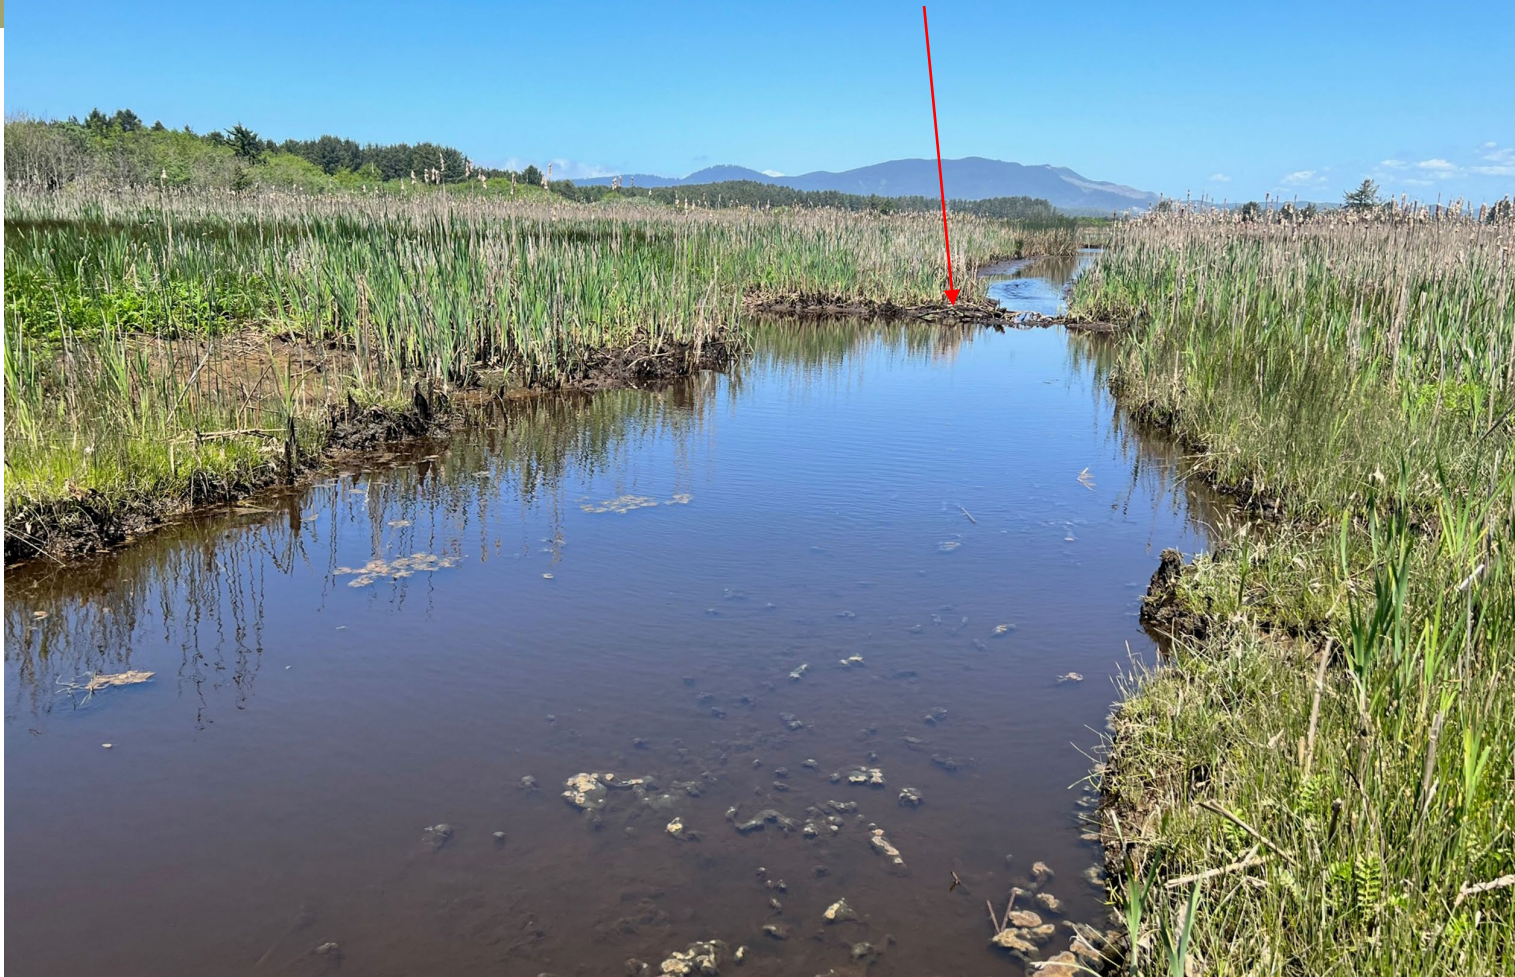
- Facing north/downstream along primary ditch. Smaller existing beaver dam downstream. Potential setback dike located between two existing dams

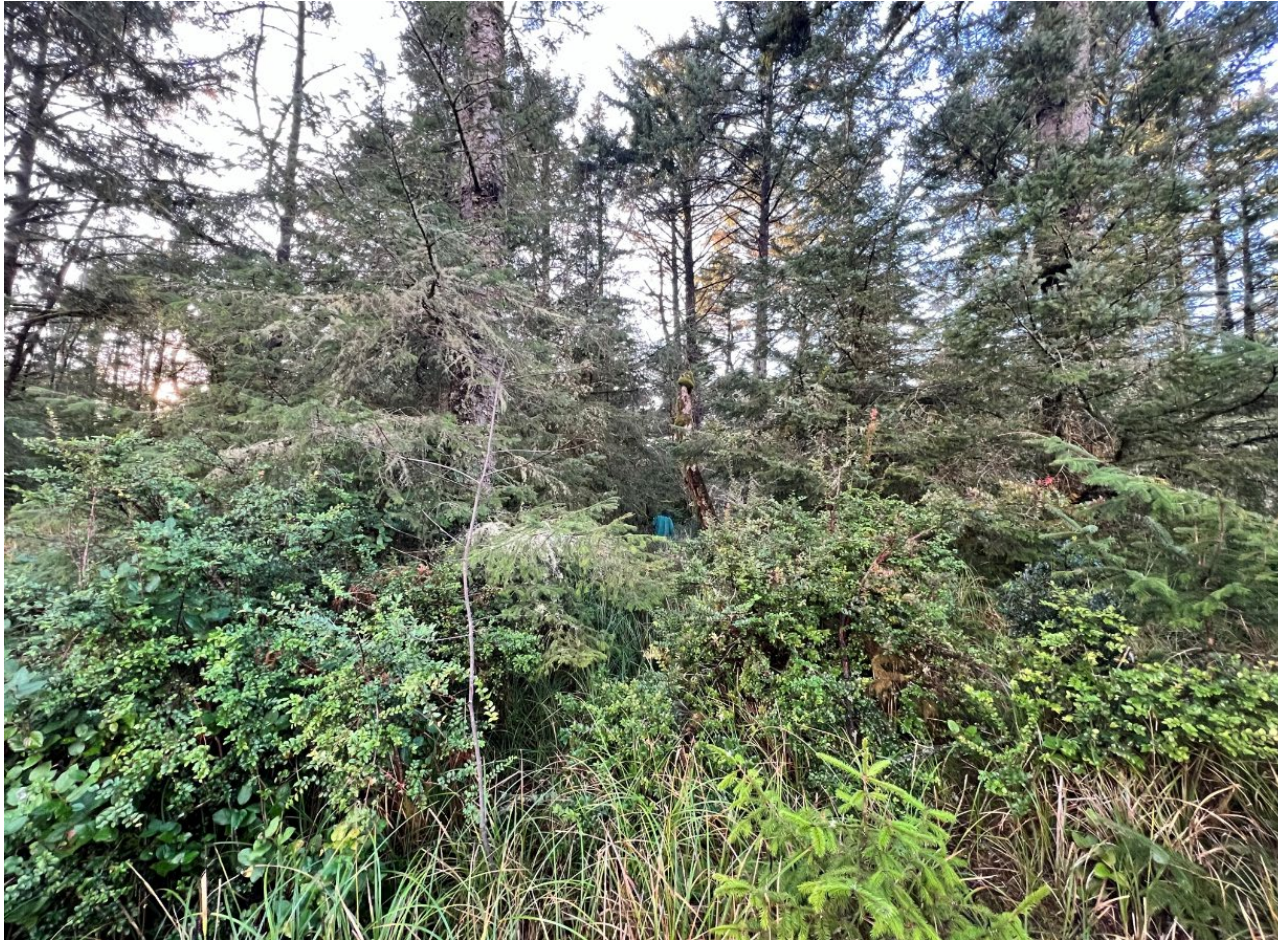
- Forested dune to tie into on west end of setback dike

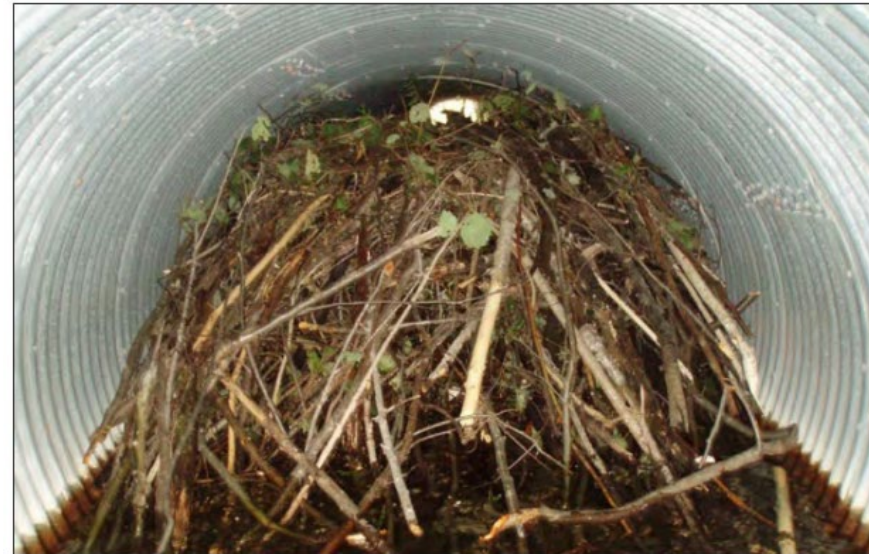
# Long-term Beaver Influence on Setback Dike, Culvert, and Tide Gate

- **Beavers will likely remain at Sitka Sedge after reconnection**
  - **Likely to maintain blockages in channel network**
  - **Assume potential dams throughout upper marsh to adjacent marsh elevation**
- **How will beavers behave around new setback dike's culvert and tide gate?**
  - **Beavers plug culverts when able and beneficial for their habitat (create ponded area)**
- **Drainage and flooding implications**
- **Maintenance implications**

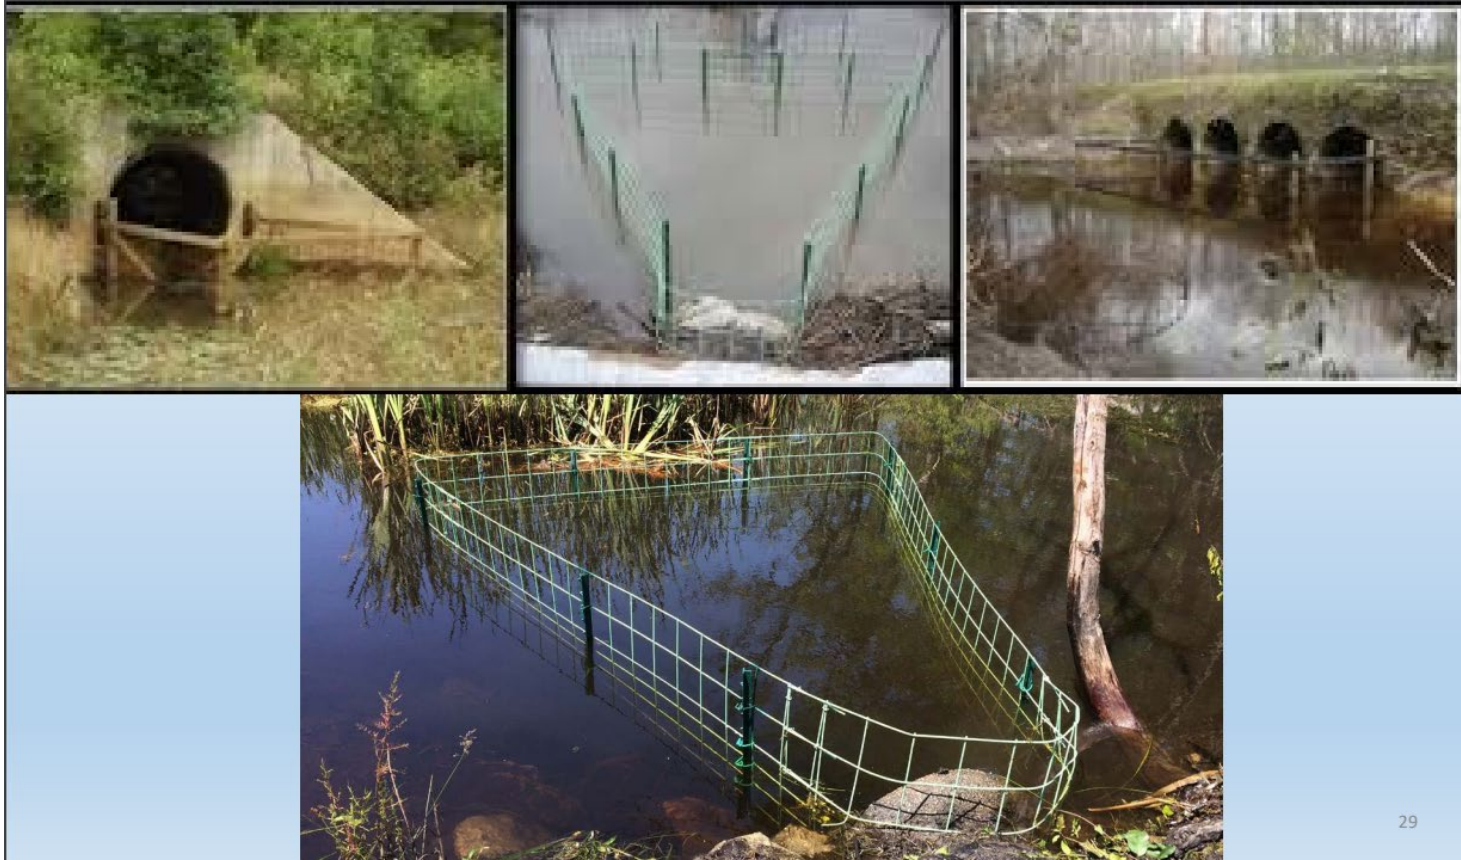
# Fish Passage Considerations with Beaver Exclusion Devices

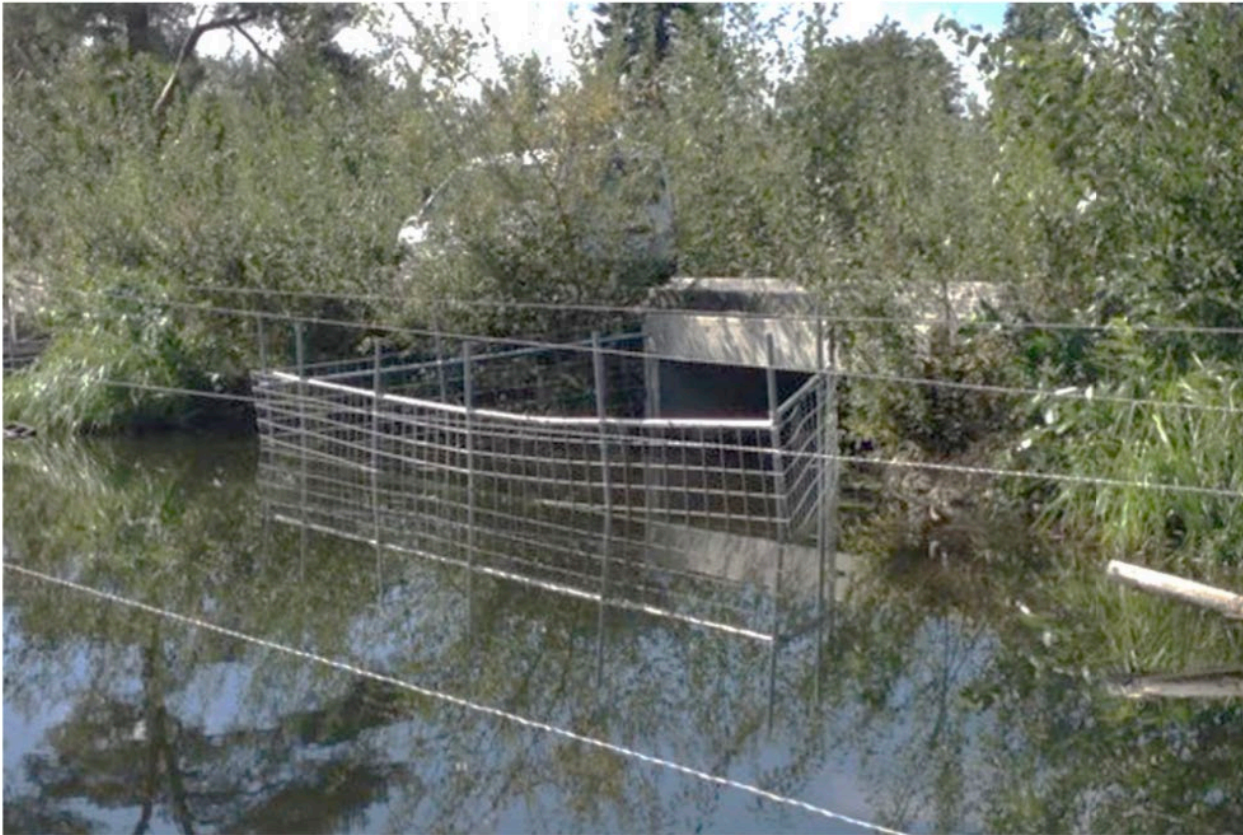
**Figure 3.** King County example: trapezoidal aquatic exclusionary fencing on box culvert inlet at Lower Stensland Creek.

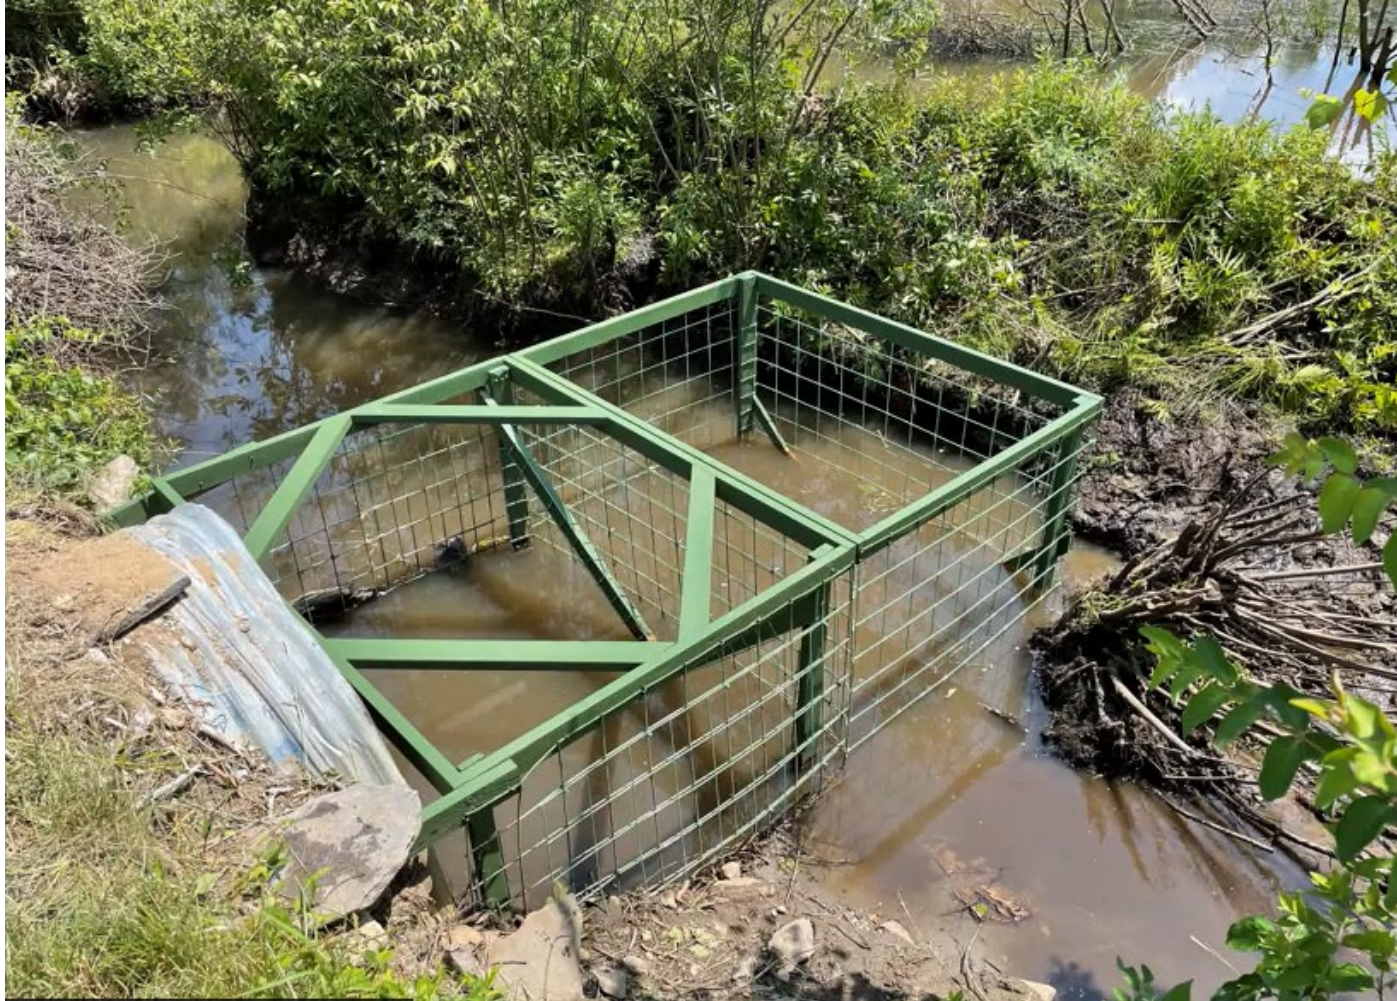
# Beaver Deceiver/Exclusion devices

- Select exact location relative to existing dam and lodge, pinch points
- Culvert/Channel Features to Make it Harder to Dam:
  - Wider Culvert, minimum 10' wide
  - Over widen and deepen channel at inlet/outlet (min 3' deep at low water, deeper around tide gate to avoid interference with opening/closing)
  - Concrete Bottom/No substrate
- Beaver Exclusion (Beaver Deceiver/fencing)
- Allow/encourage damming where acceptable
- Beaver removal (conflicts with habitat goals, not permanent)

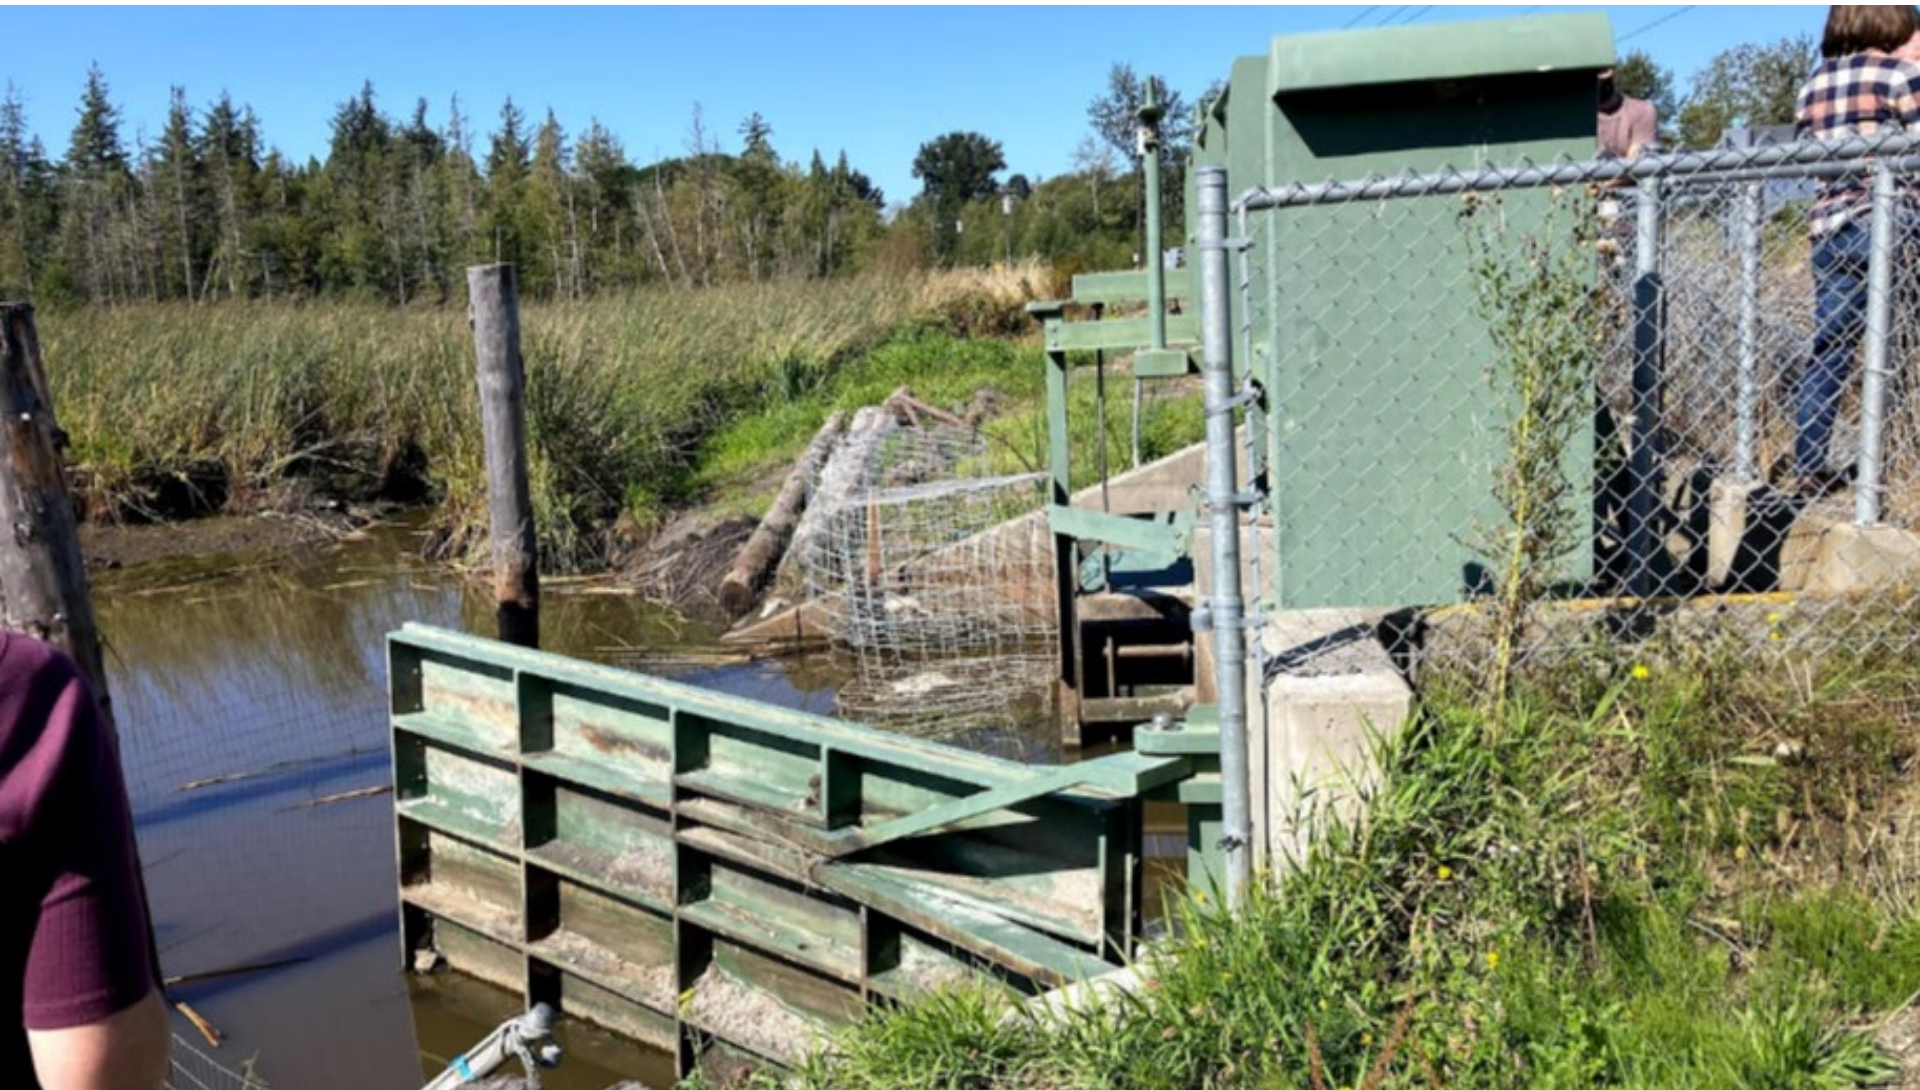
# Smuggler's Slough Tide Gate Lummi Nation – Bellingham, WA

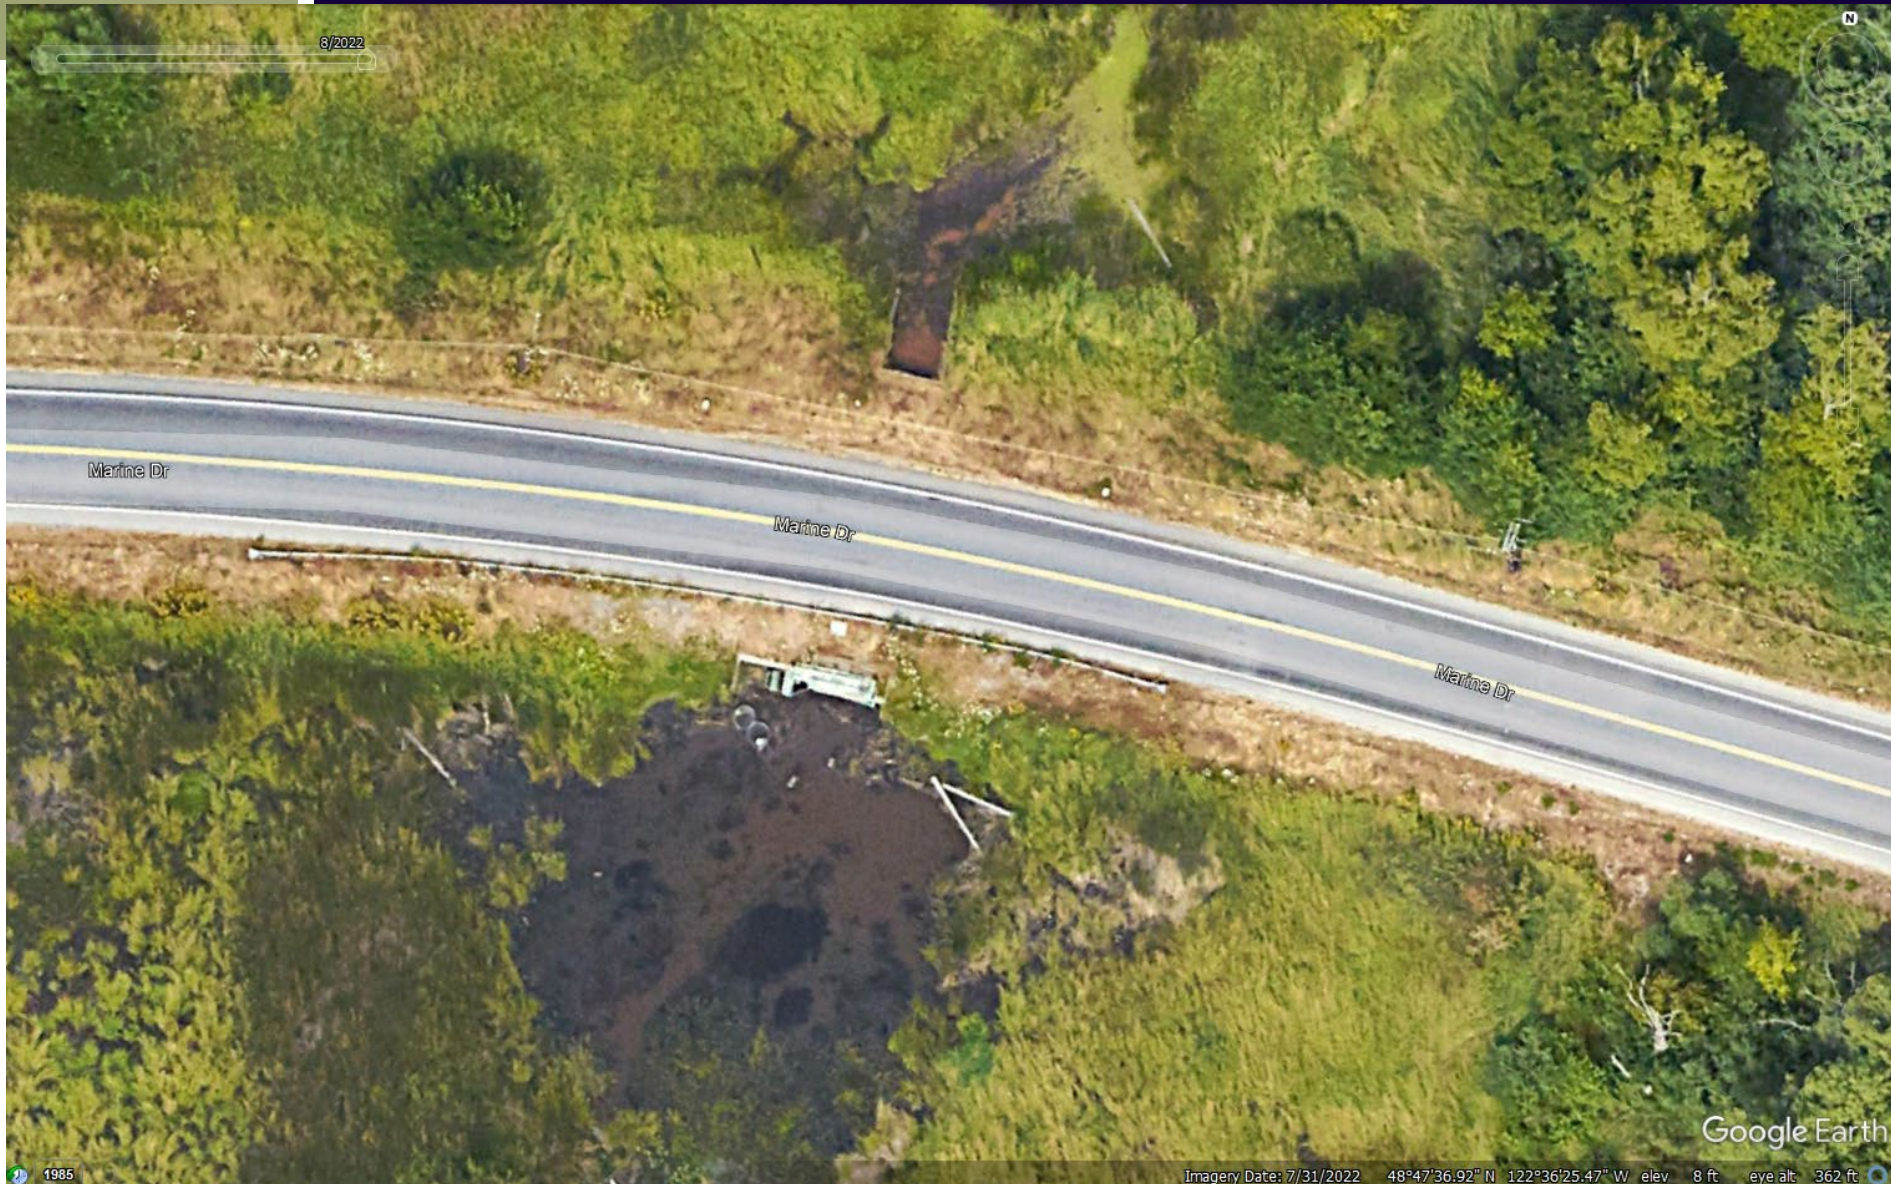
# Smuggler's Slough Tide Gate Lummi Nation – Bellingham, WA

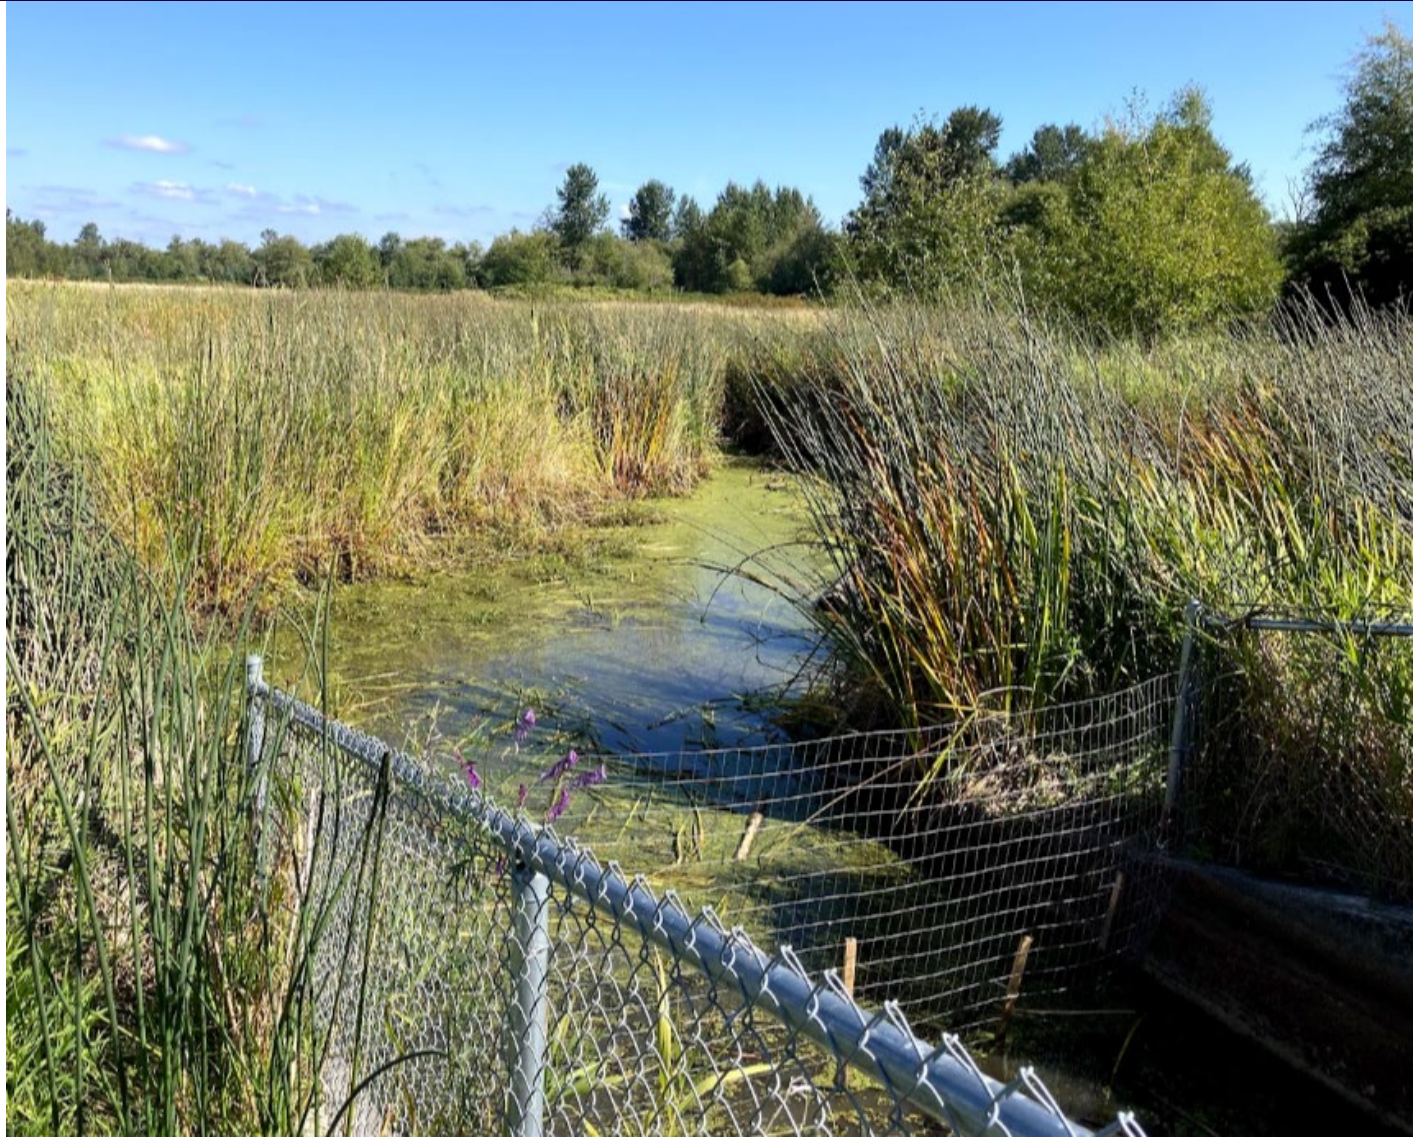
# Smuggler's Slough Tide Gate Lummi Nation – Bellingham, WA

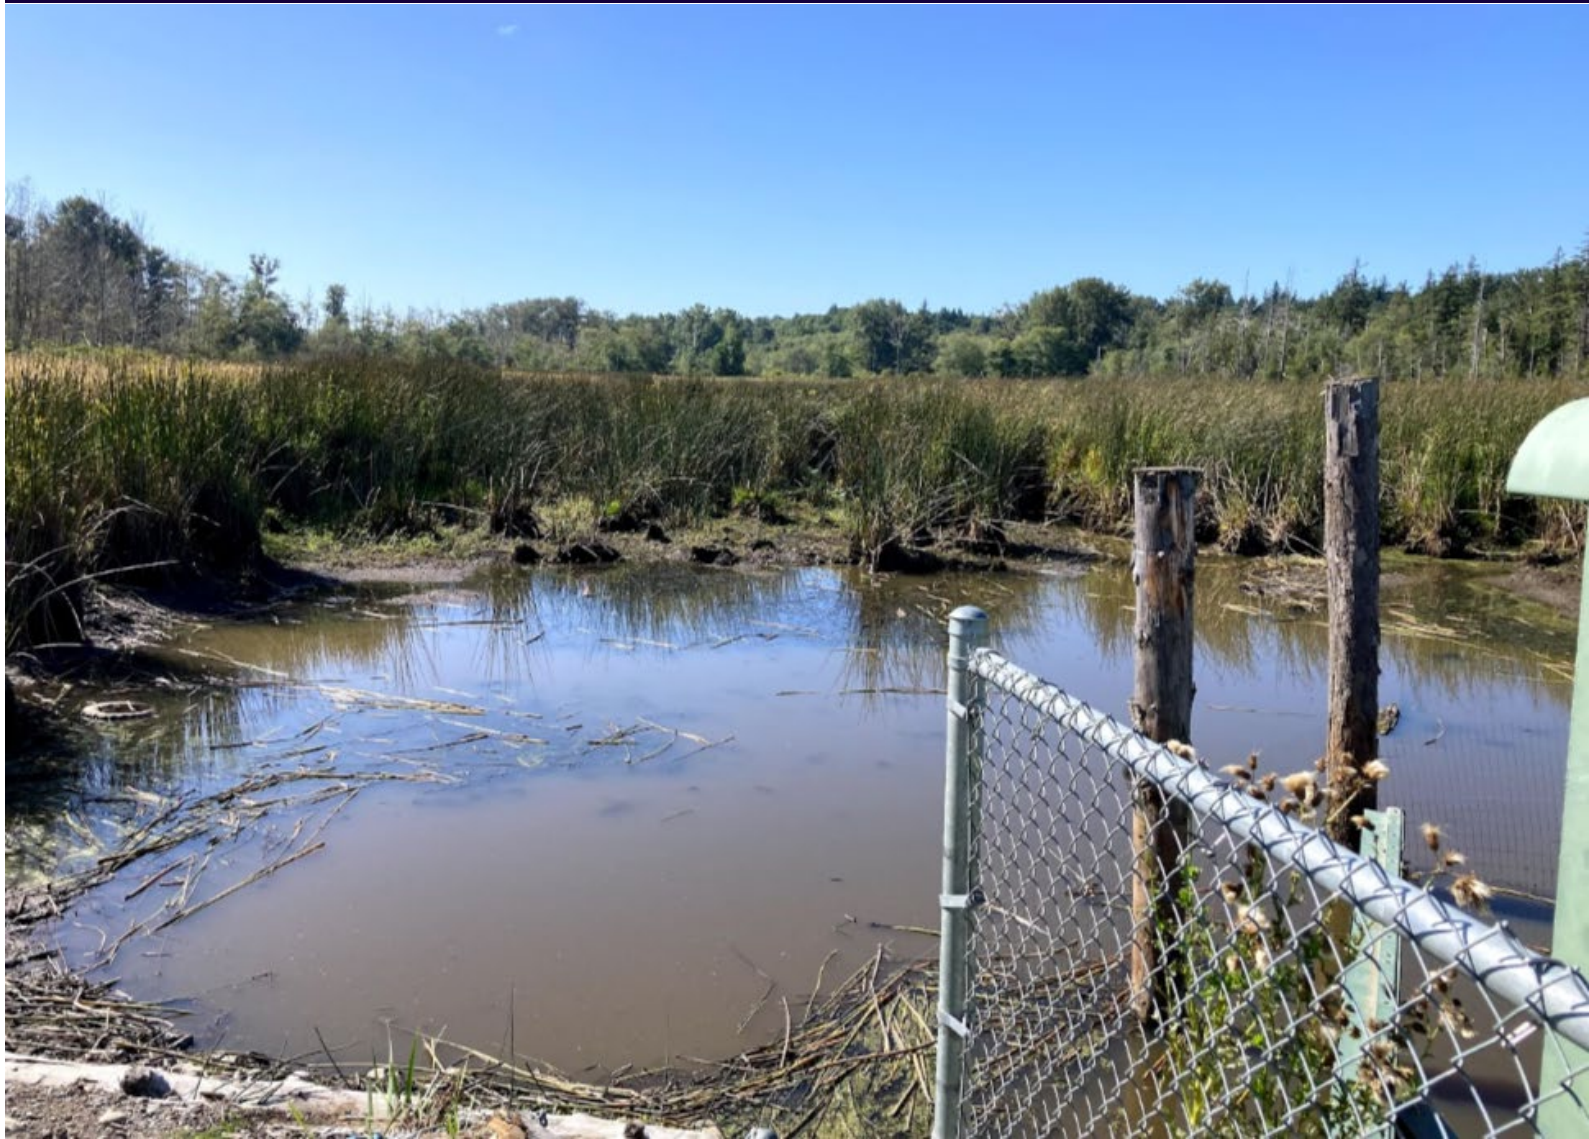
# Smuggler's Slough Tide Gate Lummi Nation – Bellingham, WA

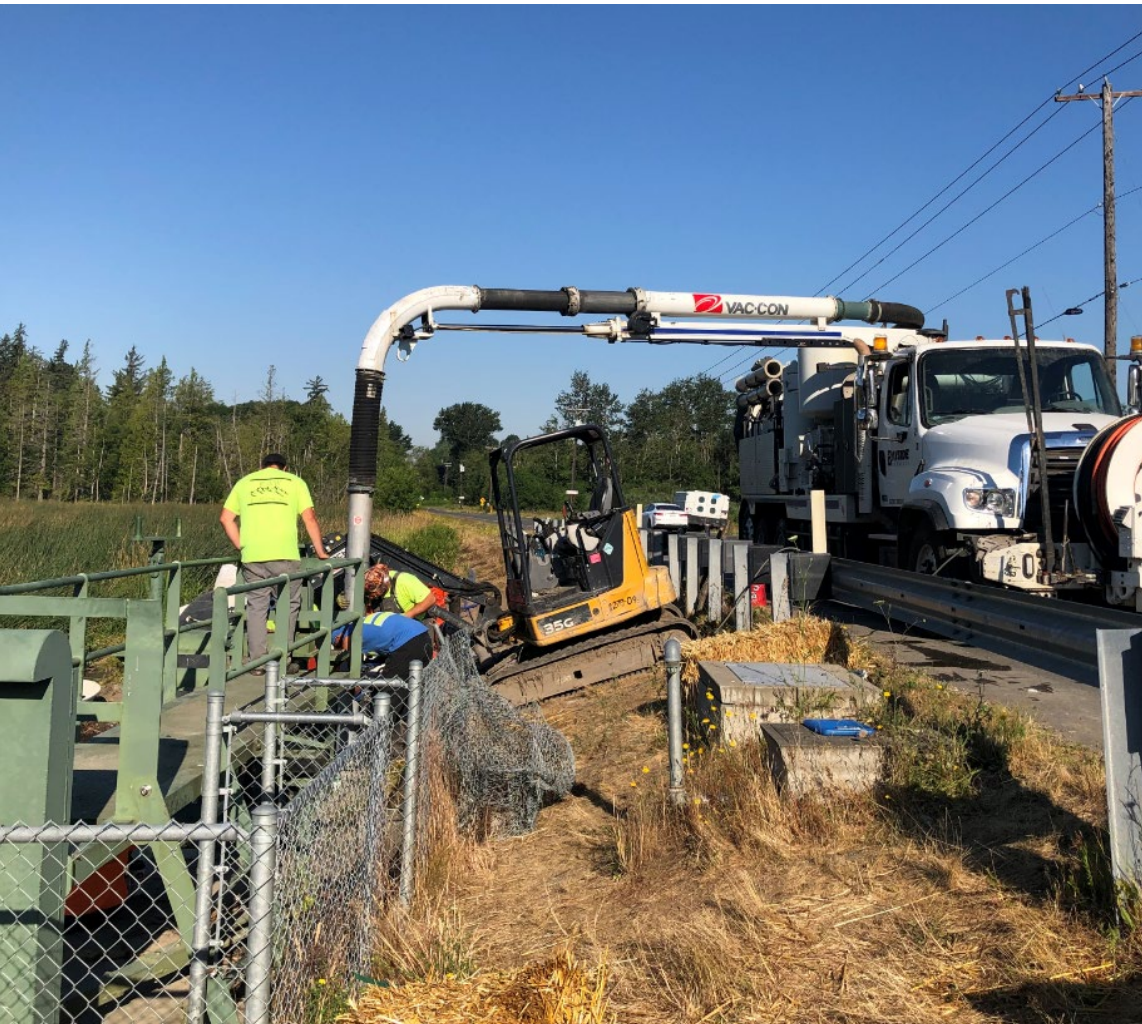
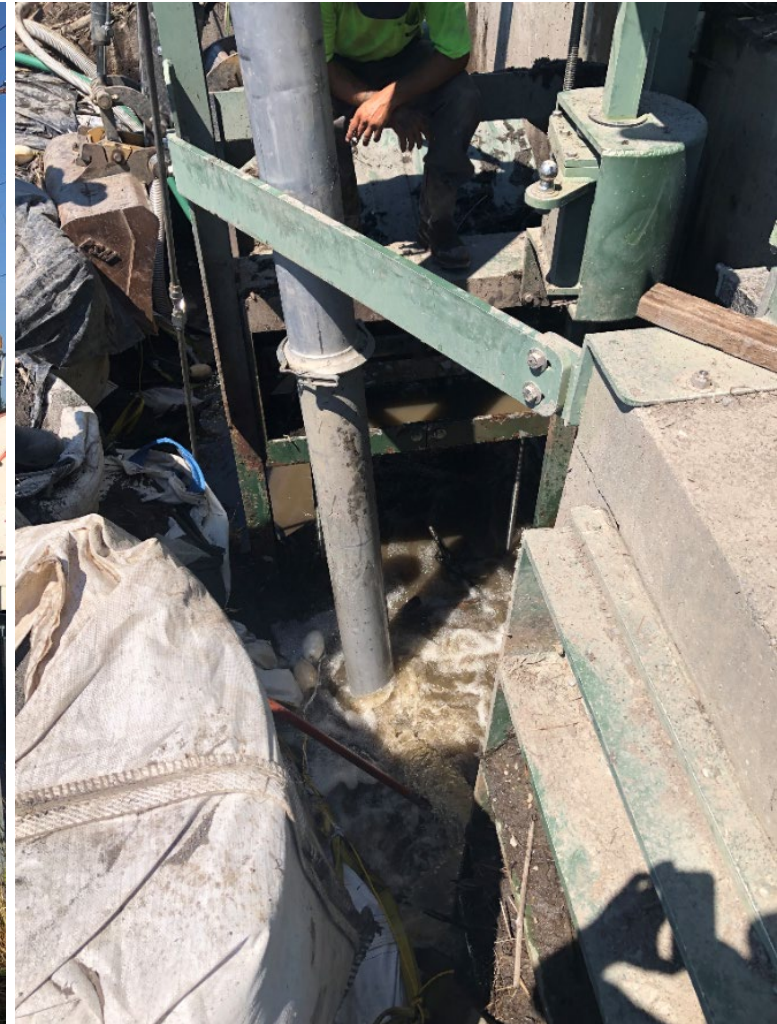
# Smuggler's Slough Tide Gate Lummi Nation – Bellingham, WA
