1. SUMMARY

This Drill Break Avoidance Plan details the plan for avoiding horizontal directional drill (HDD) break incidents in connection with the Jupiter subsea cable construction project on Lot 3200, Tierra Del Mar, Tillamook County, Oregon, and incorporates the lessons learned from the work carried out Lot 3200 during construction in 2020. This Plan establishes improved procedures to ensure the successful completion of the HDD work when construction recommences in January 2021. This Drill Break Avoidance Plan may be revised as the 2020 geotechnical data is further analyzed or as feedback is received from stakeholder agencies.

3. DRILL BREAK AVOIDANCE PLAN UPON HDD RECOMMENCEMENT IN 2021

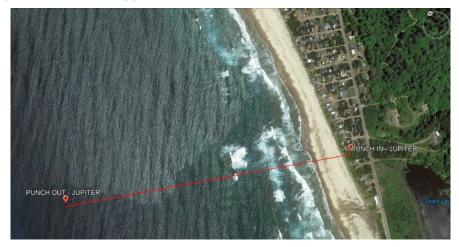
Figure 1: Project Location Map

One (1) steel conduit will be installed by HDD from Lot 3200 to an off-shore Punch-out Location (POL) and will be used as a long-lasting protective conduit for the Jupiter fiber optic cable as it traverses from the POL to the Beach Manhole (BMH) installed on Lot 3200. The map below shows the approximate location of the POL, BMH and the HDD.
