Restoring Willanch Creek

25 Years of Cooperation Benefiting Salmon

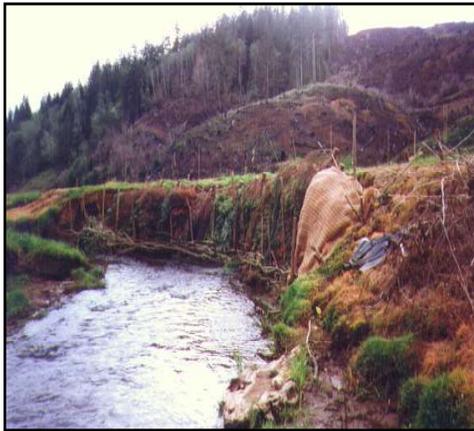
Willow wall construction helped to shade the stream and lower the water temperature. (Photo taken in 1997.)

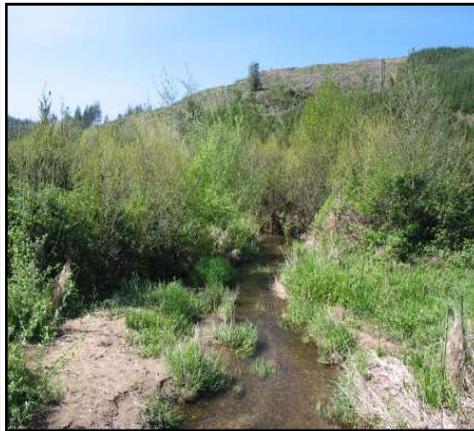
Riparian vegetation growing in Lower Valley assisted the 10°F drop in stream temperature. (Photo taken in 2004.)

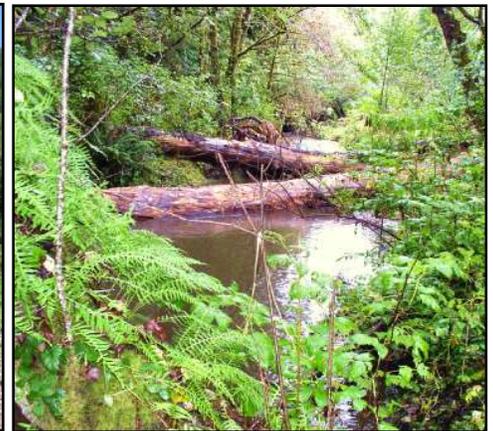
Large wood placed in Willanch Creek in 2004 aided in enhancing stream complexity.

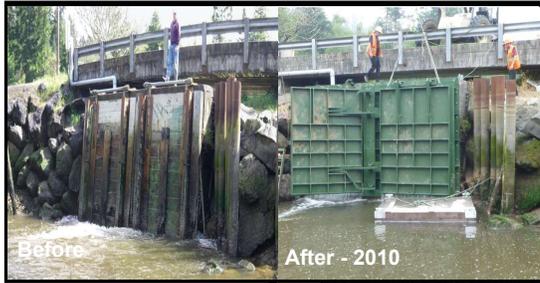
New tide gate at the mouth of Willanch Creek, summer 2010.

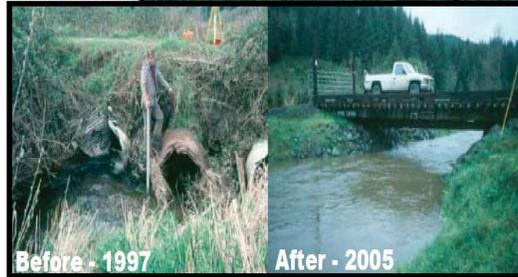
Blocked culverts replaced with a railcar bridge to allow water to flow freely.
