CALIFORNIA ENERGY COMPANY INC.

MAZAMA PROSPECT

LITHOLOGY of CORE

from 575 to 1354 feet

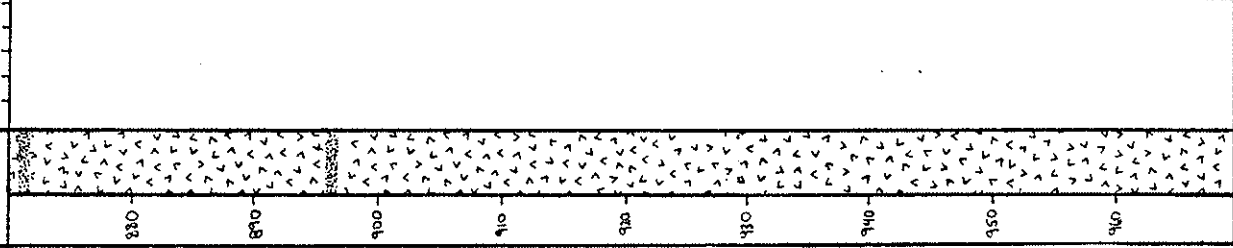
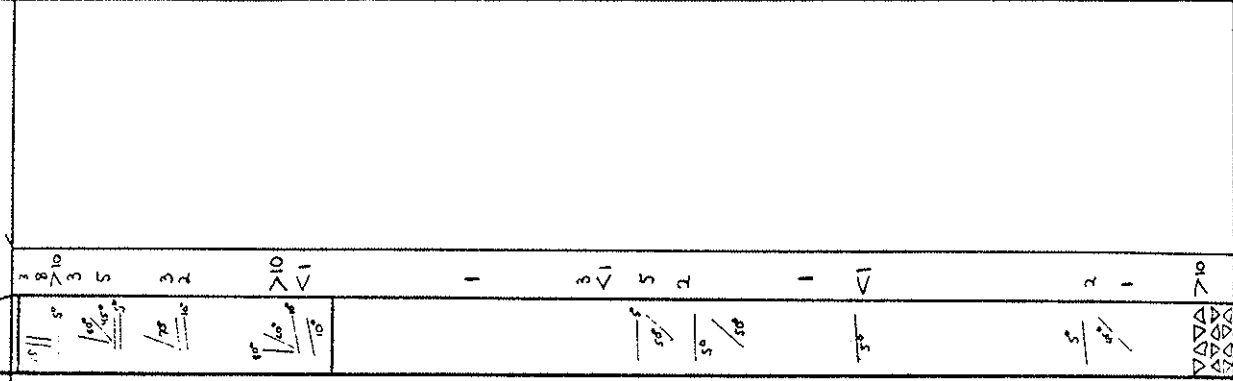
DEPTH FT.	LITHOLOGIC DESCRIPTION	RECOVERY %	FRACTURE ANGLE FRACTURE DENSITY	COMMENTS
	<p>875-882 ft. Predominately vertical fractures coated with thin dark green sheared clay. The fractures cross-cut calcite veins.</p> <p>890-892.5 ft. Fractured and brecciated zone containing minor white clay, calcite, and clear tabular zeolite (chabazite?). These fractures cross-cut earlier formed veins of calcite and pyrite. The rock surrounding this brecciated zone is strongly altered to clay.</p> <p>900-967 ft. Calcite bearing fractures. A few fracture surfaces contain a very thin zone of slickenside-like sheared rock. Occasional calcite bearing fractures show a dark green clay alteration adjacent to the rock.</p> <p>967-971 ft. Brecciated zone with a pervasive light green-gray clay alteration of the rock. Minor white clay and traces of a clear tabular zeolite (chabazite?) have formed on some of the fracture surfaces.</p>	<p>90 80 70 60 50</p>

<p> $\frac{3}{15}$ $\frac{8}{5}$ $\frac{10}{3}$ $\frac{3}{10}$ $\frac{5}{10}$ $\frac{3}{10}$ $\frac{2}{10}$ $\frac{10}{10}$ $\frac{10}{10}$ $\frac{1}{10}$ $\frac{3}{10}$ $\frac{1}{10}$ $\frac{5}{10}$ $\frac{2}{10}$ $\frac{1}{10}$ $\frac{2}{10}$ $\frac{1}{10}$ $\frac{10}{10}$ </p>

<p>** 871 ft. The core contains an 8 inch thick section of soft dark gray clay-like material with sharp upper and lower boundaries. This appears to be an artifact of drilling. When viewed through a microscope it appears to be made up of finely ground rock containing fine fresh feldspar fragments.</p> <p>897 ft. Probable drilling artifact, see comment at 871 ft.</p> <p>910-1002 ft. General increase in pervasive alteration of dacite to light green-gray clay and dark green clay, chlorite, and calcite.</p>
