Oregon Seismic Status Report - 2019

JENNIFER EGGERS, ASSOCIATE/PROJECT MANAGER
NATHAN INGRAFFEA, PRINCIPAL
KPFF CONSULTING ENGINEERS
111 SW FIFTH AVENUE, SUITE 2500
PORTLAND, OR 97204-3628

SEISMIC ASSESSMENTS FOR THE BEAVERTON SCHOOL DISTRICT

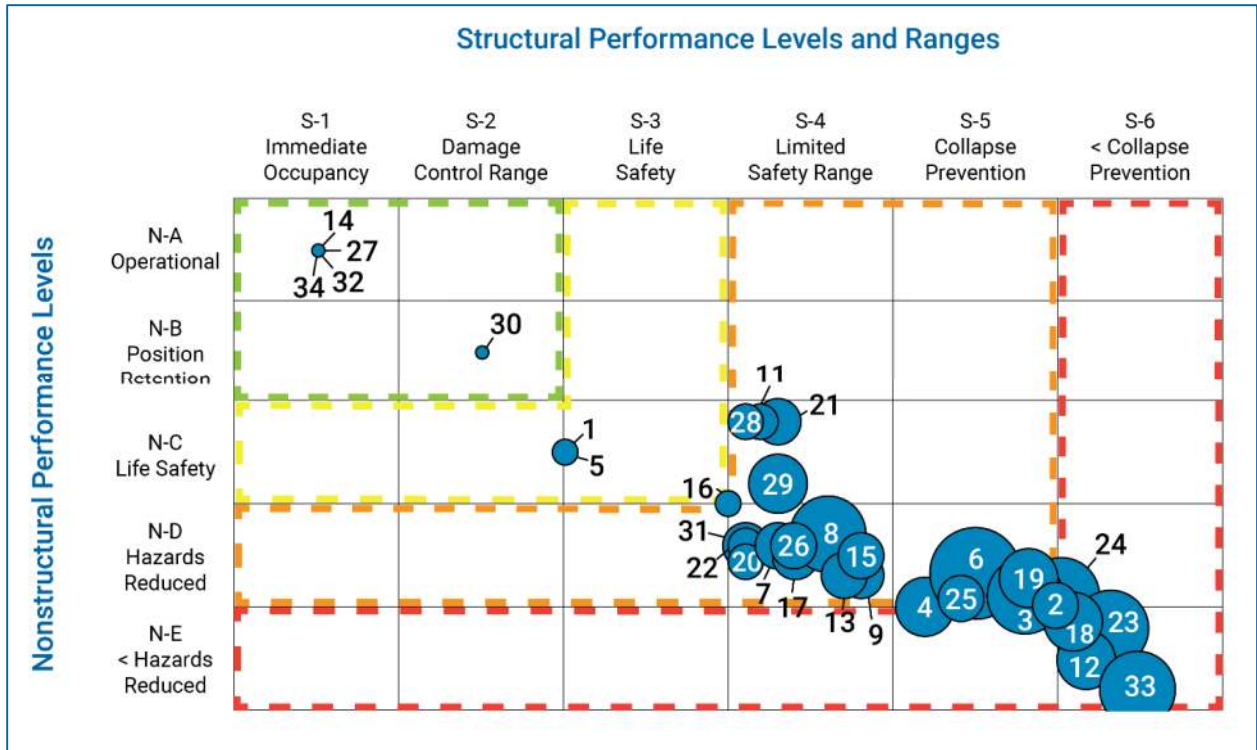
**FIGURE 5: ELEMENTARY SCHOOLS
STRUCTURAL VS. NONSTRUCTURAL VS. PROBABLE COST**

TYPE	#	Facility Name	Structural Score	Nonstructural Score	\$/SF to get to District's Goal
ELEMENTARY SCHOOLS	01	Aloha-Huber Park (K-8)	80	75	5
	02	Barnes	51	61	25
	03	Beaver Acres	52	61	45
	04	Bethany	58	60	35
	05	Bonny Slope	80	75	5
	06	Cedar Mill	55	63	55
	07	Chehalem	67	66	25
	08	Cooper Mountain	64	67	45
	09	Elmonica	62	63	25
	10	Errol Hassell	65	63	25
	11	Findley	68	78	15
	12	Fir Grove	48	55	35
	13	Greenway	63	63	25
	14	Hazeldale	95	95	0
	15	Hiteon	62	65	25
	16	Jacob Wismer	70	70	5
	17	Kinnaman	66	65	25
	18	McKay	49	59	35
	19	McKinley	52	62	35
	20	Montclair	69	65	15
	21	Nancy Ryles	67	78	25
	22	Oak Hills	69	66	15
	23	Raleigh Hills (K-8)	47	58	45
	24	Raleigh Park	50	61	45
	25	Ridgewood	56	61	25
	26	Rock Creek	66	66	25
	27	Sato	95	95	0
	28	Scholls Heights	69	78	15
	29	Sexton Mountain	67	72	35
	30	Springville (K-8)	85	85	0
	31	Terra Linda	69	66	25
	32	Vose	95	95	0
	33	West Tualatin View	45	52	45
	34	William Walker	95	95	0

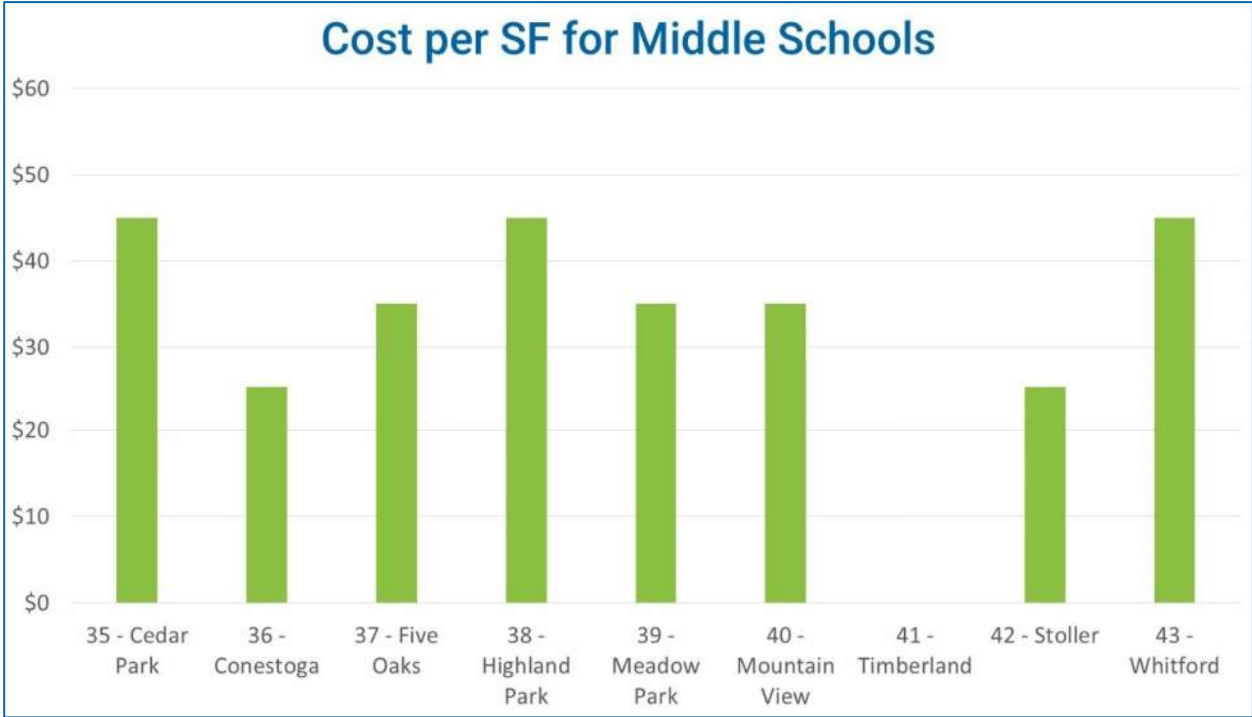
FIGURE 8: MIDDLE SCHOOLS PROBABLE COST

TYPE	#	Facility Name	Structural Score	Nonstructural Score	\$/SF to get to District's Goal
MIDDLE SCHOOLS	35	Cedar Park	50	65	45
	36	Conestoga	70	78	25
	37	Five Oaks	55	62	35
	38	Highland Park	50	65	45
	39	Meadow Park	54	65	35
	40	Mountain View	50	65	35
	41	Timberland	95	95	0
	42	Stoller	70	78	25
	43	Whitford	50	65	45

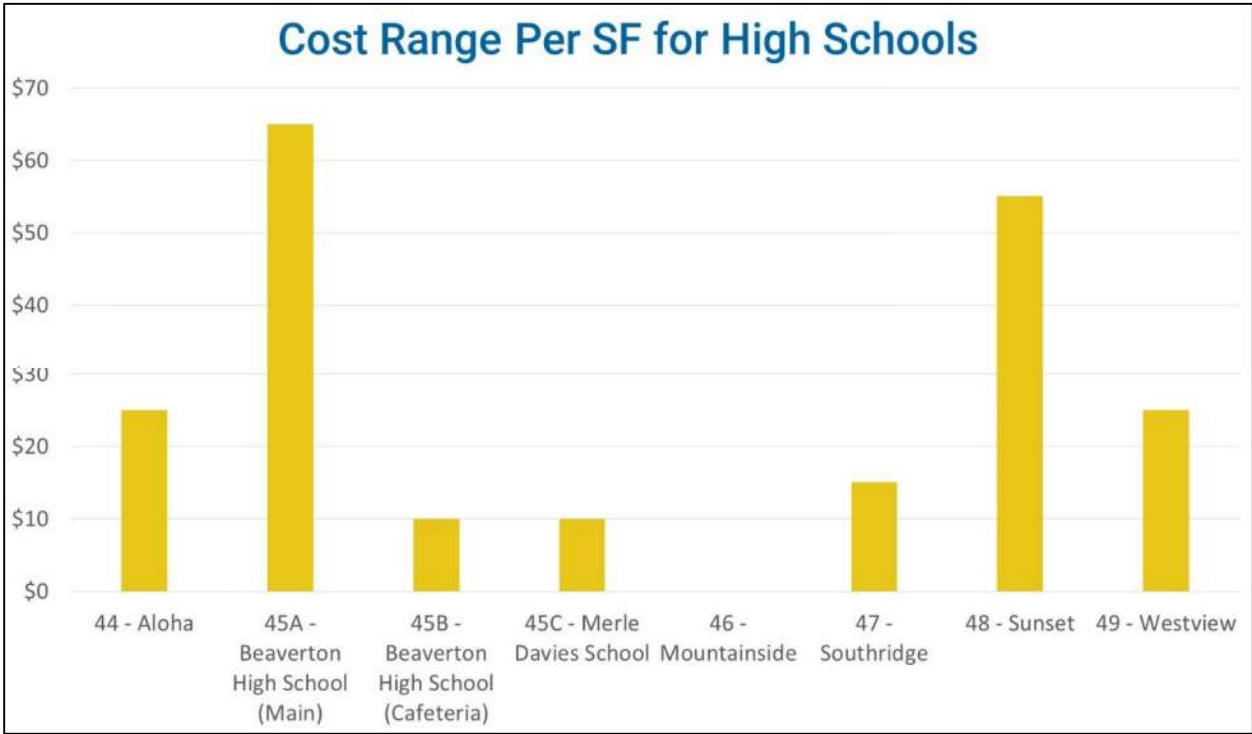
FIGURE 11: HIGH SCHOOLS PROBABLE COST

TYPE	#	Facility Name	Structural Score	Nonstructural Score	\$/SF to get to District's Goal
HIGH SCHOOLS	44A	Aloha	63	65	25
	45A	Beaverton High School (Main)	45	60	65
	45B	Beaverton High School (Cafeteria)	75	75	15
	45C	Merle Davies	69	69	15
	46	Mountainside	95	95	0
	47	Southridge	70	70	15
	48	Sunset	55	55	55
	49	Westview	68	68	25

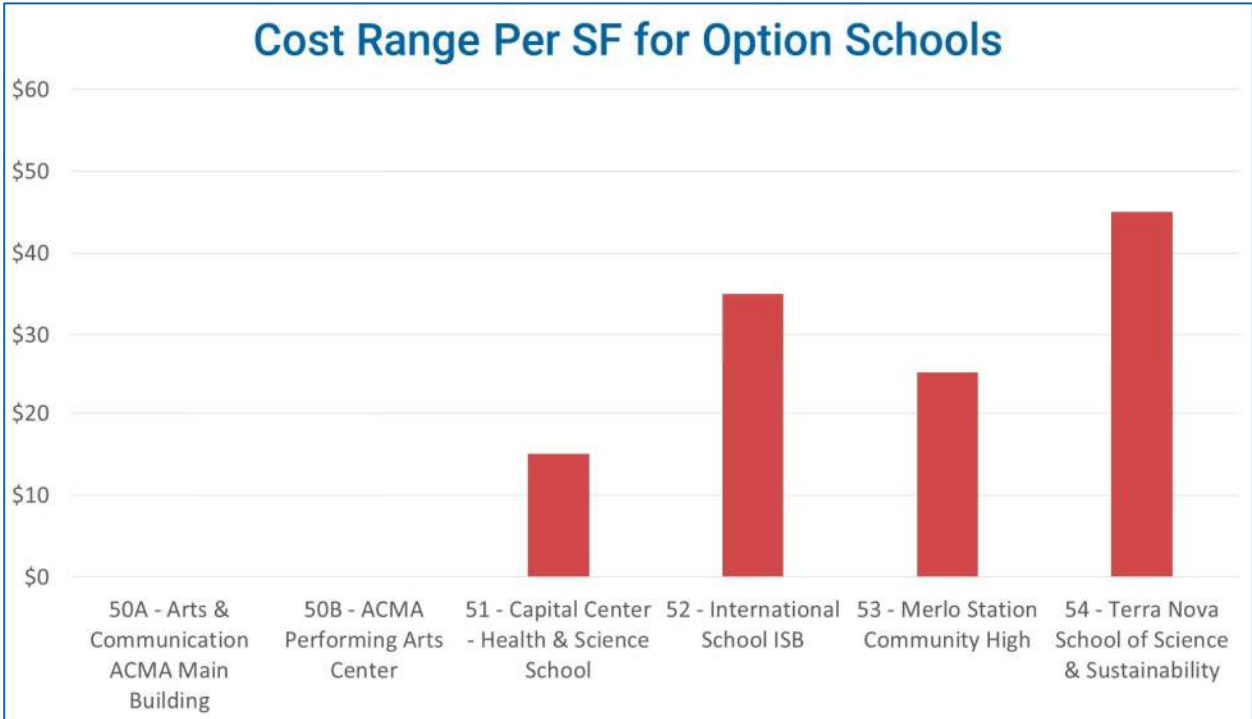
FIGURE 14: OPTION SCHOOLS PROBABLE COST

TYPE	#	Facility Name	Structural Score	Nonstructural Score	\$/SF to get to District's Goal
OPTION SCHOOLS	50A	Arts & Communication ACMA (Main Building)	95	95	0
	50B	ACMA (Performing Arts Building)	85	85	0
	51	Capital Center - Health & Science School	58	60	15
	52	International School ISB	48	58	35
	53	Merlo Station Community High	69	65	15
	54	Terra Nova School of Science & Sustainability	62	55	45

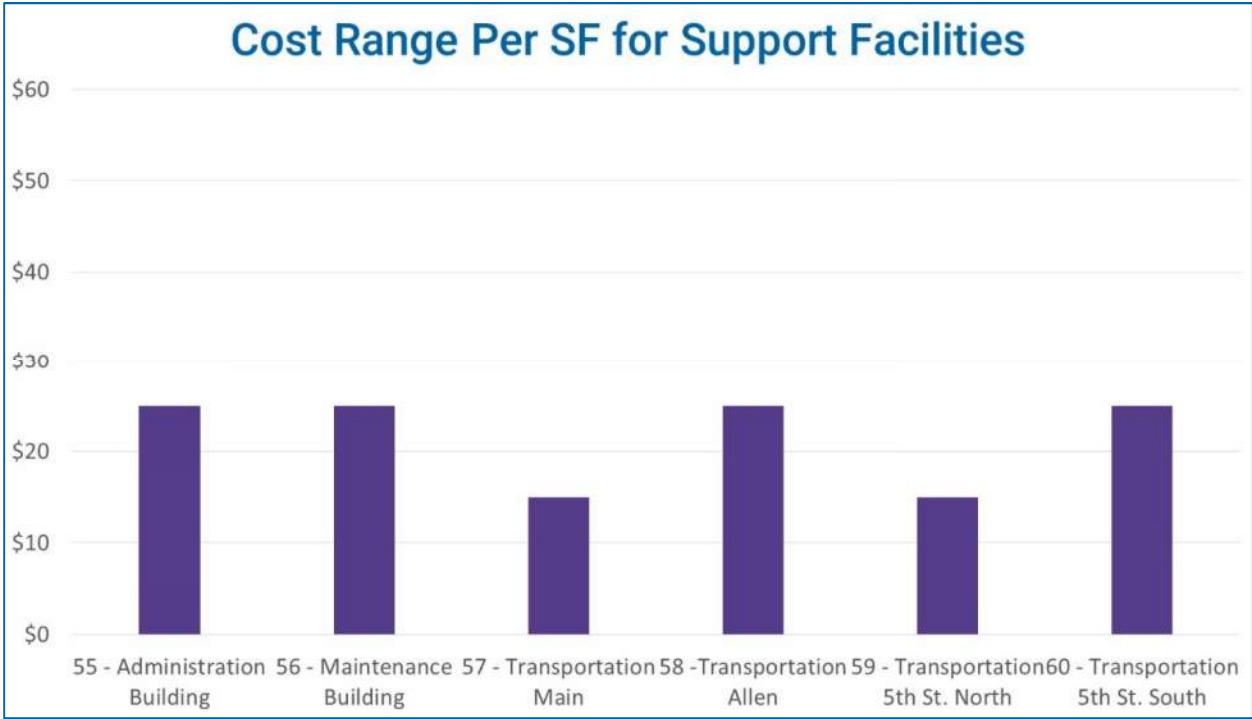
FIGURE 17: SUPPORT FACILITIES PROBABLE COST

TYPE	#	Facility Name	Structural Score	Nonstructural Score	\$/SF to get to District's Goal
SUPPORT FACILITIES	55	Administration Building	68	66	25
	56	Maintenance Building	67	60	25
	57	Transportation Main	67	61	15
	58	Transportation Allen	58	69	25
	59	Transportation 5th St. North	68	69	15
	60	Transportation 5th St. South	58	68	25

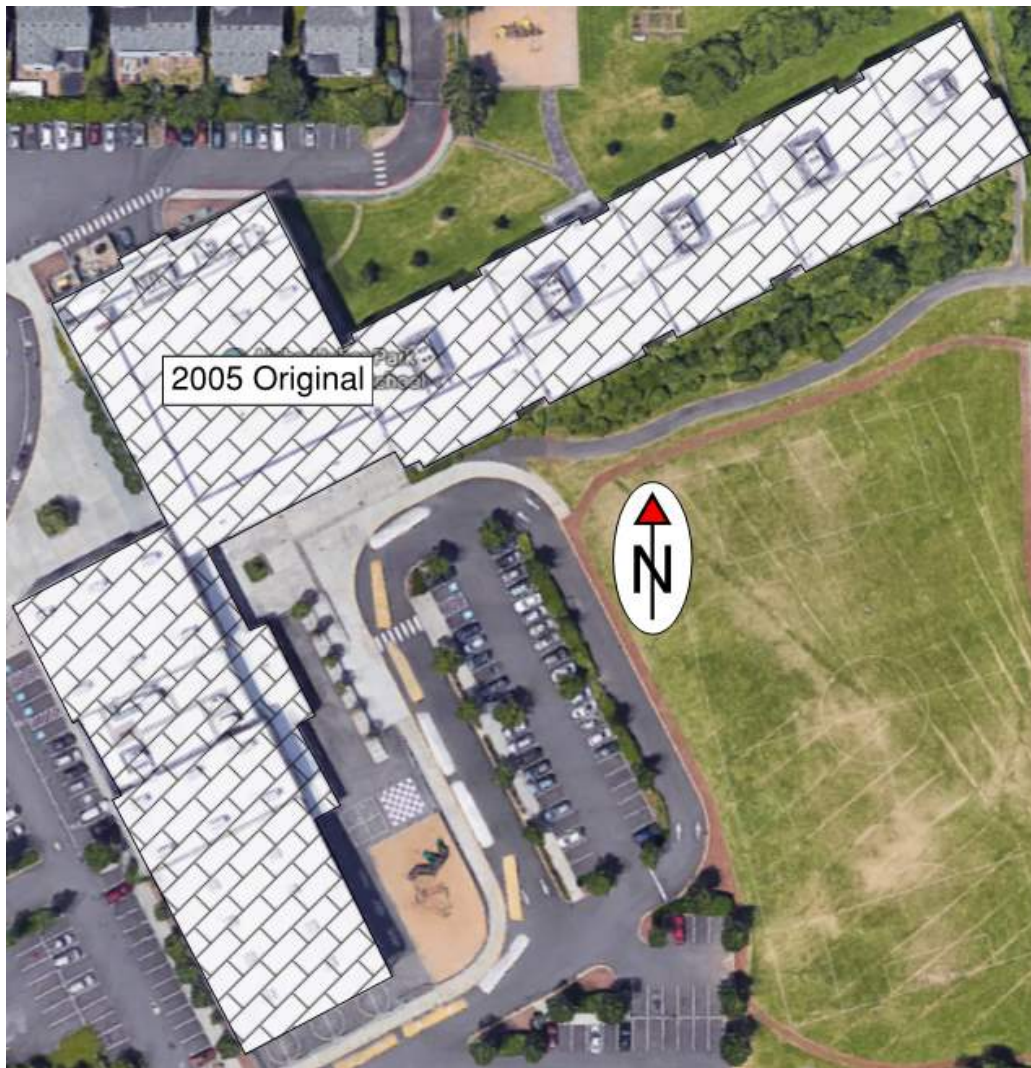
The 2005 school has two wings; the northern wing consists of an administration area, commons area, and classrooms across a two-story structure and the southern wing has a gymnasium and outdoor covered play area. Gravity elements are made up of steel framing with brick veneer at the northern wing. Reinforced masonry walls with steel roof joists support gravity loads at the gymnasium area. Foundations consist of reinforced concrete strip footings at the exterior and column footings at all interior and exterior columns. The floor system consists of a reinforced concrete slab-on-grade with connections back to foundations. The lateral force-resisting system consists of an SCBF system and reinforced masonry walls at each wing respectively. The roof diaphragm for each wing consists of normal and acoustical metal decking. The second floor diaphragm is composite metal deck with reinforced concrete topping.

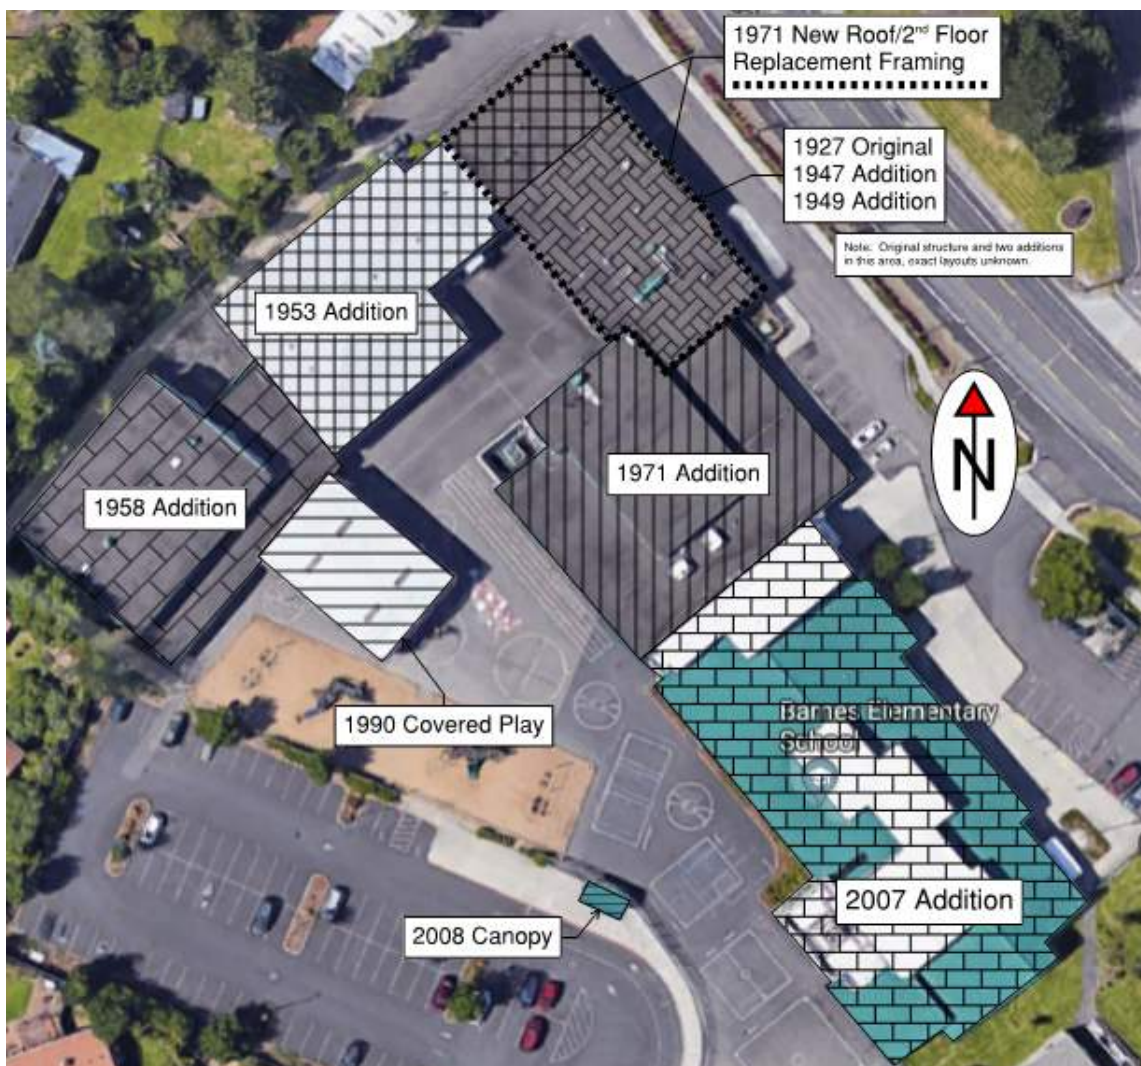
The original two-story structure was built in 1927 with two small additions added in 1947 and 1949, respectively. There are no drawings available for the 1927 initial construction. The 1947 and 1949 construction phases do not have clear existing drawings and there is no clear separation of building years through visual observations. Each addition was constructed with wood framed walls at the exterior with stucco siding. The first floor and roof are framed with wood construction including glulam beams with diagonal sheathing. Exterior concrete foundation walls are used around the lower level as bearing and retaining walls. A concrete slab-on-grade is used at the lower floor with shallow concrete foundations. The roof diaphragm was originally wood decking with a plywood upgrade and roof framing replacement during in the 1971 addition.

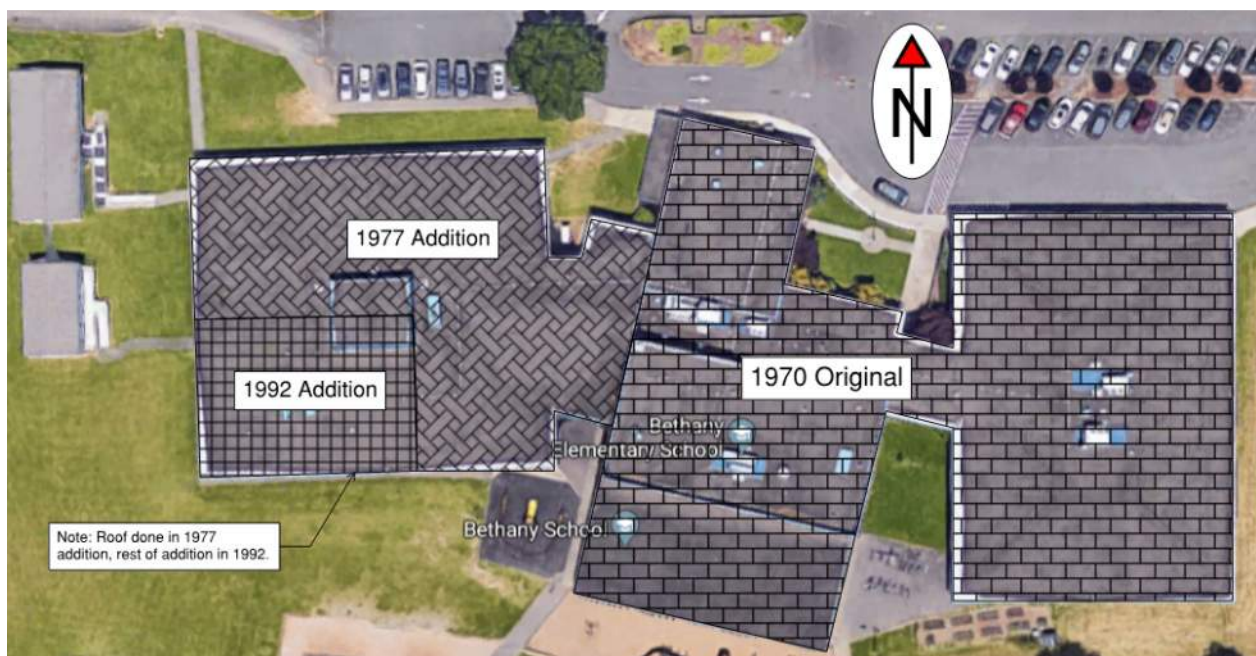
The original 1970 building construction consists of two wings with classrooms, a gymnasium, a kitchen/cafeteria area, and bathrooms. Structural elements include reinforced masonry bearing walls with steel tube columns to support the wood framing at the roof. The lateral force-resisting system consists of exterior reinforced masonry shear walls. The roof diaphragm is made up of 2" tongue & groove decking with plywood sheathing.

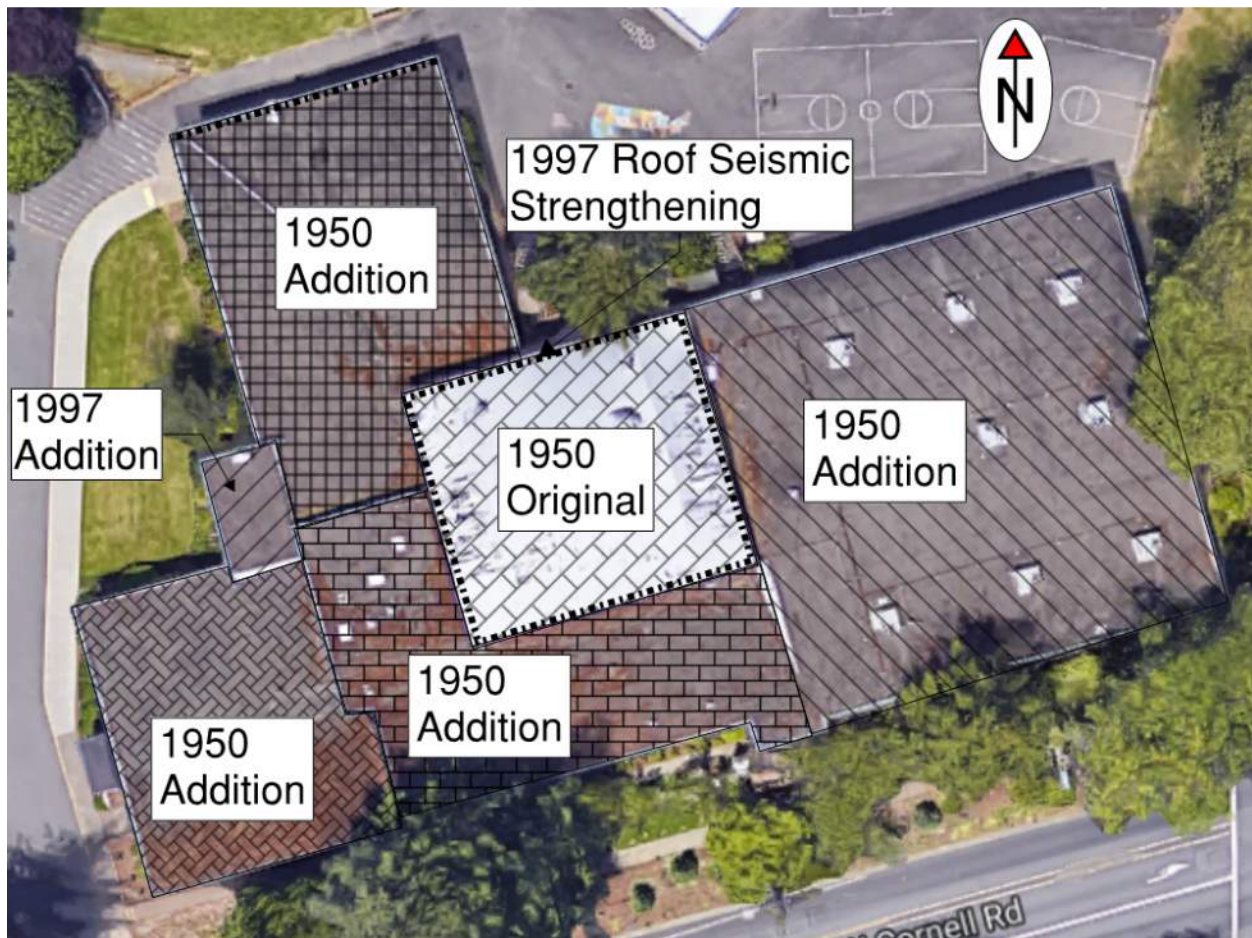
The lateral force-resisting system of this two-story structure is comprised of wood shear walls (W2) and concrete shear walls (C2). The roof diaphragm consists of diagonal sheathing in the 1950, 1953 and 1955 additions and plywood decking in the 1959, 1971 and 1997 additions. The roof and floor diaphragms are not connected to the shear walls for both in-plane and out-of-plane for the 1950 through the 1959 additions.

The 1950 gymnasium building was an addition to the now demolished original structure. The gymnasium was built with reinforced concrete slab-on-grade and reinforced concrete continuous footings which support the wood shear walls. Diagonal roof sheathing is supported by wood purlins which span between glulam bowstring trusses. There was a lateral roof upgrade in 1997 which provided connections from the roof diaphragm to the wood shear walls for in-plane lateral forces.

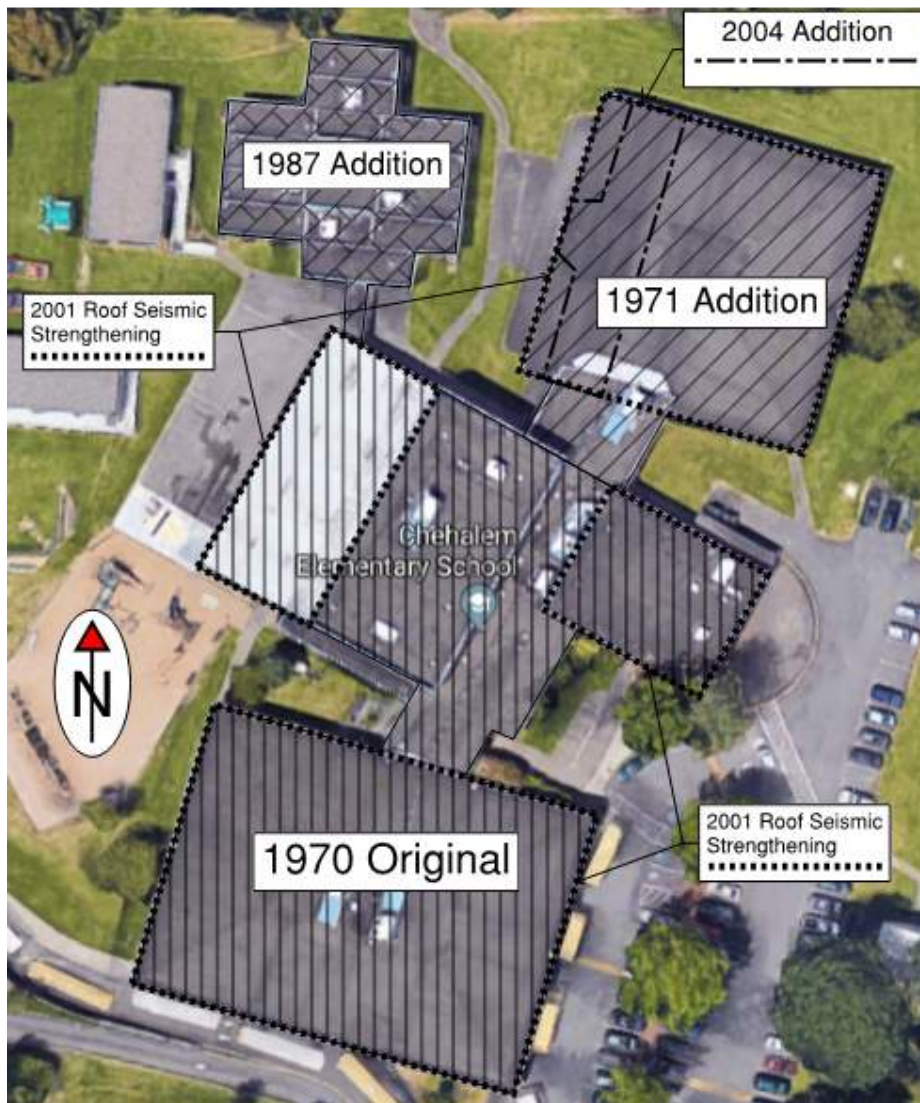
The original 1970 building construction consists of two wings with classrooms, a gymnasium, a kitchen/cafeteria area, and bathrooms. Structural elements included masonry bearing walls with steel tube columns to support the wood framed gravity framing at the roof. The floor and foundation system supporting these elements is a reinforced concrete slab-on-grade and shallow foundations. The lateral force-resisting system is comprised of reinforced giant brick masonry shear walls at the exterior and some interior locations. The roof diaphragm of the original building consists of 2x decking with a potential plywood diaphragm, much of the original roof diaphragm was strengthened with new plywood decking in the 2001 roofing upgrade.

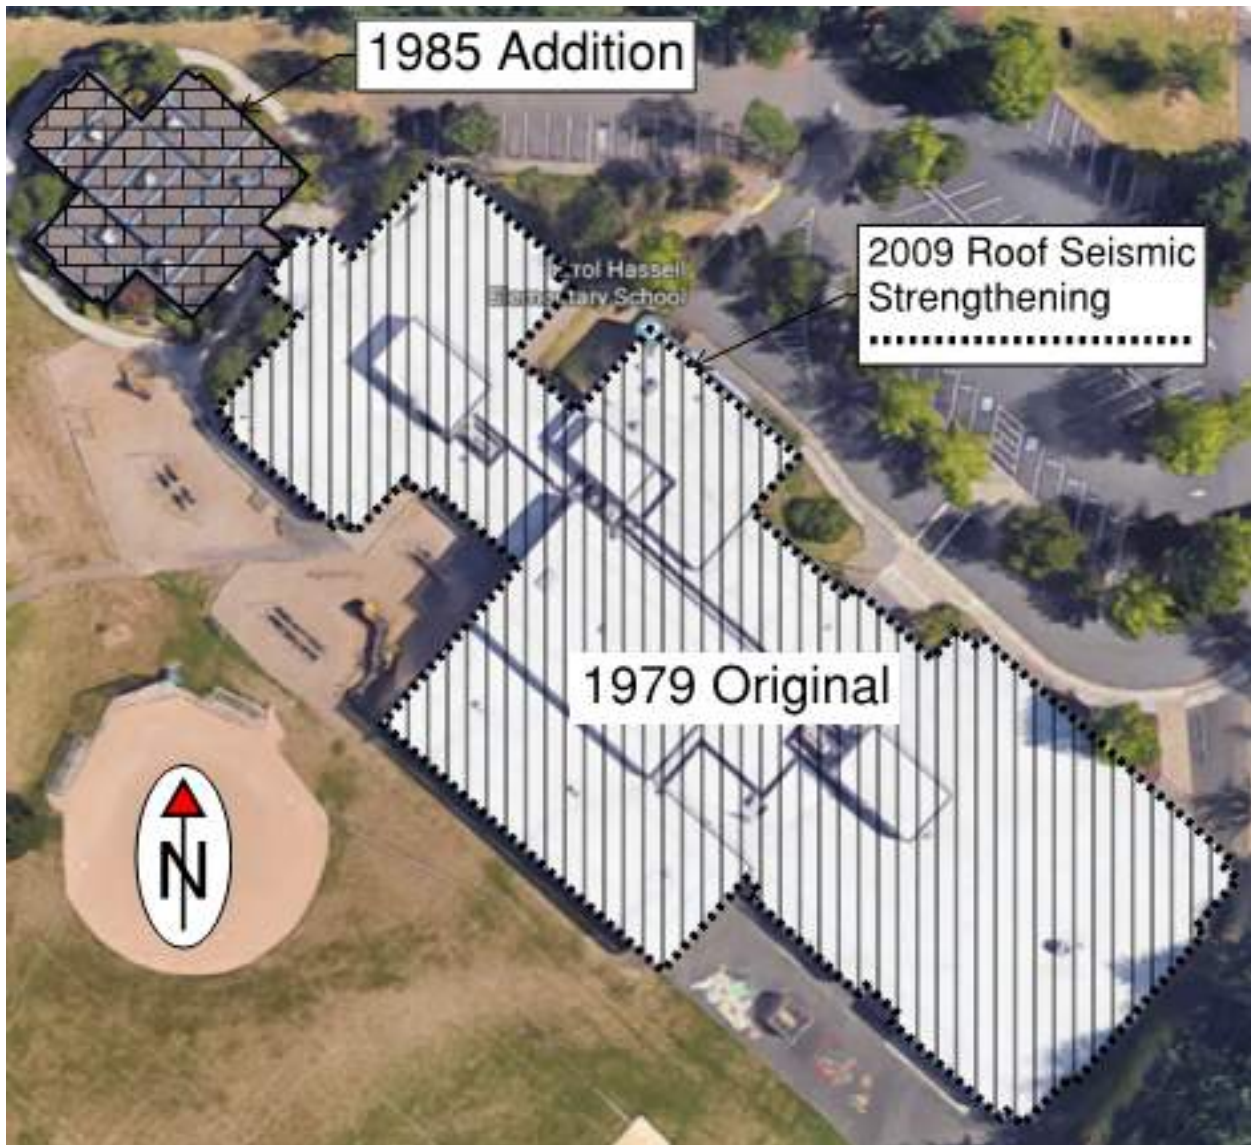
The 1979 original structure includes a classroom wing, cafeteria, bathrooms, administration area, and a gymnasium. The gravity system includes the exterior precast tilt-up walls as well as interior steel tube and wood post columns. The roof framing consists up of wood beams except at the gymnasium where the roof is framed with steel joists. The roof diaphragm is made up of three different materials. The majority of the building has a plywood roof diaphragm while the gymnasium has an acoustical metal deck diaphragm and the covered play area has a 3" straight board decking diaphragm. The lateral force-resisting system consists of the exterior precast walls.

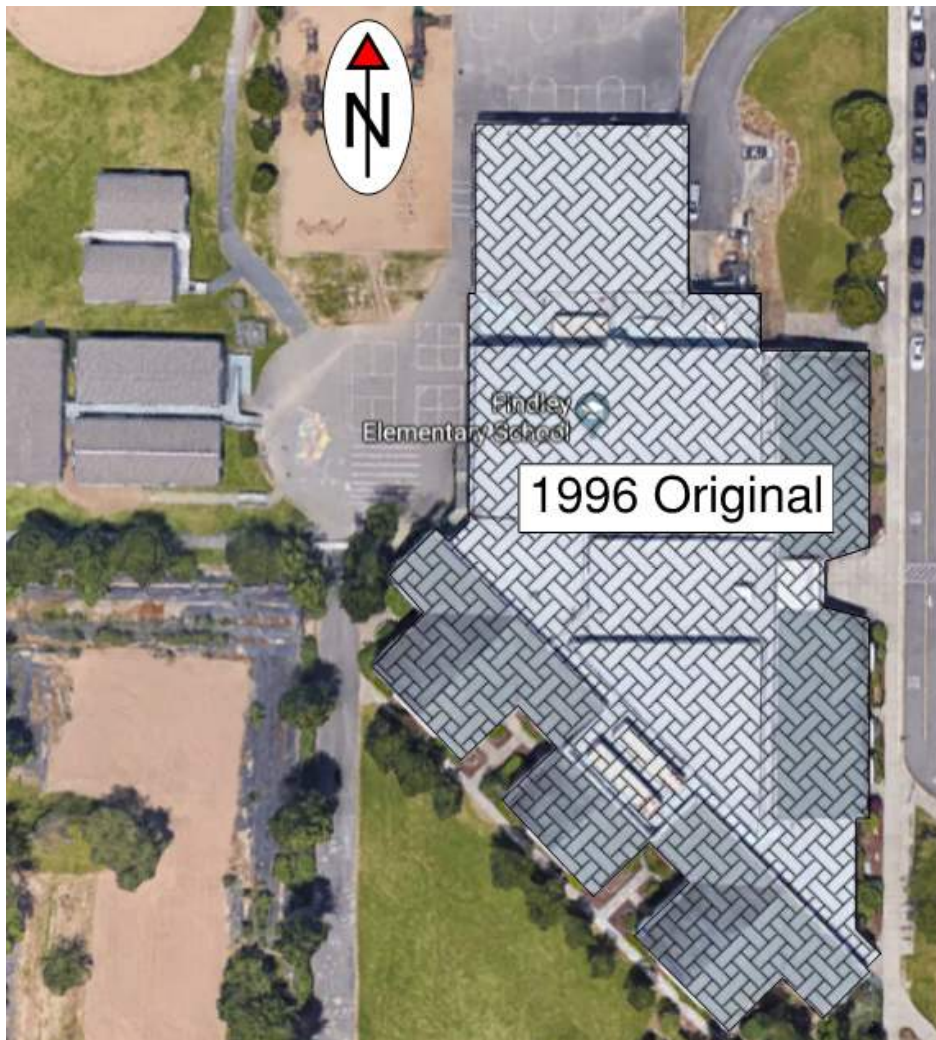
The school is a two-story structure with classrooms, gymnasium, cafeteria, covered play area, and large central open library. The vertical gravity system is composed of steel tube and pipe columns holding up primarily glulam beams at the second floor and roof level with some wood joists used as secondary support. The structure has a foundation system consisting of shallow reinforced concrete foundations and a reinforced concrete slab-on-grade floor which has direct connections to the foundations. Wood trusses and glulam beams are used to support the roof decking. A few large portions of roof framing at the southwest side are sloped while the remaining roof is flat. Plywood decking is used on the roof and at the second floor which act as the building diaphragm to move lateral loads into the wood framed shear walls acting as the primary lateral force-resisting system; there is also a large reinforced CMU masonry wall at the covered play exterior wall which provides lateral restraint in the east-west direction. The original seismic design loads are in accordance with UBC Zone 3.

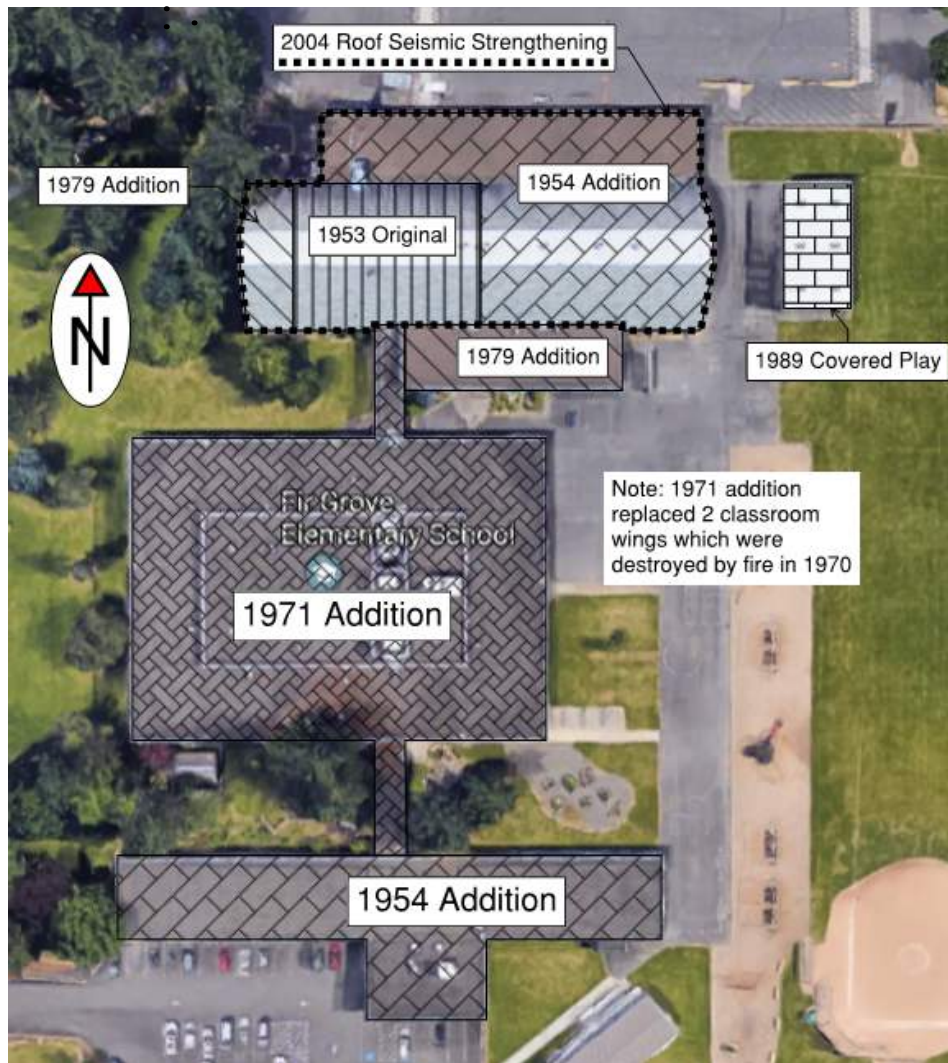
The original 1953 building consisted of three wings. Two for classrooms and a third cafeteria and kitchen area. The gravity system for the arched roof kitchen/cafeteria is exterior masonry walls and wood framed walls; there are also interior wood posts and walls. The lateral force-resisting system is primarily comprised of exterior plywood framed shear walls. The shallow foundations consist of a reinforced concrete slab-on-grade system. The roof system is an arched glulam beam with tongue and groove decking.

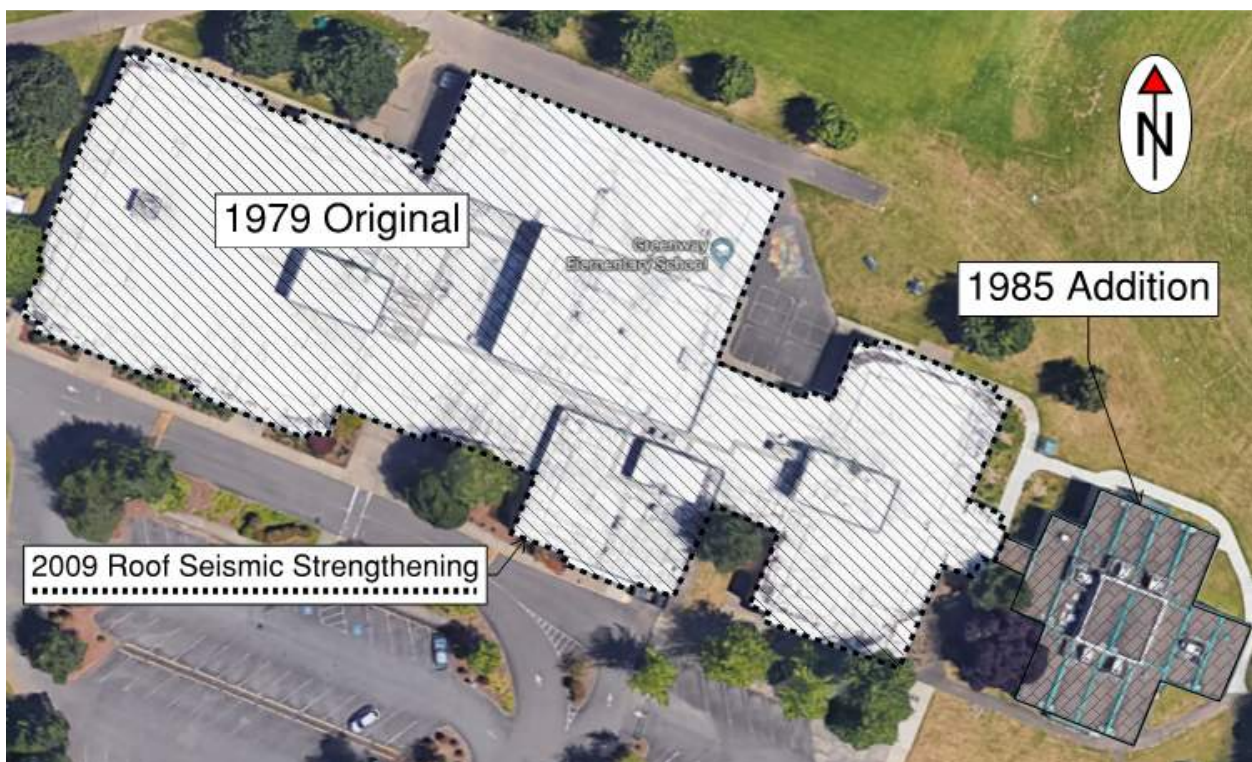
Building Description (separated by construction phases)

The original 1978 structure includes a classroom wing, cafeteria, bathrooms, administration areas, and a gymnasium. The gravity system uses exterior precast tilt-up walls, interior steel tube columns, and wood post columns. The roof framing was made up of wood beams everywhere except at the gymnasium, which was built using steel roof joists. The roof diaphragm is made up of three different materials. The majority of the building is plywood decking, the gymnasium roof uses acoustical metal deck, and the covered play area has 3" straight board wood decking.

The first addition in 1987 consists of a new classroom wing to the southeast. The lateral force-resisting system consists of wood framed shear walls at the exterior. The gravity system includes these wood walls as well as steel tube columns and wood posts. The foundation system is made of a

reinforced concrete shallow footings. The floor for this wing is an elevated wood framed system with plywood decking that ties into the foundations and exterior wood walls. The roof is framed with glulam beams and wood joists and plywood decking across the entire roof of this addition.

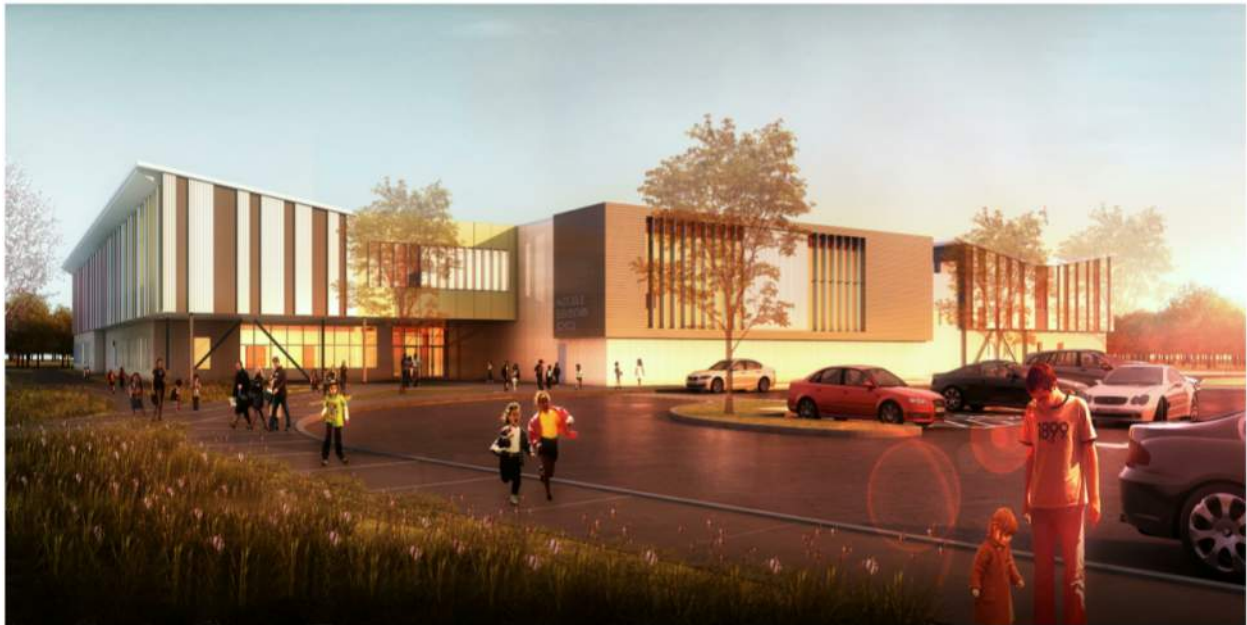
Building Description (separated by construction phases)

This is a new elementary school building constructed in 2018 replacing the older building originally constructed before 1954. This new building includes new classrooms, cafeteria, gymnasium and covered play area. The structure consists of steel framing, precast concrete wall panels and reinforced masonry walls. This building was designed for seismic risk Category IV.

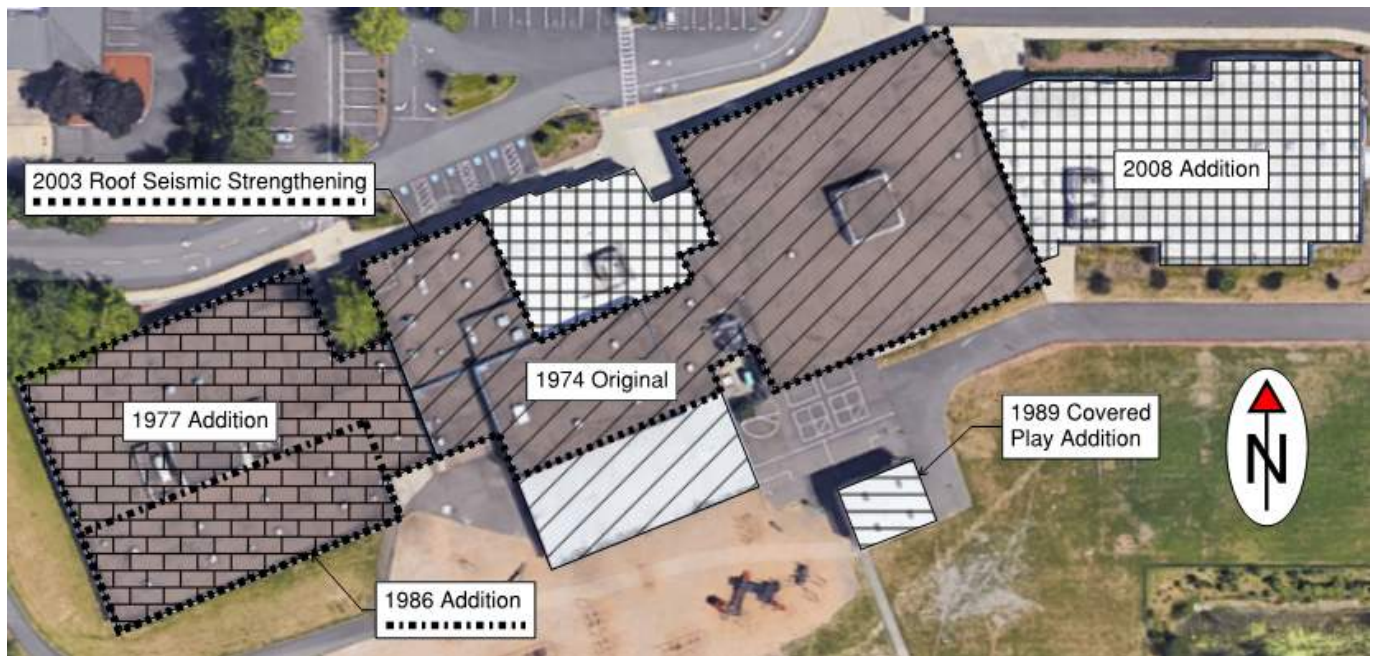
Building Description (separated by construction phases)

The original 1974 building has two separate wings, the first having classrooms and a library. The second wing includes a cafeteria, gymnasium, bathrooms, and administration areas. There is also a covered play area on the southern side of the second wing. Both wings were built with exterior reinforced masonry bearing walls and interior steel and wood columns. These elements are supported by reinforced concrete foundations and slab-on-grade floor system. The foundations are then anchored and connected into the lateral force-resisting system. The lateral force-resisting system uses the exterior masonry shear walls as well as some interior masonry at the second wing. The roof diaphragm is made up of plywood decking. The roof framing supporting the diaphragm are wood glulam beams and joists.

The addition in 1986 infilled the 1977 addition's covered play area with new classrooms. The roof framing and diaphragm was kept from the previous addition and not replaced. The asphalt pavement was replaced with a reinforced concrete slab and new exterior masonry walls were added to act as the lateral force-resisting system for the new area. An interior wood shear wall was also added in this new addition in the north-south direction.

The most recent addition was built in 2008 and has two major add-ons, the first being an expansion of the administration area from the original building, which replaced and added new roof framing and a plywood roof diaphragm. At the foundations a new reinforced slab and shallow foundation system was added for the addition with underpinning occurring at the existing foundations. The other addition was a large wing on the east side of the existing structure. This new wing is primarily wood framed and made use of wood framed shear walls for the lateral force-resisting system. Wood stud walls and steel tube columns are used as the gravity system supporting wood glulam beams at the roof with a plywood diaphragm. A new reinforced concrete foundation and floor system was constructed to match the existing foundations. This addition conformed to the 2006 IBC for its seismic design loads.

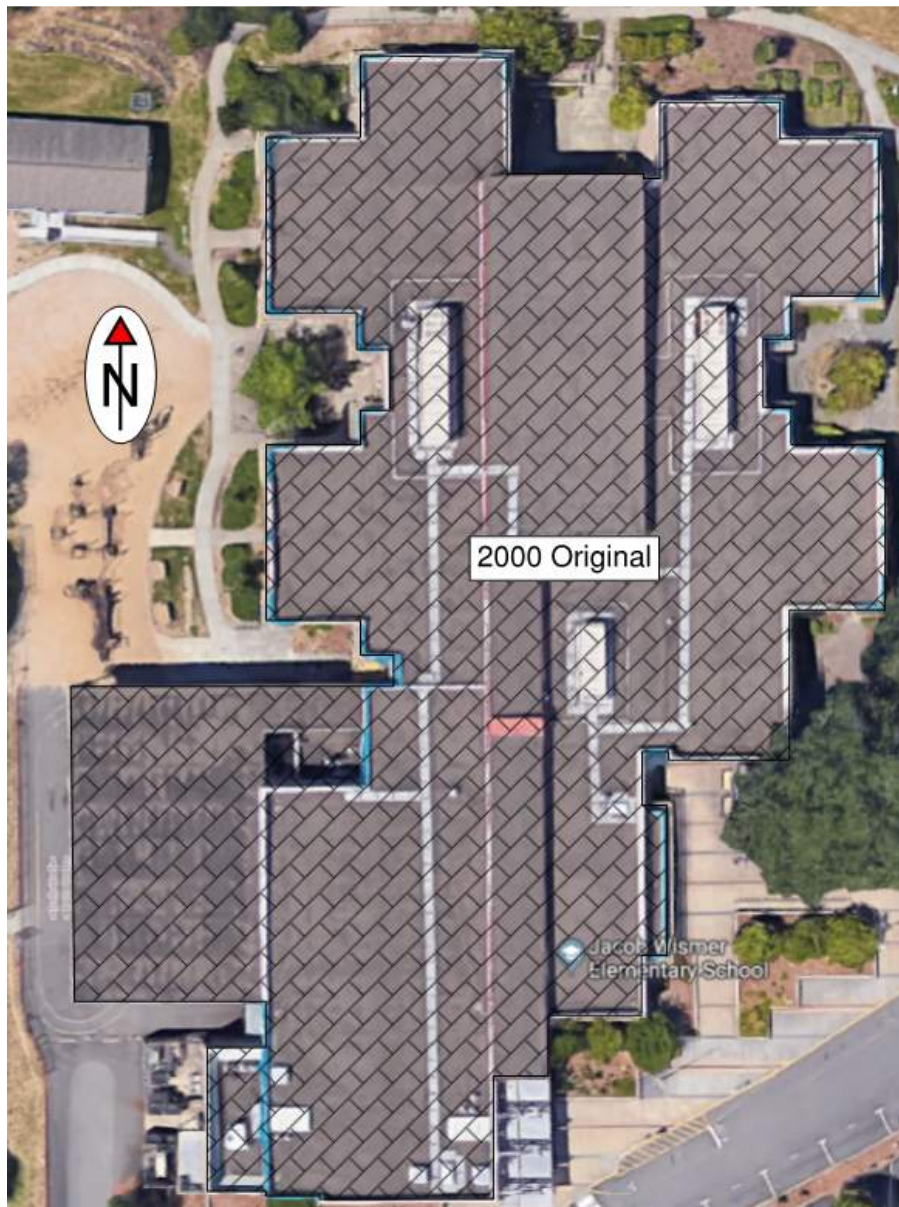
Building Description (separated by construction phases)

This two-story structure includes multiple classrooms, a gymnasium, cafeteria, and covered play area. The primary gravity system for this structure is comprised of wood framed bearing walls and steel tube columns. The roof framing is constructed mainly of wood joists, built-up wood girders, steel joists, and steel beams. There are also various concrete and masonry walls being used as gravity elements. These members support plywood and metal decking that is used at the roof diaphragm. The first floor of the building also contains a plywood diaphragm that connects to the lateral elements. The lateral force-resisting system consists primarily of wood framed shear walls with plywood sheathing.

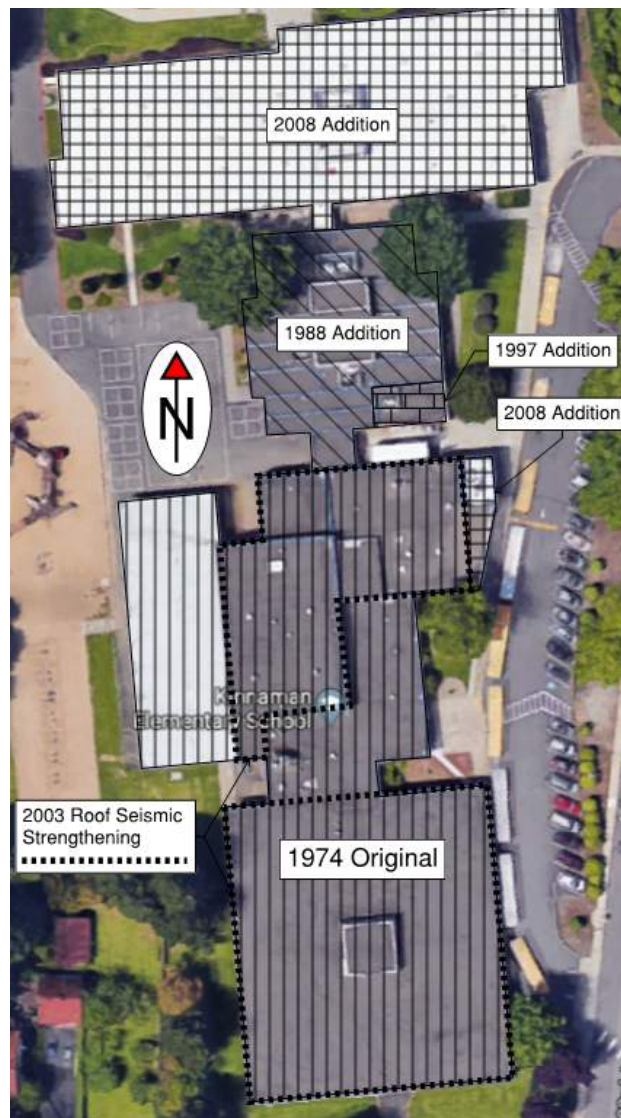
Building Description (separated by construction phases)

The original building includes two separate wings, the first includes classrooms and a library and the second wing includes a cafeteria, gymnasium, bathrooms, and administration area. There is also a covered play area on the western side of the second wing. Both wings were built with exterior reinforced giant brick masonry bearing walls and interior steel and wood columns. These elements are supported by reinforced concrete shallow foundations and a slab-on-grade floor system. The foundations are anchored and connected into the lateral force-resisting system. The lateral force-resisting system uses the exterior masonry giant brick shear walls as well as some interior masonry walls in the northern wing. The diaphragm at the roof level is made up of plywood sheathing across the entire structure except the covered play area which is straight sheathed wood tongue and groove decking. Wood glulam beam and joist framing is used at the roof level to support the diaphragm.

The 1988 addition consists of a classroom wing on the north side of the original structure. This addition uses a shallow reinforced concrete foundation system supporting steel tube columns, wood posts, and wood stud walls. The floor system for this addition differs from the original structure in that it uses a plywood sheathed floor supported by wood posts and joists rather than the concrete slab-on-grade. The wood posts do bear on the concrete foundations but lack positive connections to those foundations. The lateral force-resisting system for this addition is made from exterior wood shear walls using plywood sheathing. The roof diaphragm is built with plywood decking. There is a large clerestory pop-up area in the roof of this addition.

For the 1997 addition, a new classroom area was added to the previous 1988 addition on the southeast corner. This is a small area that matches the previous additions construction using a plywood floor system while bearing on shallow concrete foundations. New exterior wood shear walls were also installed to provide lateral support to this area. Wood beams and joists were used at the roof framing to provide support for the plywood roof diaphragm.

The 2008 addition added a large classroom wing to the north side of the previous addition and also made a renovation to the front entry area at the original building. The main classroom area is similar to the original building as it has a concrete slab-on-grade floor system with reinforced concrete foundations supporting the remainder of the structure. The gravity system for this addition consists of exterior metal stud bearing walls with brick veneer in some areas, interior metal stud bearing walls, built-up wood columns, and tube steel columns. These vertical elements support a steel roof framing system comprised of steel beams and joists which support the metal deck roof diaphragm. The roof diaphragm connects to metal stud shear walls with plywood sheathing for the lateral force-resisting system. A seismic joint is present between the 2008 addition and 1988 addition, it should be noted that the seismic joint was at the roof structure but did not continue to the ground.
