Oregon Seismic Status Report - 2019

JENNIFER EGGERS, ASSOCIATE/PROJECT MANAGER
NATHAN INGRAFFEA, PRINCIPAL
KPFF CONSULTING ENGINEERS
111 SW FIFTH AVENUE, SUITE 2500
PORTLAND, OR 97204-3628

SEISMIC ASSESSMENTS FOR THE BEAVERTON SCHOOL DISTRICT

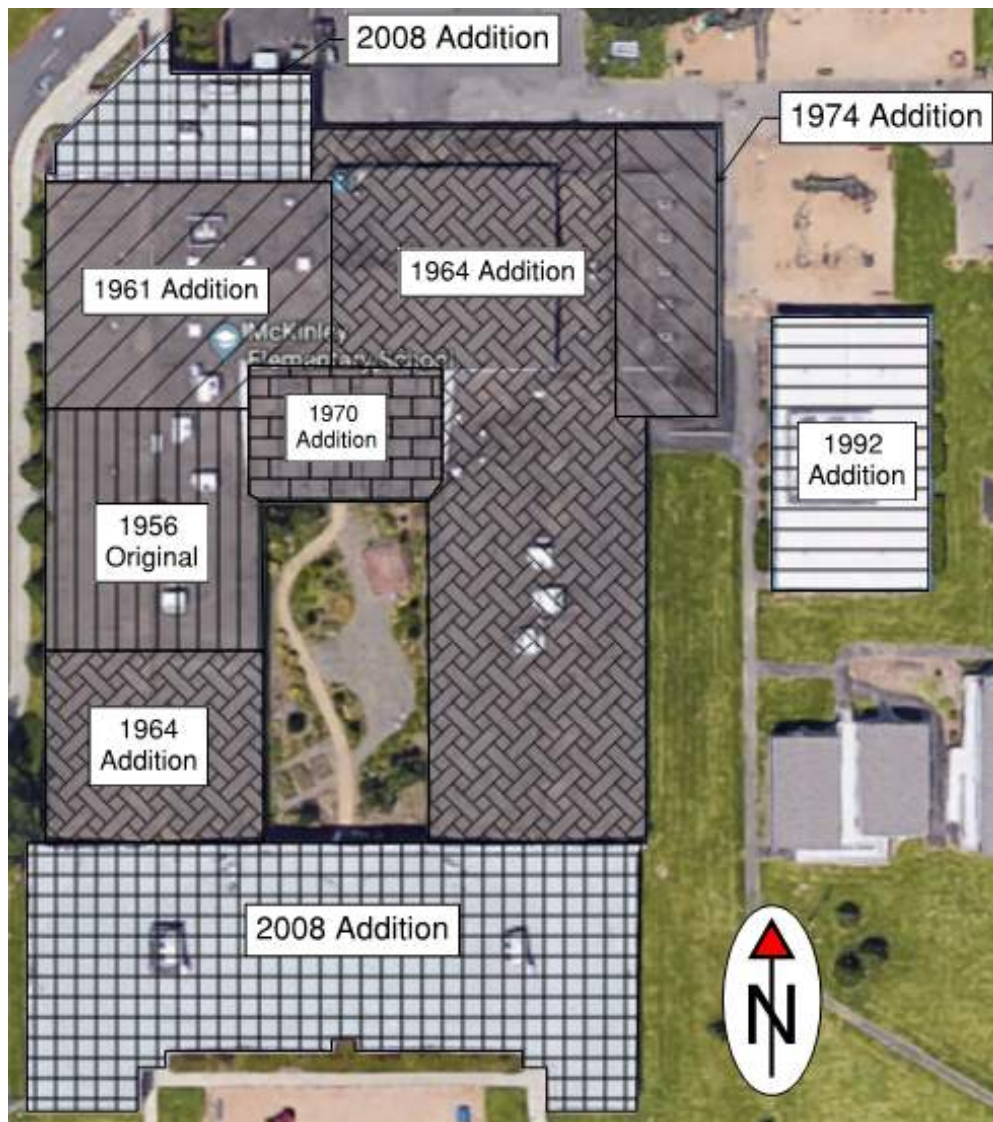
Building Description (separated by construction phases)

The original 1956 structure consists of classrooms, bathrooms, and an outdoor covered play area. This portion of the structure uses wood framed bearing walls and wood posts for the gravity system. The roof system consists of glulam beams supporting a straight sheathed wood decking. The lateral force-resisting system is wood framed shear walls with gypsum board sheathing. The original covered play area was demolished while building the 1961 addition. The roof system is continuous over the covered play area and the rest of the original structure. A reinforced concrete foundation and floor system are used to support all of the above elements, the bearing and shear walls are tied into the foundations. An asphalt floor system was used at the covered play area but then replaced in the 1961 addition. The wood post columns do not have a positive connection and may allow for upward forces to make the structure unstable.

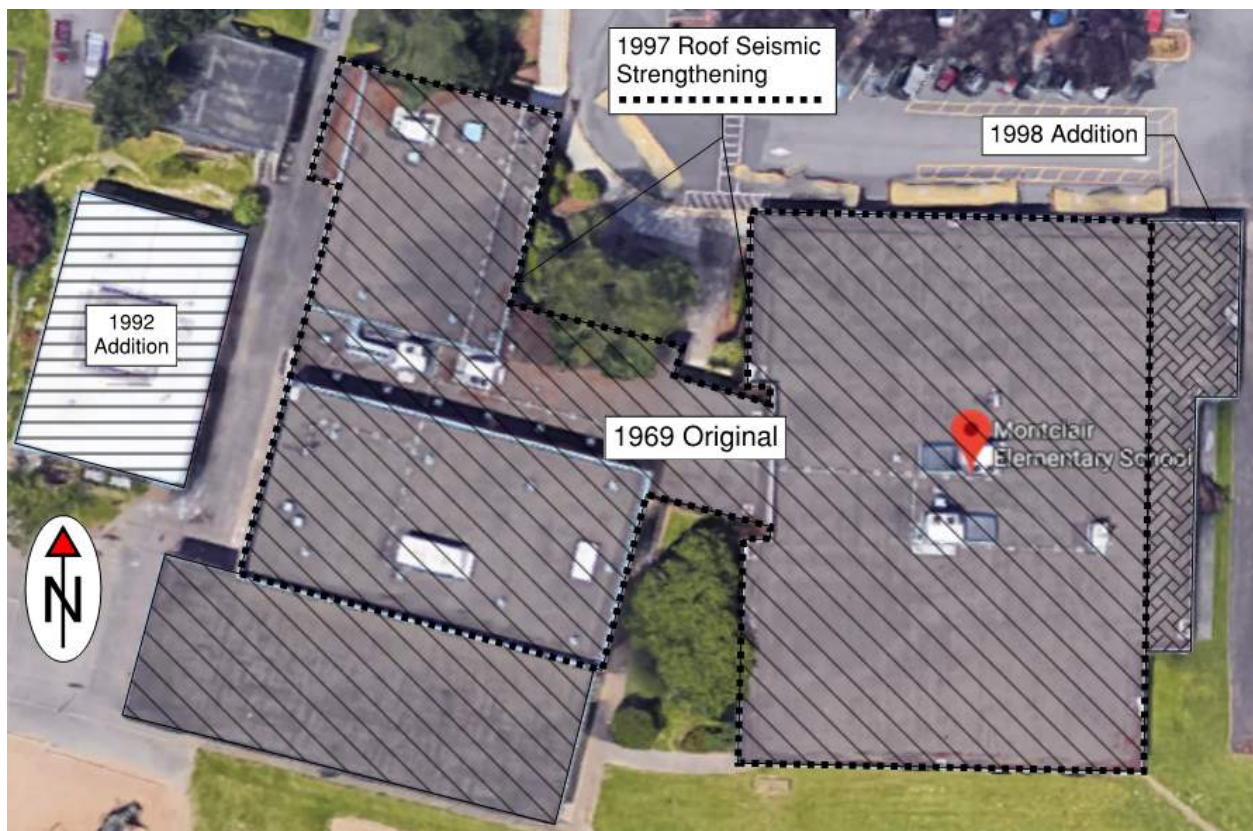
Building Description (separated by construction phases)

The original 1969 building consists of a large classroom wing on the east side and a combination of a cafeteria, gymnasium, administration, and outdoor covered play area on the west wing. The gravity system uses exterior and interior masonry bearing walls along with some interior wood framed walls. These elements were supported by a concrete slab-on-grade floor system and reinforced concrete shallow foundations. Roof framing consists of glulam beams, wood joists, and some steel girders and

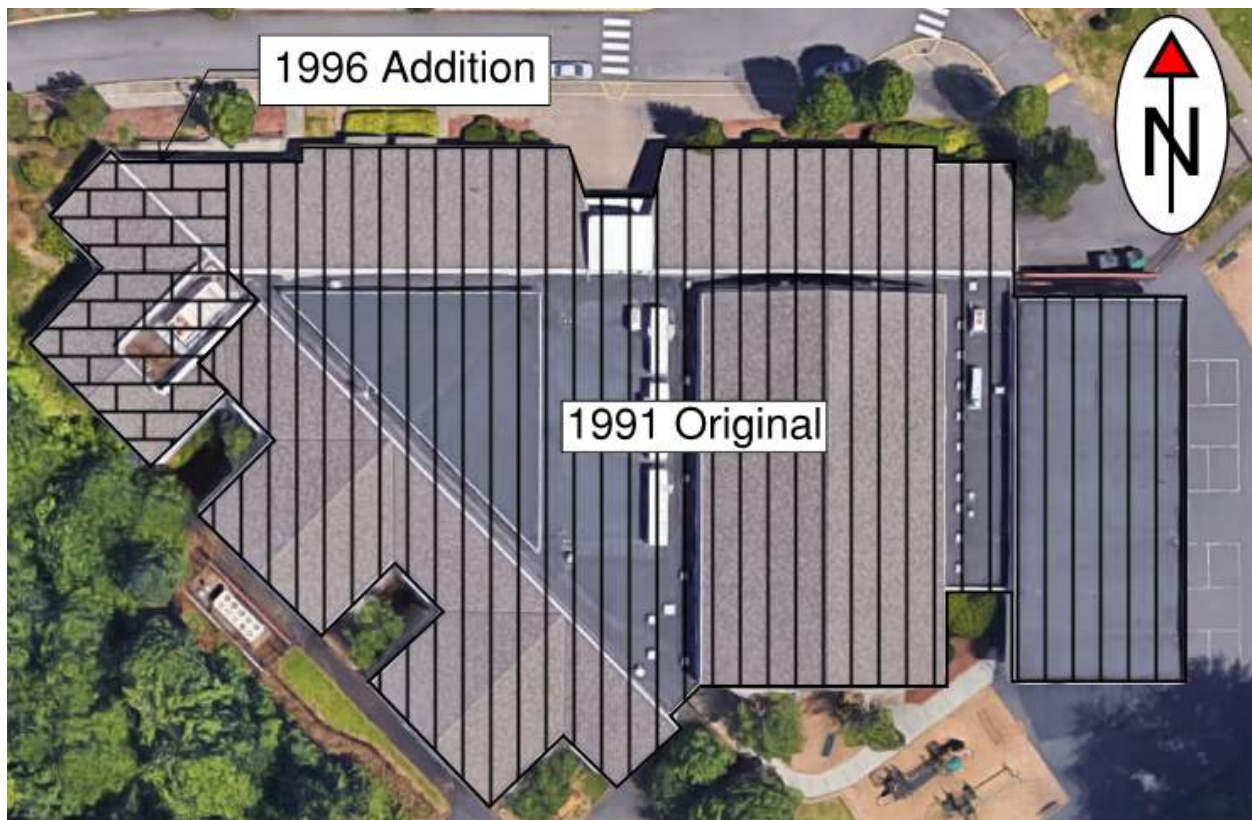
Building Description (separated by construction phases)

The original 1991 structure includes two classroom wings, administrative areas, a commons/library space, a gymnasium and a covered outdoor play area. The building is located on a sloped site that drops off to the southeast. The gravity system in typical classroom and administrative areas consists

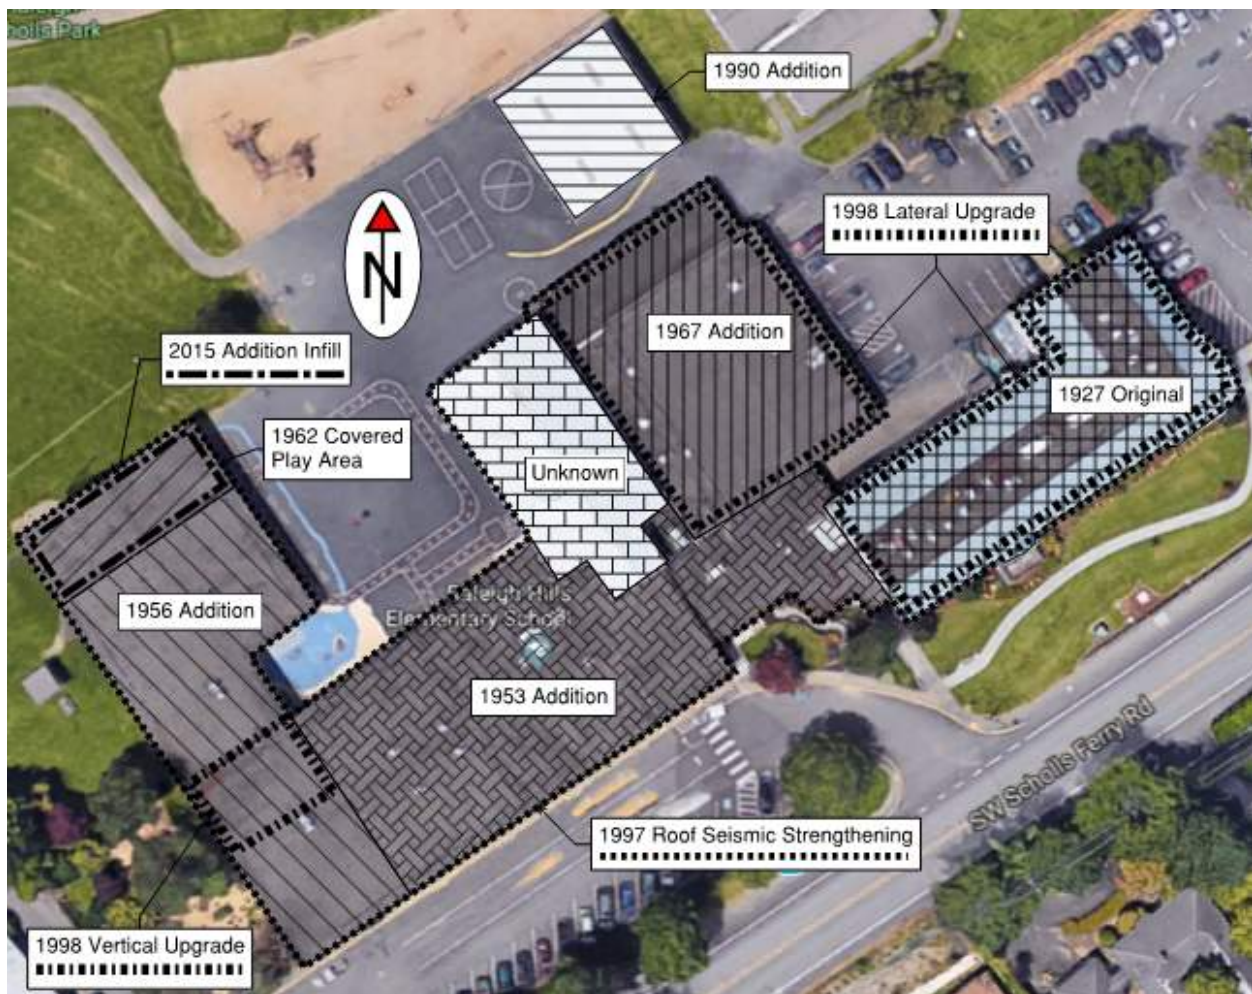
Building Description (separated by construction phases)

The original 1927 building is a two-story structure with multiple classrooms, offices, and a library area. There are no existing drawings available but through visual observations it can be seen that the first story exterior walls are likely unreinforced concrete with wood framed walls at the second story. The brick seen on the exterior is veneer and is not loadbearing but also does not appear to have proper tieback to the structure. The original sloped roof structure appears to be a straight board wood decking diaphragm.

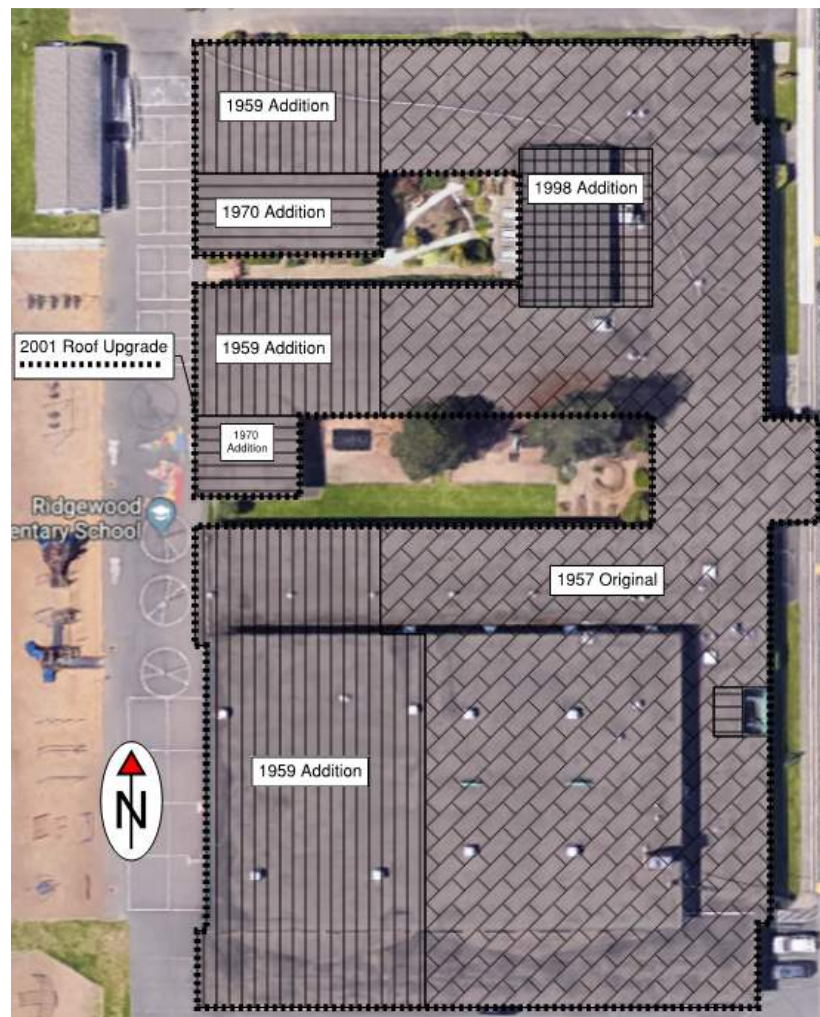
Building Description (separated by construction phases)

The original 1957 building consists of multiple classroom wings, an administration area, and a cafeteria/gymnasium with an attached covered play area. The structure is primarily built using concrete frames at the exterior with unreinforced masonry infill and interior wood and brick walls. The roof framing is mainly wood glulam beams with tongue and groove decking for the diaphragm. The lateral force-resisting system consists of the concrete frames with masonry infill at the gymnasium and interior wood framed walls at the classrooms. The foundations are reinforced concrete shallow foundations and the floor is a reinforced concrete slab-on-grade. Neither the foundations nor floor system are tied into the exterior walls. The lateral force-resisting system at the classrooms consist of wood framed shear walls was not adequate to provide lateral resistance, a new lateral force-resisting system was added in the 1998 addition that provided lateral support at the lower classroom areas.

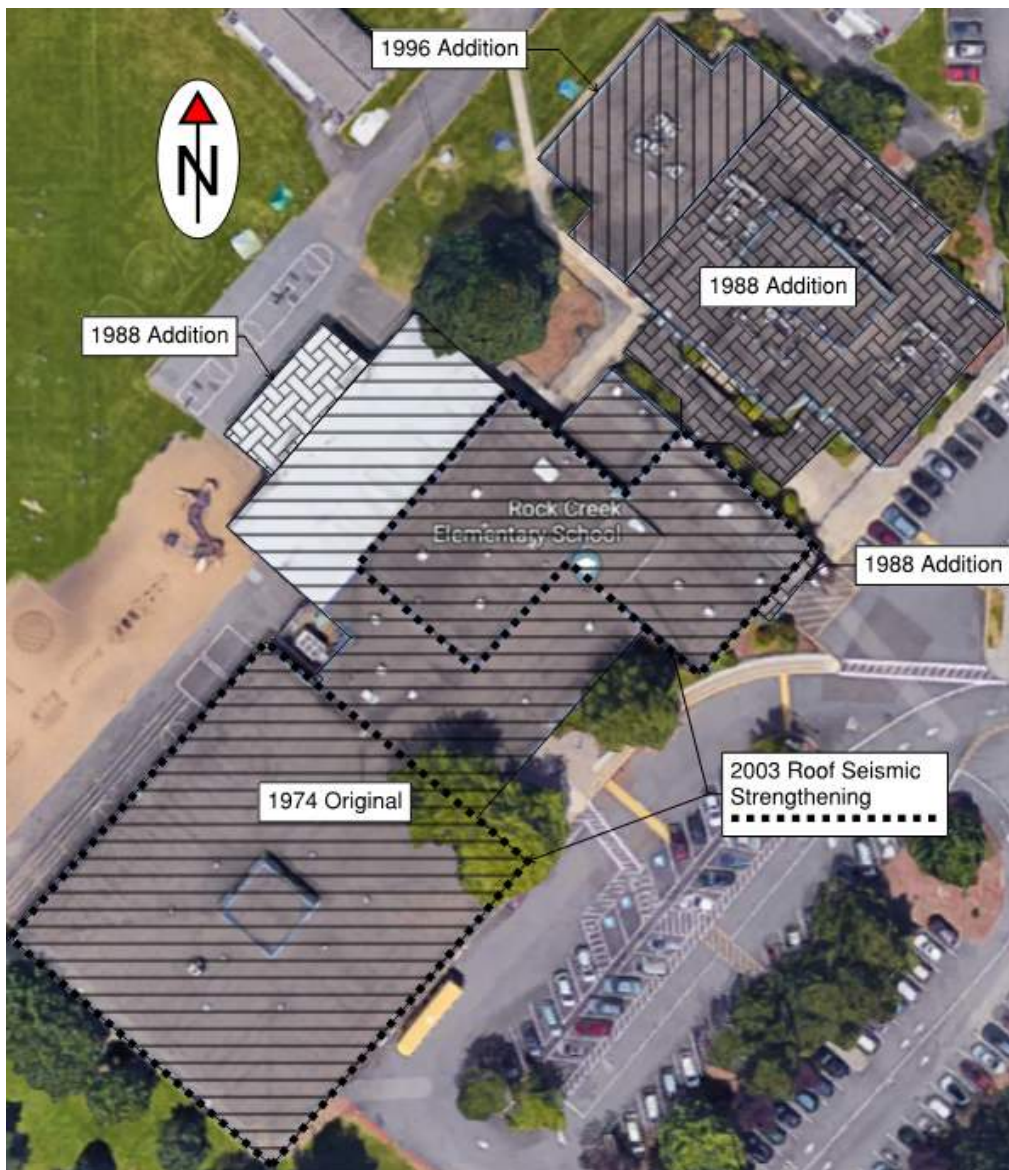
Building Description (separated by construction phases)

The 1974 original building included two separate wings, the first contains classrooms and a library. The second contains a cafeteria, gymnasium, bathrooms, and administration area. There is also a covered play shelter on the western side. The gravity system consists of reinforced masonry bearing walls, steel tube columns and wood bearing walls. These elements are supported by reinforced concrete foundations and concrete slab-on-grade systems. The foundations are anchored and connected into the lateral-force resisting system. The lateral force-resisting system is composed of the exterior and interior reinforced masonry shear walls. The roof diaphragm is plywood decking except for over the covered play area where it is tongue and groove decking. The roof framing supporting the deck is composed of wood glulam beams and joists at the majority of the structure except the gymnasium which uses steel joists.

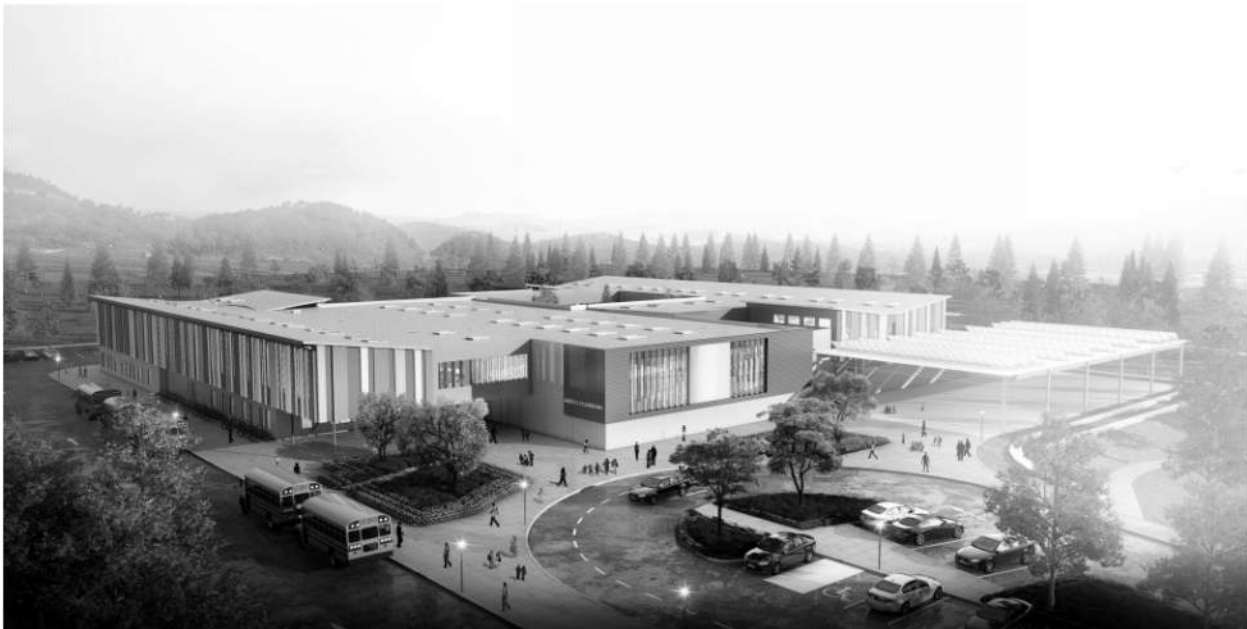
Building Description (separated by construction phases)

The 2017 school includes classrooms, cafeteria, gymnasium and covered play area. The structure consists of steel framing, precast concrete wall panels and reinforced masonry walls. This building was designed for seismic risk Category IV.

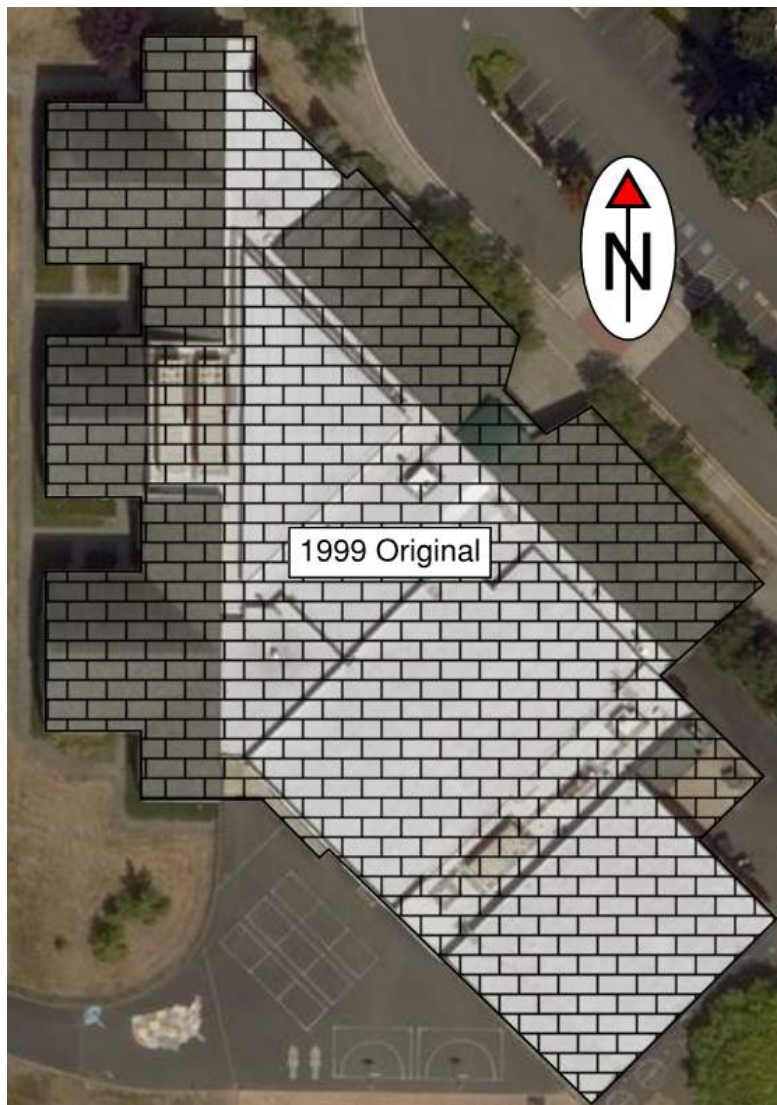
Building Description (separated by construction phases)

The original 1999 structure includes a classroom wing, administrative areas, a commons/library space, a gymnasium and a covered outdoor play area. The building is located on a sloped site that drops off to the southwest. The gravity system in typical classroom and administrative areas consists of plywood floor sheathing, wood joists and wood framed bearing walls. Larger spans including the library/commons are framed with plywood sheathing, glulam beams and steel columns. The gymnasium is framed with steel open web trusses and steel columns. The roof diaphragm is made of plywood sheathing and has blocked adjacent to shear walls that are parallel to the direction of joist framing. The main lateral force-resisting system consists of plywood or gypsum wallboard bearing and shear walls distributed around the perimeter and throughout the interior of the building. Shear walls are anchored to the foundation with equally spaced anchor bolts along the length of each wall, along with hold-downs. A covered play area at the east side of the structure is supported by a reinforced masonry shear wall (RM1) along the adjoining gymnasium.

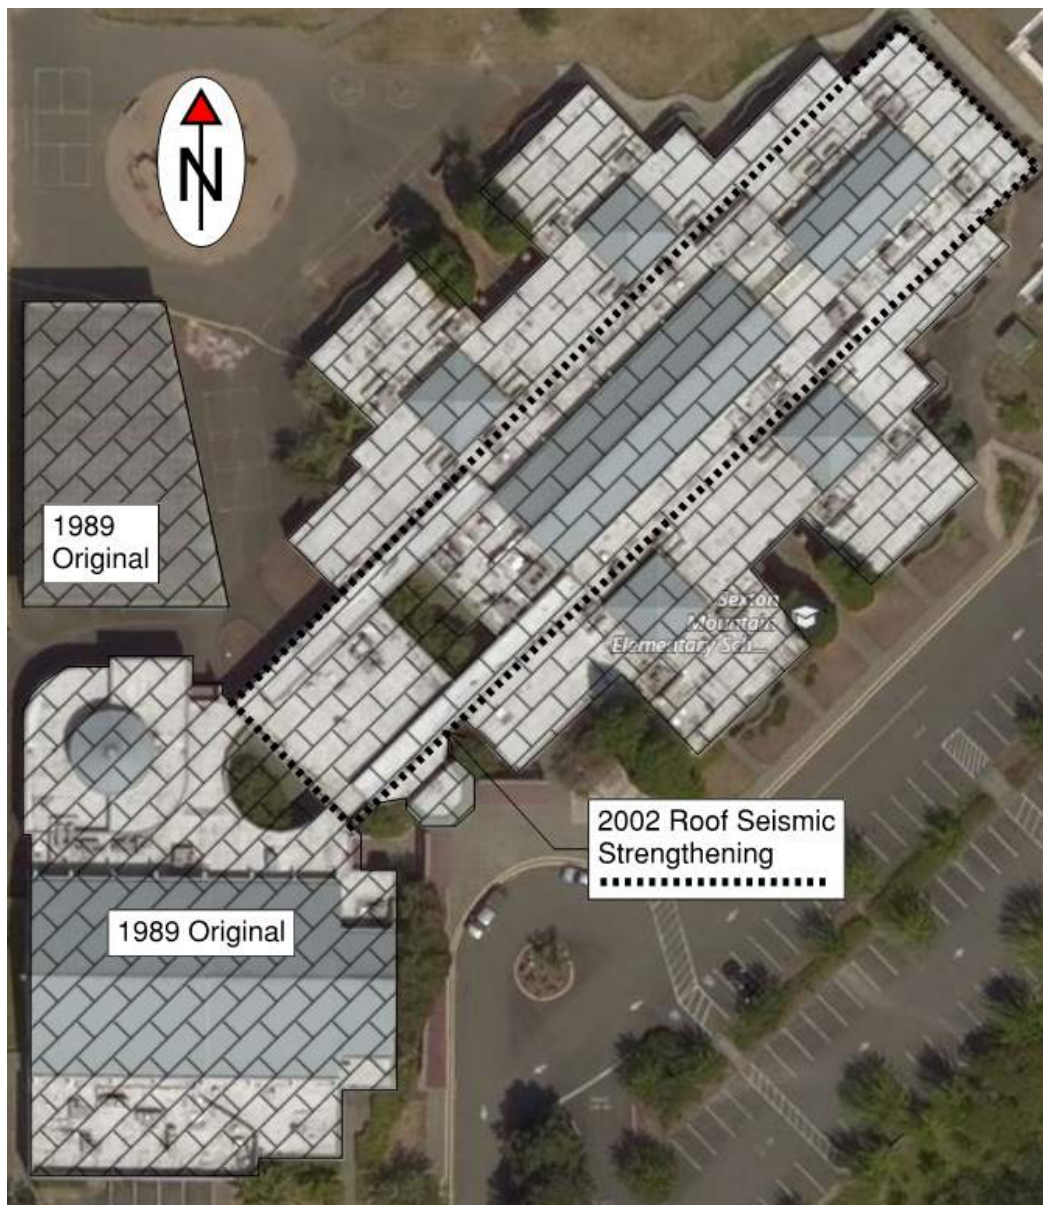
Building Description (separated by construction phases)

The structure consists of both perimeter and interior wood shear walls and some interior reinforced CMU shear walls. Interior shear walls are well distributed throughout the structure; however, plywood diaphragms span more than 40 ft in some cases. Foundations are typical strip and isolated concrete footings with concrete stem walls that extend up to meet either CMU or wood walls at the building perimeter. Floor structure is reinforced concrete slab-on-grade on the middle portion of the building (with direct connection to foundation stem walls, while the east and west portions of the building consist of a wood framing (with crawl space) supported on isolated footings and perimeter strip footings.

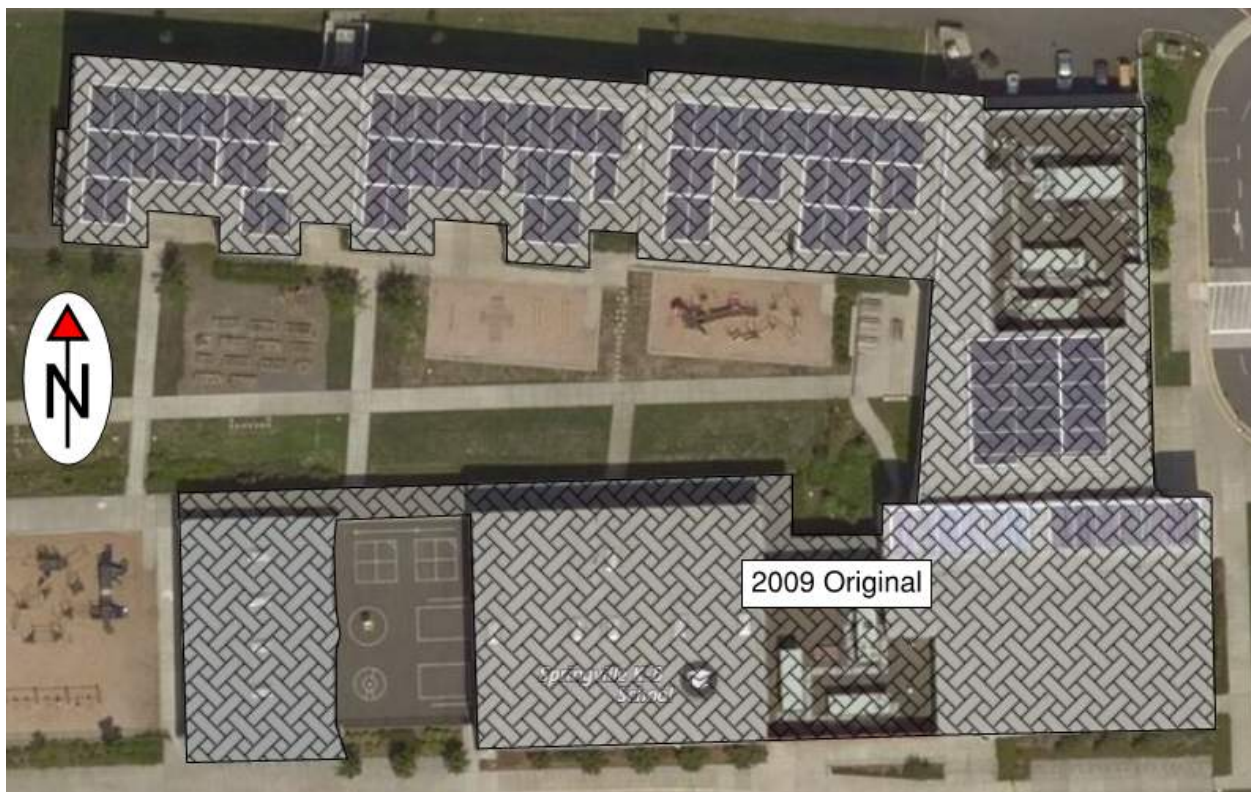
Building Description (separated by construction phases)

The school, built in 2009, includes three distinct areas: a west classroom wing, a main building (east classrooms, commons, administration and stage), and gymnasium with an adjacent covered play area (designed by others). The gravity system is made up of steel framing at the west classroom wing and main building areas, while tilt-up concrete walls with steel open-web roof joists support gravity loads

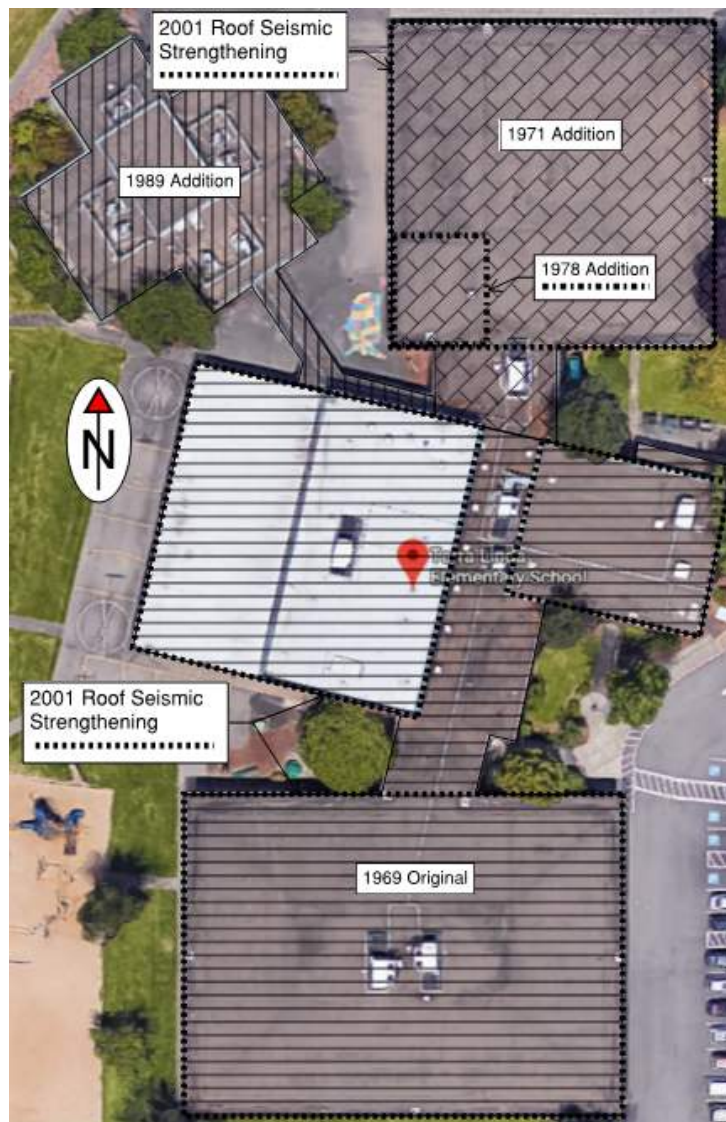
Building Description (separated by construction phases)

The original building area consists of two wings with classrooms, a gymnasium, a kitchen/cafeteria area, and bathrooms. Structural elements included masonry bearing walls with steel tube columns to support the wood framing at the roof. The floor and foundation systems are reinforced concrete slab-on-grade and shallow foundations. The lateral force-resisting system is reinforced giant brick masonry at the exterior and some interior walls. The roof diaphragm of the original building consists of 2x decking with a plywood overlay, much of the original roof diaphragm was replaced with new plywood decking in the 2001 roofing upgrade.

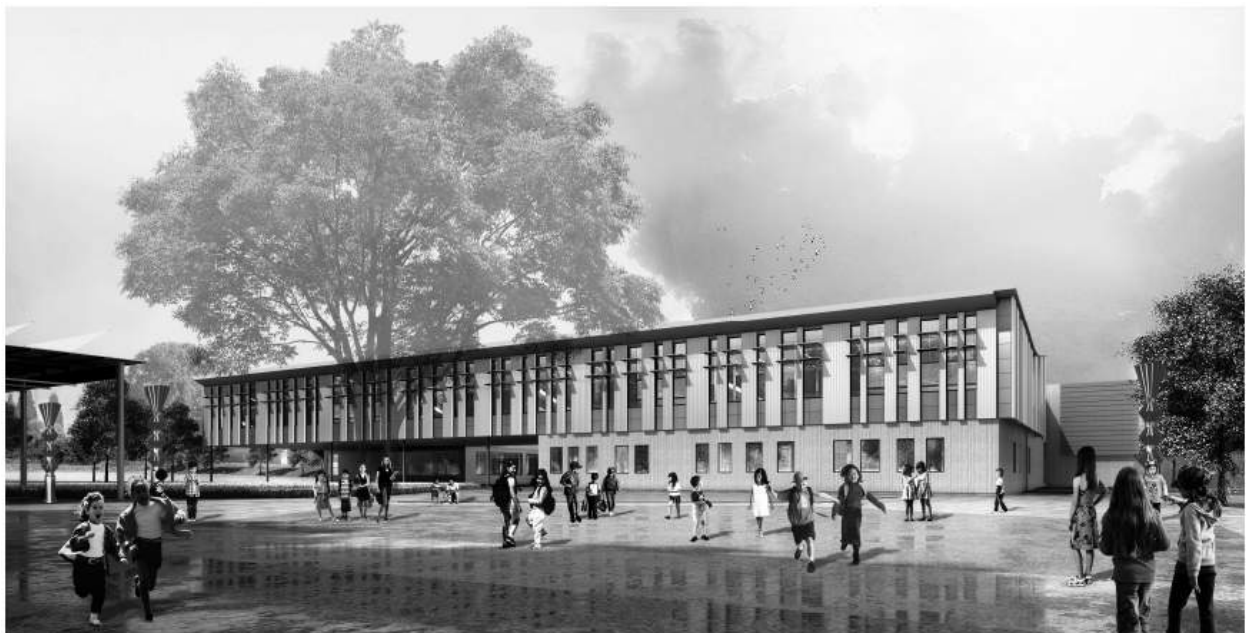
Building Description (separated by construction phases)

The new elementary school replaced the original school built in 1960. This new building includes classrooms, cafeteria, gymnasium and covered play area. The structure consists of steel framing, precast concrete wall panels and reinforced masonry walls. This building was designed for seismic risk Category IV.

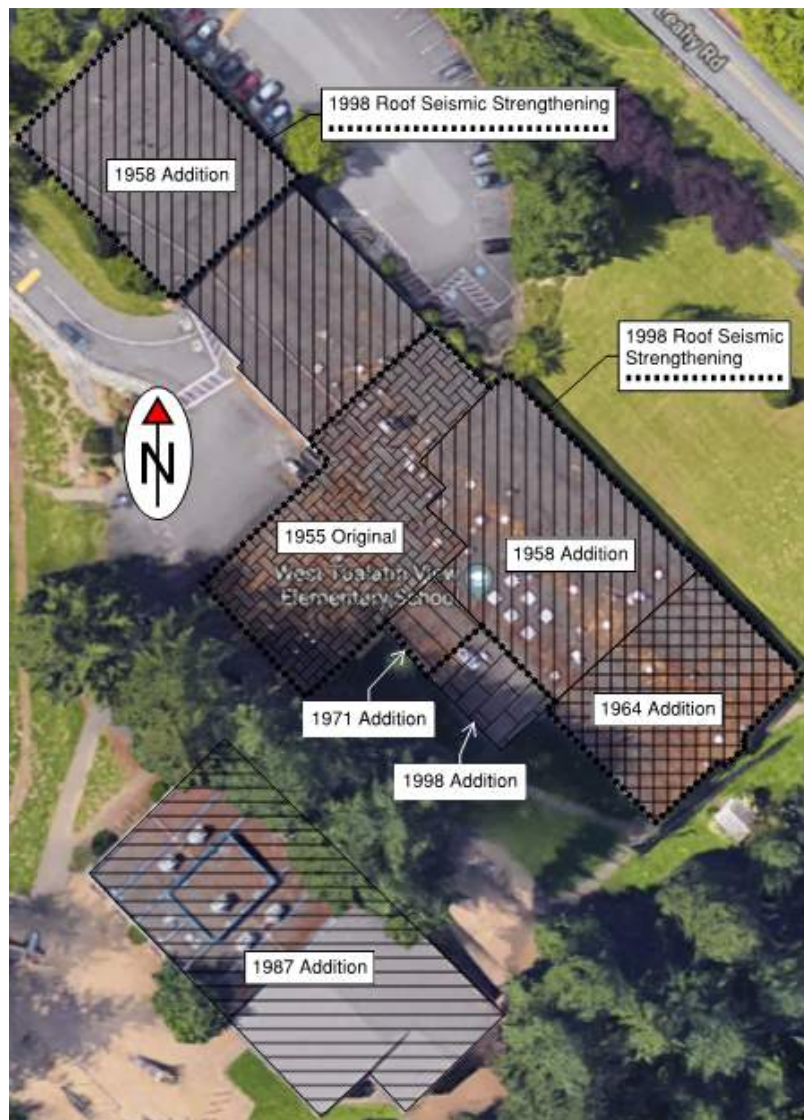
Building Description (separated by construction phases)

The original 1955 building includes a basement and main floor level with a large number of classrooms on the main level and a large playroom area in the basement as well as a crawl space and boiler room. The gravity elements for the original structure include primarily wood bearing walls with a small central core of masonry walls. These masonry walls are the primary lateral force-resisting system for the structure. Wood shear walls were later added during the 1998 addition/lateral upgrade. The floor diaphragm has plywood sheathing, while the roof diaphragm has straight wood sheathing.

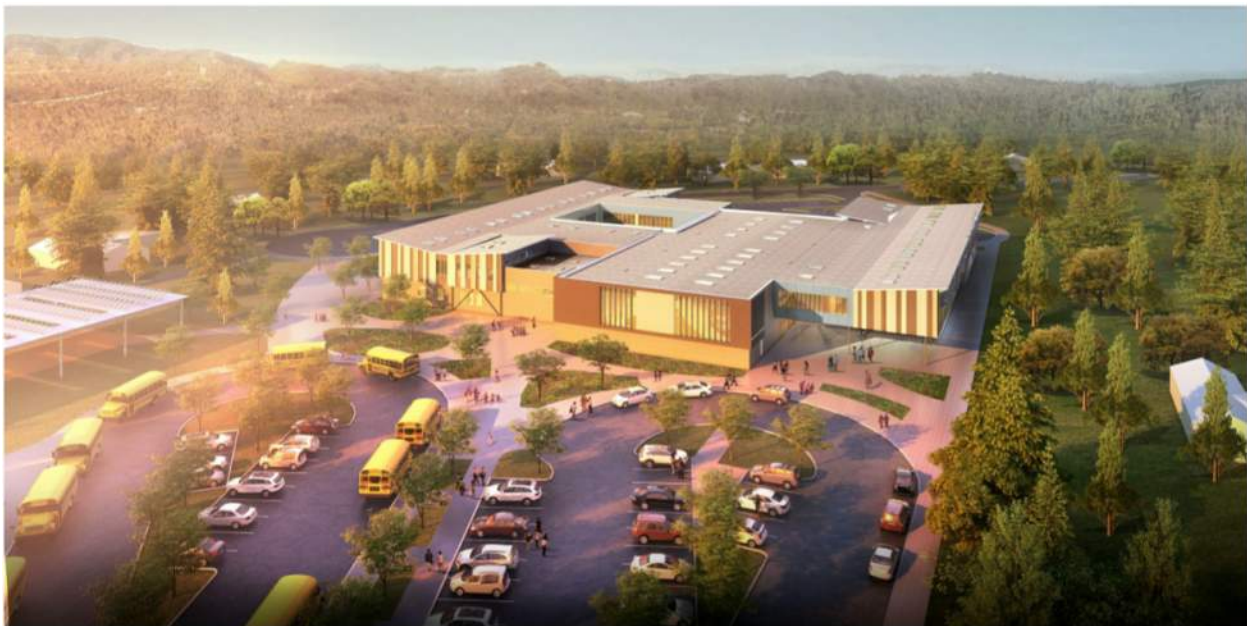
Building Description (separated by construction phases)

The new elementary school replaced the original school built in 1960. The new school includes classrooms, a cafeteria, gymnasium and covered play area. The structure consists of steel framing, precast concrete wall panels and reinforced masonry walls. This building was designed for seismic risk Category IV.

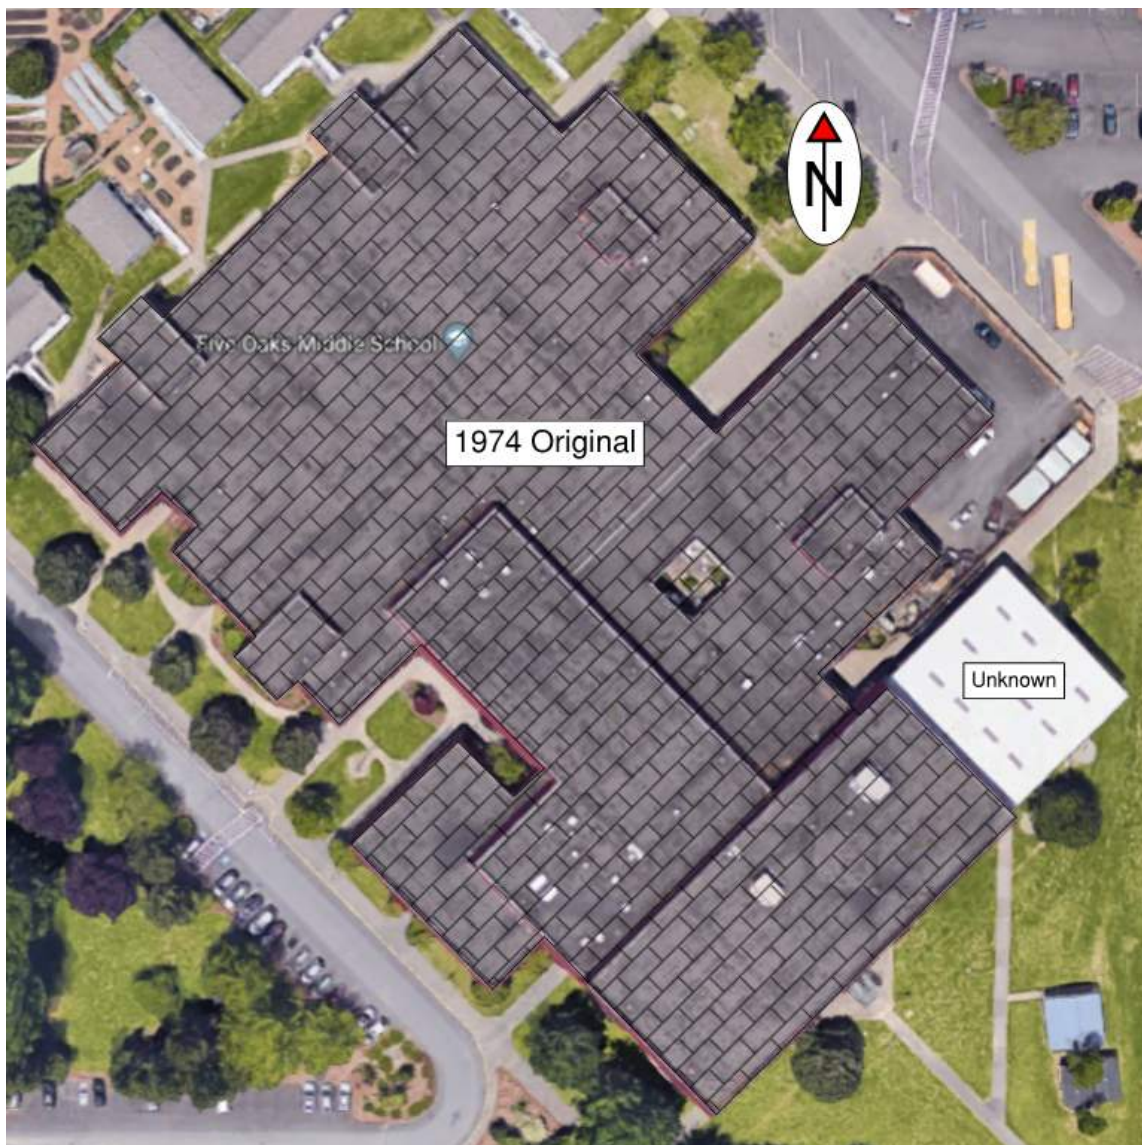
Building Description (separated by construction phases)

The original 1974 building has a combination of reinforced brick masonry shear walls, reinforced CMU shear walls, precast concrete shear walls and wood bearing walls. Connections between the concrete shear wall panels and pilasters are made through dowels cast into the wall panels at a typical spacing. Details show conditions where tilt-up concrete panels are not directly attached to foundations, but reinforced brick/CMU walls are doweled into strip footings and stem walls. The ground floor is constructed of a concrete slab-on-grade that is not directly connected to any foundation or wall elements. Gravity support for the roof is provided by the bearing walls along the perimeter and steel HSS posts on the interior. The roof is built from a combination of open web steel joists and wide flange beams which support bare metal decking.

Exterior shear walls are predominantly constructed of reinforced brick and reinforced CMU. The connection between the metal deck diaphragm and the shear walls are inconsistent. There are a number of shear walls that do not continue to the diaphragm (including locations where metal stud walls stack on top of CMU walls. Reinforced CMU walls that intersect concrete wall panels are positively connected using anchors at typical spacing. All CMU walls are directly connected to foundations.

- Exterior shear walls are not adequately anchored to diaphragms for both in-plane and out-of-plane forces.
- Precast wall panels lack a positive connection to the foundation capable of developing strength of the wall.
- Shear wall lines lack continuous collectors at the roof level which may lead to a potential deficiency in the diaphragm.
- No connection is present between slabs and foundation elements.
- Re-entrant corners lack sufficient tensile capacity to develop strength of diaphragm.
- A potential deficiency exists at the gymnasium pilasters for out-of-plane loading.
- Seismic joint detailing and size likely insufficient between main building and gymnasium.
- Reinforced brick site walls could be a falling hazard and should be analyzed further.

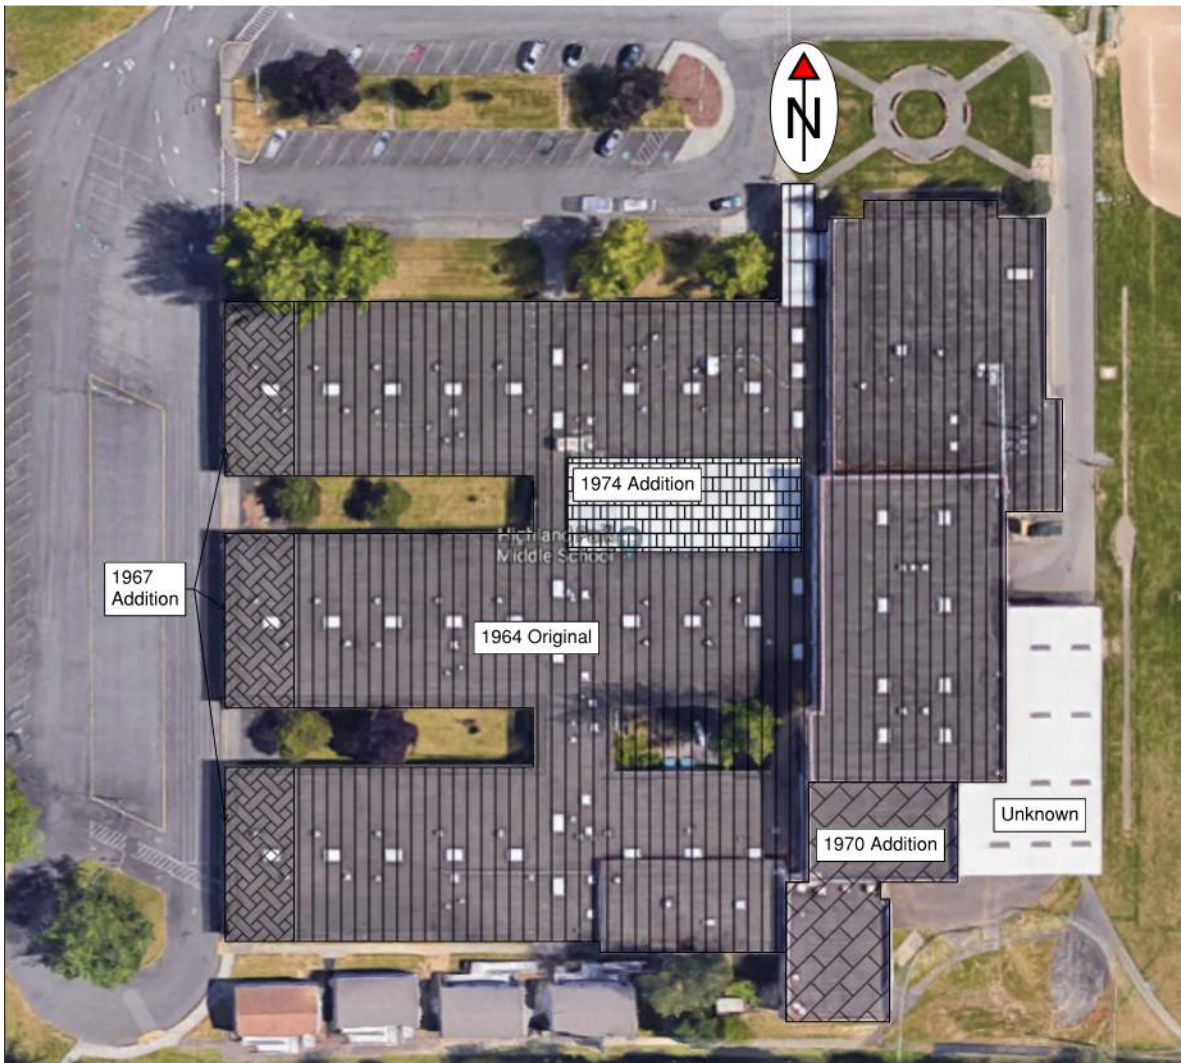
Building Description (separated by construction phases)

The original 1964 construction and later additions are well documented and consistently use the same building scheme between the four middle schools listed:

The lateral structure consists of perimeter tilt-up concrete walls spanning between steel columns and concrete pilasters. Interior wood bearing walls are not explicitly sheathed for any lateral performance. Foundations are typical concrete strip footings with concrete stem walls that extend up to meet either concrete or wood stud walls. Floor structure is reinforced concrete slab-on-grade with no direct connection to any foundation or stem walls. The diaphragm is typically connected to shear walls for in-plane load transfer but lacks adequate connections for out-of-plane loading. The classroom wings contain plywood diaphragms while the gymnasium and 1970 addition contain Tectum sheathing.

- Precast wall panels lack a positive connection to the foundation capable of developing strength of the wall.
- Classroom wings exterior walls contain “ribbon windows” and do not have any dedicated shear walls. Provide interior wood shear walls to address diaphragm span deficiency.

- A potential deficiency exists between diaphragms at original construction and 1974 courtyard infill for both in-plane and out-of-plane load transfer.

- Potential deficiency exists at the large concrete entry canopy that will likely require foundation and column strengthening.
- Covered play area does not appear to contain a lateral force-resisting system and should be tied into the main building.

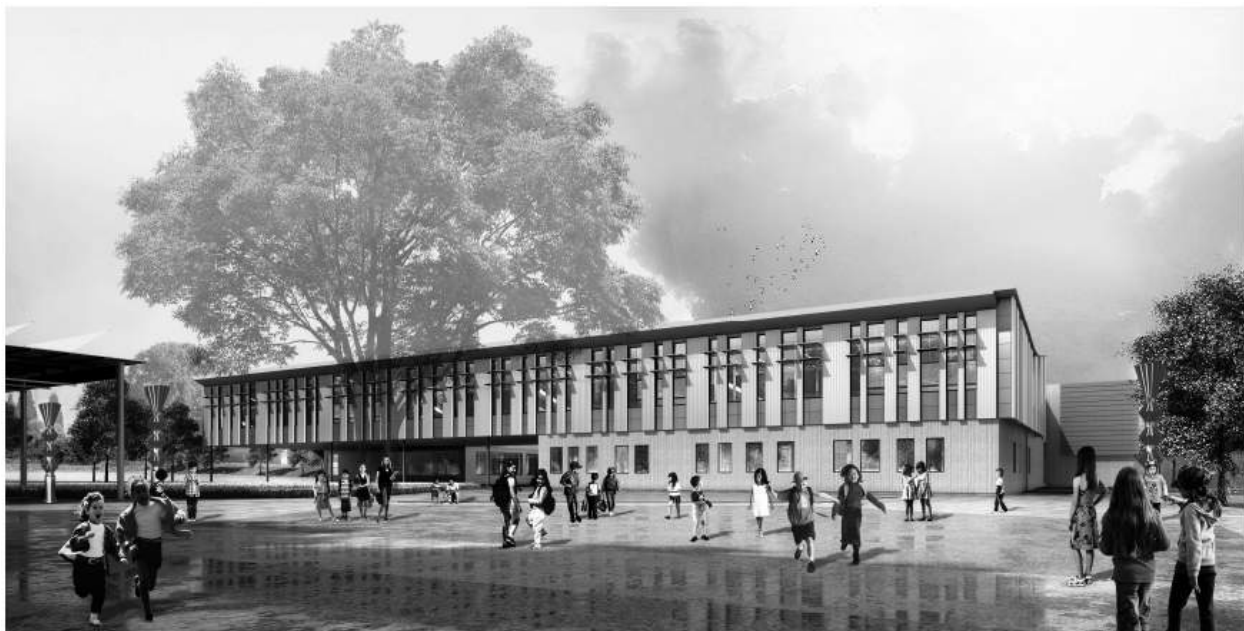
Building Description (separated by construction phases)

This new building includes classrooms, cafeteria, gymnasium and covered play area. The structure consists of steel framing and precast concrete wall panels. This building was designed for seismic risk Category IV.

Due to the recent year of construction, this is a “benchmark building” per ASCE 41-13 and was not evaluated during this assessment for structural deficiencies.

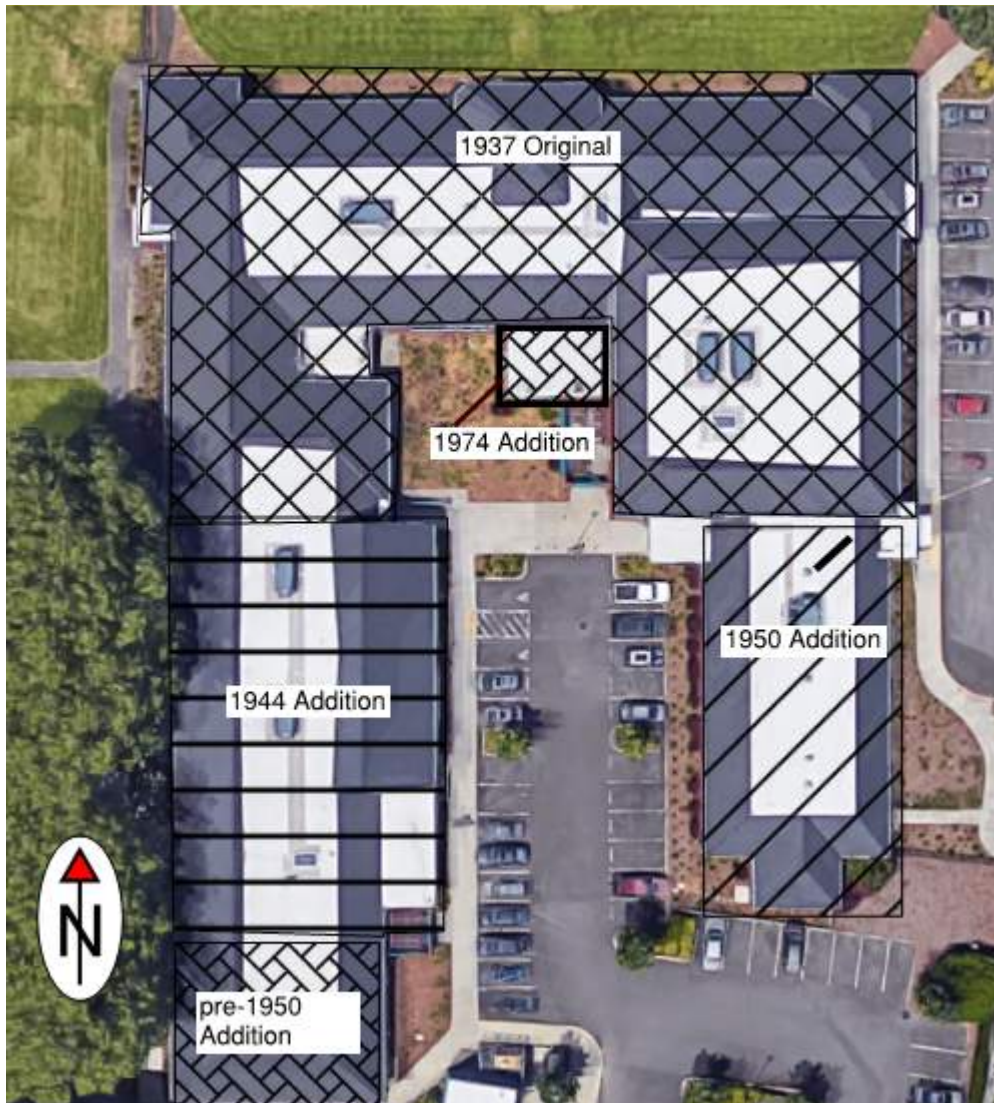
The primary lateral system for this structure is wood framed construction (W2) with one building wing consisting of unreinforced masonry (URM) bearing walls. The roof diaphragm is a flexible plywood roof.

Building Risk Category III
 ASCE 41-13 Damage Control Performance Level

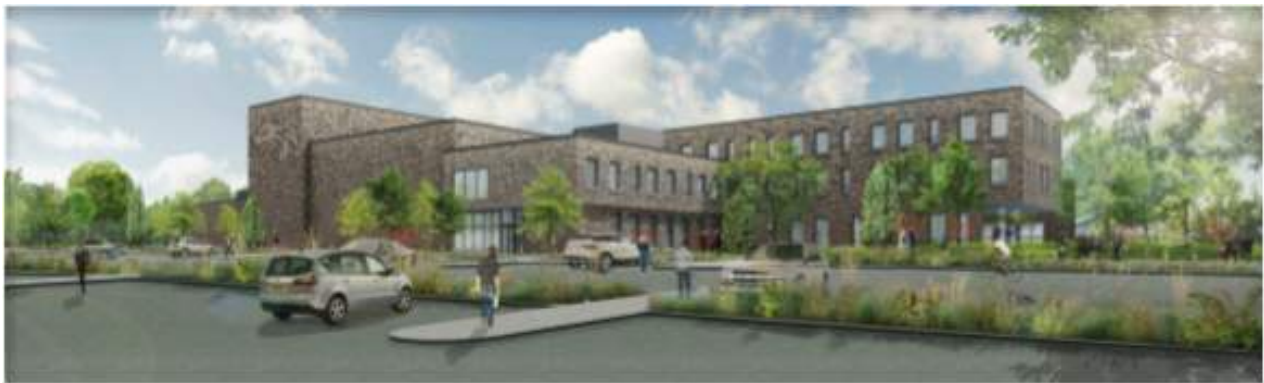
Building Description (separated by construction phases)

This new building includes classrooms, cafeteria, a gymnasium and a covered play area. The structure consists of steel framing and precast concrete wall panels. This building was designed for seismic risk Category IV.
