Oregon Seismic Status Report - 2019

JENNIFER EGGERS, ASSOCIATE/PROJECT MANAGER
NATHAN INGRAFFEA, PRINCIPAL
KPFF CONSULTING ENGINEERS
111 SW FIFTH AVENUE, SUITE 2500
PORTLAND, OR 97204-3628

SEISMIC ASSESSMENTS FOR THE BEAVERTON SCHOOL DISTRICT

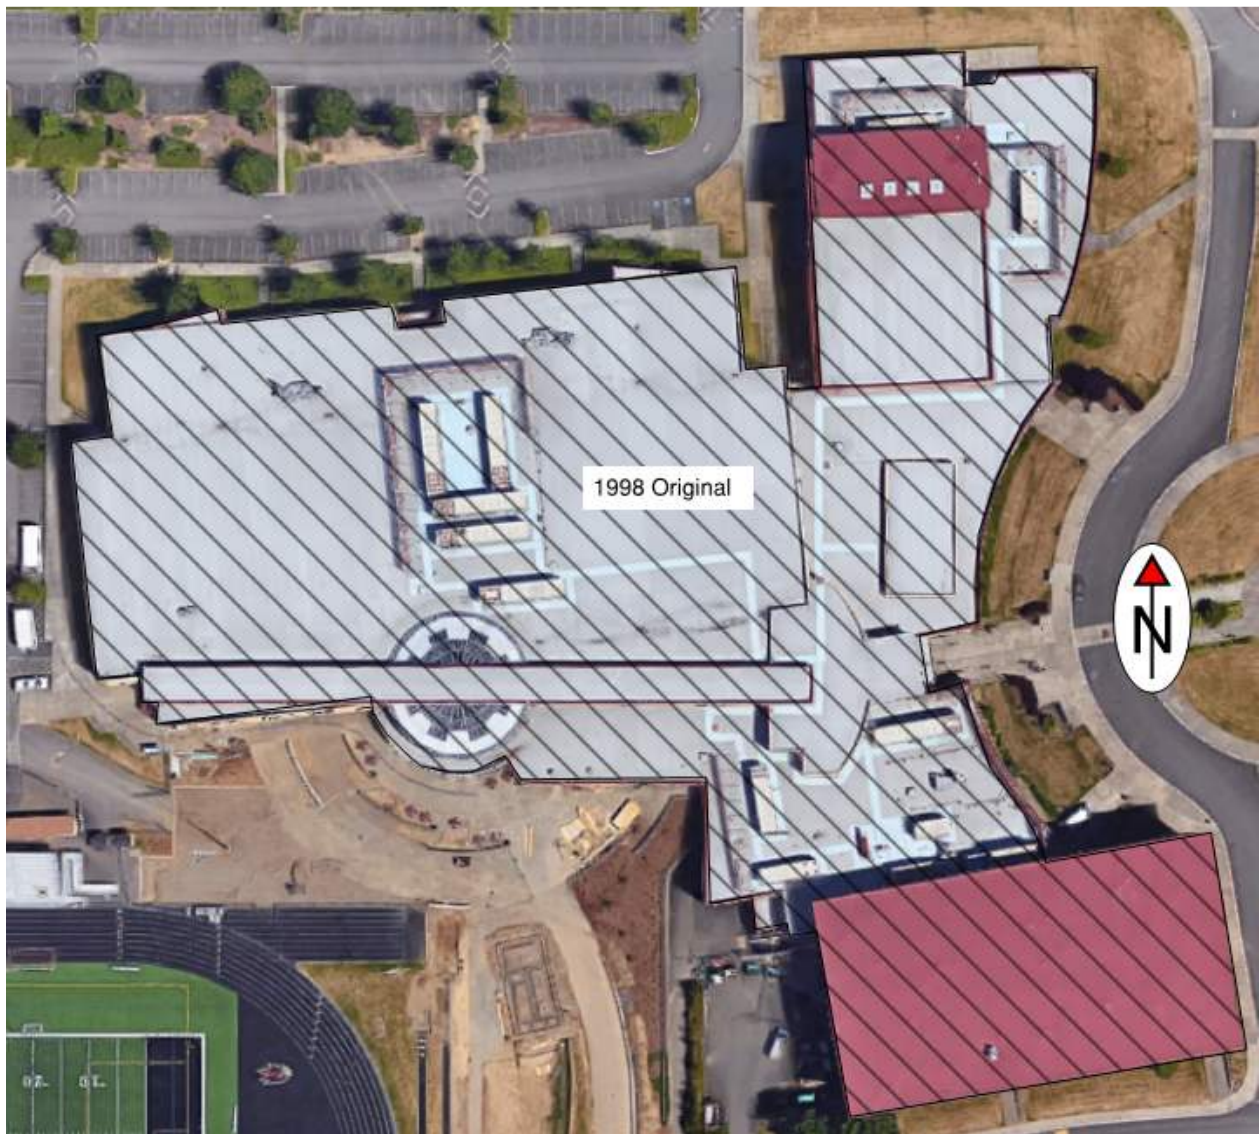
Building Description (separated by construction phases)

Southridge High School was constructed in 1998 in Beaverton, Oregon. It is a steel building consisting of a main classroom wing, one auditorium wing, and one gymnasium.

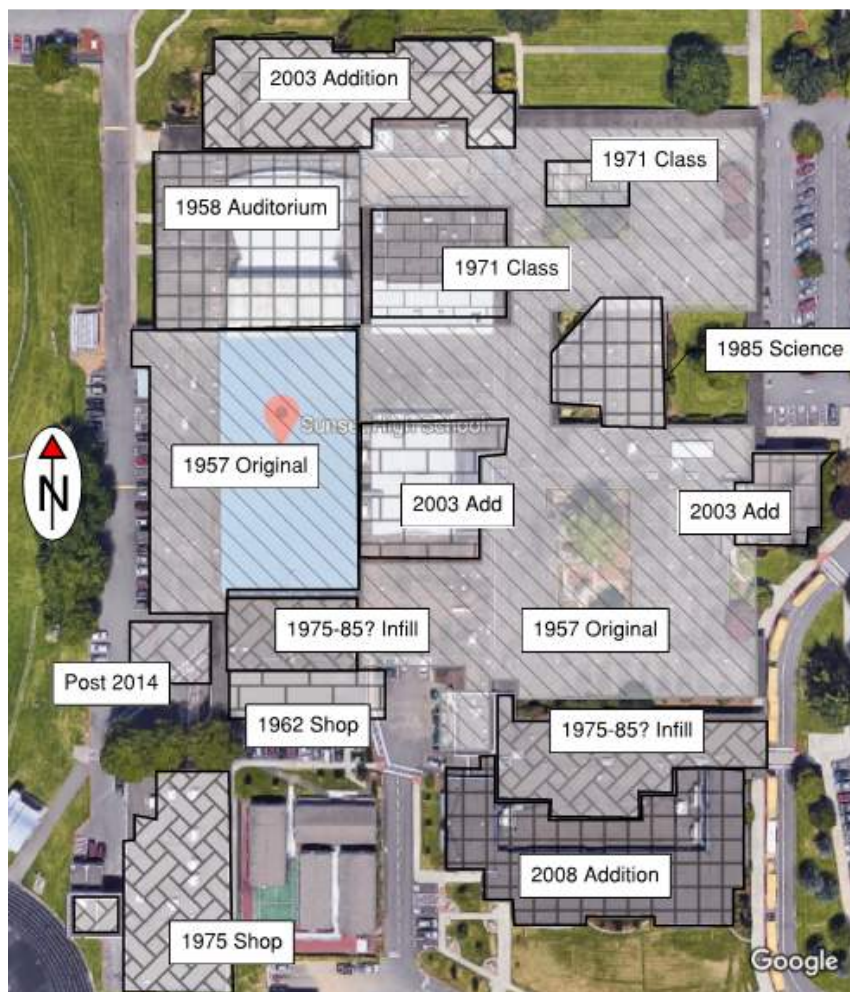
Building Description (separated by construction phases)

The original building was constructed in 1957 and has had several additions. The original building is a single-story structure with a large mezzanine serving as an auxiliary gymnasium to the main gymnasium. The main building is post and beam wood construction (W2). The roof consists of sheathing on 2x joists and glulam girders. The exterior walls are constructed with 2x wood stud framing with brick veneer. The building is supported laterally with interior gypsum sheathed wood shear walls and exterior plywood sheathed wood shear walls. There is an attached gymnasium that consists of a steel beam and tilt-up concrete wall construction (PC1a). The concrete walls provide lateral support for the gymnasium. The foundation systems for both building types consist of interior concrete spread footings and continuous concrete footings at the building perimeter.

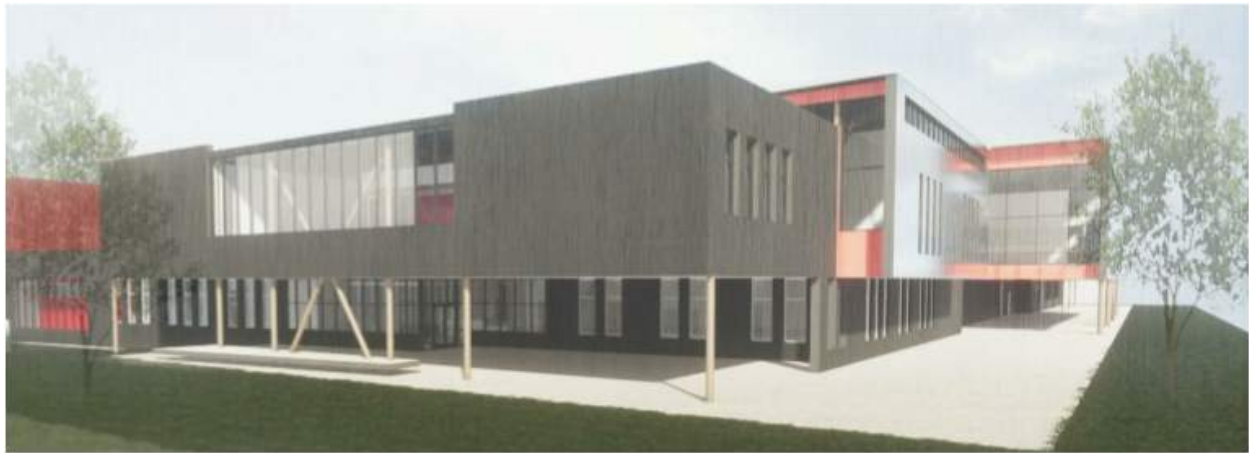
Building Description (separated by construction phases)

A new school building is to be constructed in 2019 replacing the building originally constructed in 1948. The 2009 Performing Arts Center is to remain. The new structure will contain classrooms, large commons area, and kitchen. The new building will connect to the Performing Arts Center that was built in 2009 and designed by James G. Pierson structural engineers. The 2009 building was designed for a seismic risk Category III and the 2019 building is being designed for seismic risk Category IV.

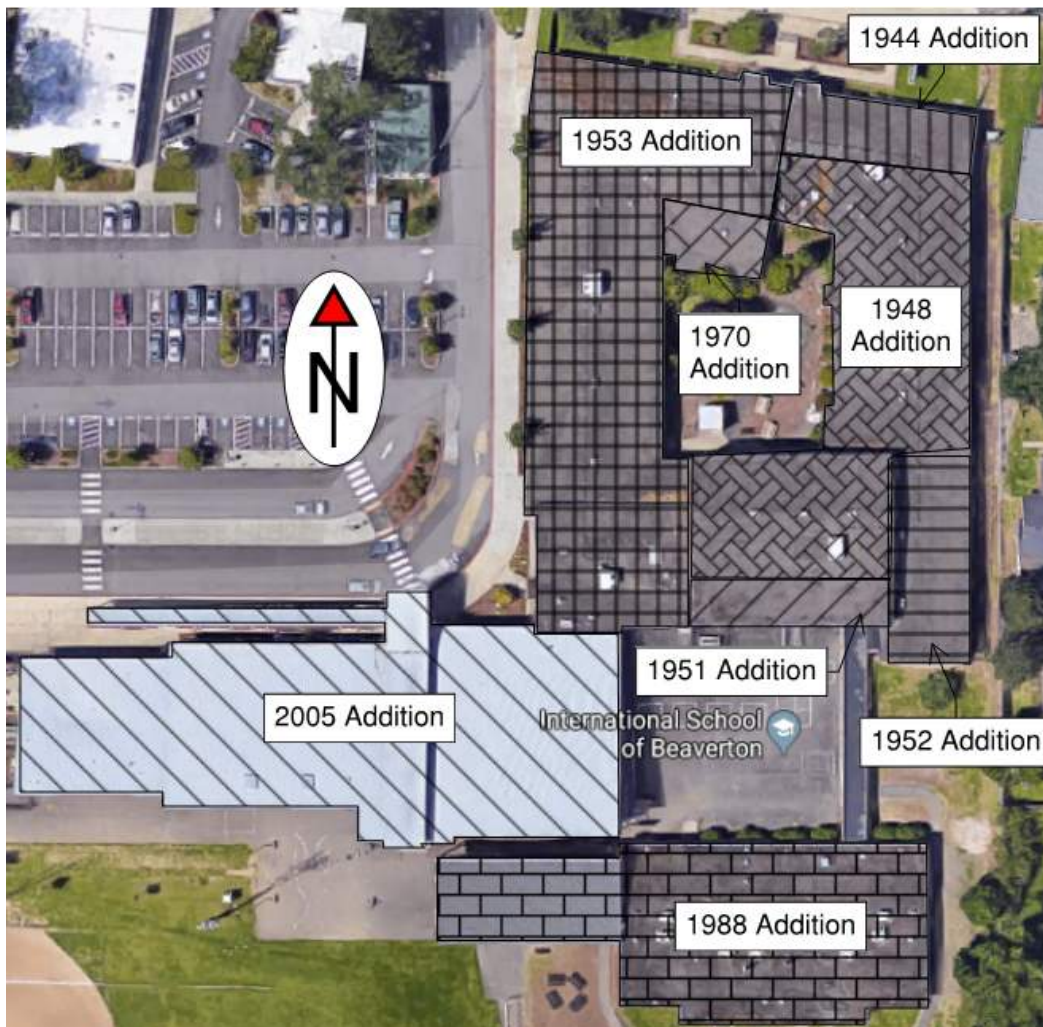
Building Description (separated by construction phases)

The 1944 addition is one-story building constructed of concrete strip footings, straight sheathed wood shear walls, and a shiplap diaphragm. There is a crawl space under the first floor in both the hallway and in the classrooms. The first floor is constructed of wood joists spanning between the strip footings and supporting a plywood deck. All of the brick along the exterior is nonloadbearing and acts only as a veneer. There is a URM parapet around the original front entry of the building on the north side.

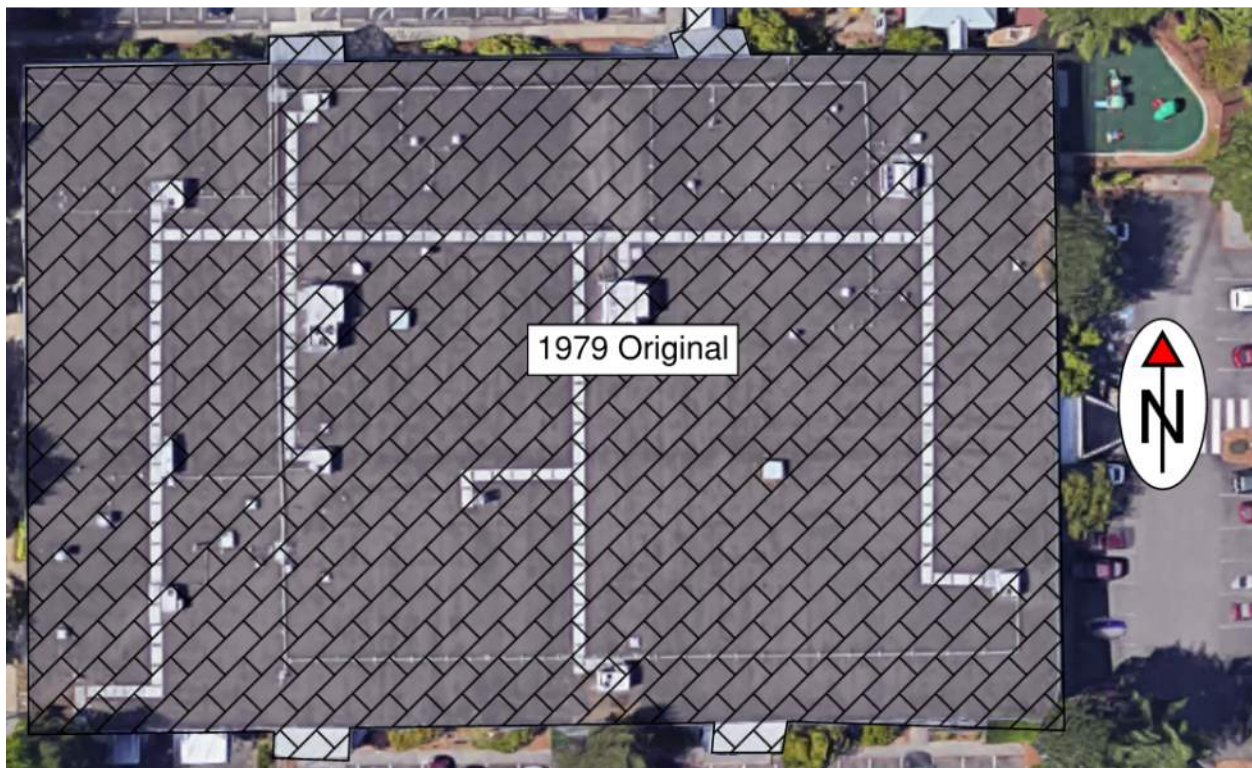
Building Description (separated by construction phases)

The building was constructed in 1979 and served as a support facility for the school district before being converted into an alternative high school. The foundation was built with a concrete slab-on-grade and a concrete strip footing. The lateral force-resisting system consists of concrete tilt-up panels along the perimeter of the building with a plywood sheathed roof diaphragm. The gravity system has open web wood trusses that are supported by glulam beams. The glulam beams are supported by the precast tilt-up wall panels and interior steel pipe columns for support.

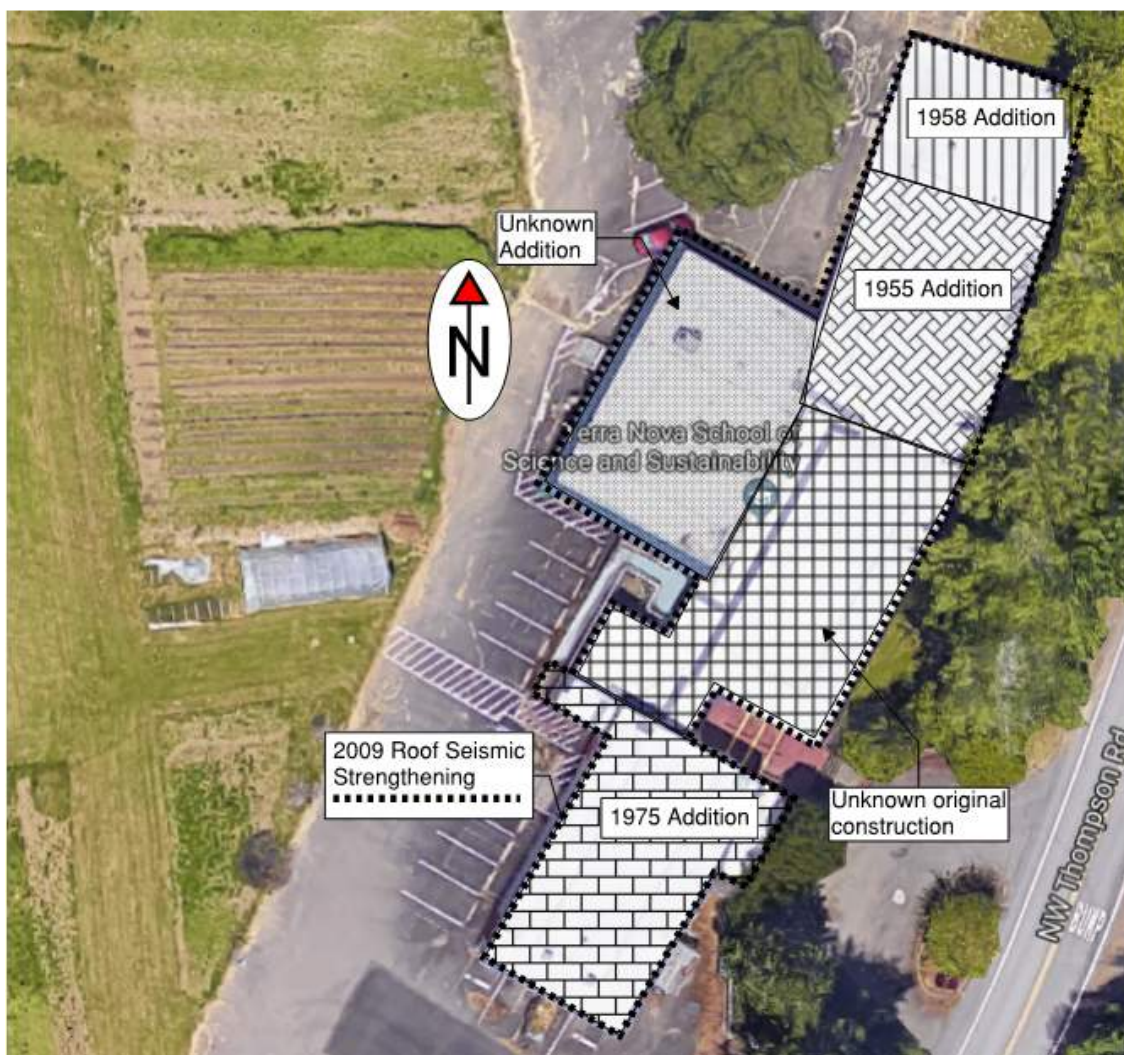
Building Description (separated by construction phases)

The original building was observed to be similar to the 1955 and 1958 additions. These additions have strip footing foundations and a concrete slab-on-grade. The strip footings support wood shear walls. The shear walls are tied into the footings with steel anchors and attached to the roof diaphragm. There was a wall infill for the covered roof over the hallway, but drawings were not available during this review. It is assumed that the structure is a wood wall infill similar to the construction of the rest of the building.

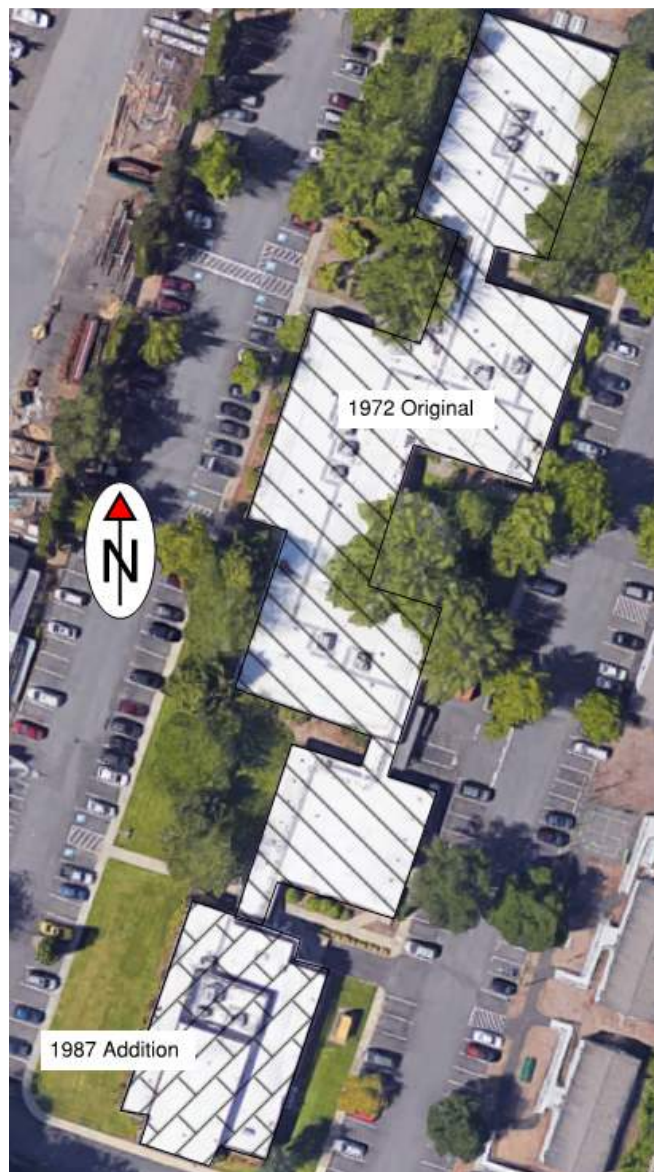
Building Description (separated by construction phases)

The main portion of the administration building was constructed in 1972. The roof of this single-story masonry structure (RM1) consists of plywood sheathing on TJI's on glulam beam girders. The roof is supported by reinforced clay brick perimeter bearing walls and interior steel columns. The first floor is a slab-on-grade. The foundation consists of continuous concrete walls at the building perimeter and isolated concrete footings at the building interior. The building is laterally supported with plywood sheathed roof diaphragms and clay brick shear walls.

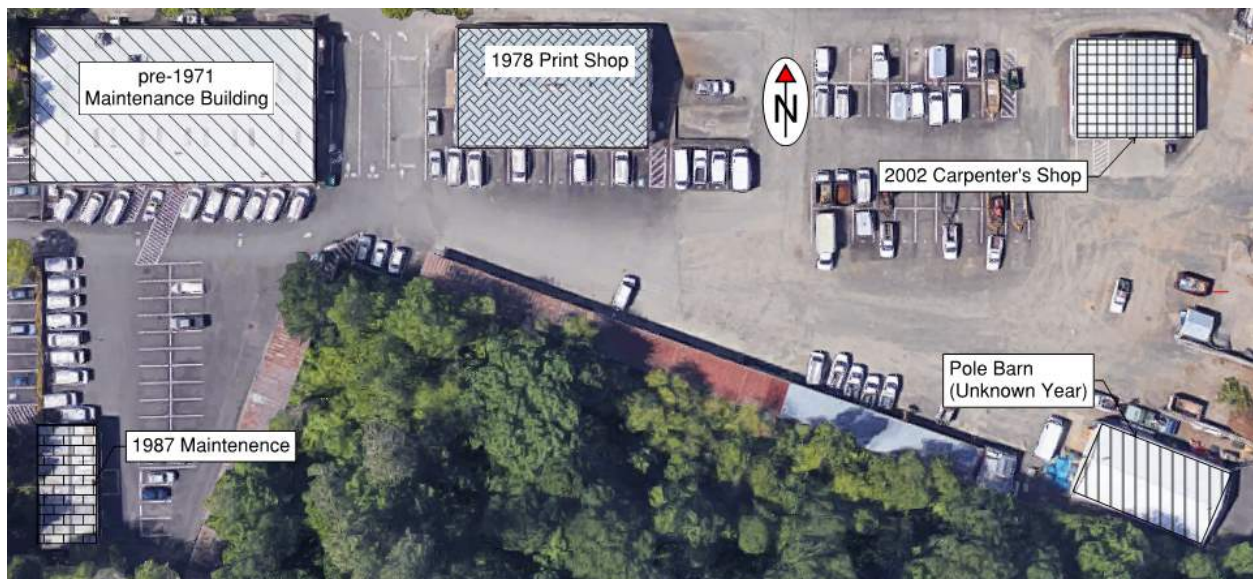
Building Description (separated by construction phases)

Built prior to 1971, the maintenance shop is a single-story steel warehouse (S2). The roof is a steel deck supported on steel beams and plate girders. The plate girders are supported by tapered plate columns. The building is laterally braced with steel tension braces at the exterior walls in the long direction and steel moment frame (plate girders) in the short direction. The first floor is a slab-on-grade. Foundation elements are unknown.

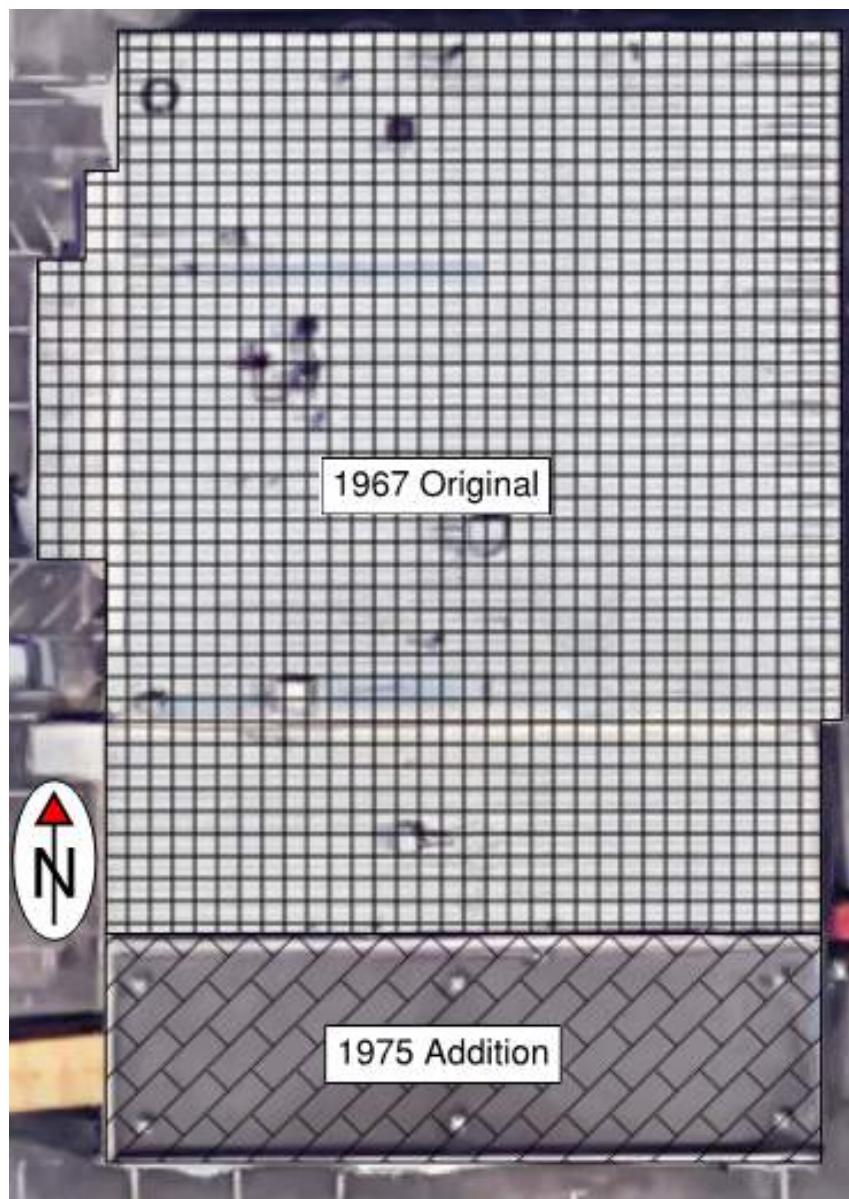
Building Description (separated by construction phases)

The Transportation Allen building was built in 1967 and functions primarily as a maintenance facility. The original building is a single-story masonry building (RM1). The roof is a corrugated metal roof supported by glulam beams and CMU pilasters. The first floor is slab-on-grade. The foundation is unknown. The building is laterally braced by a corrugated metal deck diaphragm and CMU shear walls. There is a mezzanine driver’s lounge on the west side of the building. The construction of this lounge could not be determined in the field due to hard ceilings below. There is a wood mezzanine in the shop constructed with 2x joists and supported by wood posts.

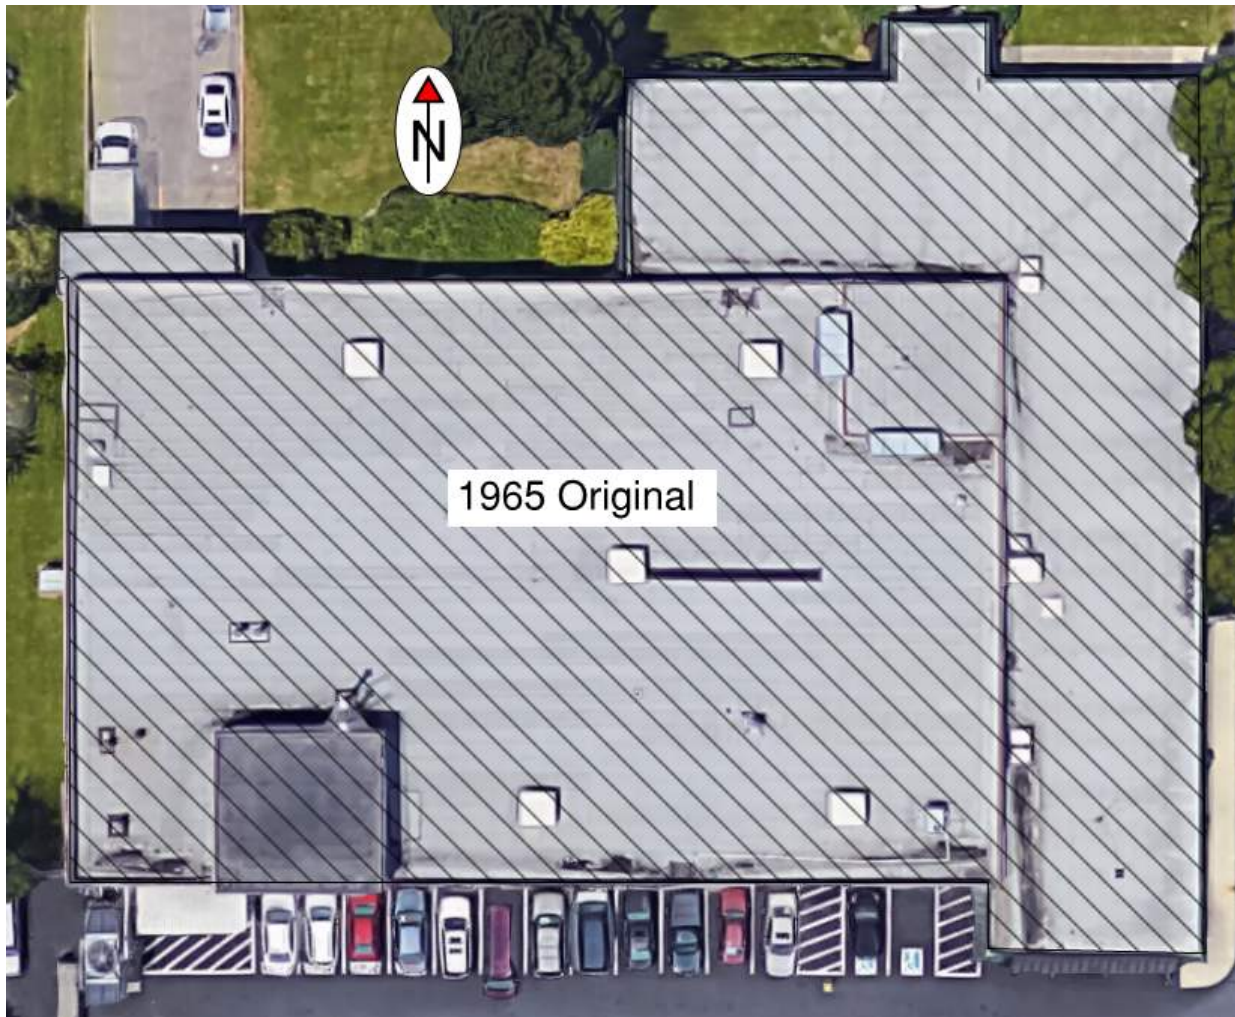
Building Description (separated by construction phases)

The Transportation 5th St. South building was constructed in 1965 as print shop. This is a single-story structure that encloses a warehouse space and several offices. The roof consists of metal deck on steel wide flange beams. These beams are supported by steel girders. These girders are supported by interior steel columns and exterior CMU pilasters. The exterior of the building is constructed with reinforced CMU walls (RM1). The columns are supported by concrete spread footings and the CMU
