Preparing for a smooth inspection

Alternative fuel compatibility

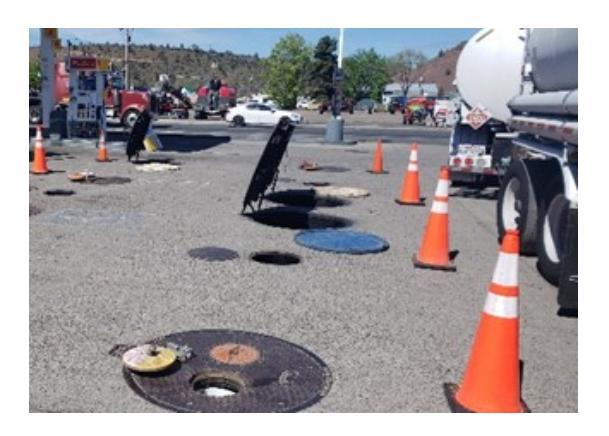
Tank top sumps are accessible, clean and dry, sensors are installed correctly, and interstitial boots are open.

This tank was installed in 1998!

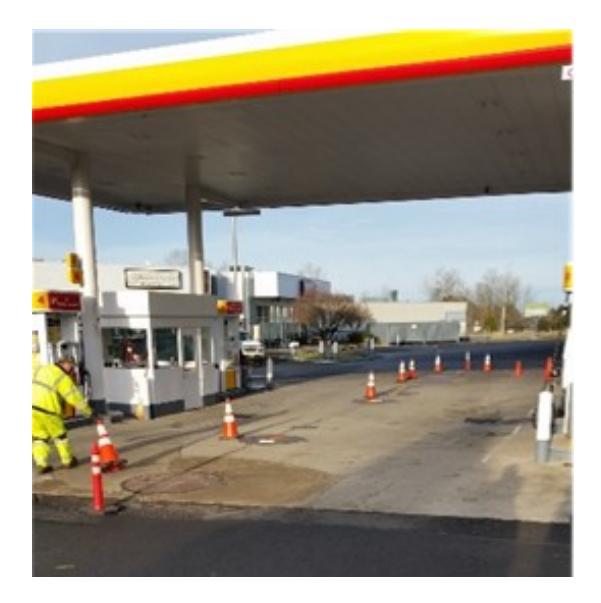
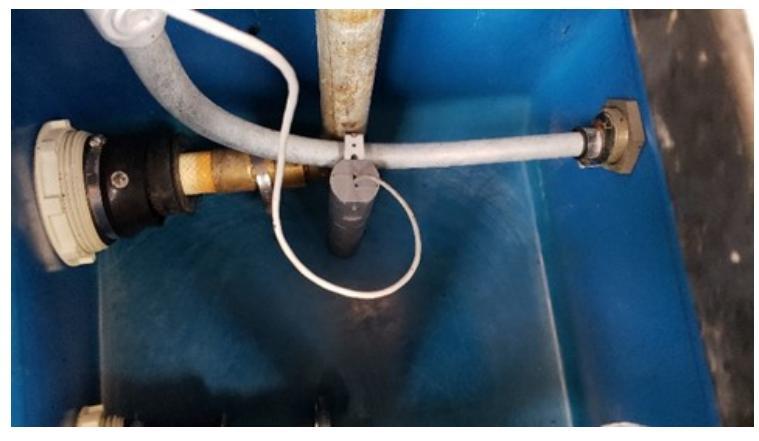
Again, UDC sumps are clean and dry and sensors are installed correctly, able to detect liquid at the lowest part of the sump.

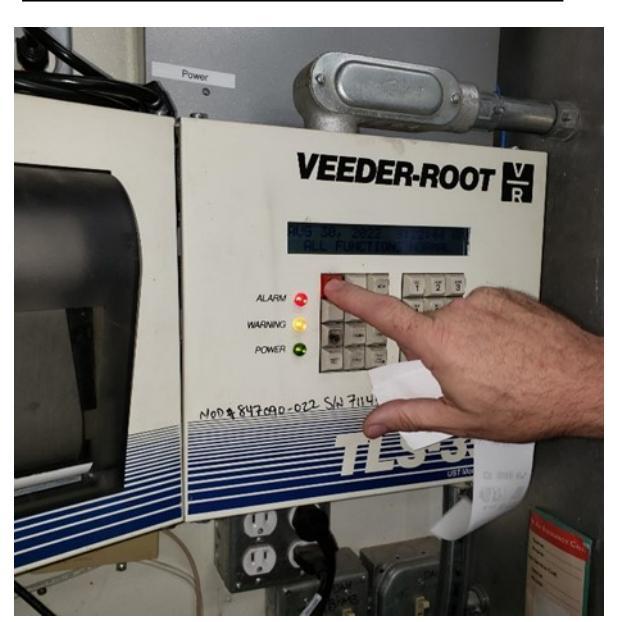
Tank gauges are easily accessible, and Leathers ensures that someone is present at the facility who knows how to print any required paperwork and sound the overfill alarm.

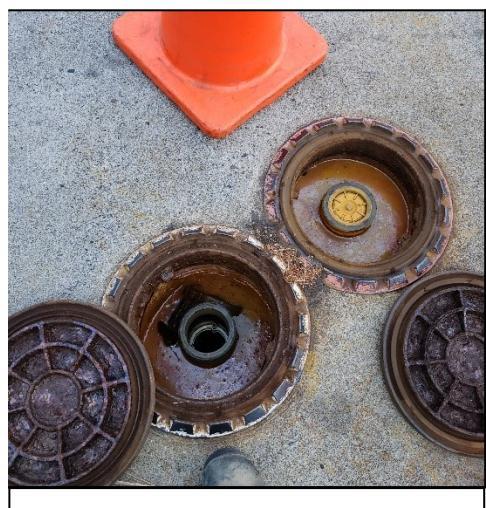
Spill buckets must be visually inspected at least once a month. Spill buckets full of debris or water may limit the effectiveness of catching overages from fuel drops and may require extensive cleanups over time.

Poorly maintained spill bucket: filled with dirty liquid

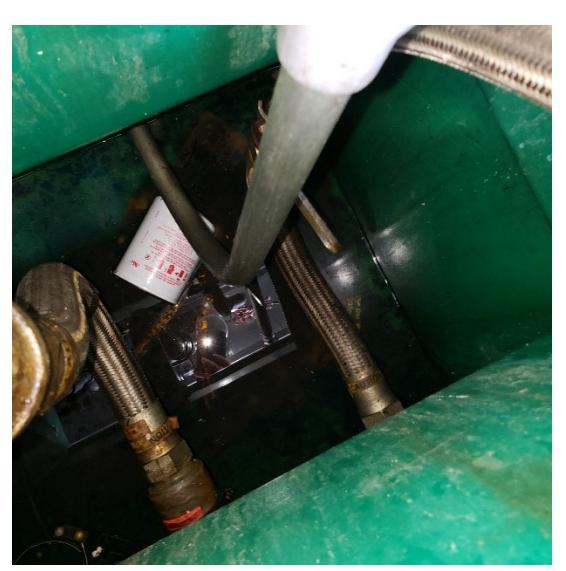
Poorly maintained dispenser containment: full of liquid

Containment sumps such as tank top sumps and dispenser sumps need to be inspected yearly. The inspection is to ensure the sumps are clean and properly maintained, which may help limit a catastrophic release from equipment.

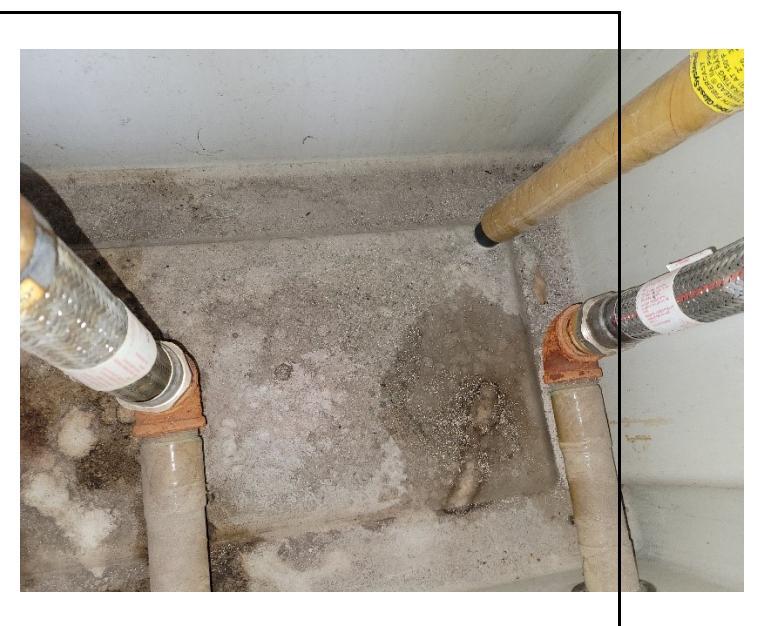
Well maintained dispenser containment: clean and dry

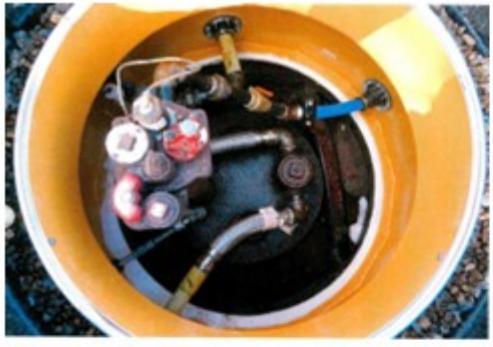
Installed March 2019. New piping, union, and coupling

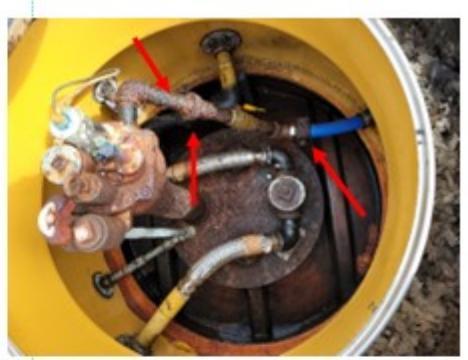
May 2023 inspection. Corrosion due to gasoline vapors containing ethanol escaping from loose equipment

At the right are some examples of ethanol corrosion due to vapor leaks in containment sumps.

Corrosion will reduce the life expectancy of the equipment and may also interfere with release detection. A few minutes of maintenance may prevent a large release!

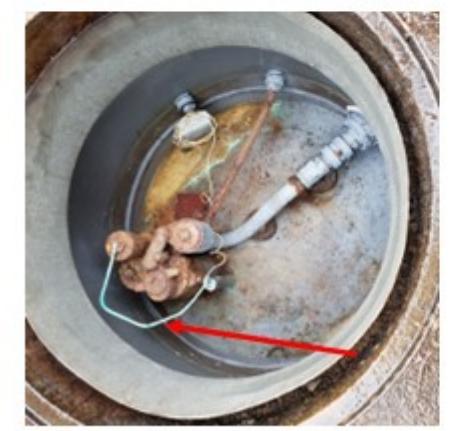
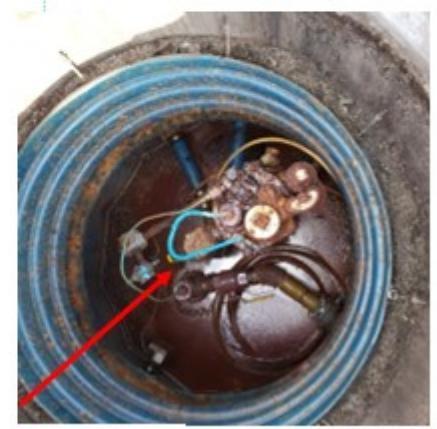
Blue residue on copper piping is a result of corrosion due to gasoline vapors
