**ASSESSMENT AND MITIGATION OF  
LIQUEFACTION HAZARDS TO  
BRIDGE APPROACH EMBANKMENTS  
IN OREGON**

**Final Report**

**SPR 361**

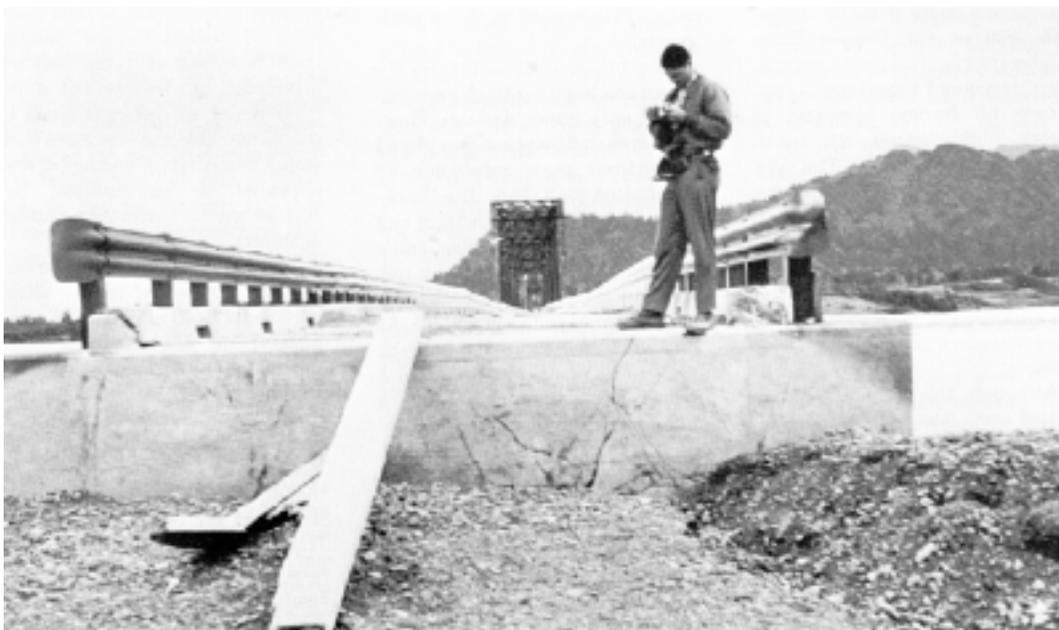
Figure 2.10(b): Post-earthquake Settlement at Copper River Bridge 334

Nineteen bridges were also damaged along a 35-km stretch of highway on the Copper River. Most of these bridges sustained moderate to severe deformations with spans collapsing in at least six crossings. Prevalent types of failure included severe abutment deformation and vertical displacement of foundations. At Bridge 334 shown in Figure 2.10(a), damage occurred as a result of differential pier settlement. Extensive deposits of sand and gravel dominate the Copper River region, where considerable evidence of liquefaction was present in the form of fissures and subsidence craters with adjacent ejected soil. Extensive post earthquake settlement of the approach fill was also evident at Bridge 334 as shown in Figure 2.10(b).

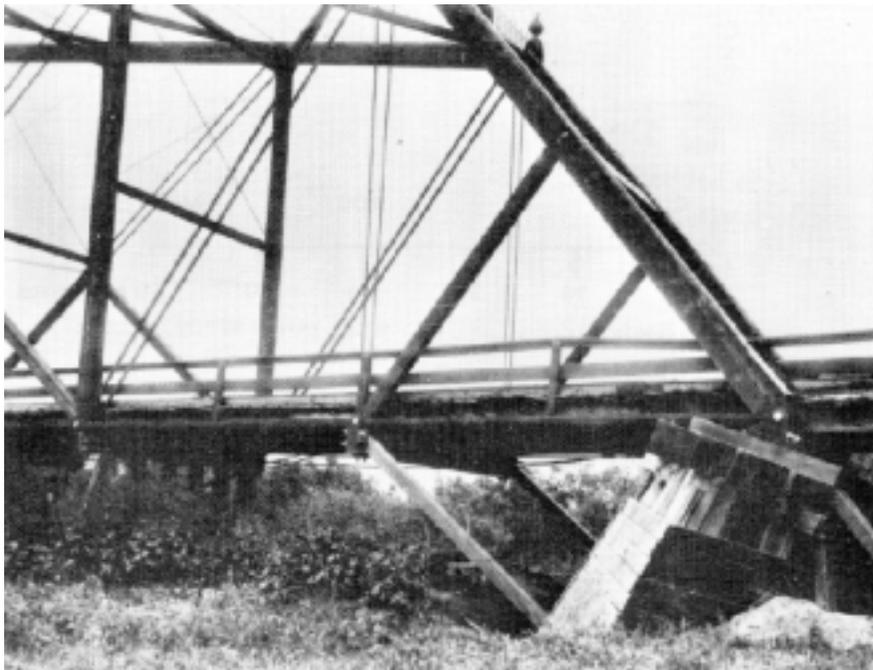
Figure 2.20: South Terminal Pier of Bridge over Salinas River 6.4 km South of Salinas

Several intriguing comparisons can be made regarding the seismic performance of highway and railroad bridges in the lower Salinas River region. The Salinas River Highway Bridge is located roughly 5 km from the Moss Landing site. Damage to a highway bridge at this site during the 1906 earthquake is illustrated in Figure 2.20. The ground displacement moved the base of the pier 2.8 m toward the river. The bridge deck and truss acted as strut, holding the tops of piers in place while their bases shifted inward.

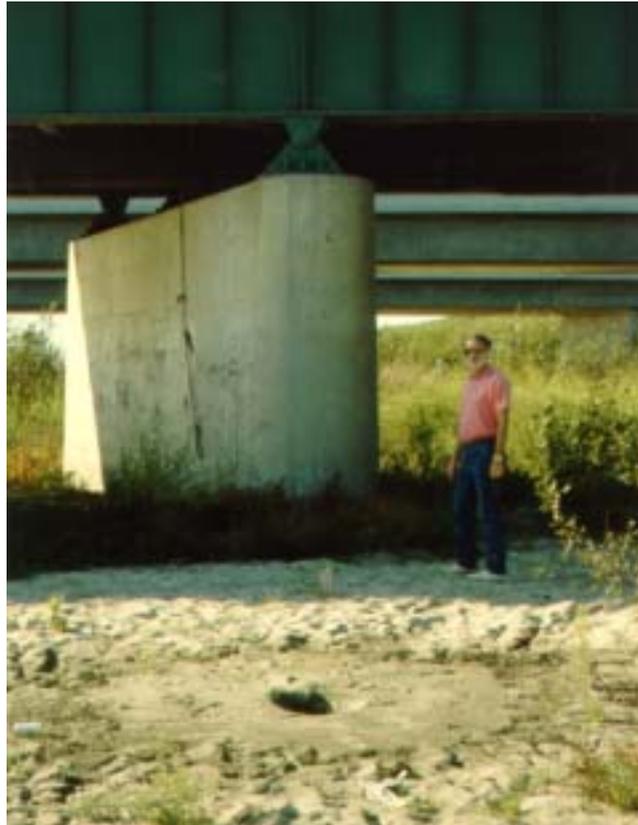
Figure 2.21: Liquefaction-induced Lateral Spreading beneath the Salinas River Highway Bridge

In this vicinity during the 1989 earthquake, liquefaction-induced lateral spreading was once again evident as shown in Figure 2.21. The U.S. Highway 1 and adjacent frontage road bridges were undamaged by the earthquake despite evidence of sand boils, ground oscillation, and lateral spreading of approximately 0.5 meter toward the river. At this same site, relatively large lateral and vertical ground deformations were observed next to a railroad bridge as shown in Figure 2.22. However, the bridge components were not damaged during this earthquake. It is of historic interest that the bridge pier shown in Figure 2.22 was substantially damaged during the 1906 earthquake. Finally, a one-lane bridge located at Moss Landing (in close proximity to the Research Facility) sustained minor damage due to lateral spreading of the approach fill as shown in Figure 2.23.

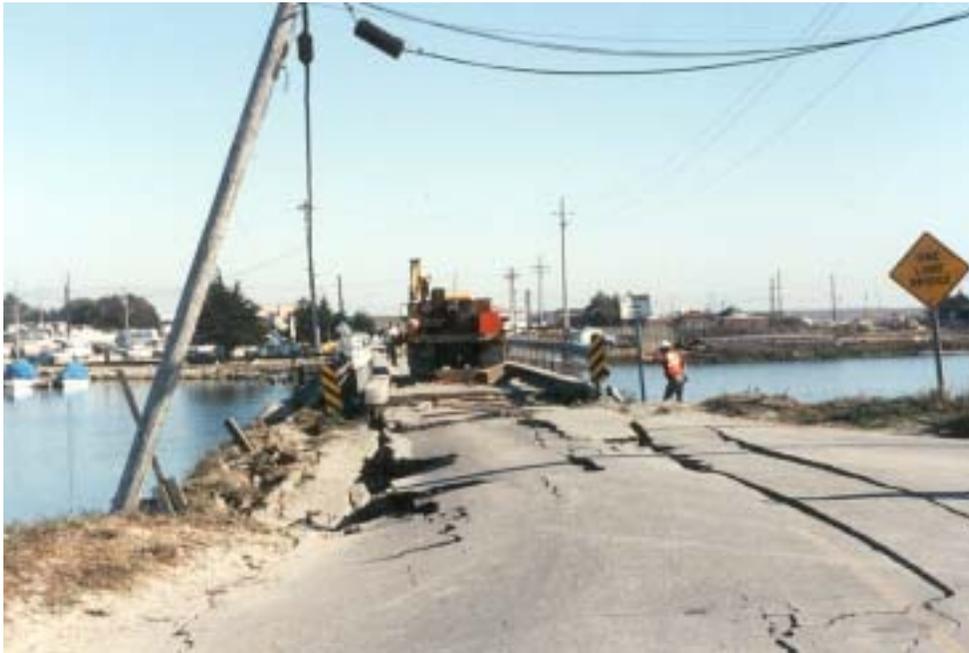
Figure 2.23: Excessive Settlement of Approach Fill

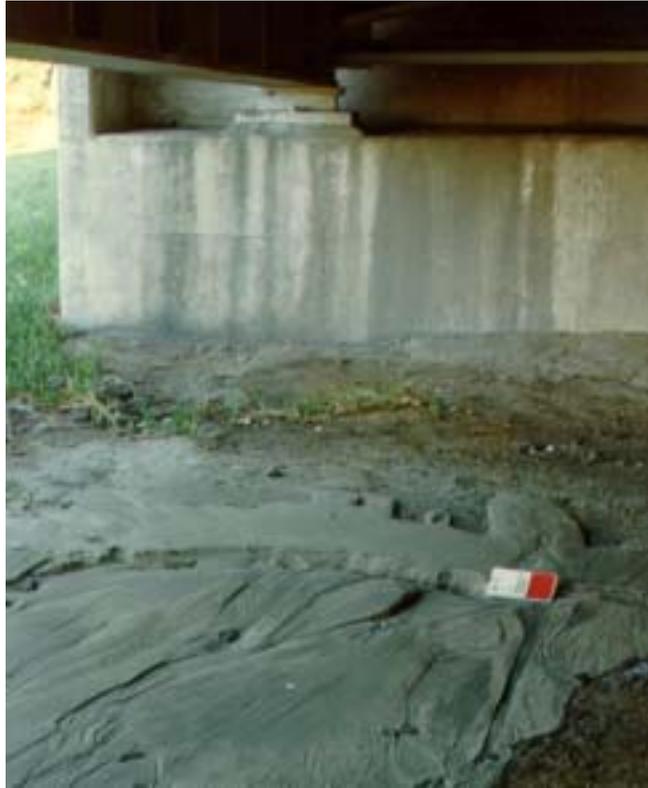
Figure 2.24: Sand Boils at the Oakland-San Francisco Bay Bridge Approach Fill

In the San Francisco Bay area, much farther from the rupture zone, minor liquefaction as evidenced by small sand boils also occurred beneath several elevated sections of the I-80/Grand Avenue Highway “distribution structure” immediately inland of the Oakland-San Francisco Bay Bridge approach fill. Figure 2.24 shows a linear zone of boils adjacent to a pile-supported abutment.

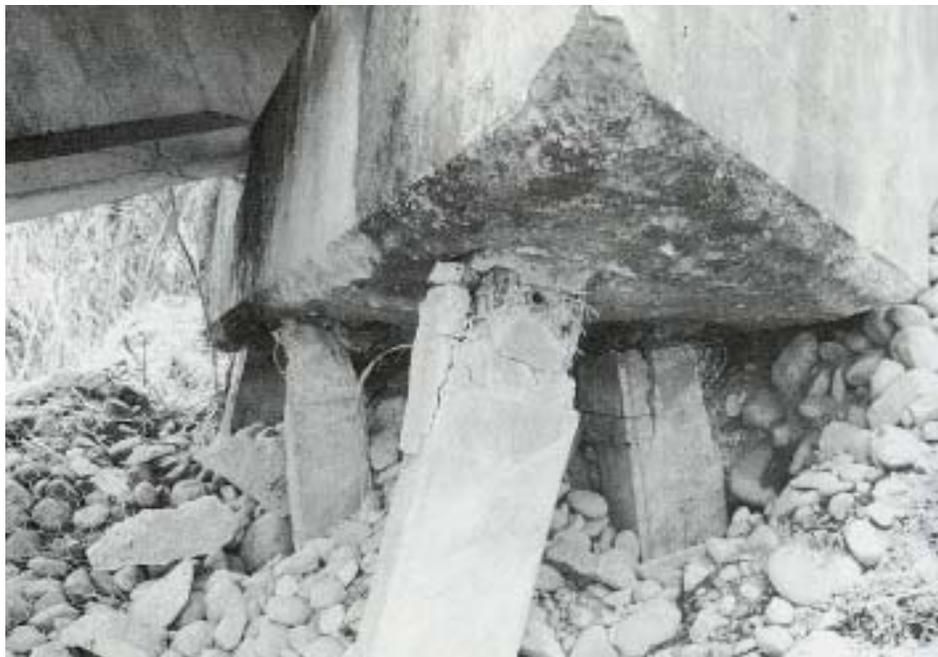
Figure 2.25: Rio Vizcaya Bridge, Pile Failures (North Abutment)

The Rio Viscaya Bridge, a three-span pre-stressed concrete bridge founded in loose sands, collapsed due to loss of soil support and ground deformations resulting from liquefaction. The bridge lost two spans due to severe abutment rotation, resulting in pile distress (Figure 2.25) and the collapse of one interior support. A second interior support settled vertically about 1 m. Geotechnical boring logs near the north abutment showed that the entire length of piles were supported in sands and silty sands. Liquefaction of soils in approach fills caused lateral spreading and bearing capacity failure. The north roadway approach fill settled approximately 1.2 m. Both north and south abutments rotated as a result of movement of liquefied soils.

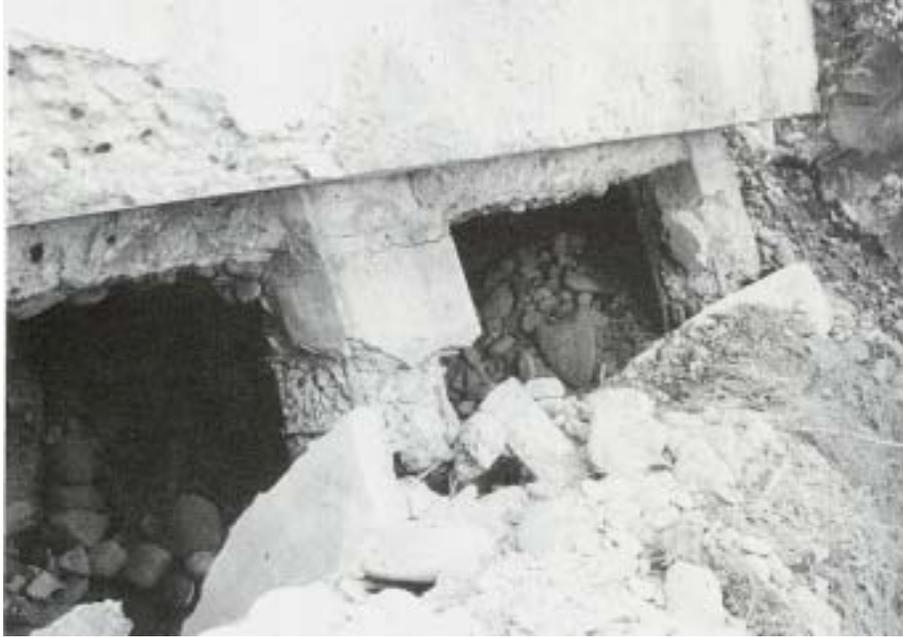
Figure 2.26: Damage due to Liquefaction at Rio Banano Bridge

The Rio Banano Bridge provides an additional example of severe damage due to liquefaction. It was a single lane bridge consisting of three 22 m spans of twin prestressed concrete I-beams, located at a river crossing. The soil movement caused about a  $9^\circ$  rotation of the south abutment resulting in a movement of the pile tops toward the river of roughly 0.7 m. All piles were 36 cm square precast concrete piles. The front piles, driven at a batter of 1H:5V, suffered flexural as well as shear failures (Figure 2.26). Vertical piles at the rear portion of abutment pile caps showed less damage. As observed at other bridges, the approach fills slumped substantially and restricted access until the grade could be restored.

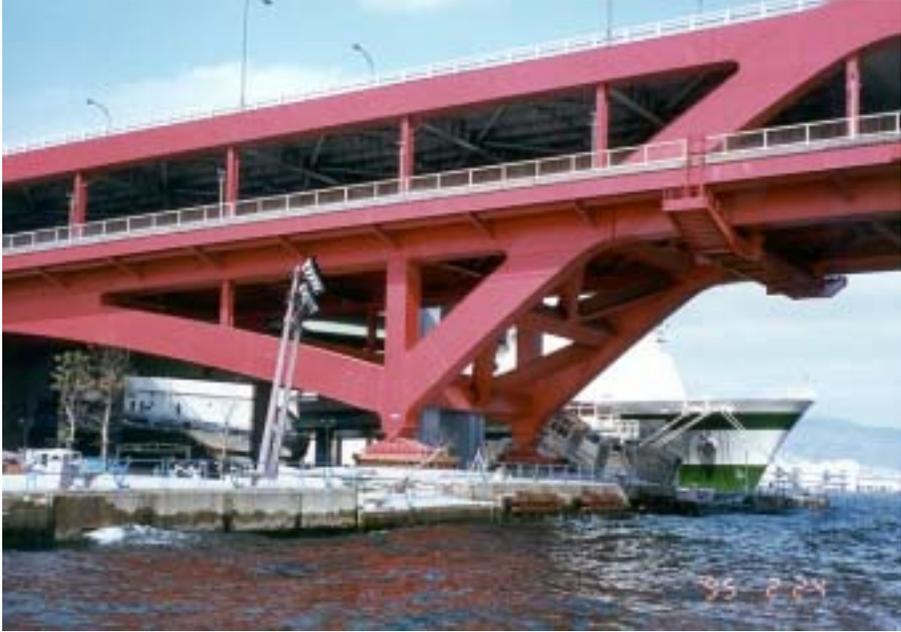
Figure 2.32: Kobe Ohashi Bridge Damage

The Kobe Ohashi Bridge also suffered damage due to the lateral displacement of the caisson foundations as shown on Figures 2.32 and 2.33. In this latter case, the effects of vertical and lateral foundation deformations were evident along the waterfront and at the sliding bearing at the north side of the bridge where roughly 0.6 m of offset was observed (Figure 2.33).

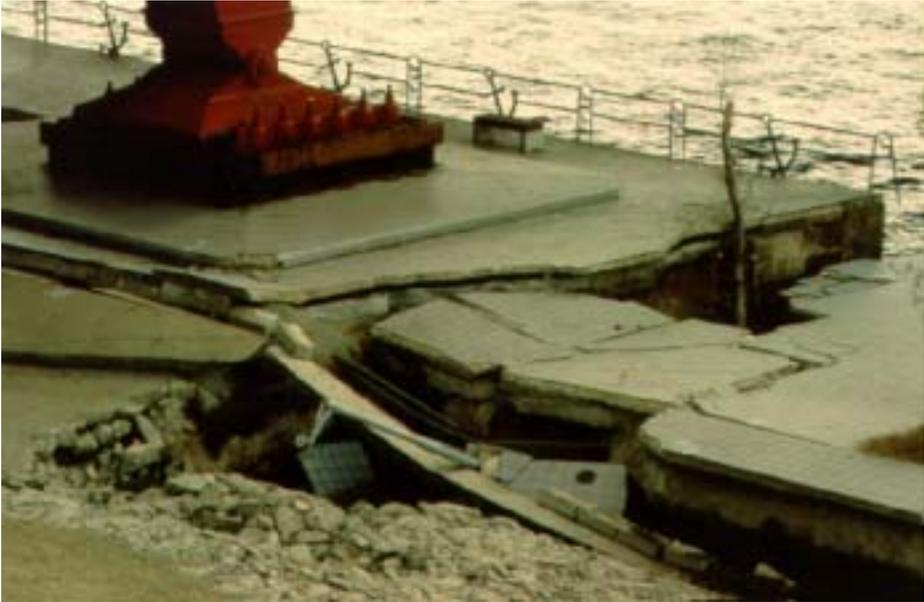
Figure 2.33: Foundation Damage at Kobe Ohashi Bridge

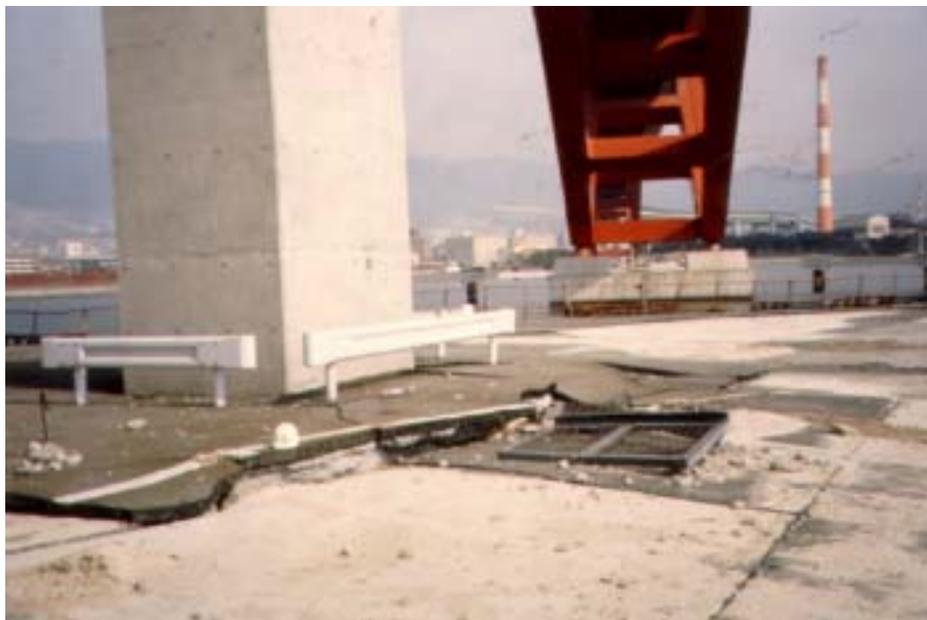
Figure 2.35: Liquefaction Damage Adjacent to the Nadahama Ohashi Bridge

Examples of acceptable bridge foundation performance also were observed in areas conspicuous for liquefaction-induced ground failures. The foundations employed at several of these sites were large groups of steel pipe piles filled with concrete, thereby providing significant resistance to the lateral earth pressures and drag caused by liquefied soil. One such example is the Nadahama Ohashi Bridge where lateral spreading of about 0.5 m was found, as shown in Figure 2.34, yet the bridge did not experience any loss of service (*Hamada et al. 1995*). Soil liquefaction and ground surface settlement was evident at the pile cap adjacent to the waterfront (Figure 2.35).
