SW TUALATIN VALLEY HIGHWAY AT 185TH AVENUE

INTERSECTION IMPROVEMENT DIAGRAM

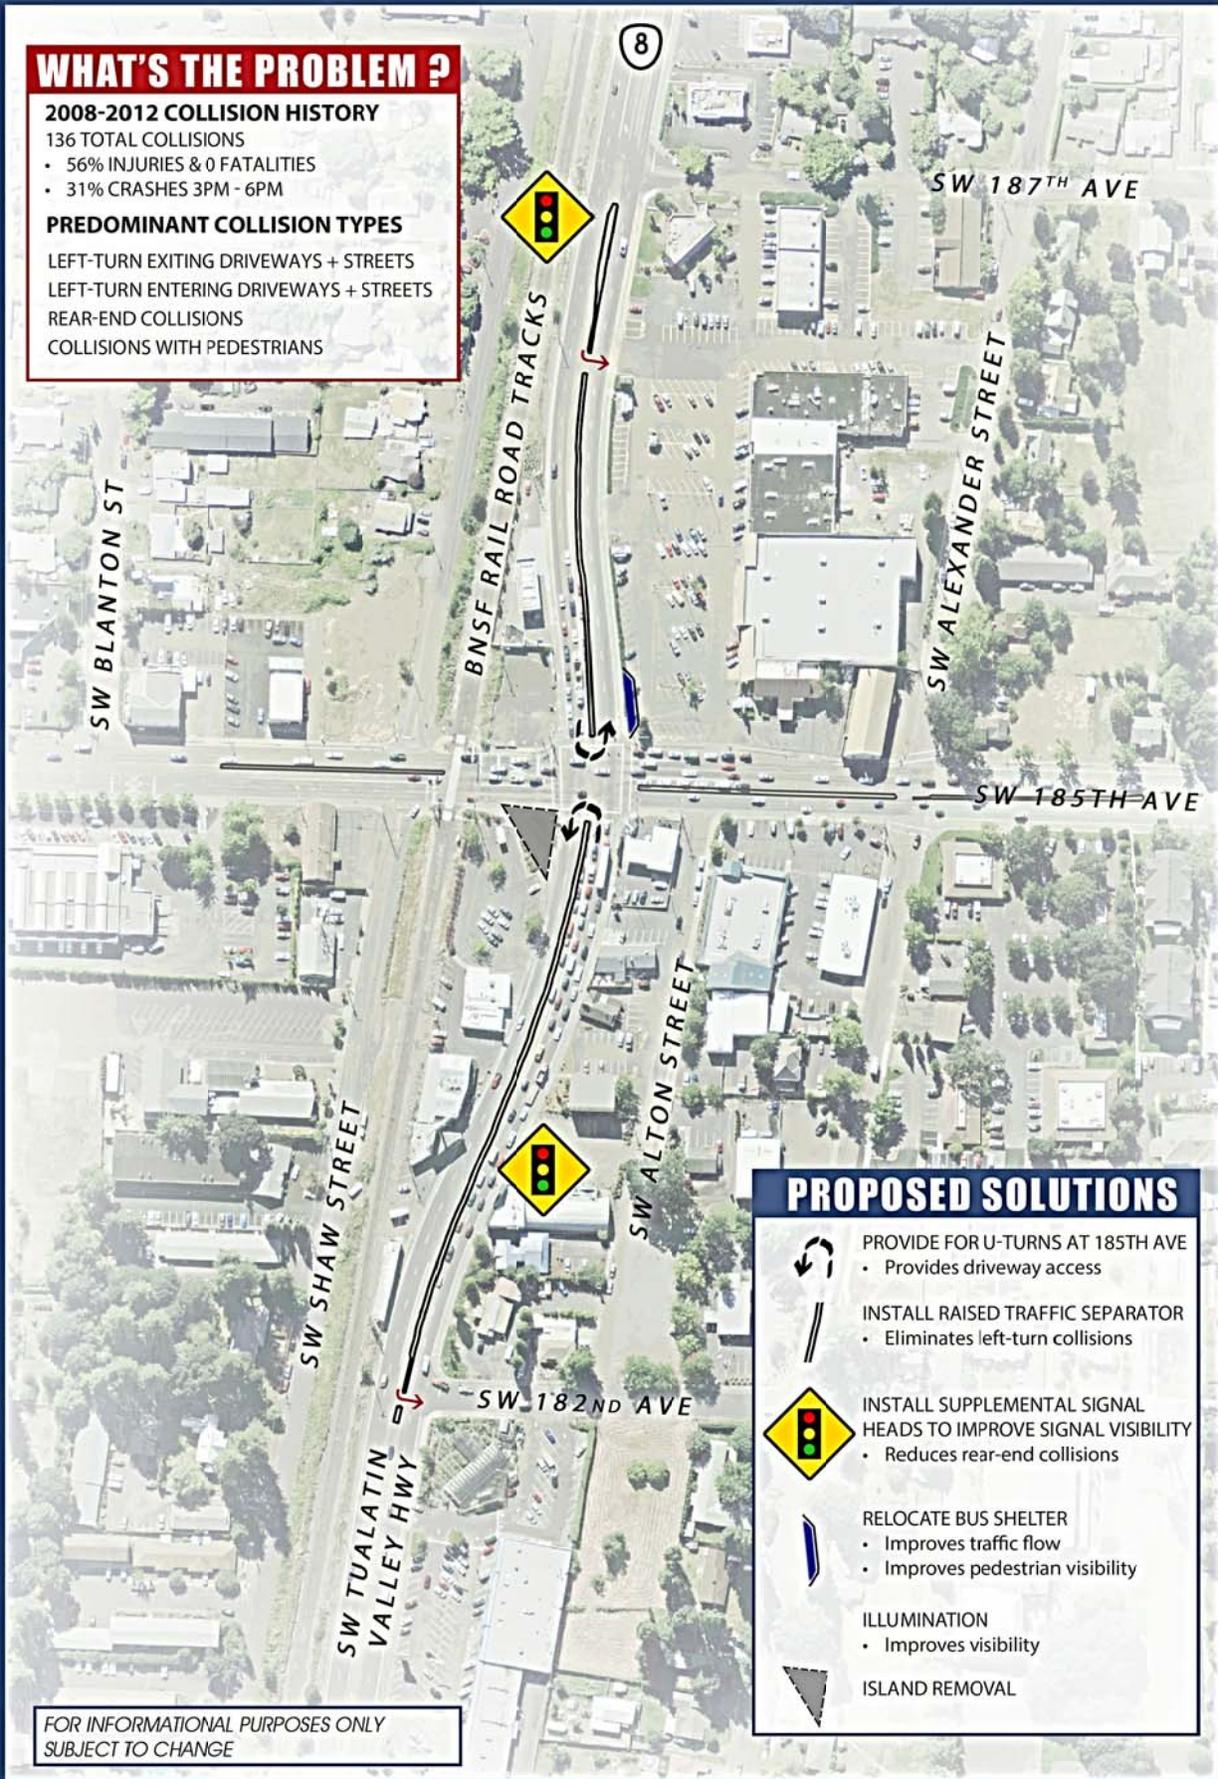
PROPOSED SOLUTIONS

PROVIDE FOR U-TURNS AT 185TH AVE
 - Provides driveway access
-

INSTALL RAISED TRAFFIC SEPARATOR
 - Eliminates left-turn collisions
-

INSTALL SUPPLEMENTAL SIGNAL HEADS TO IMPROVE SIGNAL VISIBILITY
 - Reduces rear-end collisions
-

RELOCATE BUS SHELTER
 - Improves traffic flow
 - Improves pedestrian visibility
-

ILLUMINATION
 - Improves visibility
-

ISLAND REMOVAL
