US 30 AT NW CORNELIUS PASS ROAD INTERSECTION IMPROVEMENT DIAGRAM

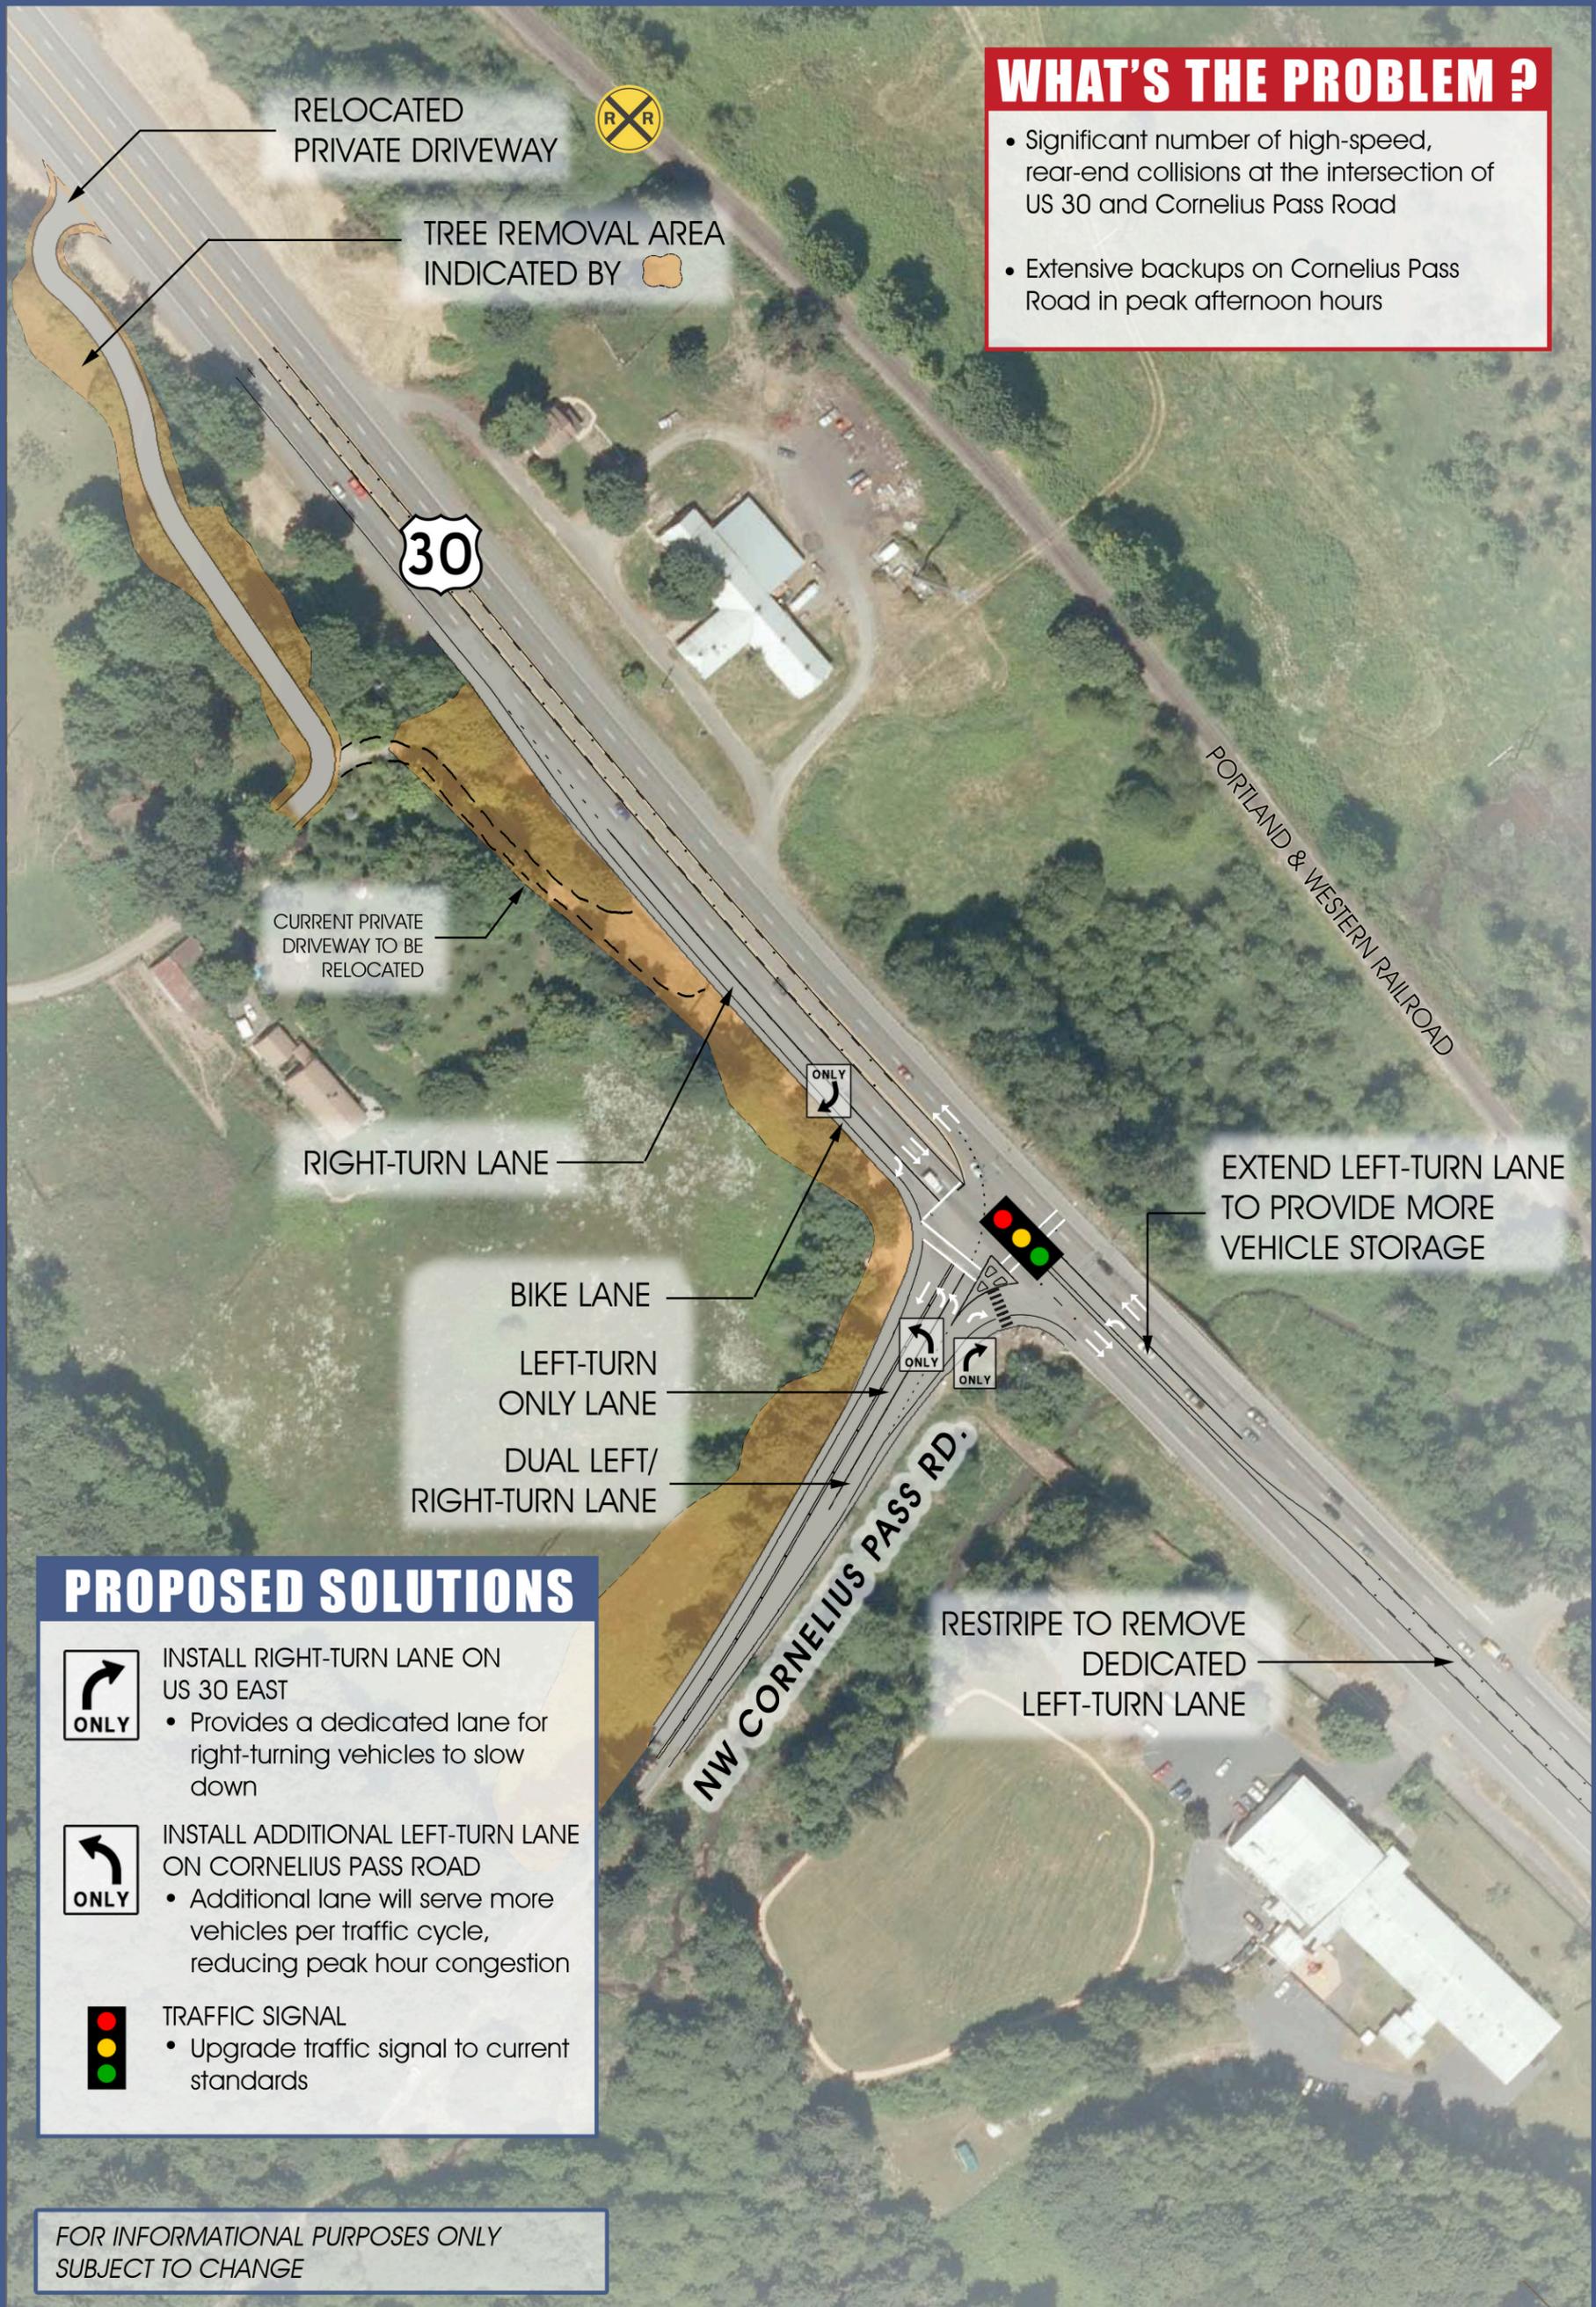
INSTALL RIGHT-TURN LANE ON US 30 EAST

- Provides a dedicated lane for right-turning vehicles to slow down

INSTALL ADDITIONAL LEFT-TURN LANE ON CORNELIUS PASS ROAD

- Additional lane will serve more vehicles per traffic cycle, reducing peak hour congestion

TRAFFIC SIGNAL

- Upgrade traffic signal to current standards
