# **WASHING BRIDGES TO REDUCE CHLORIDE**

**Interim Report**

**SPR 304-031**

Steven Soltesz  
Research Unit  
Oregon Department of Transportation

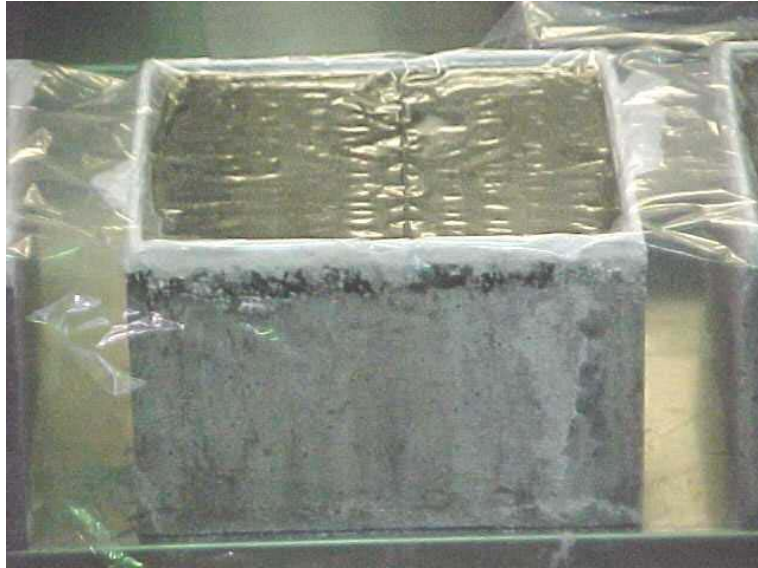
After curing, a 13 mm (0.5 in) dam was placed around the edge of four of the slabs using latex caulk. These four slabs were ponded at ambient laboratory temperature with 13% saltwater solution made from reagent-grade NaCl and deionized water. Plastic sheeting was placed over the blocks to prevent evaporation. Figure 2.2 shows a slab undergoing ponding. The ponding was conducted for 12 weeks with the solution replaced after 6 weeks.

Figure 2.2: Concrete slab undergoing ponding

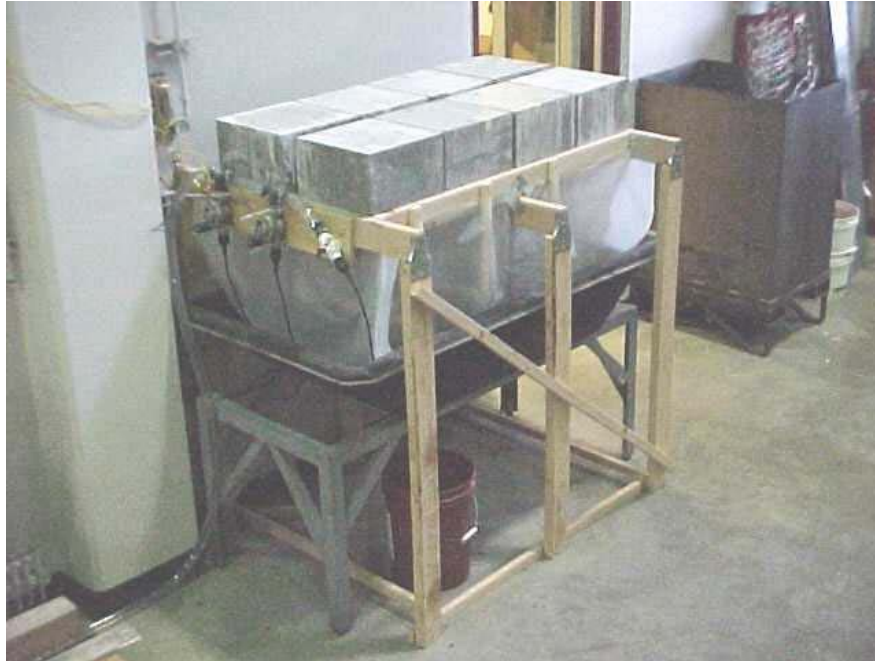
All eight slabs were then placed on a wash rack, as shown in Figure 2.3, and washed according to the schematic shown in Figure 2.4. Four types of wash treatment were applied to the slabs, one treatment type for each of four slab pairs consisting of one ponded and one unponded slab: once per day, once per week, once per month, and no washing. The ponded slabs were positioned with the ponded face down.

Figure 2.3: Rack for washing slabs

Water was applied to the washed slabs with a mister positioned 380 mm (15 in) under each slab. Electronic valves controlled by a timer were used for the slabs washed 1/day and 1/week. A manual valve was used for the slabs washed 1/month. A wash cycle lasted 2 minutes, which delivered approximately 1 liter of water, which is equivalent to approximately 11 liters/square meter. An activated charcoal water filter was installed at the tap to remove chlorine from the city water.
