**HUMECTANTS TO AUGMENT CURRENT
FROM METALLIZED ZINC CATHODIC
PROTECTION SYSTEMS ON CONCRETE**

Final Report

SPR 384

December 2002

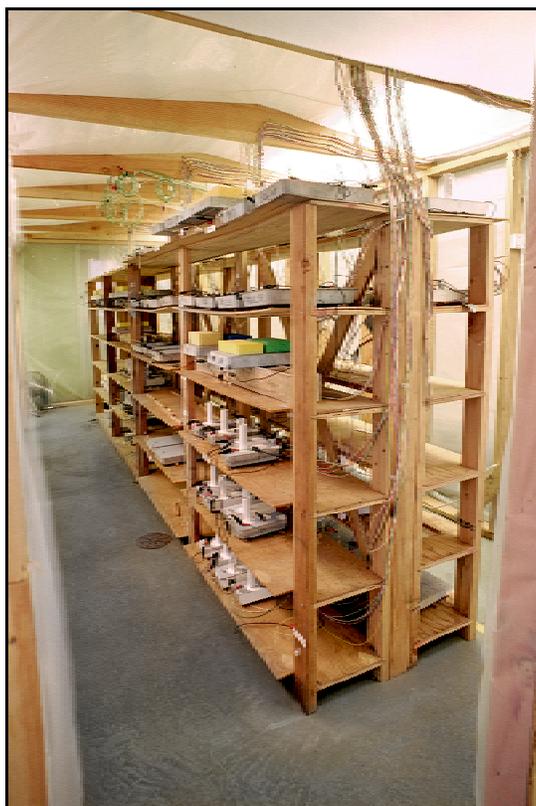
Figure 4.2: New and aged zinc slabs wired in series in the high RH enclosure

Two enclosures were used to provide either a high or a low RH environment. Humidifiers and dehumidifiers controlled the RH. Heaters and air coolers controlled the temperature. Fans also provided air circulation. Mean values in the high RH enclosure were 81±5% RH and 26±2°C (79±4°F). Mean values in the low RH enclosure were 45±4% RH and 29±2°C (84±4°F). Figure 4.2 shows the samples in the high RH enclosure.

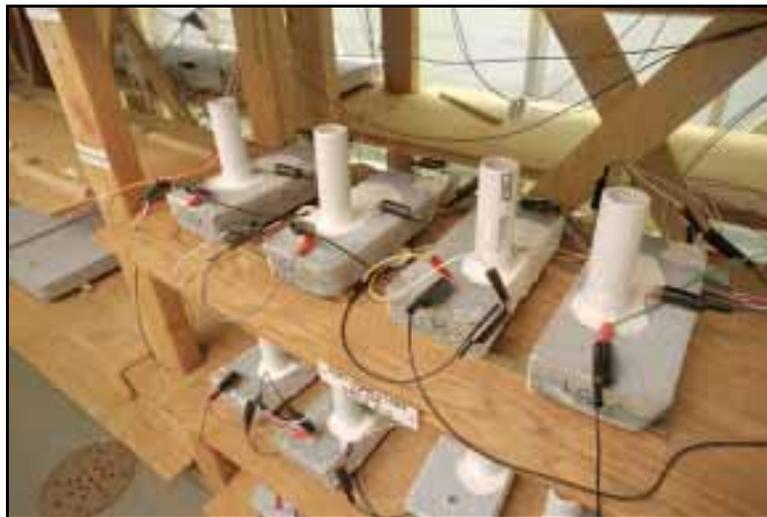
Figure 4.3: Aged zinc slabs wired in series in the high RH enclosure. Note the reference electrode holders (PVC pipe) mounted in areas without zinc left from prior adhesion strength pull tests.

Depolarization was measured on the cyclic ICCP slabs at various times throughout the experiment. Prior to depolarization, the impressed current was reduced to 0.2 mA/ft² (2.2 mA/m²) to reduce the polarization caused by the accelerated aging experiment. A Cu/CuSO₄ reference electrode was used with a wet sponge between the reference electrode and an area of bare concrete (without Zn) on the sample. For the new slabs the reference electrode was contacted to the underside of the sample. On the aged slabs the reference electrode made contact in an area without Zn left from prior adhesion strength pull tests, Figure 4.3.
