**EFFECTIVENESS OF
ANTISTRIPPING ADDITIVES
VOLUME I**

May 1989

1. Report No. FHWA-OR-RD-89-03A	2. Government Accession No.	3. Recipient's Catalog No.	
4. Title and Subtitle EFFECTIVENESS OF ANTISTRIPPING ADDITIVES Volume I		5. Report Date May 1989	6. Performing Organization Code

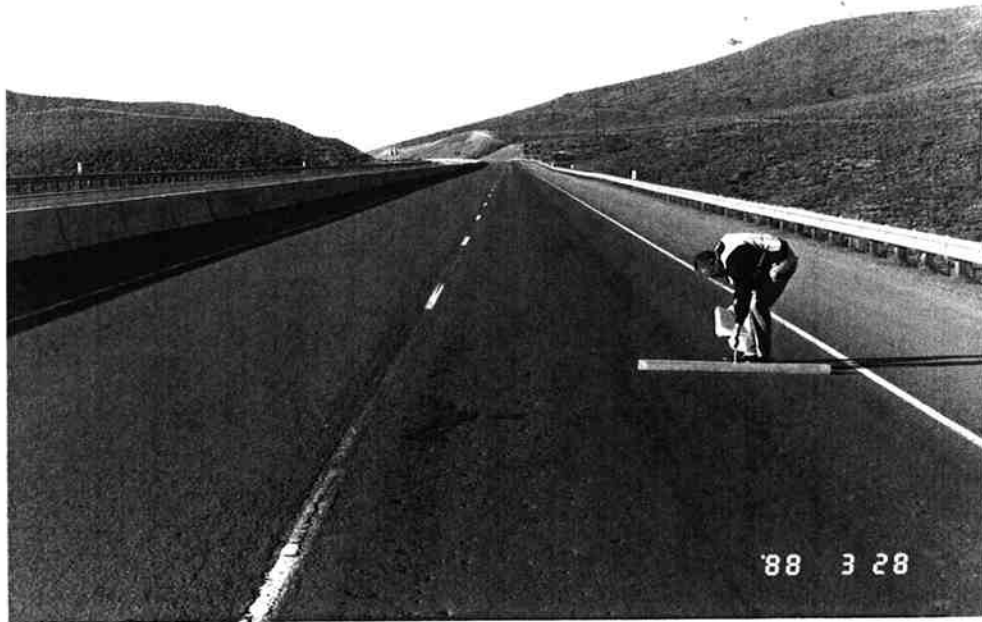
Figure 4.5. Baldock Slough-South Baker Interchange.

a) Milepost 305.8 Westbound

b) Milepost 305.8 Westbound

Baldock Slough to South Baker Interchange, built in 1979, is the only project in this category with an overall condition survey evaluation of "poor." This project had received some chip seal maintenance. However, the outside lane at milepost 305.8 westbound did not receive a chip seal application. This outside lane is pitting in the wheel paths, as displayed in Figure 4.5a, and does not show signs of thermal cracking. However, the inside lane, with a chip seal, does not show signs of pitting, but thermal cracking is present as illustrated in Figure 4.5b. It appears the chip seal, acting as a barrier, has helped reduce the moisture damage in the outside lane by limiting water intrusion into the pavement structure. The aggregate in the mix has a coating of 40%, shown in Figure 4.6a, which indicates this project
