**ASPHALT-RUBBER CONCRETE (ARC) AND
RUBBER MODIFIED ASPHALT CONCRETE
(METRO RUMAC) EVALUATION**

**NE 181st Avenue - Troutdale Section
Columbia River Highway (U.S. I-84)**

Construction Report

Research Unit
Materials and Research Section
Oregon Department of Transportation

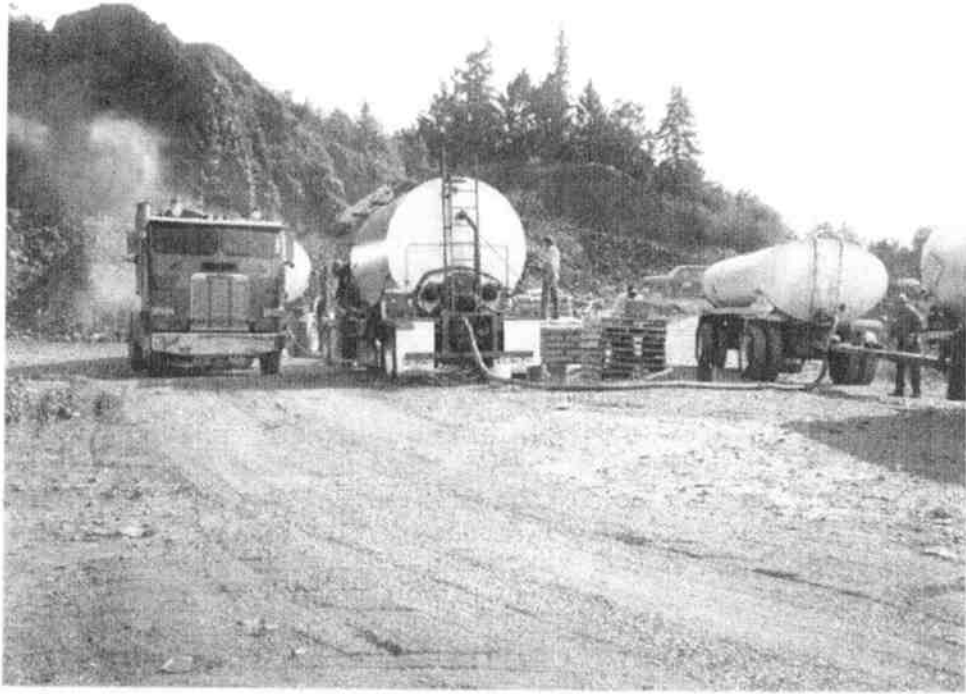
Figure 3.1: Blending Asphalt-Rubber

a) Equipment near blending unit. From left to right: transfer truck, blending unit, and tanker with base asphalt.

b) Equipment near drum plant. From left to right: drum, pump, and storage truck.

To make the asphalt-rubber, the base asphalt was pumped from the tanker into a large tank at the rear of ISI's blending unit by a pump on the unit. In the tank, the asphalt was heated from the 300°F delivery temperature to 400° to 450°F. The bags containing the tire rubber were broken by hand and

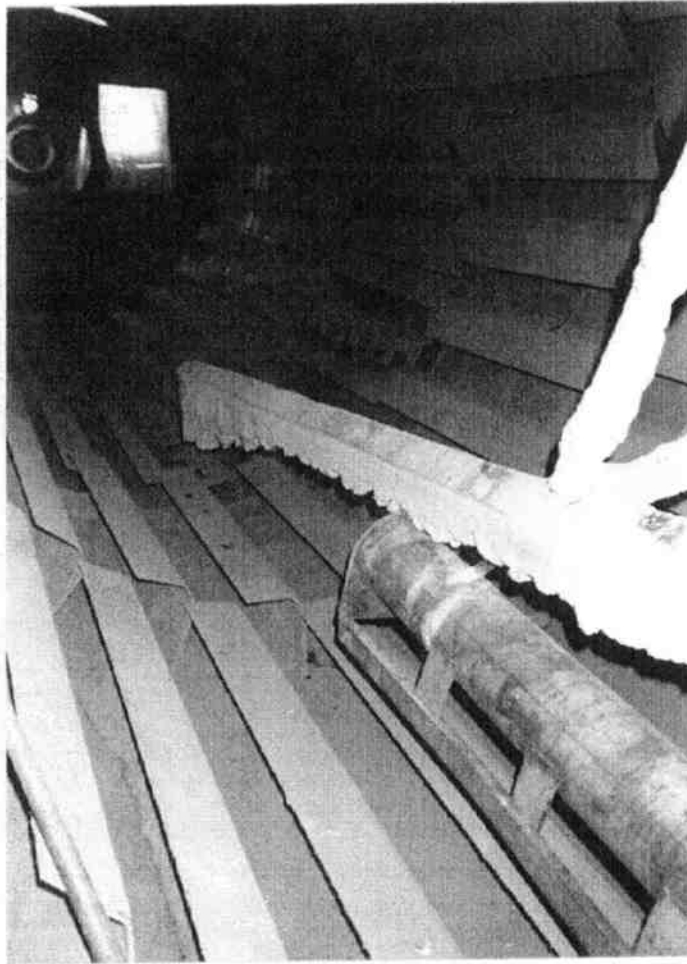
a) Inside of drum.

b) Outside end of auger on drum.
Figure 3.2: Mixing METRO RUMAC

Overall, 33 tons of rubber were used in the 1,652 tons of METRO RUMAC mix in three sublots on this project. This amount of rubber gave the mix a nominal rubber content of the desired 2%. However, problems with the rubber feed system caused the rubber content in the individual sublots to vary considerably from the desired percentage.
