TICKET TAKER AUTOMATION

Final Report

Experimental Features Project OR 98-02

Prepared for
Oregon Department of Transportation
Research Group
Salem, Oregon

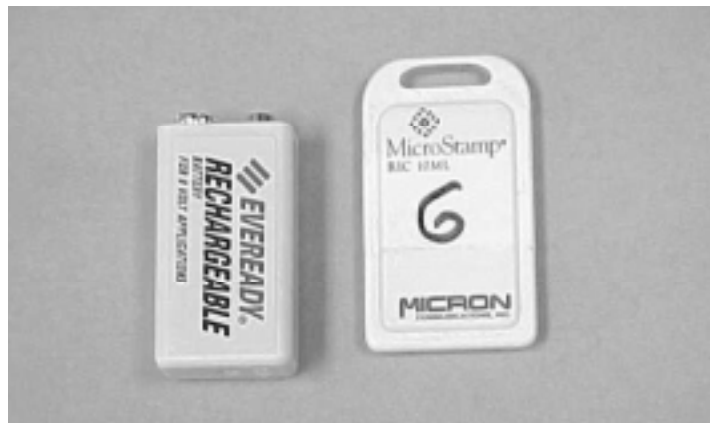
Figure 1.1: The MicroStamp 10ML tag shown next to a nine-volt battery.

The current study tested the MicroStamp RIC system to replace ticket takers on ODOT construction projects. The RIC tag is shown in Figure 1.1. Note the small size of the device as compared to a nine-volt battery. This recently-developed system has not been used in construction environments. It has been successfully used in inventory control by reading tags on trucks going slowly through gates at storage facilities and garbage trucks being weighed at landfills.

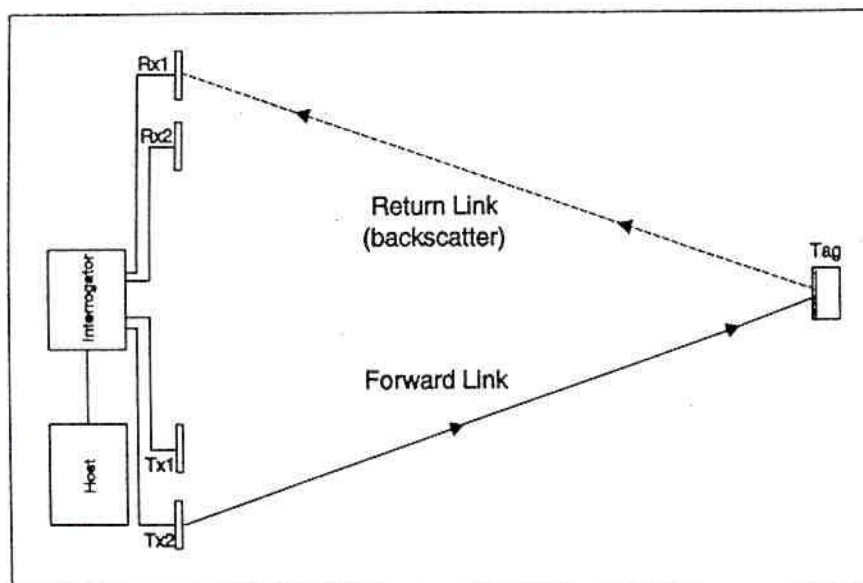
Figure 2.1: MicroStamp 4000 System (courtesy of Micron Communications, Inc.)

The MicroStamp 4000 system is composed of a host computer, an interrogator unit, and a RIC tag as shown in Figure 2.1. One complete system is needed at both the material plant and on the job site. The system sends a signal that includes batch time, truck number, job contract number, drivers name, mix weight, and material type to the tag mounted on the truck. At the construction site, another system reads the tag information and stores it in the host computer. In this test, only one system was used because of the experimental nature of the project.

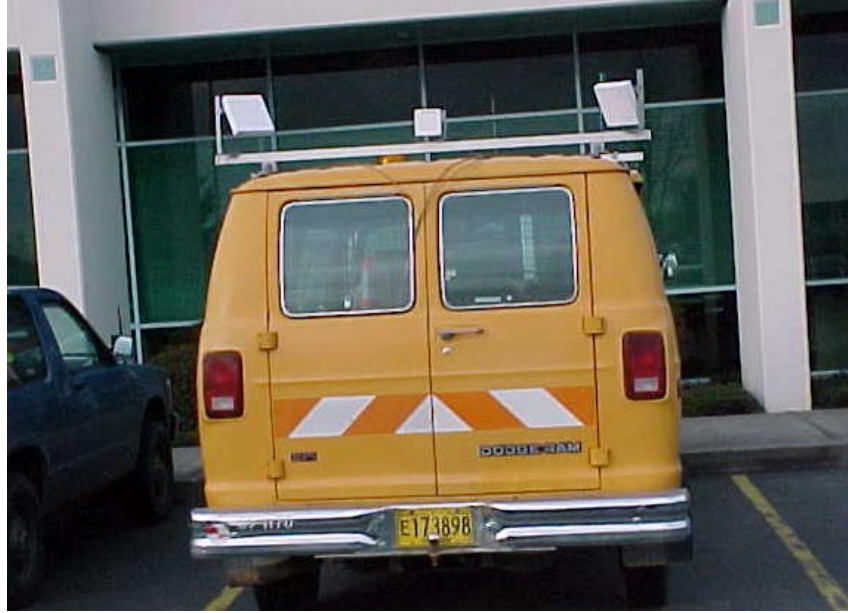
Figure 2.2: The patch antennas, mounted on the rear light bar of the van.

The host computer used was a Hewlett Packard OmniBook 5700CT operated by a Windows 95 system. The interrogator was a MicroStamp model 4000 and the RIC tags were the 10ML by Micron Communications Inc. Other equipment included four “patch” antennas, an inverter (DC to AC converter), a power strip, antenna mounting brackets and a Dodge Van (see Figure 2.2).

The laptop computer was setup on the front seat of the van. The interrogator was set up in the rear of the van on the shipping case in which it was delivered. A long serial cable connected the interrogator to the computer. An extension cord from the inverter supplied the operating power. Power for both the computer and the interrogator was taken from an inverter connected to the cigarette lighter. The patch antennas were mounted on an aluminum light bar on the rear of the van roof with the connecting cables routed through the rear door window to the interrogator. These antennas could be aimed in azimuth and elevation.

After the first trial, the antenna array mounting system and the tags were modified to improve the reading range. The antennas were mounted on the roof of the van with a bracket that allowed them to be aimed in both azimuth and elevation, as shown in Figure 2.2. Also, the addition of a back plane doubled the reading range of the tags (see Figure 2.3).

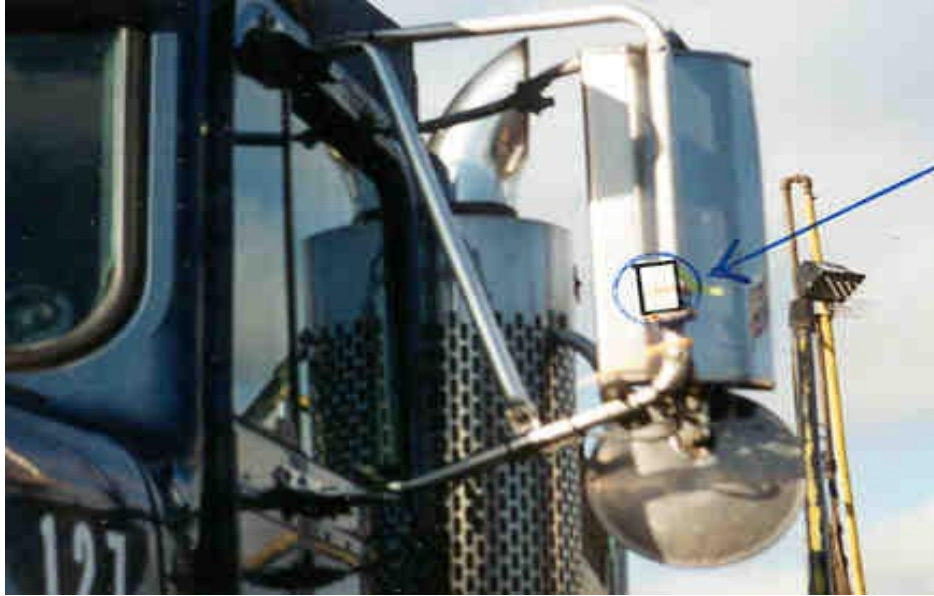
Figure 2.4 The arrow points at the MicroStamp 10ML tag.

Tags were attached to the left side mirror bracket on the asphalt trucks. Nylon cable ties were used to secure the tag to the post in a vertical position and the tag was aimed out and ahead with the back of the mirror at near right angles to the tag as seen in Figure 2.4.
