**ANIMAL-VEHICLE CRASH
MITIGATION USING
ADVANCED TECHNOLOGY
PHASE II: SYSTEM
EFFECTIVENESS AND SYSTEM
ACCEPTANCE**

Final Report

SPR 3(076)

March 2009

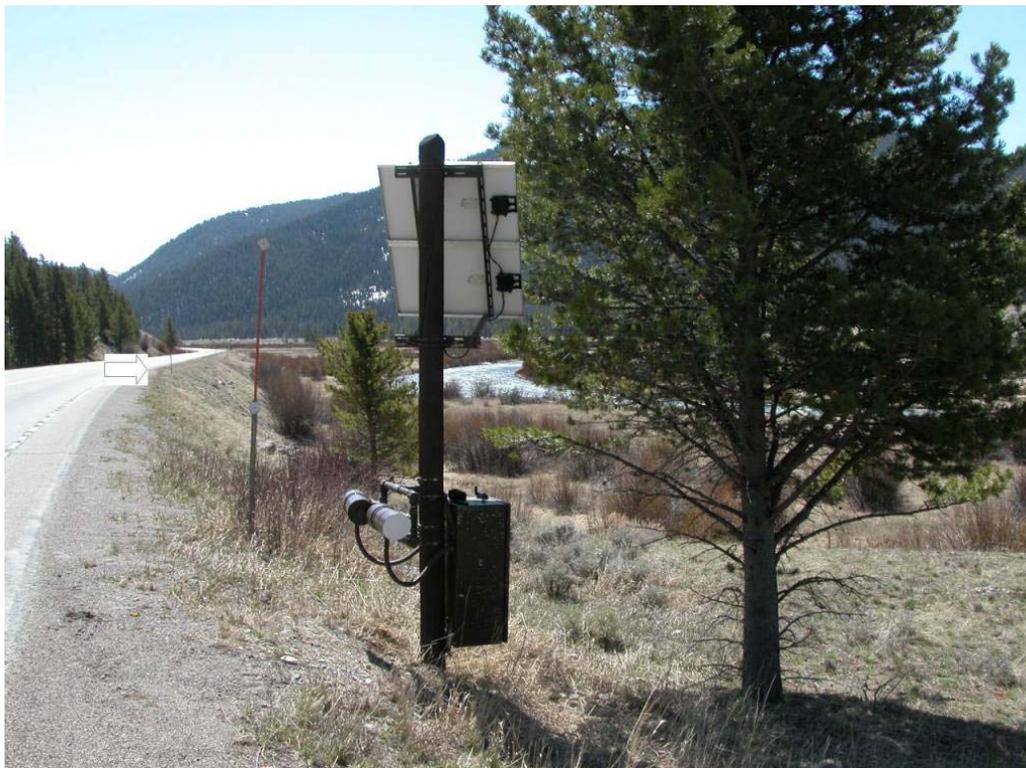
Figure 2.5: Proposed relocation of Station 11, looking south; relocated 275 ft (84 m) to the southeast (at a bend in the road, indicated by arrow) (Photo: Lloyd Salsman, STS)

The proposed system modifications included removing Station 13, relocating Station 11 (Figure 2.5), and including the entrance to the parking area for the Black Butte Trailhead in the sensor array. The Technical Advisory Committee (TAC) for the project had decided that, after system modifications, the percentage of blind spots in the total length of the system must be between 2% and 5% at a maximum. Should a higher percentage of the system have blind spots after system modification, the system would have to be removed.

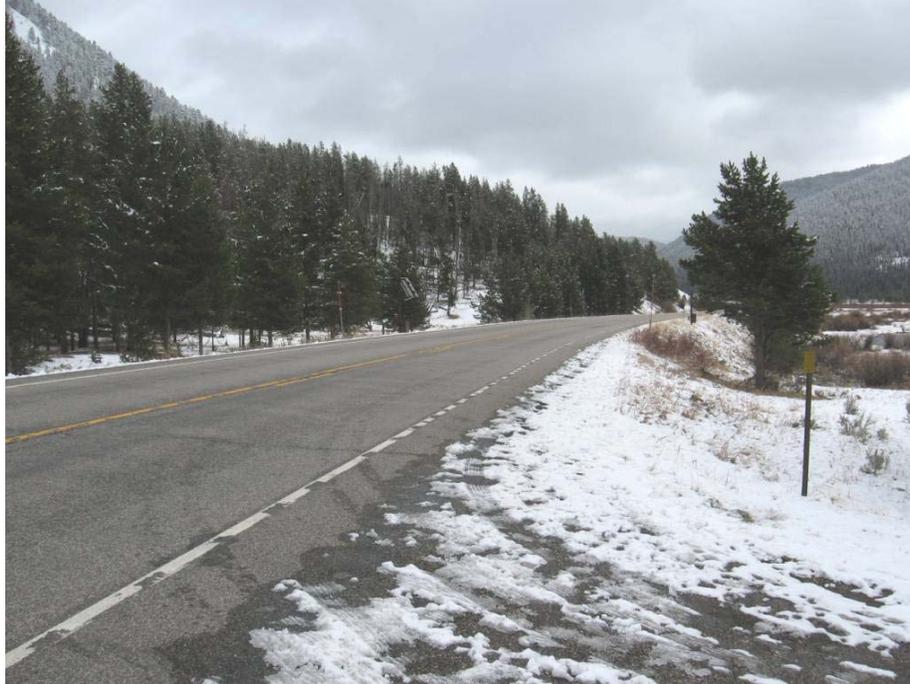
Figure 2.7: Area just south of Black Butte Trailhead after Station 13 was removed and Station 11 was relocated. Station 11 (new location) can be seen on the left side of the tree (Photo: Marcel Huijser, WTI-MSU).

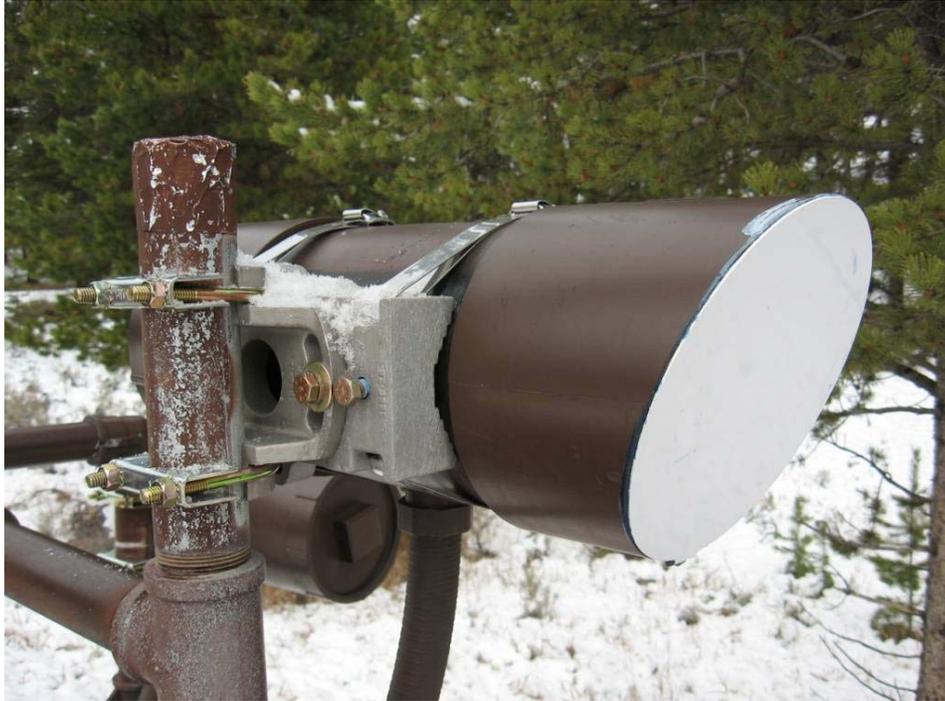
Figure 2.10: Sensor equipped with new bracket (aluminum casting, metal bands around sensor tube) (Photo: Marcel Huijser, WTI-MSU)

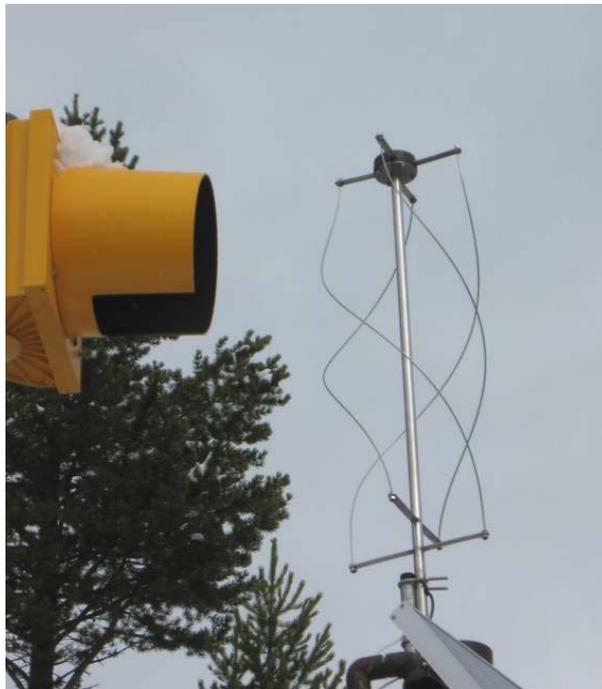
Figure 2.11: Antenna for remote access through satellite connection (Photo: Marcel Huijser, WTI-MSU)

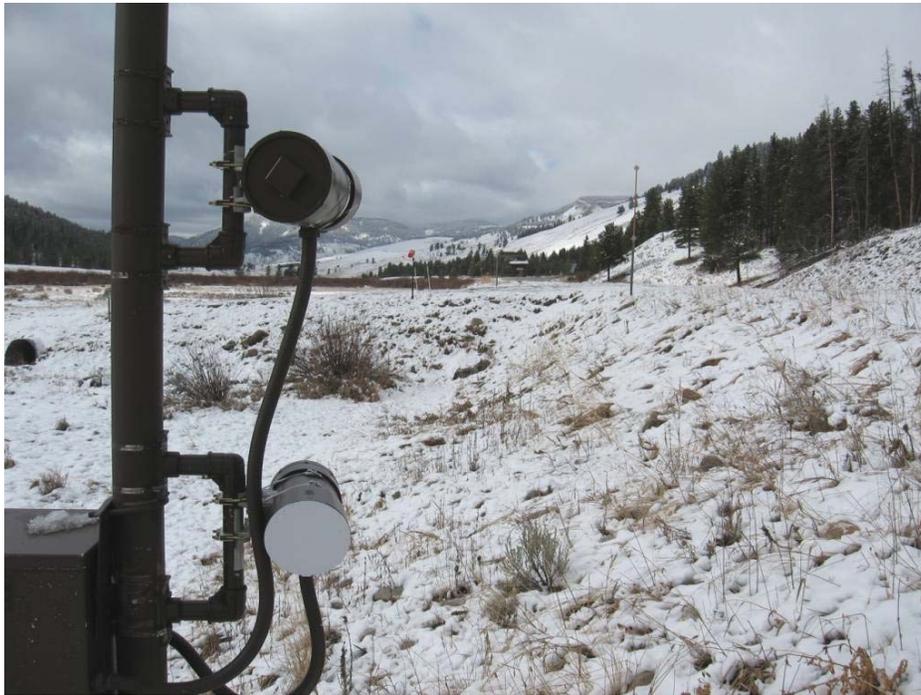
Figure 2.12: Looking north from Station 23 (Detection Zone 3) towards the Black Butte Ranch access road and Station 21. There is a blind spot in the area between Station 23 and the Black Butte access road because the sensor had to be placed high on the pole in order to shoot across the embankment of the Black Butte access road (Photo: Marcel Huijser, WTI-MSU).

The testing revealed that there were no blind spots present, except in Detection Zone 3 (55 ft (≈ 16.9 m), and Detection Zone D (60 ft (≈ 18.3 m)). The blind spots in Detection Zone 3 were related to a sensor that had to be placed high on a pole in order to shoot the beam across the Black Butte Ranch access road. The blind spot in Detection Zone D resulted from the sensor at Station 23 shooting up a slope towards Station 7. Figures 2.12 – 2.14 show these blind spots from various perspectives. The total length of the blind spots after system modifications was estimated at 115 ft (35.2 m), or 1.09% of the total length covered by the system. This number was well below the maximum percentage of allowable blind spots (5%).

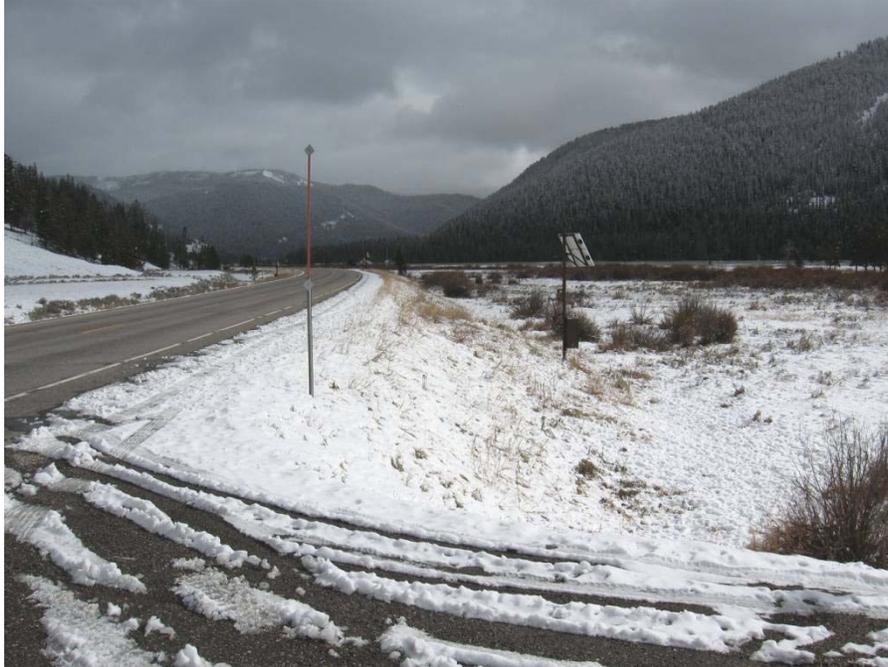
Figure 2.13: Looking south from the Black Butte Ranch access road towards Station 23. There is a blind spot in the area between the Black Butte access road and Station 23; the same blind spot is illustrated in Figure 2.12 (Photo: Marcel Huijser, WTI-MSU).

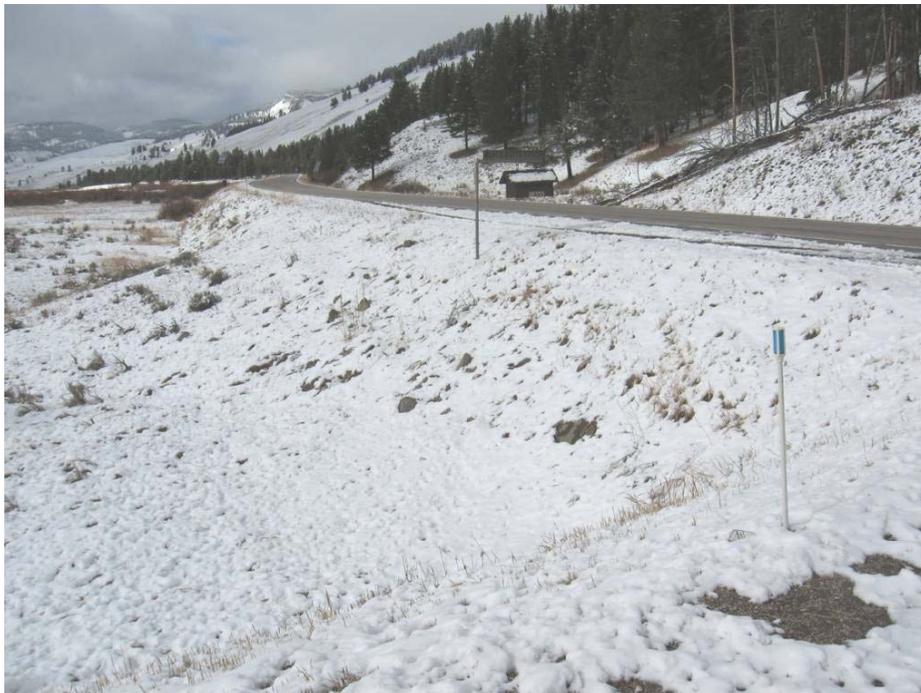
Figure 2.14: Looking north from the Black Butte Ranch access road towards Station 21. There is a blind spot in the area between the Black Butte access road and Station 21, because the sensor on Station 23 had to be placed high on the pole in order to shoot across the embankment of the Black Butte access road (see Figure 2.12) (Photo: Marcel Huijser, WTI-MSU).

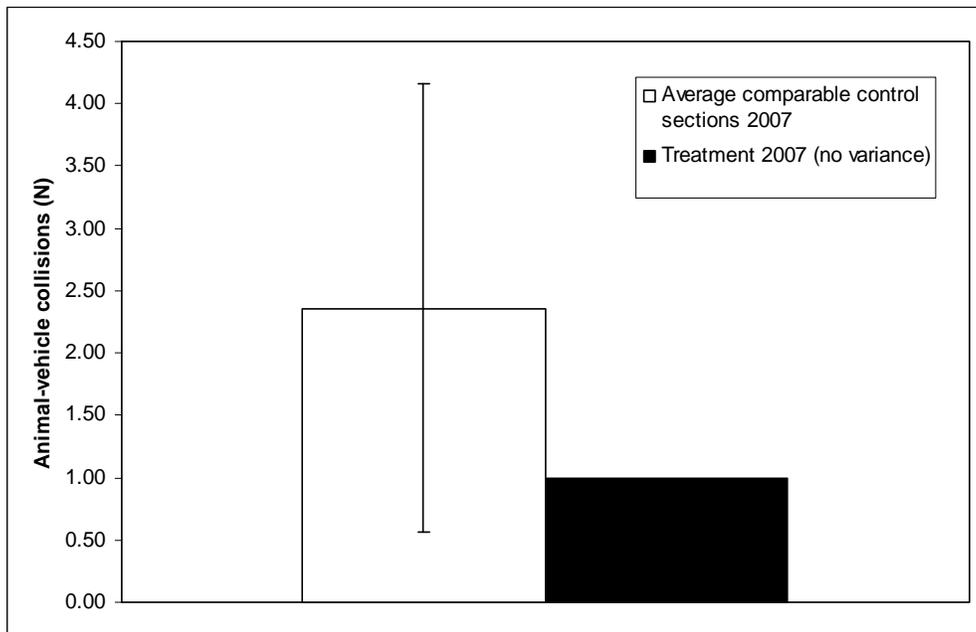
Figure 4.6: Average number (\pm SD) of reported collisions with large mammals and large mammal road mortalities from selected comparable control sections (N=11) and the treatment section while the system was fully operational
