**MULTI-MODAL INTERSECTIONS:
RESOLVING CONFLICTS
BETWEEN TRAINS, MOTOR
VEHICLES, BICYCLISTS AND
PEDESTRIANS**

Final Report

SPR 794

Oregon Department of Transportation

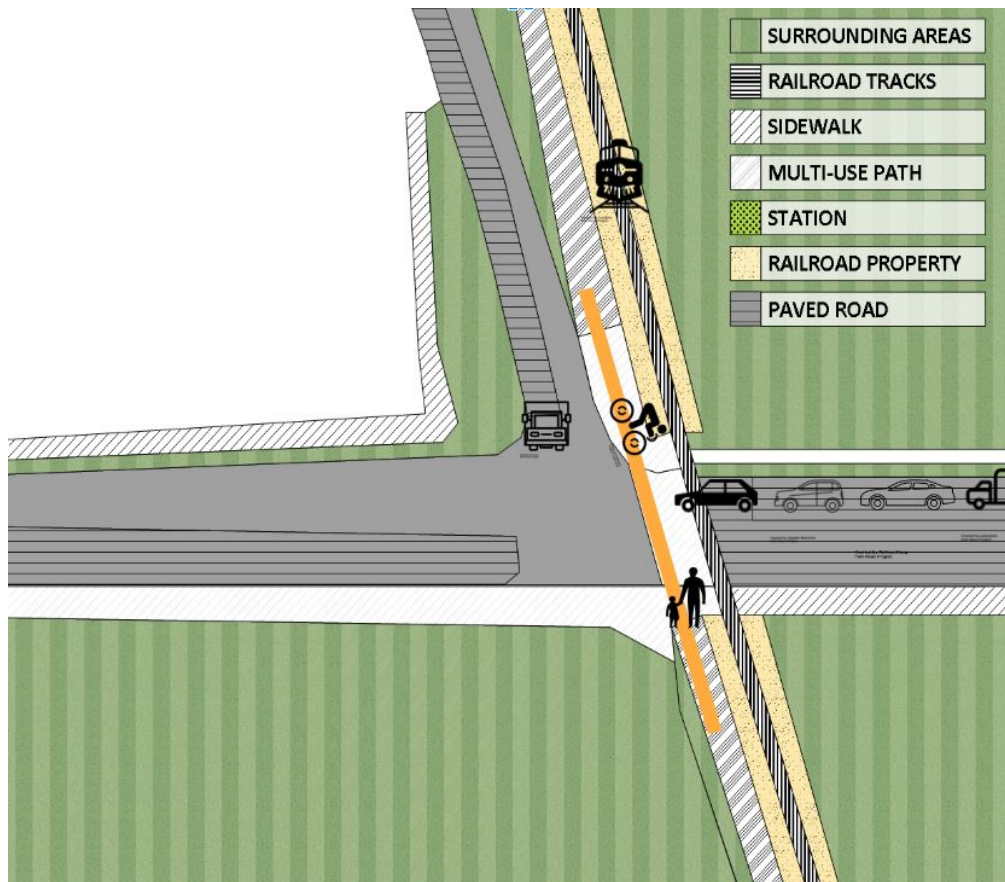
Figure 1.1: The illustration above depicts the issue with multimodal intersections discussed in this report

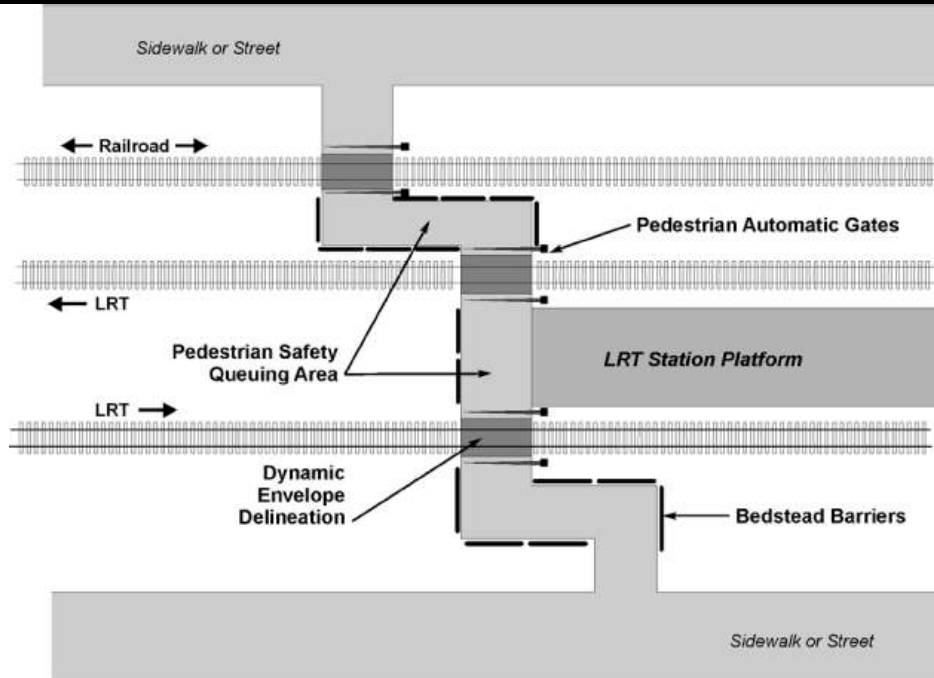
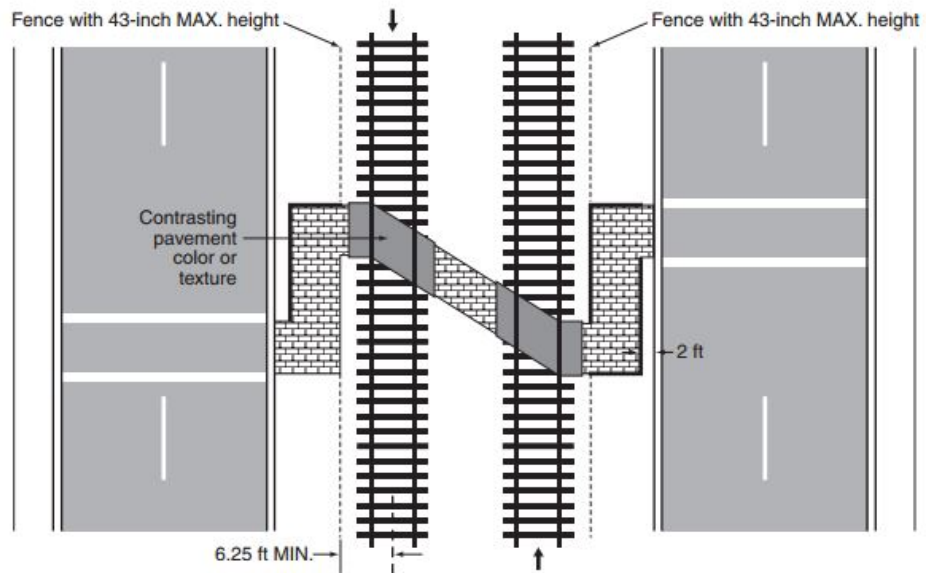
Pedestrian Channelization (Z-Crossing)

(Primarily used for LRT) (FHWA, 2007)

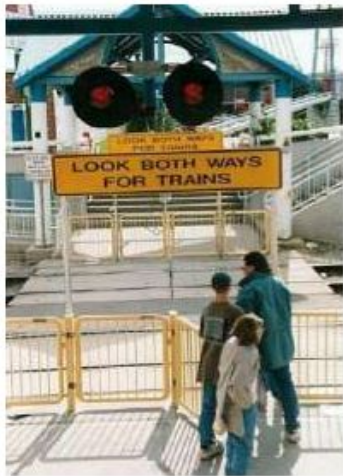
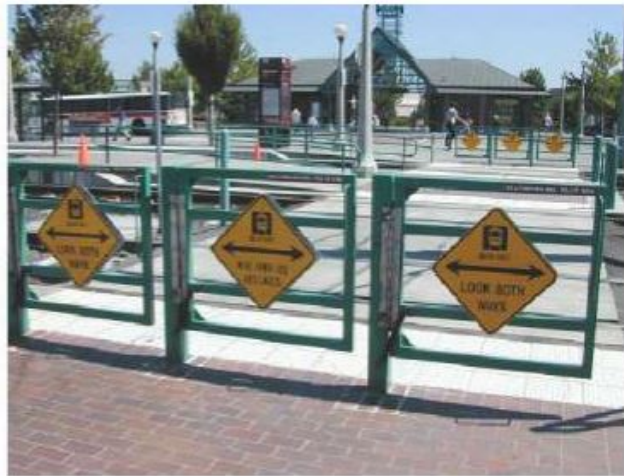
Manual Swing
Gates

(Primarily used for LRT) (FHWA, 2007)

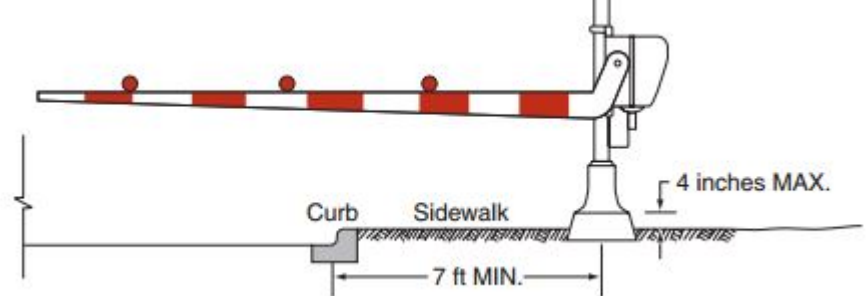
<p>(FHWA, 2009)</p>
Automatic Gates

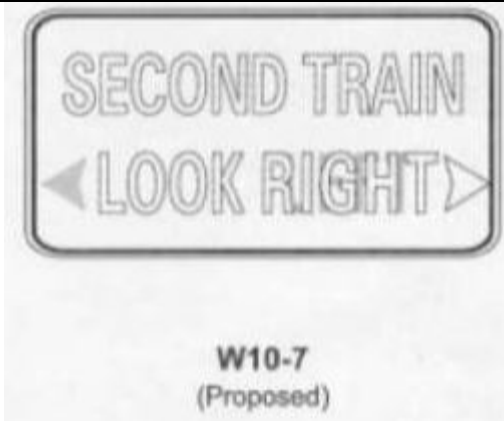
“Second Train Coming” Icons

“An LRV-activated, internally illuminated matrix sign displaying the pedestrian crossing configuration with one or two (or three or four, etc.) LRVs passing may be used to alert pedestrians to the direction from which one or multiple LRVs are approaching the crossing, especially at locations where pedestrian traffic is heavy (such as LRT stations)” (FHWA, 2007)

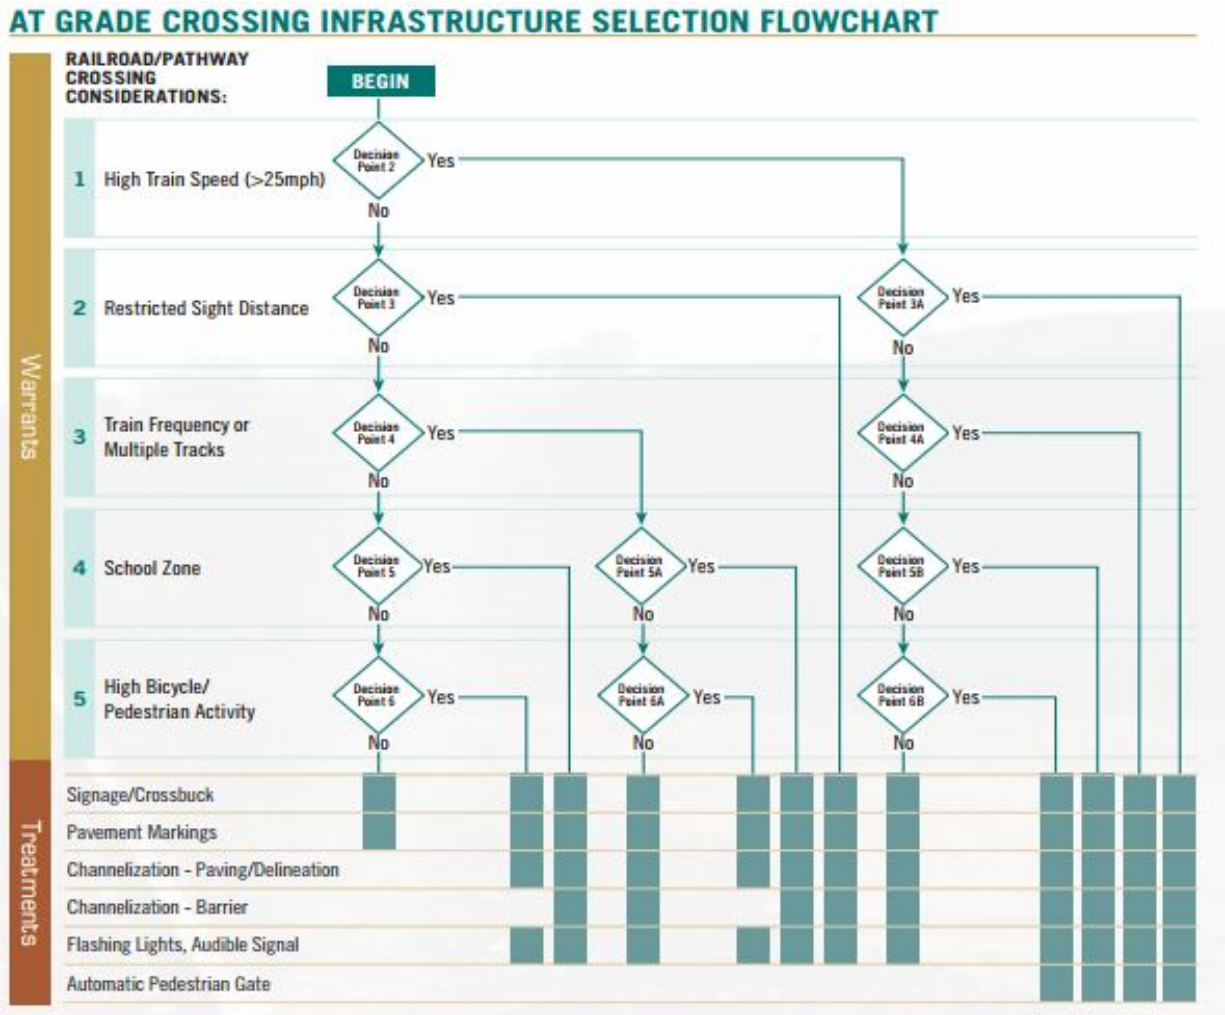
Figure 2.1: At-grade crossing infrastructure selection flowchart (MAG, 2014)

The Arizona-based regional planning organization Maricopa Association of Governments published a report in 2014 with recommendations for improving safety for pedestrians and bikes at crossings. With the report, they developed a flowchart to decide which treatments should be used at an at-grade crossing. The flowchart is shown in full below.

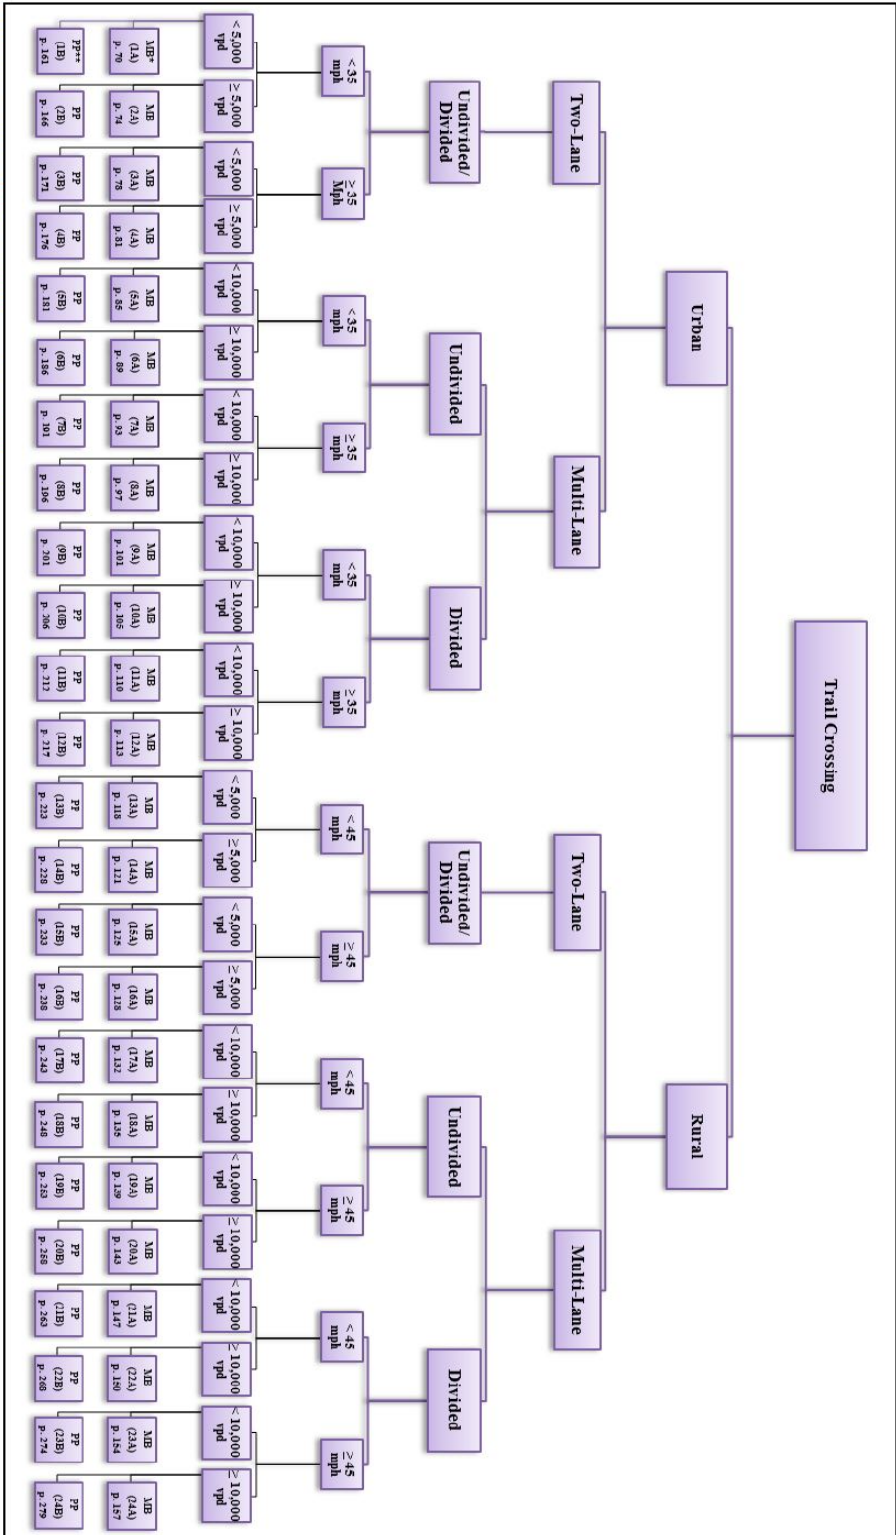
*MB denotes the Midblock trail-roadway crossing;
 **PP denotes the Parallel Path trail-roadway crossing; and,
 O denotes the look-up table that contains all alternative treatments for the corresponding type of trail crossing.

A similar approach was completed previously, where a thorough study from Minnesota resulted in the decision tree in figure 2.3, which is used to determine which type of treatment should be utilized

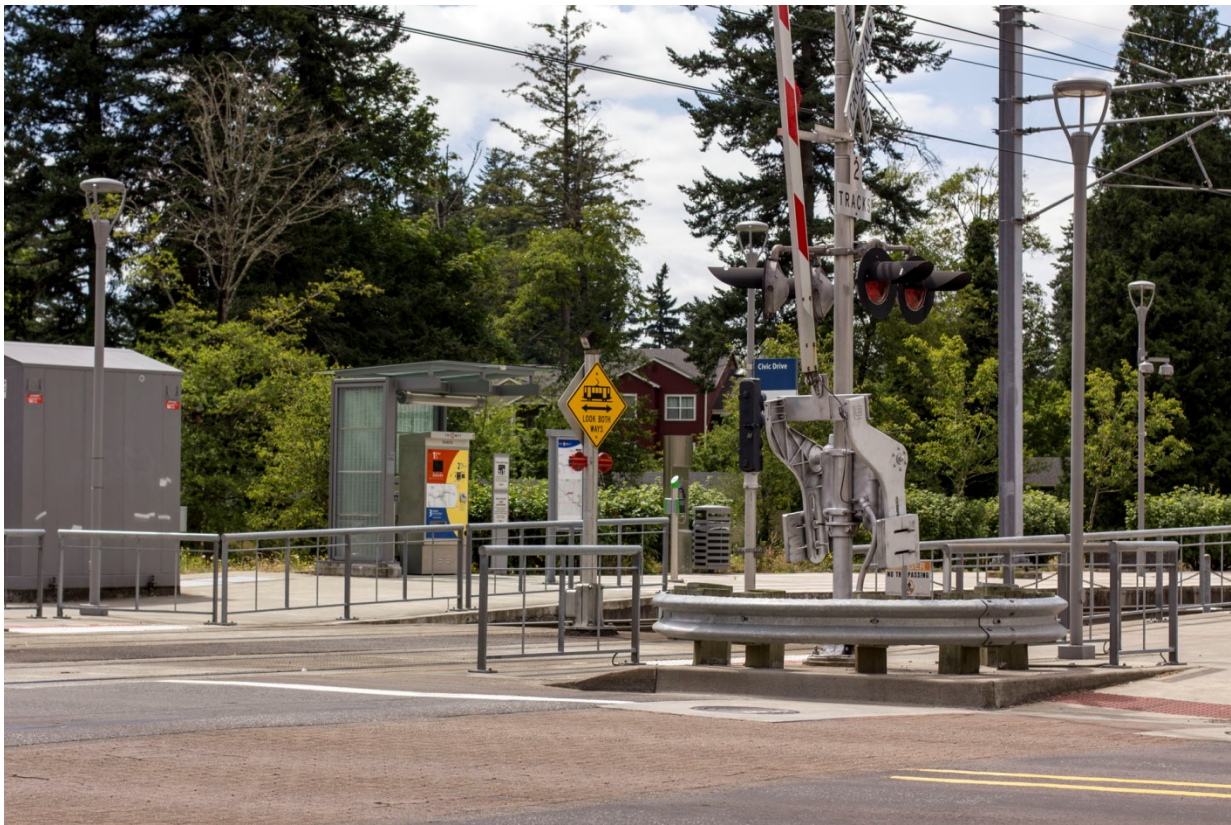
Figure 3.2: Active and passive treatments, and the adjacent light rail station.

The current treatments at this site includes a variety of active and passive equipment. The crossing is fitted with active gates, lights and bells. Signage includes a 2-tracks cross buck, a sign telling pedestrians to look both ways, and signs pointing out the sites of the pedestrian crosswalk field. Underneath the pedestrian crosswalk sign, which can be illuminated with the help of a push button (Rectangular Rapid Flash Beacon), a sign telling drivers to not stop on tracks is installed. Where the tracks can be crossed, channelization has been installed to make pedestrians look both ways. The Z crossing enables the pedestrian and the train operator to be in nearly constant eye contact during the crossing movement. The use of a median refuge island separates the crossing into two movements. These are accompanied by an active mini pedestrian light and bell between the two sets of tracks, and a sign telling pedestrians to look both ways. There is a stop line for road users and no median. The pedestrian crosswalk zone is furthermore marked using a different type of surfacing.

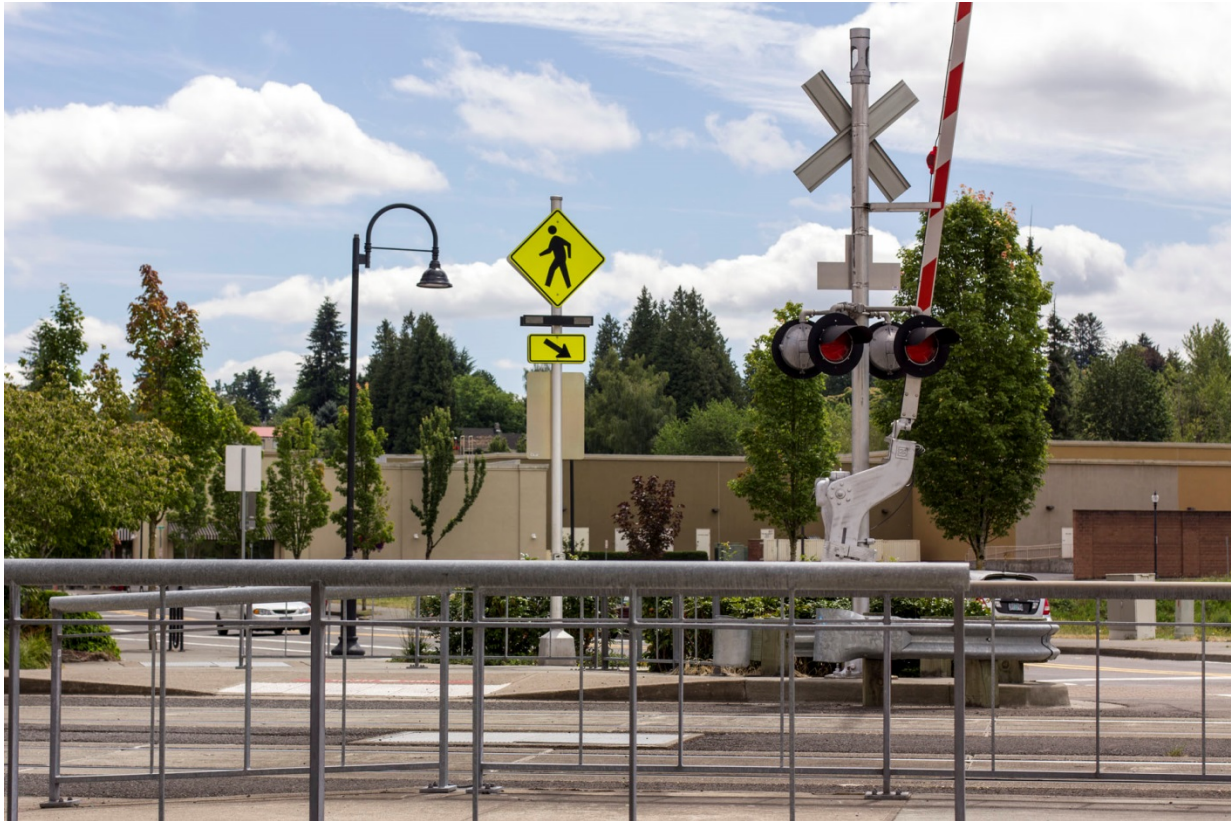
Figure 3.3: Active and passive treatments at the NW Civic Dr crossing

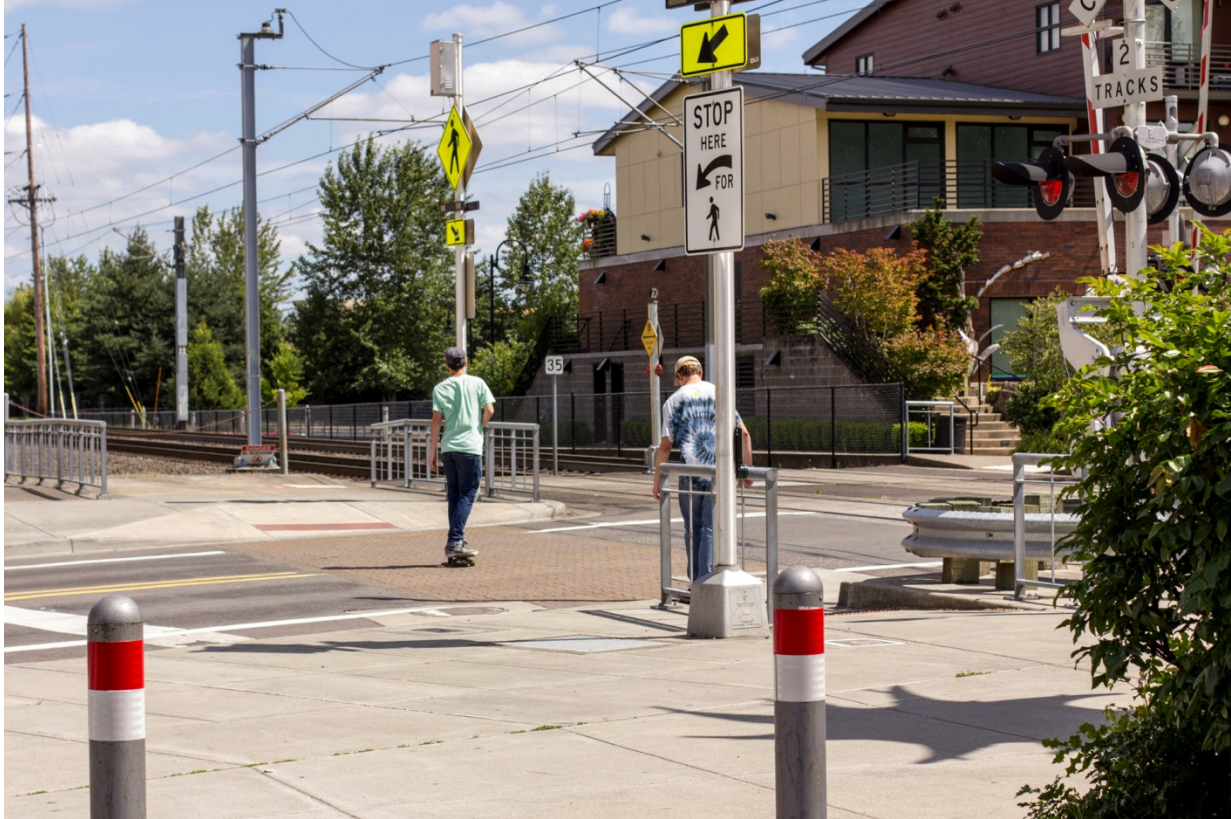
Figure 3.4: Pedestrian facilities found at both sides of the crossing

This location allows pedestrians to cross adjacent to the tracks on both sides. As one side is equipped with a trail, which is where most of the crossing take place, though there's also quite a few crossings made adjacent to the tracks, by people walking to and from the station. Both crosswalks are marked with tactile surfaces, different crossing surface, and pedestrian-activated push buttons (RRFBs) that can be enabled by users wishing to cross adjacent to the tracks. The crosswalk fields are marked by signage as seen in Figure 3.4.

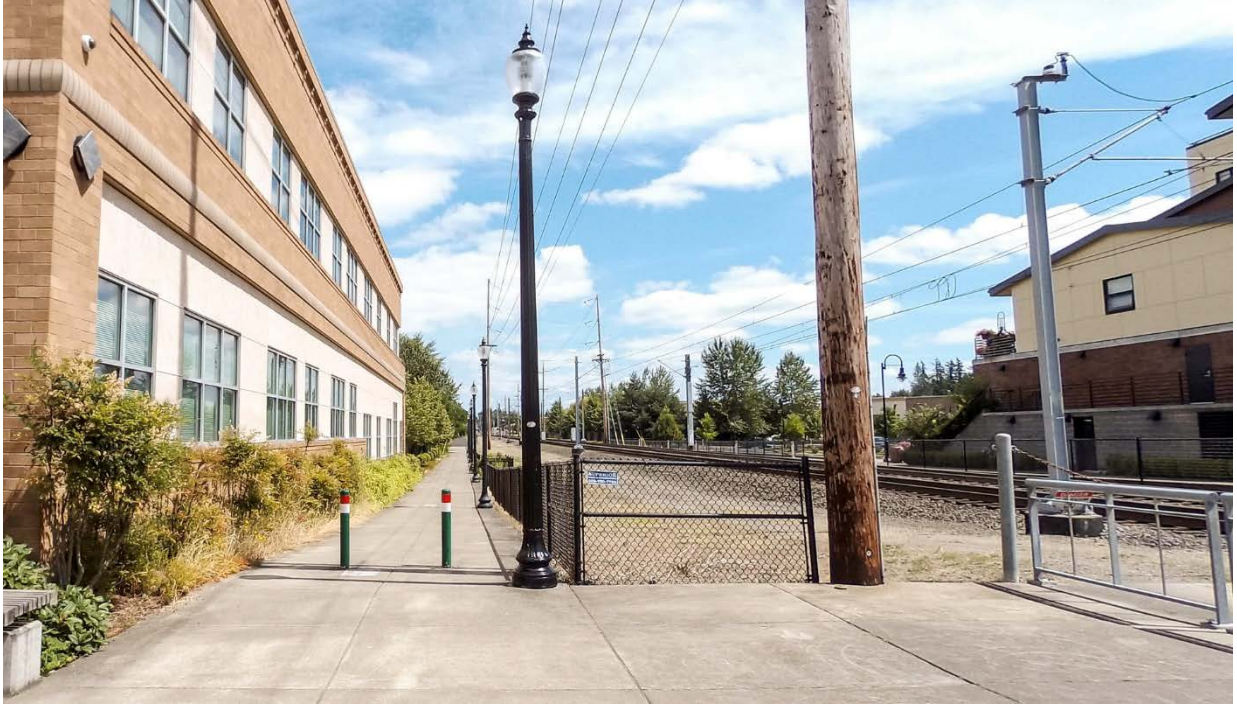
Figure 3.5: Multiuse trail

This location has several different forms of facilities for bike and pedestrian traffic. There is a multi-use trail running adjacent to the light rail tracks, called the Max Rail Trail. Though there is a trail running across the road, it did not appear that the two trails were connected or used for their connection, and few users were seen moving from one side of the trail to the other. Both sides of the road are equipped with sidewalks and the road and tracks can be crossed four ways. There is passive pedestrian management across the tracks, and pedestrian-activated push buttons to cross the road next to the track. Both sides of the road are equipped with bike lanes.

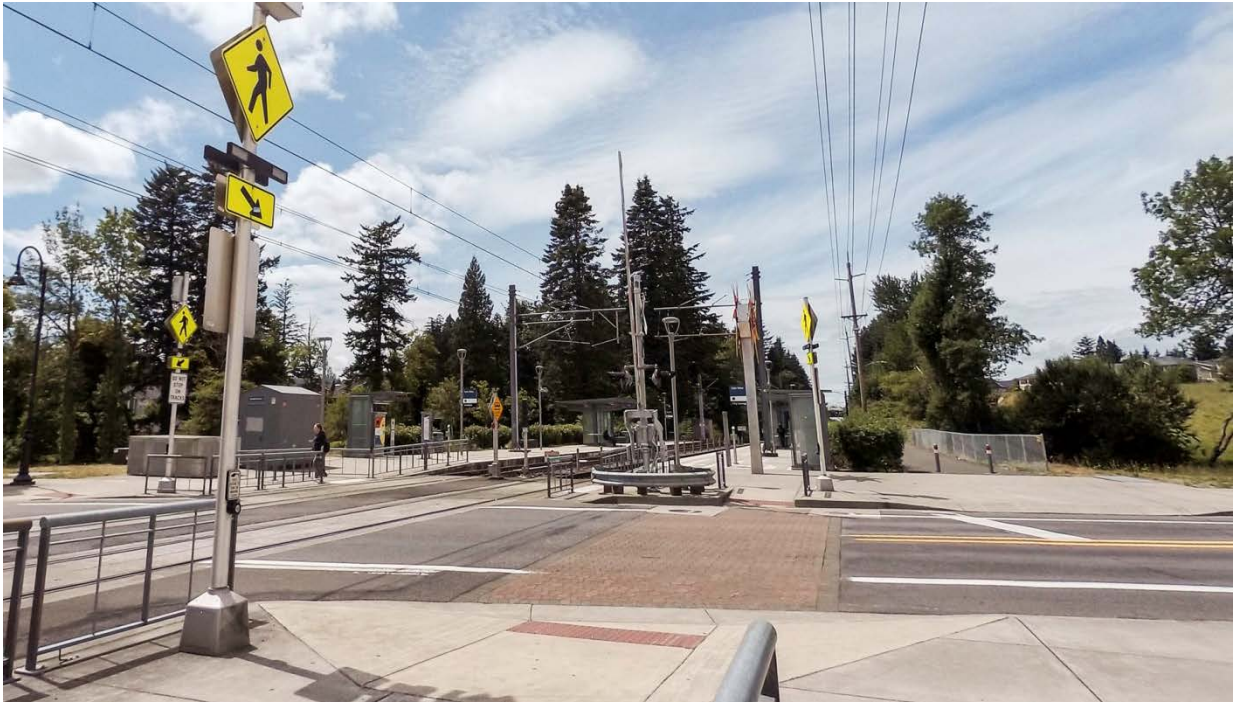
Figure 3.6: Pedestrian facilities and trailhead

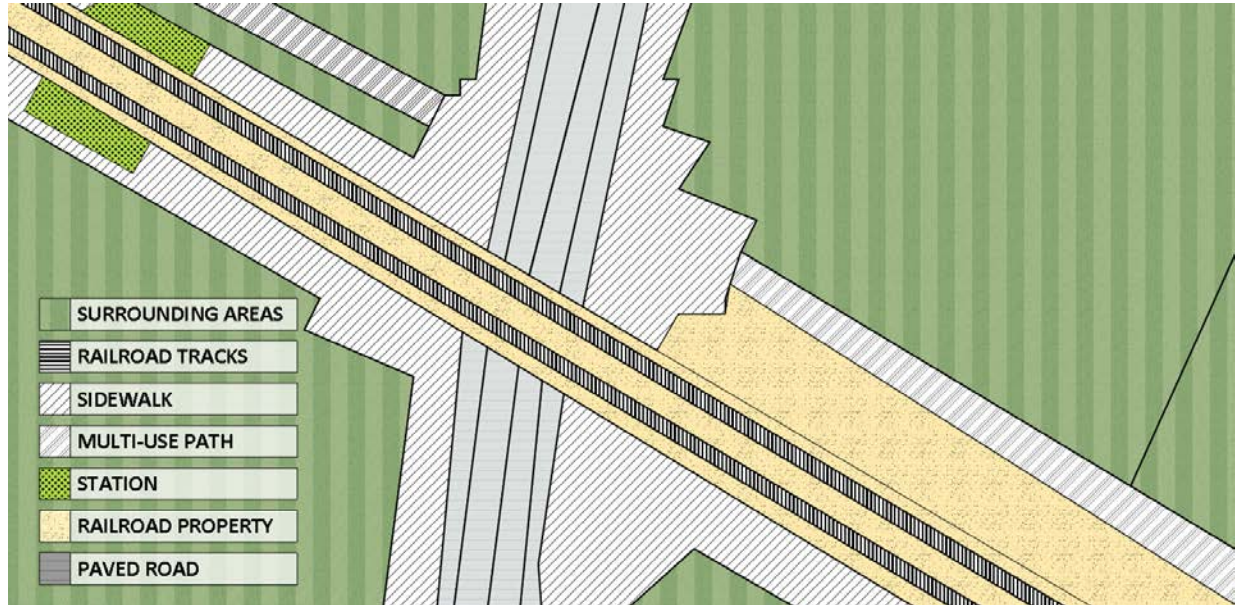
Figure 3.7: Diagram of NW Civic Dr.

A simplified diagram of NW Civic Dr. is included below to exemplify the dynamic movements of road and path users at this crossing.

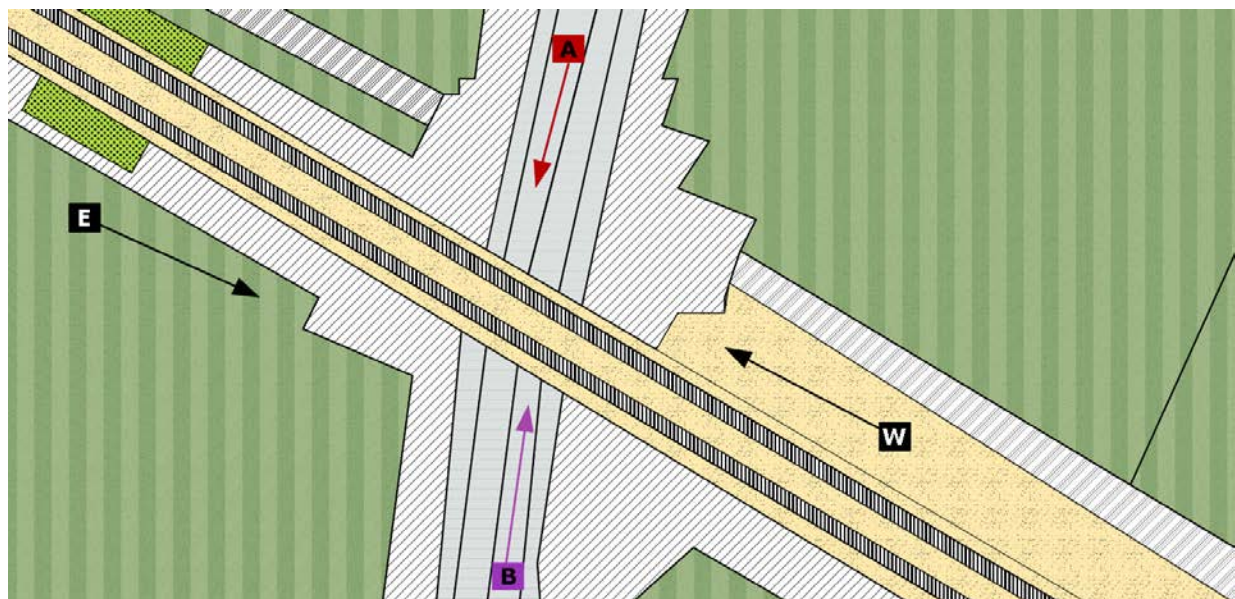
Figure 3.8: Diagram depicting observed vehicle and train movements

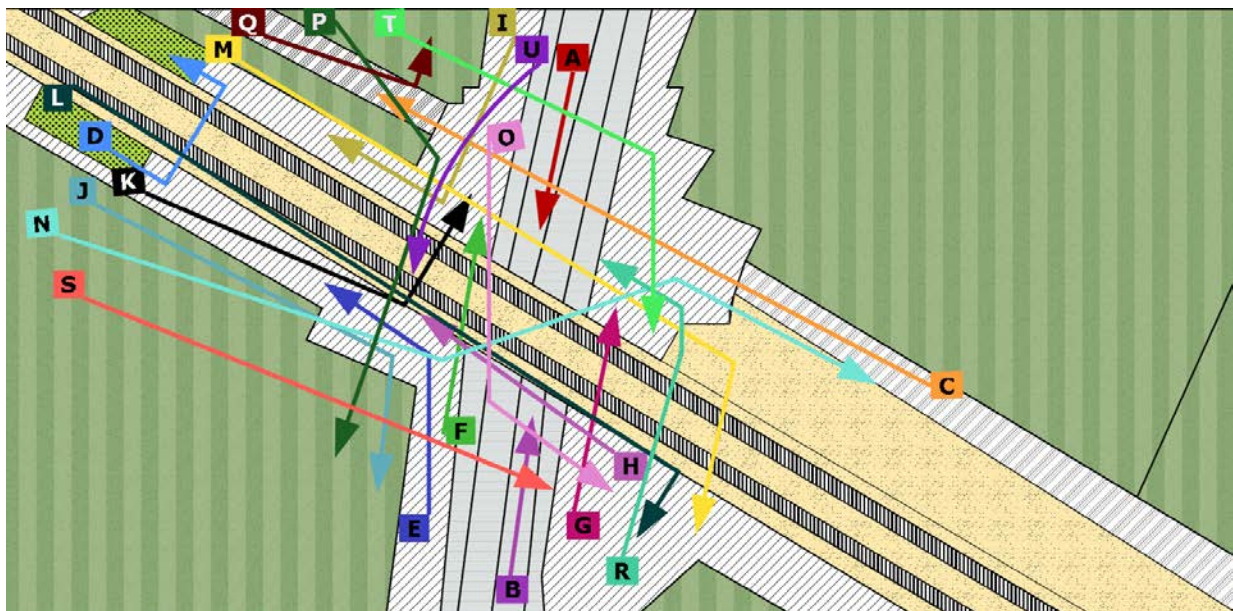
Figure 3.9: Diagram depicting observed pedestrian and bike movements

Most frequently observed pedestrian movements, Movements I & J involve keeping to the sidewalk.

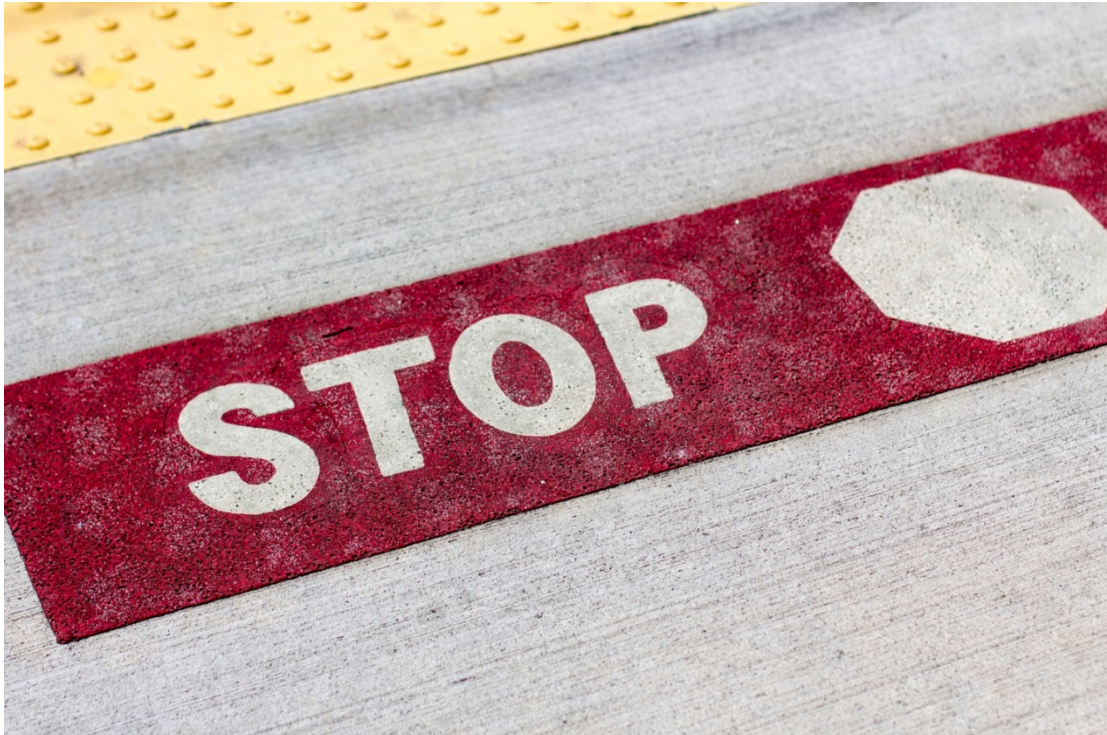
Figure 3.11: Tactile surface and painted stop signs for pedestrians

This crossing has the most treatments of all the surveyed crossings. First, the crossing is controlled with a traffic signal. While the southbound light is only used to stop cars when pedestrians are present and when a train is crossing, the northbound light is different. Upstream another light is found, and when that is red, the northbound light is too. This leads to some confusion. The crossing is also equipped with active gates, flashing lights and bells, activated by an oncoming train and active TriMet Style Pedestrian Flashers (TMPF's), which are placed at both pedestrian track crossings between each set of tracks. There is standard signage such as cross bucks, railroad ahead, etc. In addition to that there is a TriMet "LOOK BOTH WAYS" black on yellow warning sign, which are utilized by TriMet exclusively and are permitted to be installed. Other passive treatments at this location includes pedestrian gates and pedestrian fencing, along with tactile surfaces and painted road marks.

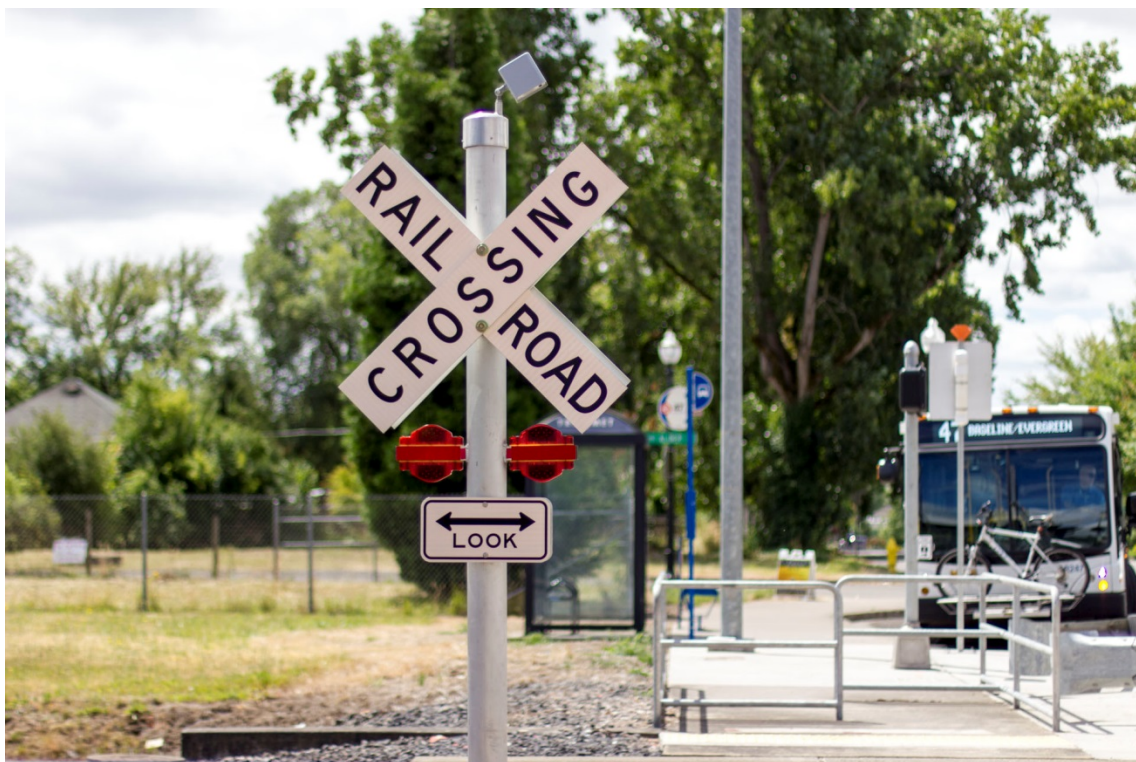
Figure 3.12: Active TriMet Style Pedestrian Flashers (TMPF's) and pedestrian fencing

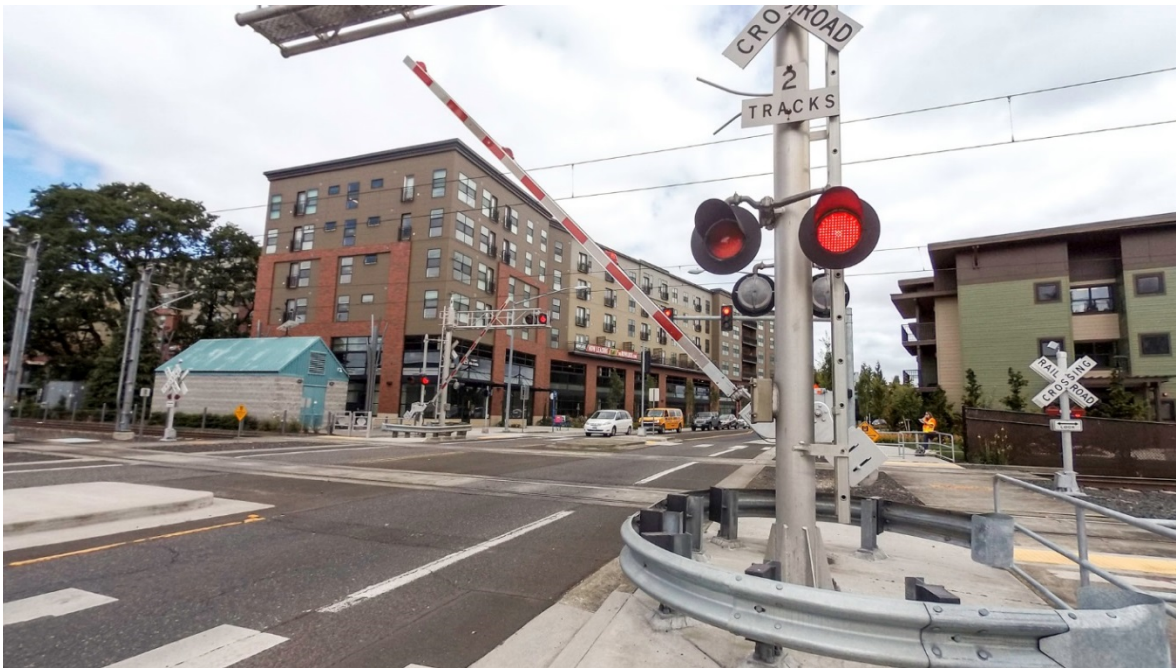
Figure 3.13: This crossing has many different types of treatments

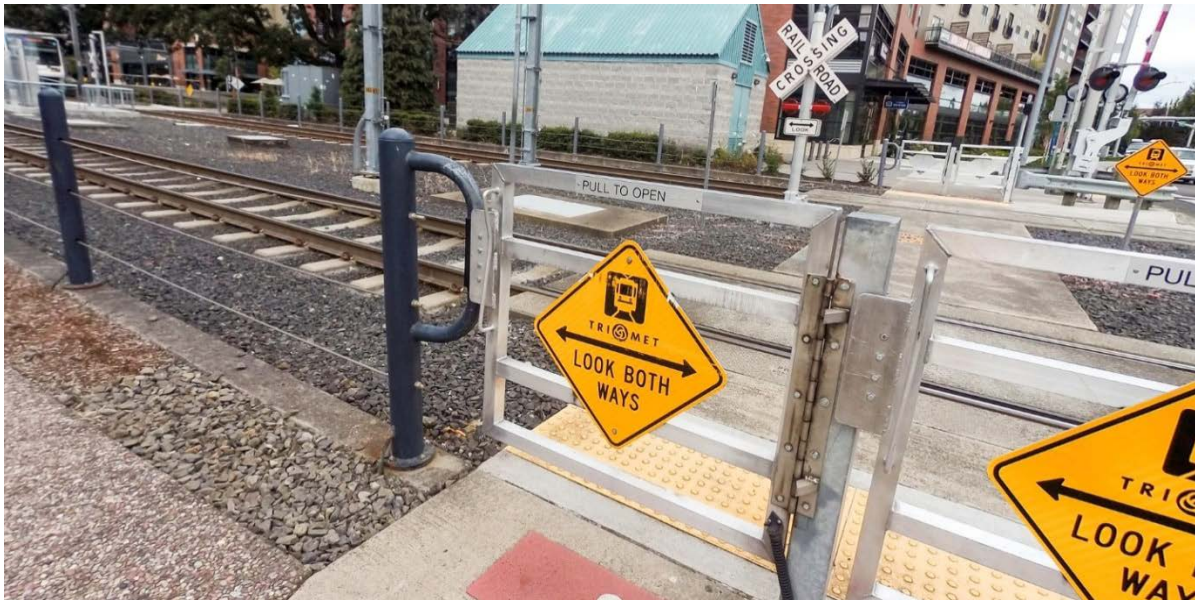
Figure 3.14: Passive gates close off both sides of the crossing closets to the light rail

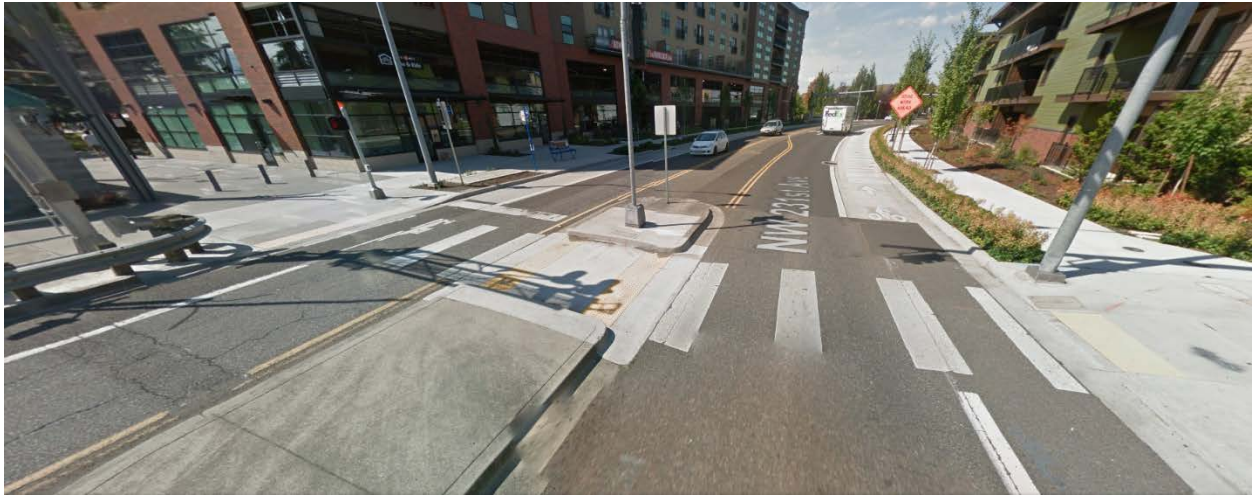
Figure 3.15: Highway/Path Crossing (Google, 2016)

The adjacent path is primarily used by pedestrians, though a few bikes were also observed. The trailhead is marked by bollards on one side, the one leading from the station and the plaza, but not on the other side. There are pedestrian crossings on both sides of the street and they are both marked with stripes and yellow tactile warning plates.

Both crosswalks have refuge islands in the middle, and are signaled with a button activated light signal.

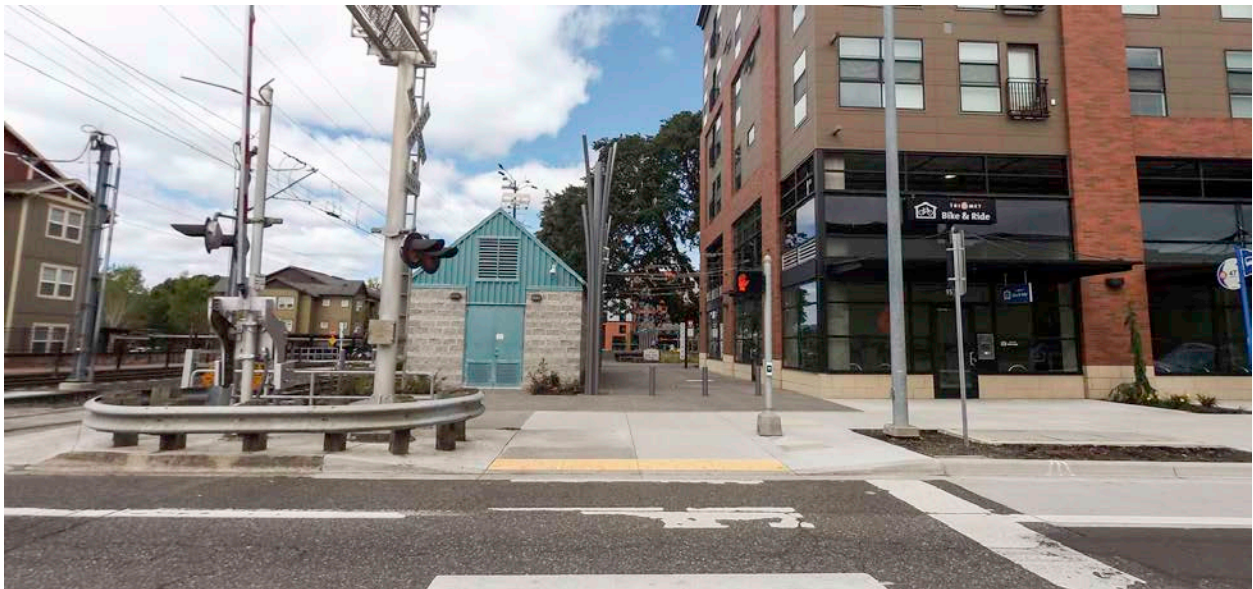
Figure 3.16: Pedestrian facilities, the light rail station and the Orenco Plaza entrance

This crossing has several infrastructure installations designed for bikes and pedestrians. Both sides of the road are equipped with both sidewalks of varying width and with on-road bike lanes. The sidewalks enable users to cross the railroad tracks on both sides, through passive fences as previously described. There is not a continuous trail running adjacent to the road at this location, but there is some activity stemming from the plaza and the light rail station, using a pedestrian walkway that leads into a residential complex.

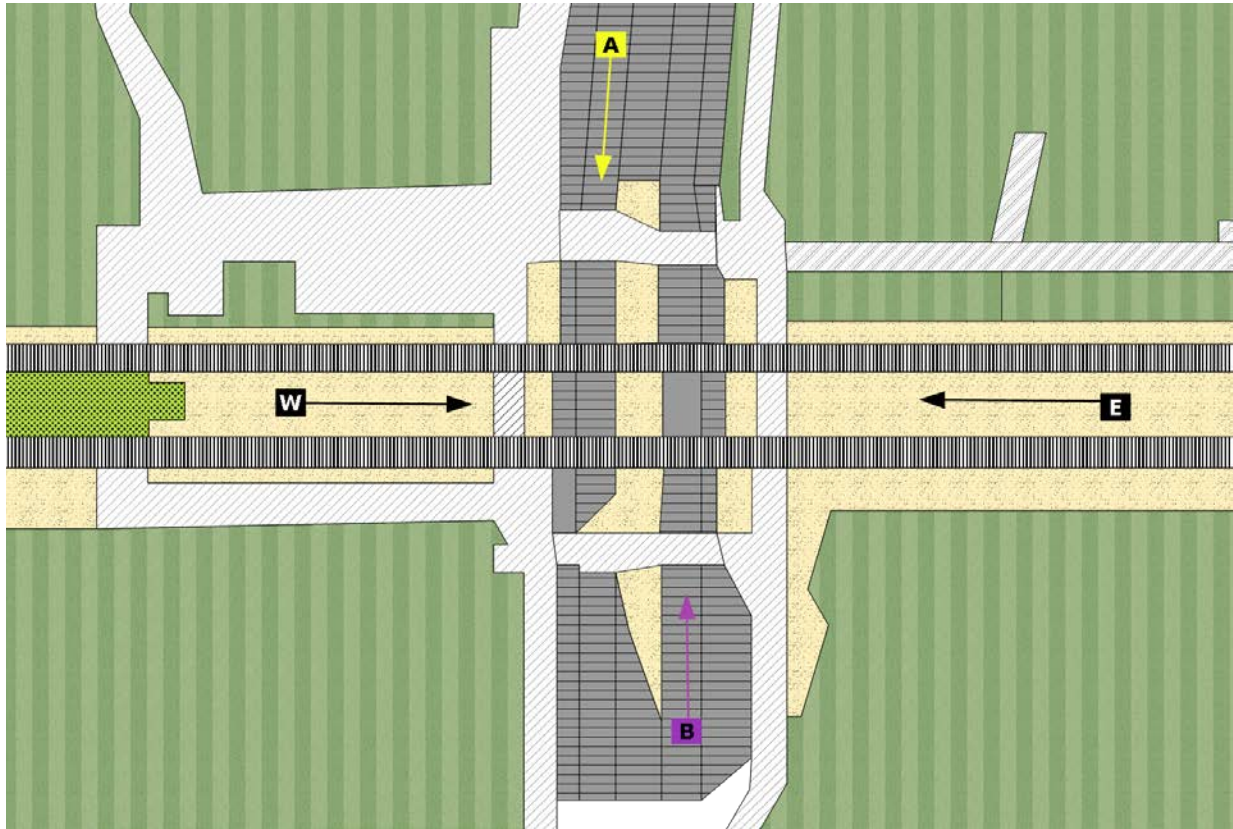
Figure 3.18: Diagram depicting observed vehicle and train movements

Vehicles speed through the crossing while the light rail warning lights are flashing red.

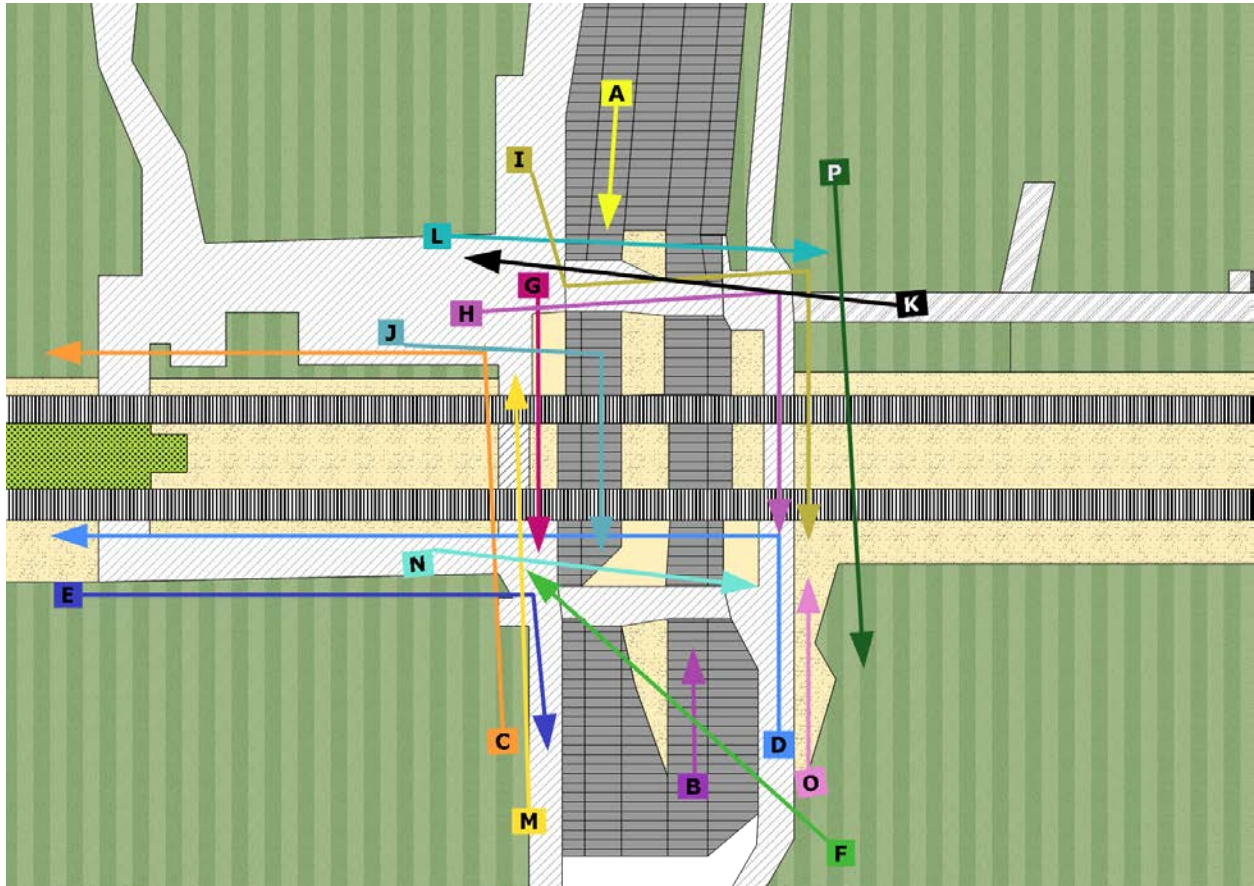
Figure 3.19: Diagram depicting observed pedestrian and bike movements

Four of the most frequently observed movements during morning rush hour; Movements C, D, K & L involve entering and exiting the path.

Undesired observed pedestrian movements include Movement F.

Most observed bicyclists utilized the road's bike path. This is indicated by Movement B during morning rush hour and Movement A during evening rush hour.

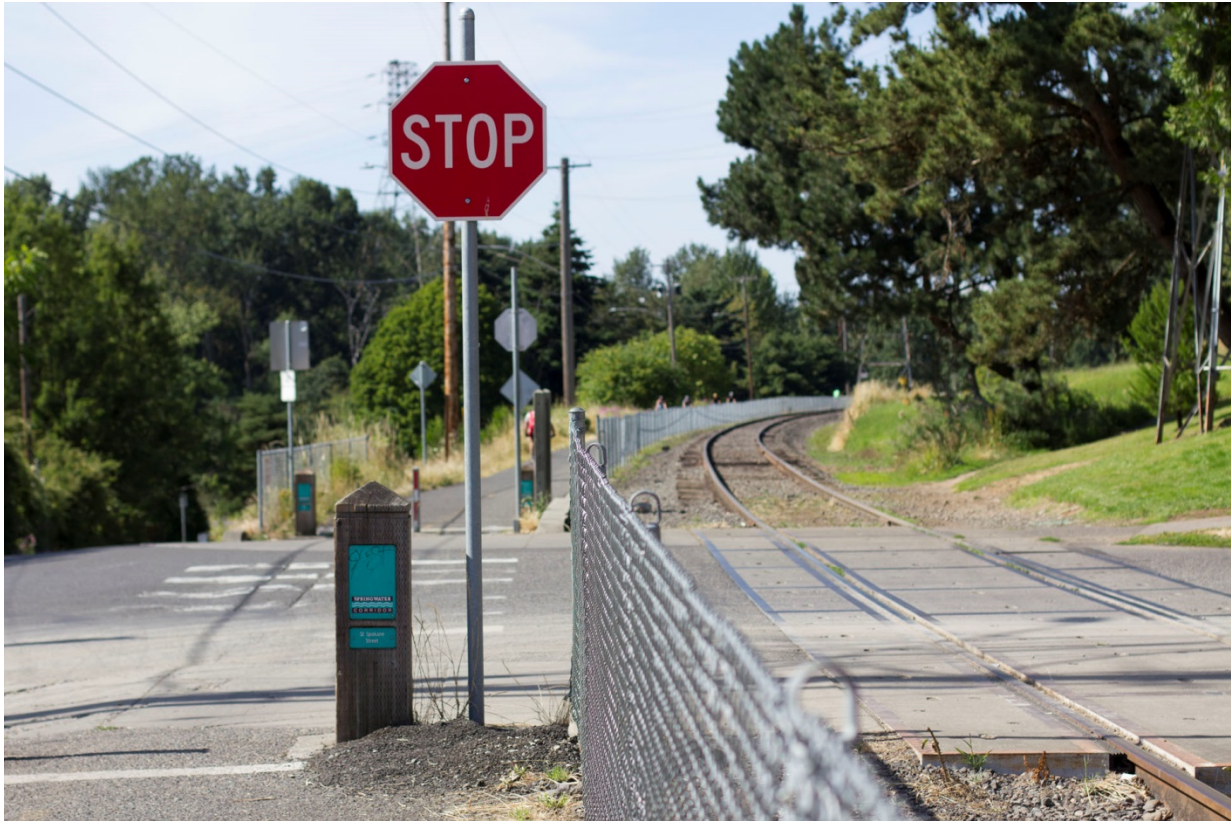
Figure 3.21: There are stop signs installed at all approaches and for all road users

The multi-use trailheads are both equipped with stop signs of a design specified for use on trails which are placed lower and are smaller than a standard sign, and designed according to MUTCD Section 8D and Part 9. Both trailheads are equipped with a stop line and both have one bollard, which is placed to show the two-way nature of the multi-use path. The crossing is marked.
