**MULTI-MODAL INTERSECTIONS:
RESOLVING CONFLICTS
BETWEEN TRAINS, MOTOR
VEHICLES, BICYCLISTS AND
PEDESTRIANS**

Final Report

SPR 794

Oregon Department of Transportation

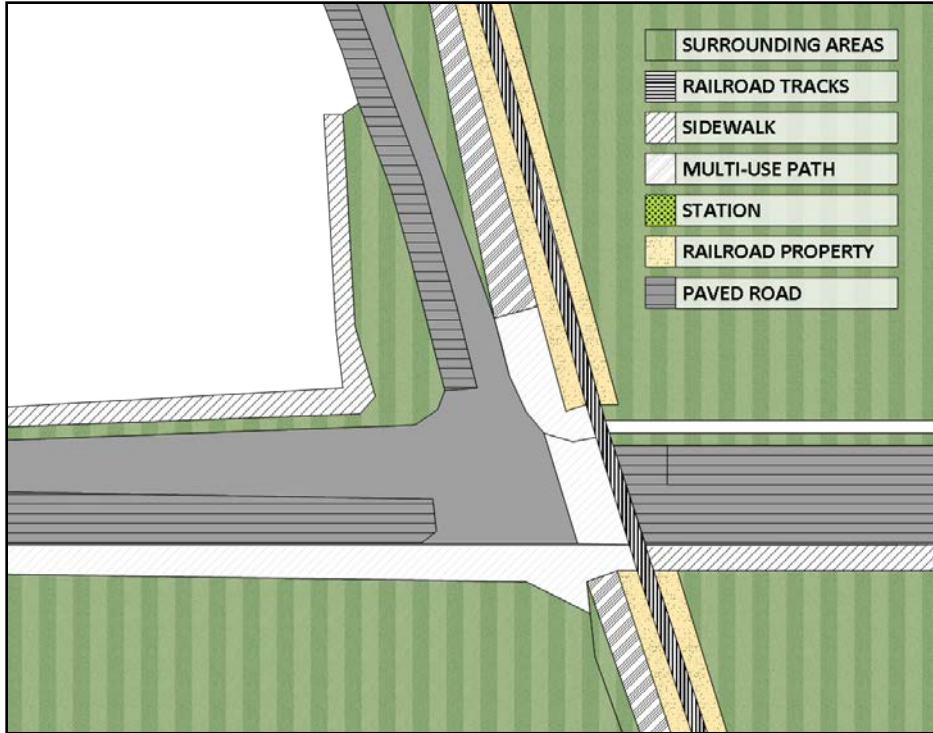
Figure 3.22: Diagram of SE Spokane St.

A simplified diagram of SE Spokane St. is included below to exemplify the dynamic movements of road and path users at this crossing.

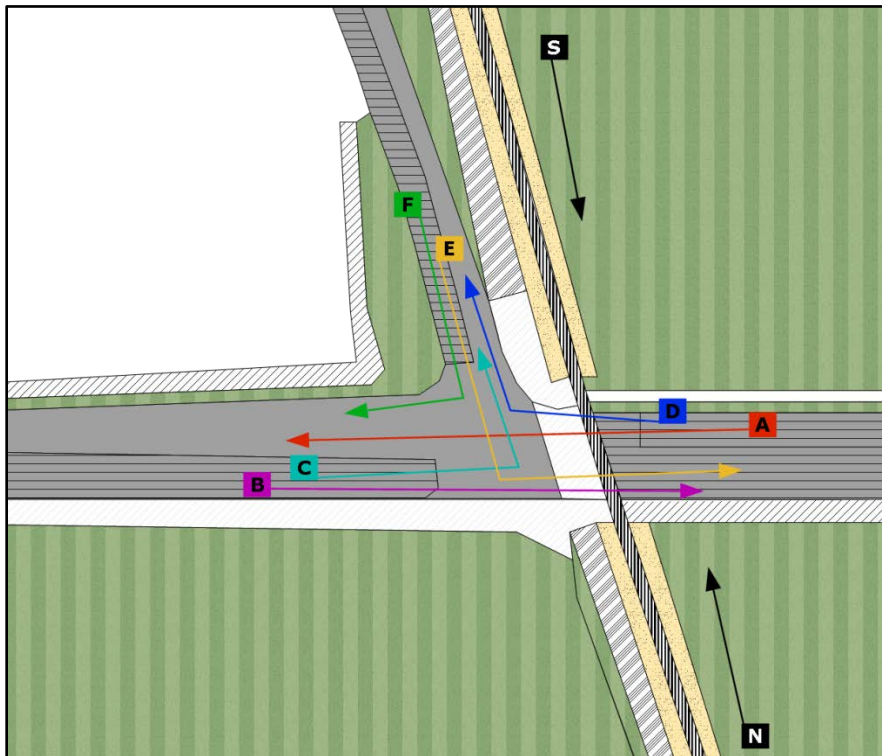
Figure 3.23: Diagram depicting observed vehicle and train movements

Movement D is on average the most frequently observed vehicle movement. Video observations reveal that there is a conflict between vehicles and path users during this movement because turning vehicles often drive on the pavement or path after turning, before readjusting to being fully on the road. This is because the path is at-grade with the roadway. This issue is addressed in the case studies of the location.

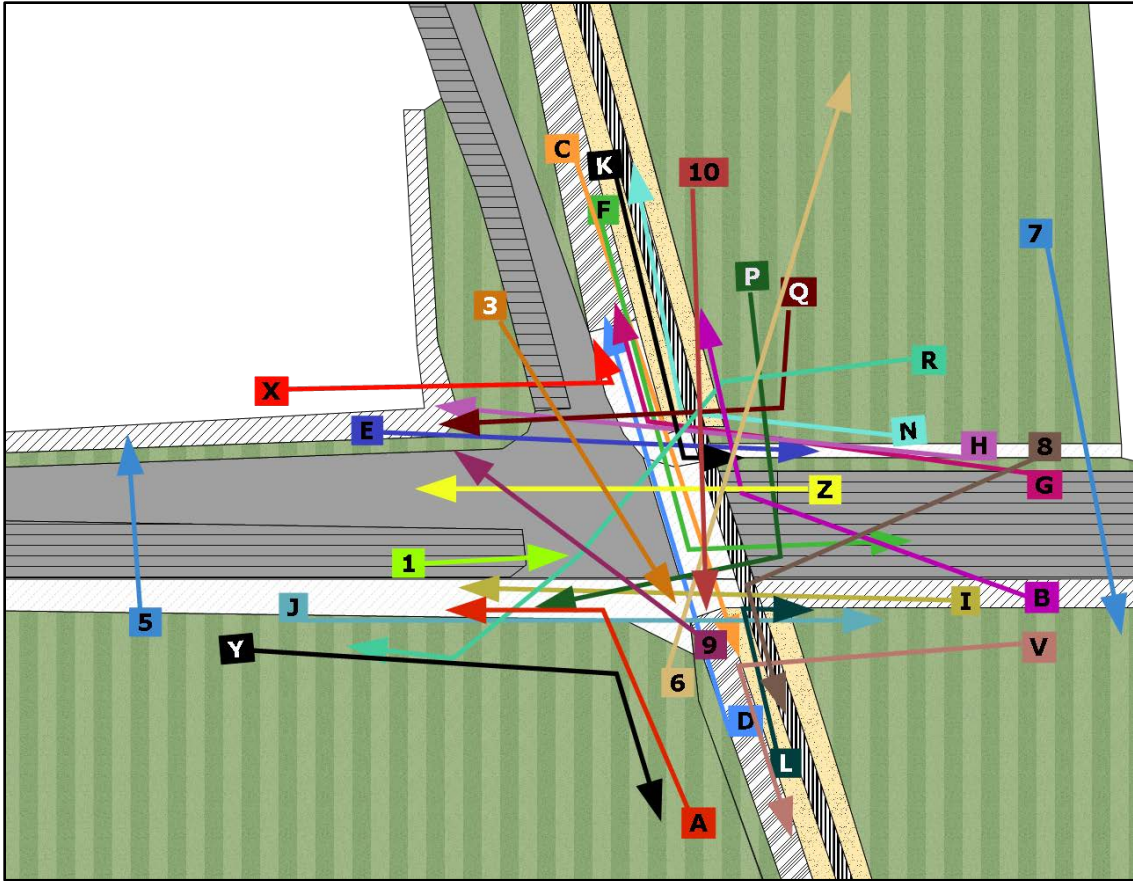
Figure 3.24: Diagram depicting observed pedestrian movements

The most frequently observed movement during rush hour is Movement F where pedestrians coming from the trail continue up the street, either on or off the sidewalk.

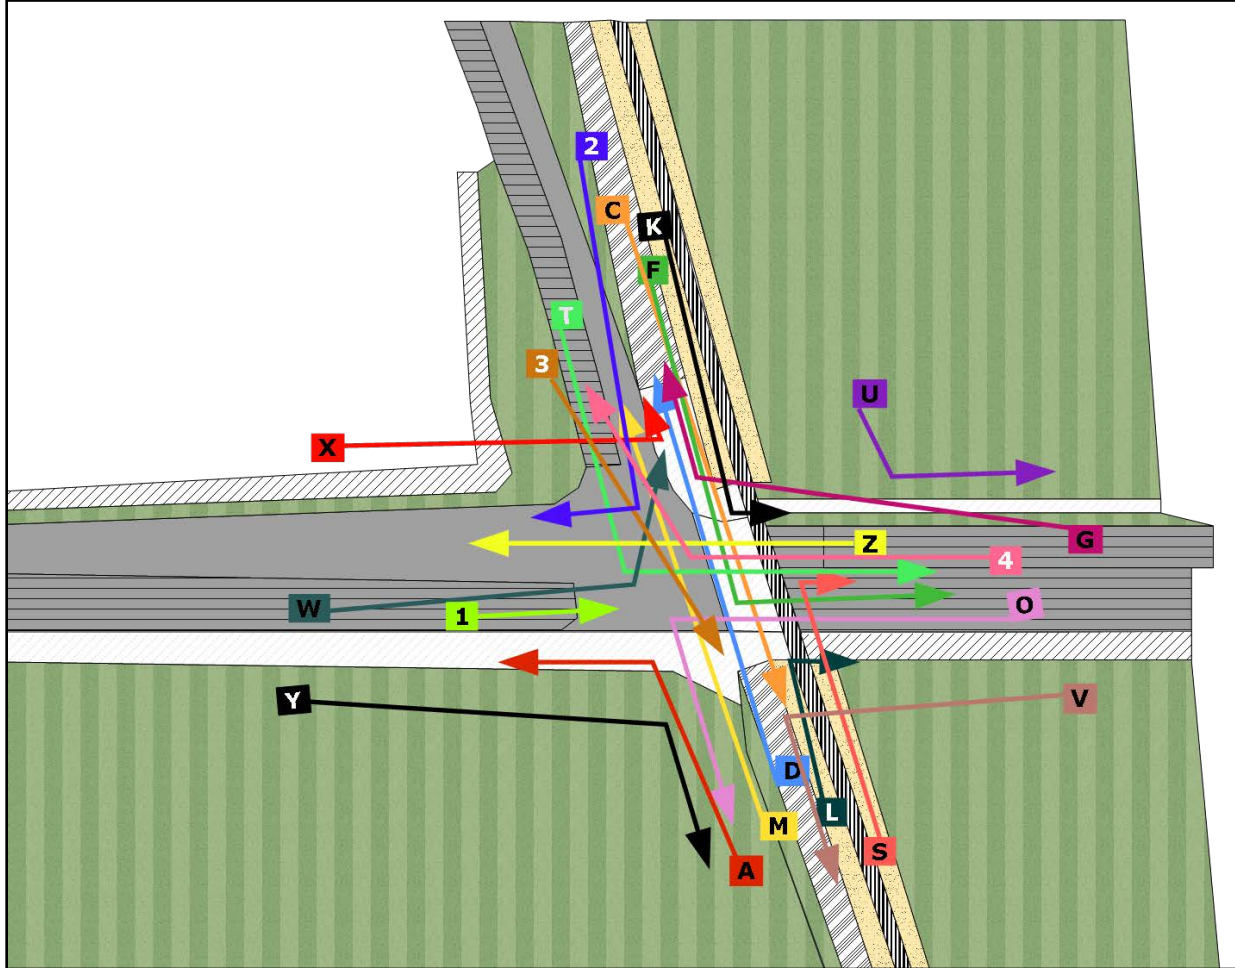
Figure 3.25: Diagram depicting observed bike movements

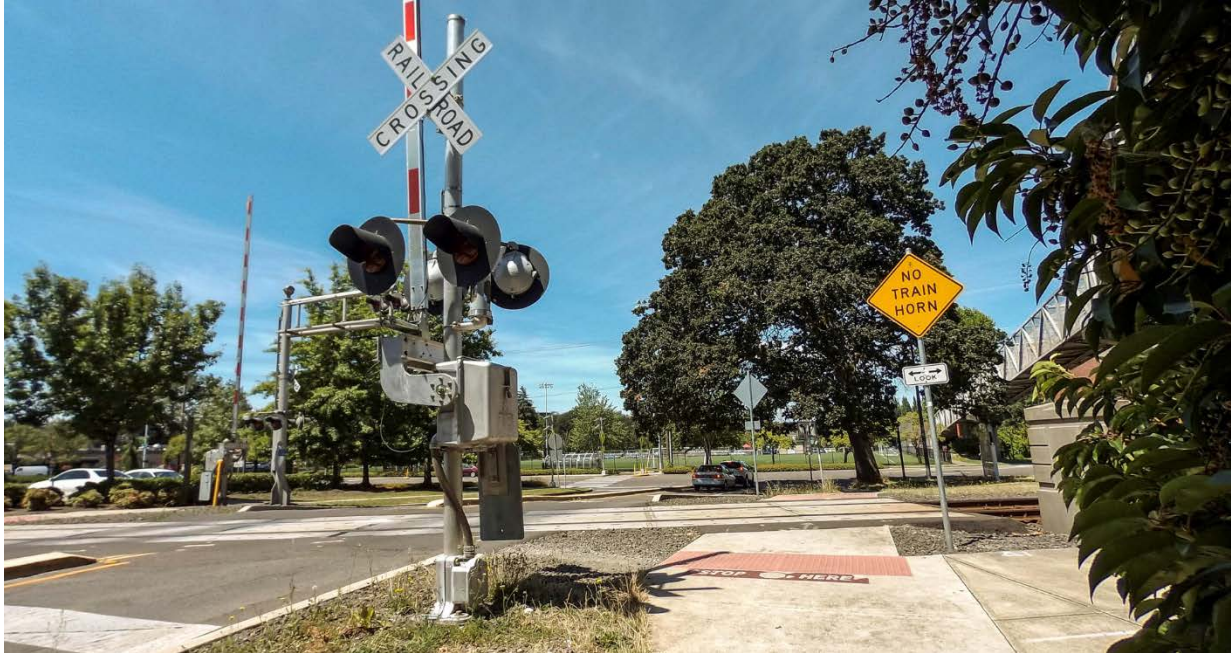
This crossing is equipped with active treatments in the form of gates, lights and bells. It also has several other treatments including cross bucks, pavement markings and a stop lines. For pedestrians, there are only passive treatments, except for the audible device. These include tactile markings, a painted warning mark on the sidewalk and a sign “NO TRAIN HORN” reminding pedestrians that the train at this location does not use its horn and that it can be coming from both sides. This is due to the crossing being in a Quiet Zone. The road is equipped with a median, potentially to discourage road users to drive around the gates.

Figure 3.27: Active and passive treatments at the SE Mill St Crossing

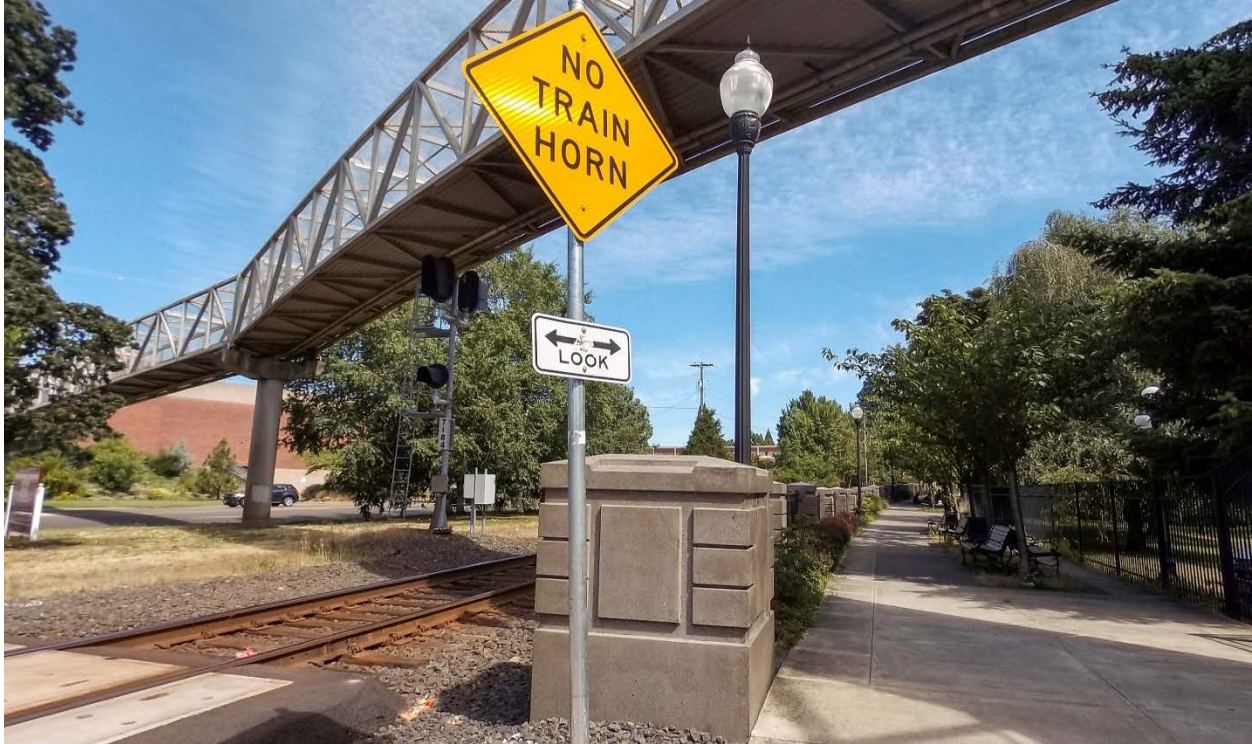
Figure 3.28: The sight from the pedestrian stop line at the end of the trail

The crossing at SE Mill St is equipped with a variety of pedestrian and bike facilities. First, it has a trail coming from one side, which seems to be more geared towards pedestrians, though it is categorized as a Promenade, where motor vehicles are legally permitted to share with bicyclists and pedestrians. The trail does not continue onto the other side. There is nothing facilitating crossing the road adjacent to the railroad tracks, but instead it is designed so that people continue down the sidewalk to the next intersection, cross there, before walking back up on the other side.

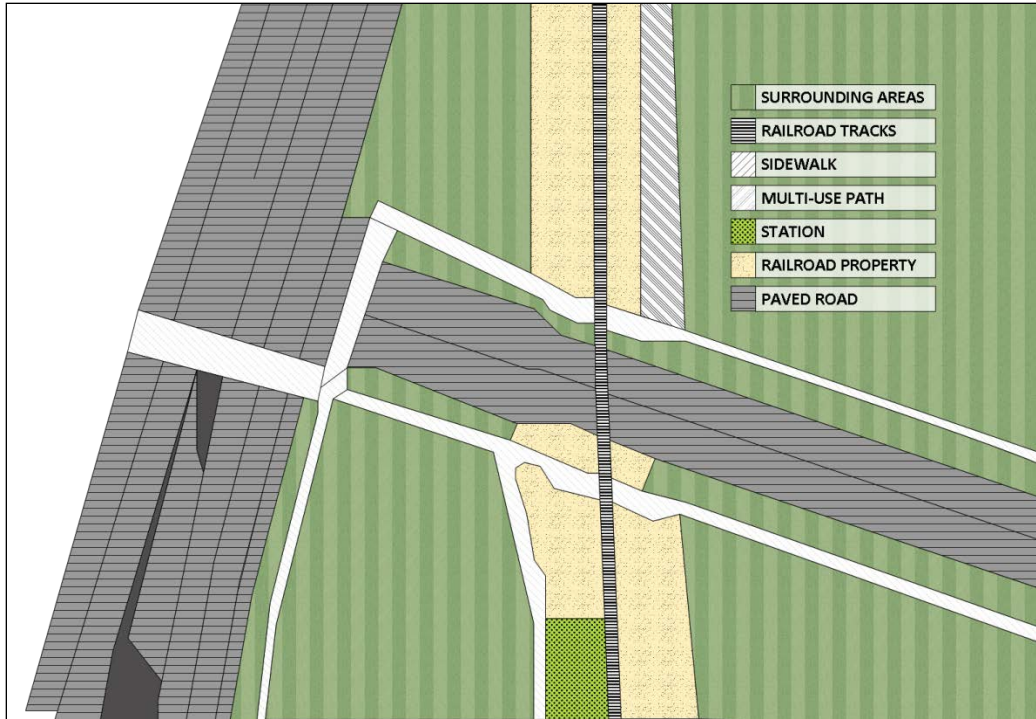
Figure 3.29: Diagram of SE Mill St

A simplified diagram of SE Mill St is included below to exemplify the dynamic movements of road and path users at this crossing.

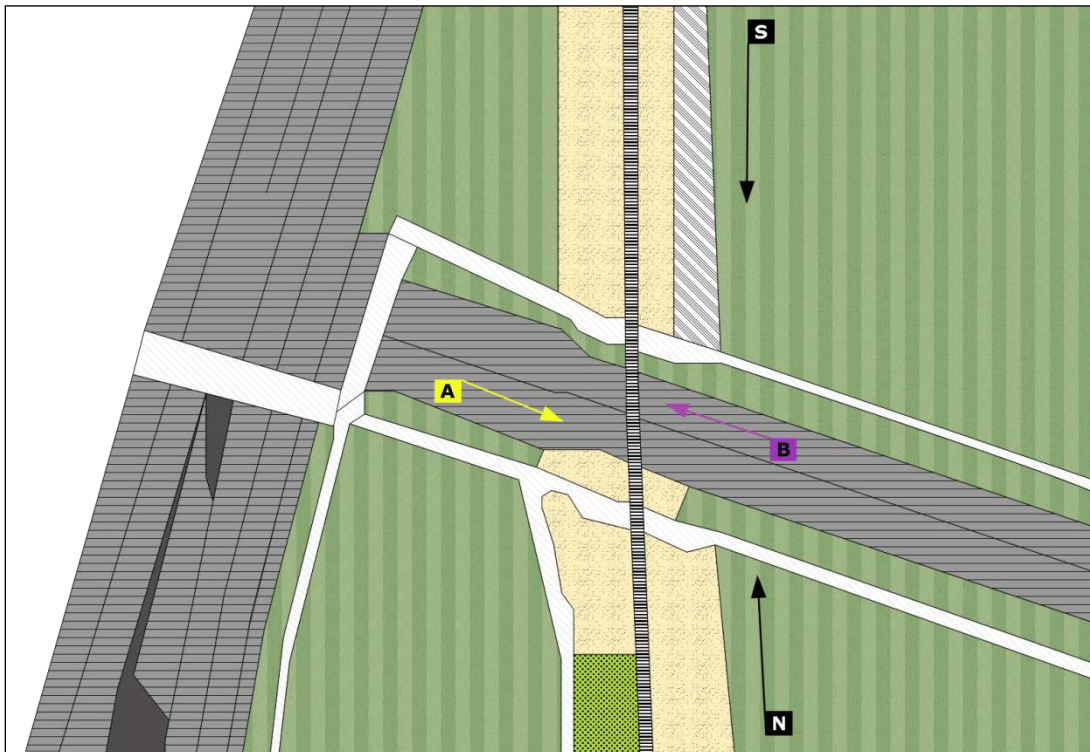
Figure 3.30: Diagram depicting observed vehicle and train movements

VIDEO COUNTS			
	2016/06/02 7.40am-8.40am	2016/06/01 4.40pm-5.40 pm	Average
Vehicles	274	247	260.5
Movement A (EB)	112	139	125.5
Movement B (WB)	49	108	78.5
Trains	1	2	1.5
Movement N (NB)	1	1	1
Movement S (SB)	0	1	0.5

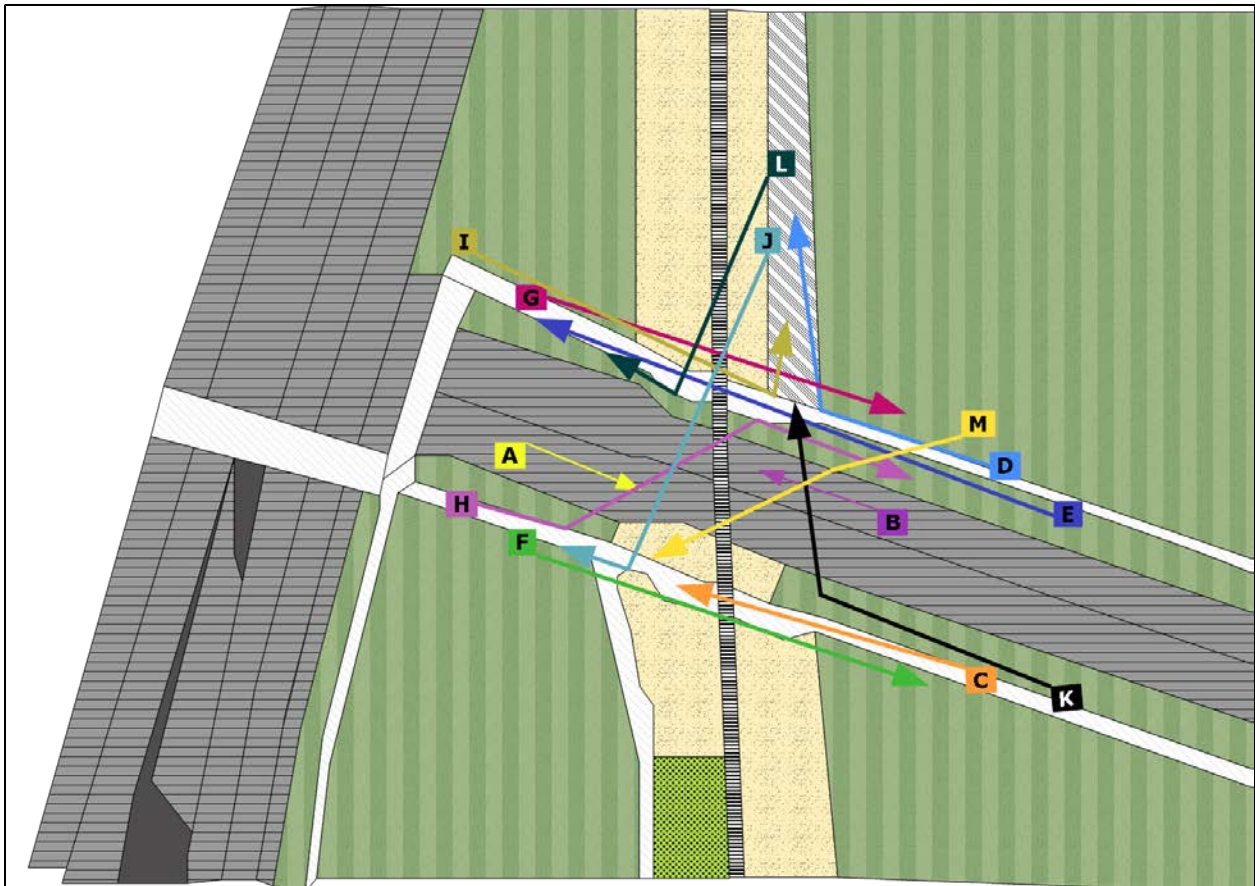
Figure 3.31: Diagram depicting observed pedestrian and bike movements

Majority of pedestrian movements include staying on a sidewalk. For example, Movement C & F.

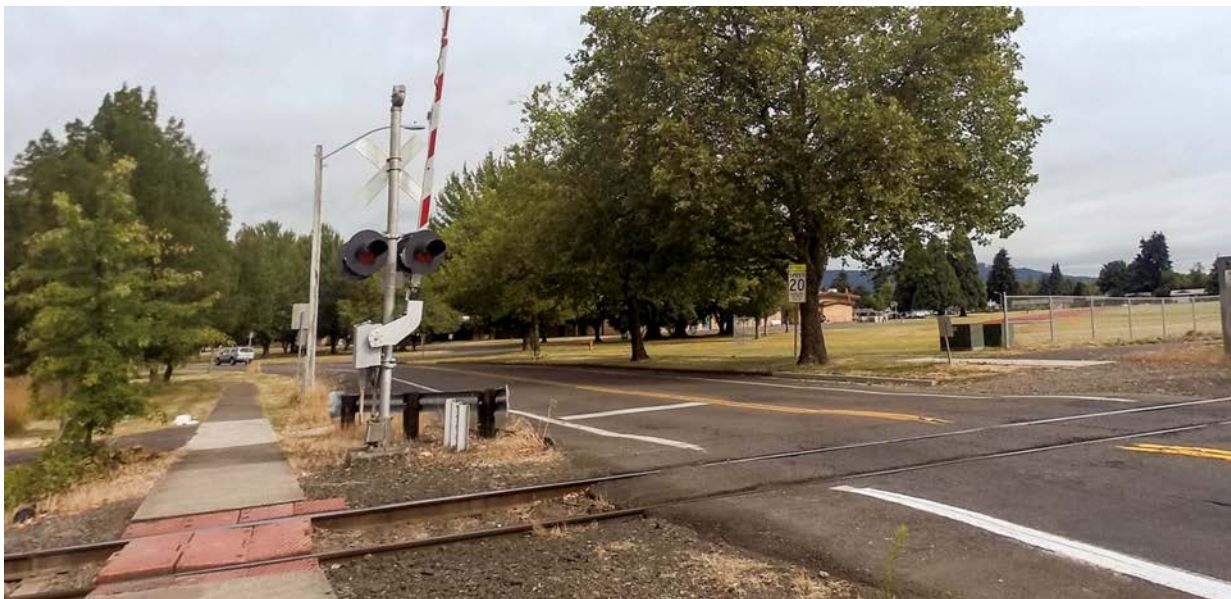
This location is equipped with both active and passive treatments. This include active gates, lights and bells and a railroad warning sign, W10-1 cross bucks and a stop line for vehicular users.

Figure 3.33: The active treatments at NE Conifer Blvd (School marked in yellow)

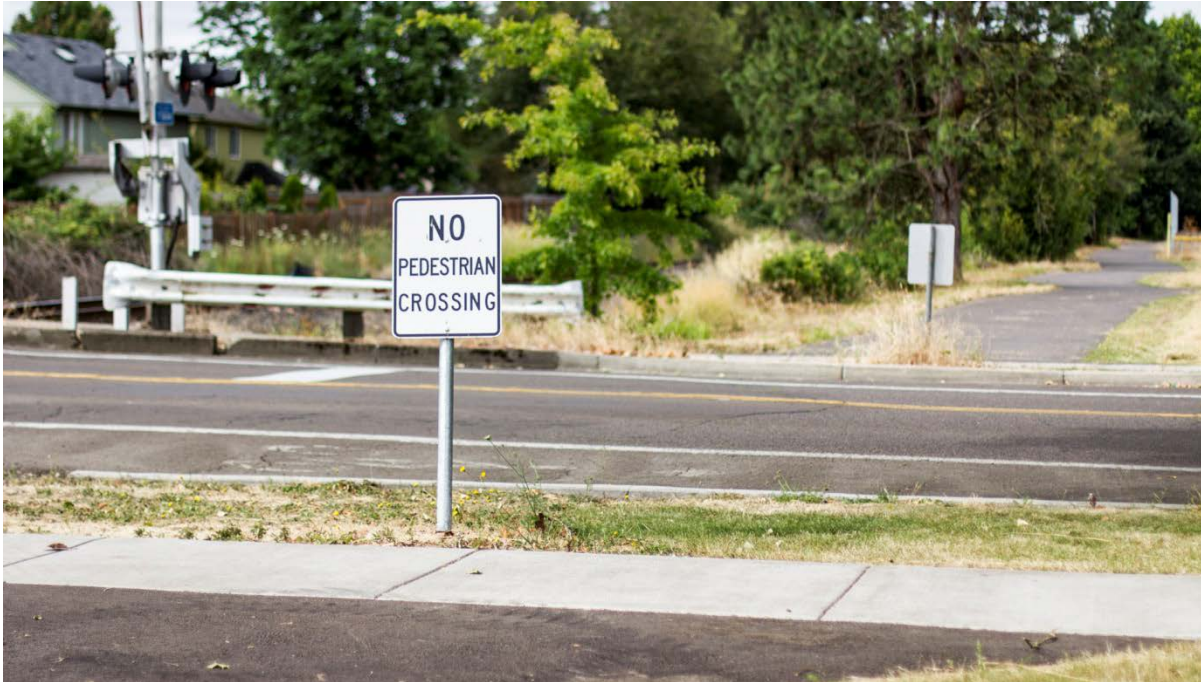
Figure 3.34: The” No Pedestrian Crossing”-sign placed at both trailheads.

At the end of both trailheads, a “No pedestrian crossing”-sign facing people who are approaching the crossing from the path, is placed as seen in Figure 3.34. Under ORS 810.080 the authority can: “(...) prohibit [] pedestrians from crossing a roadway where a crosswalk has been closed by placing and maintaining signs giving notice of closure. prohibit [] pedestrians from crossing a highway at any place other than within a marked or unmarked crosswalk”, why crossing the road at such a location is considered prohibited.

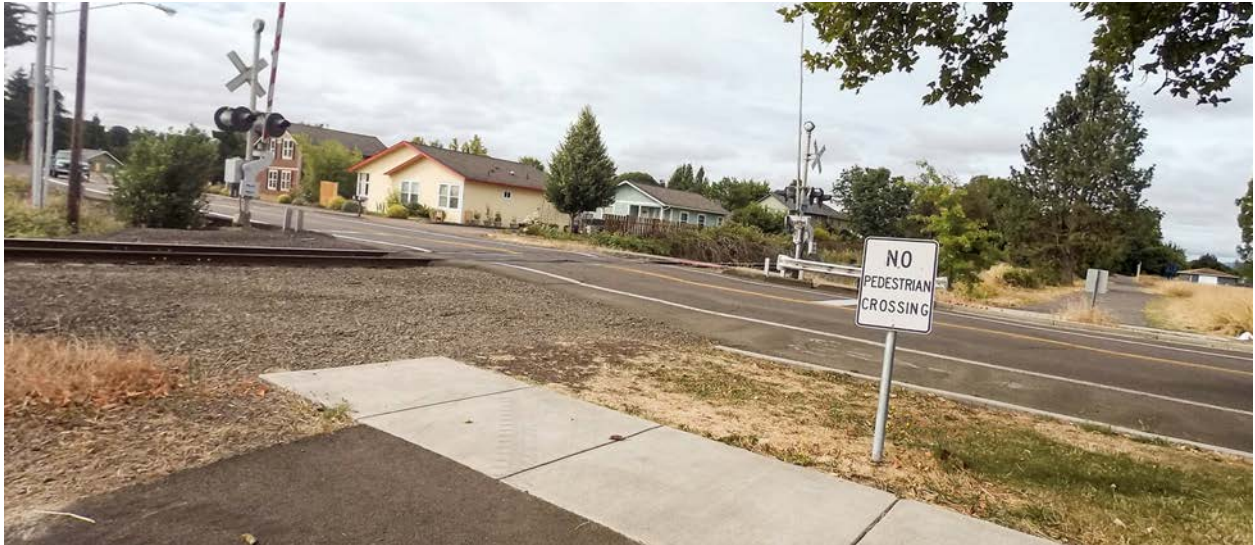
Figure 3.35: The sidewalk suddenly stops at the tracks

The trail at this location is part of a long section of trail that is primarily intended for commuters, but also used by locals walking dogs or exercising, school children from the nearby school etc. This location is equipped with sidewalks on both sides of the street, through one of them ends before entering the NE quadrant, following the road and crossing the tracks on one side. On the other side, the sidewalk stops suddenly, as seen in Figure 3.35 and it is not possible to cross at the location of the path. Pedestrians can either step over the rails or walk down the street where crossing is not prohibited. Adjacent to the railroad tracks run a multiuse trail, which is unnamed. Previously it was possible to cross the road to continue the trail, according to ODOT RPTD, but at some point, the curb was reinstalled and the two “No pedestrian crossing”-signs were put up. There is nowhere nearby where it makes sense to cross, except for in the middle of the road further down. Both sides have dedicated bike lanes.

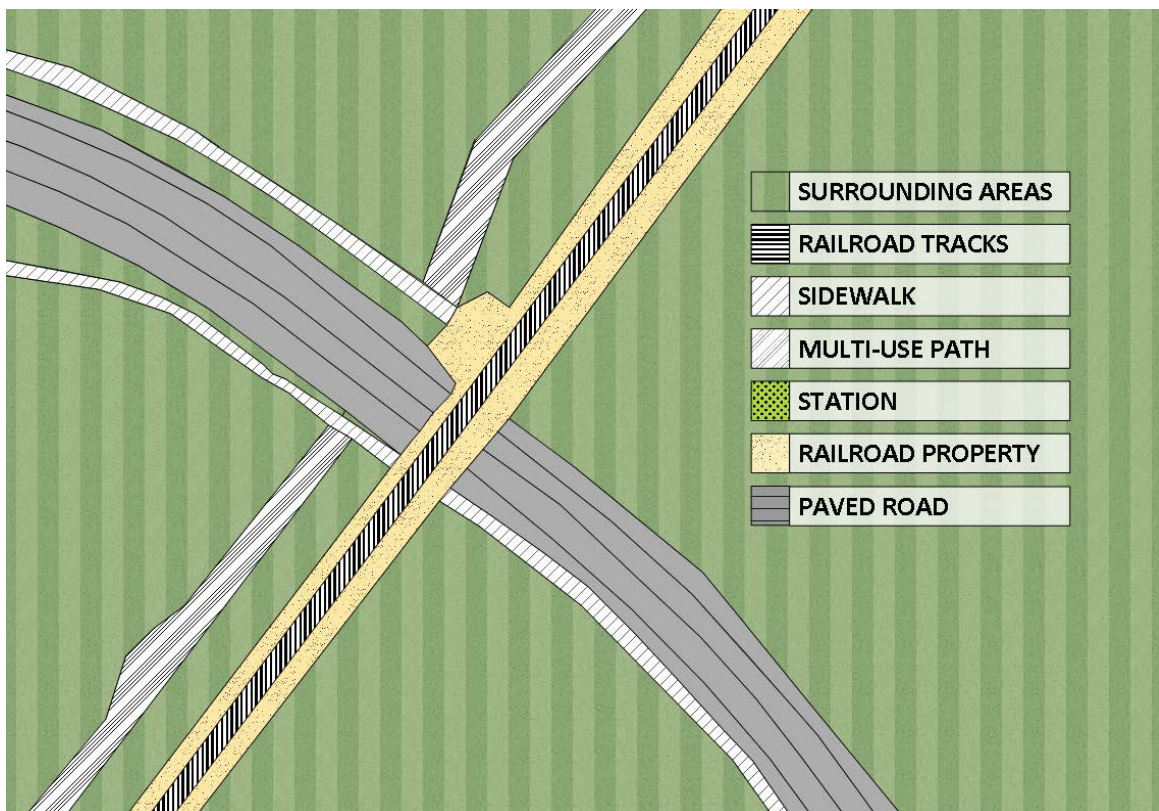
Figure 3.36: Diagram of NE Conifer Blvd.

A simplified diagram of NE Conifer Blvd. is included below to exemplify the dynamic movements of road and path users at this crossing.

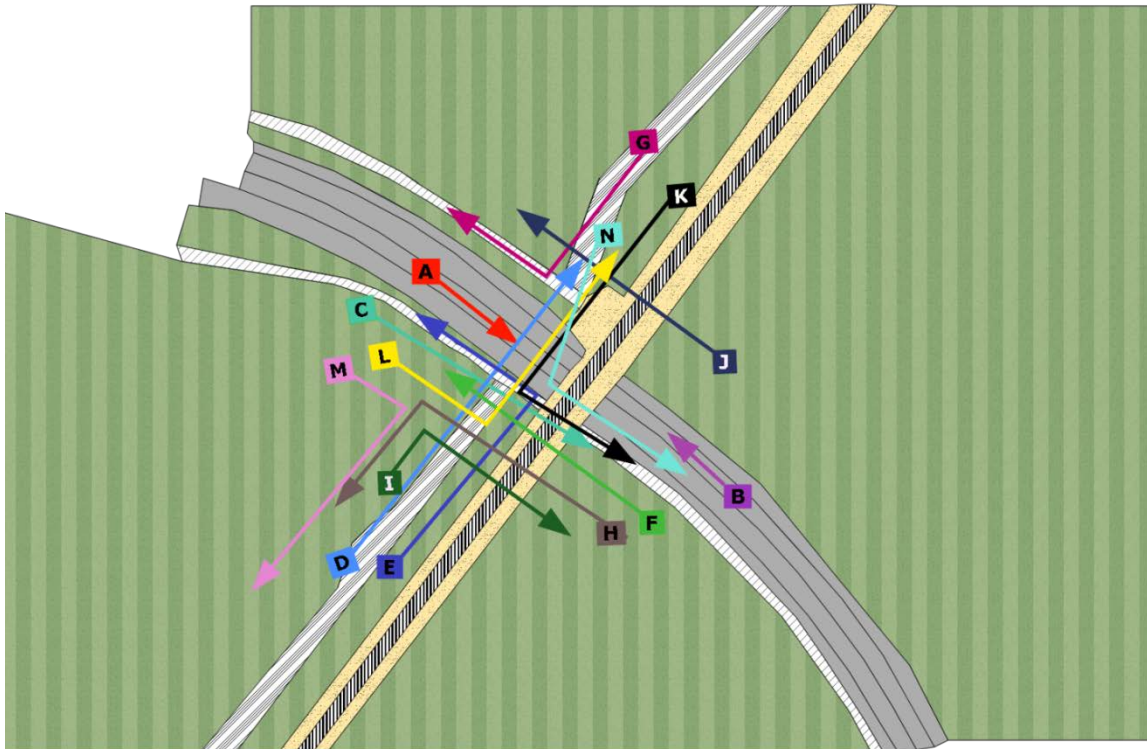
Figure 3.38: Diagram depicting observed pedestrian and bike movements

The most frequently observed pedestrian movement, Movement D, involves staying on the path and crossing parallel to the railroad tracks. This also becomes a prohibited movement while crossing the road to continue onto the path. It is considered prohibited because of the sign indicating on both sides that pedestrians are not allowed to cross, as mentioned in the previous section.

Prohibited pedestrian movements observed: Movement D, K, L, & N.

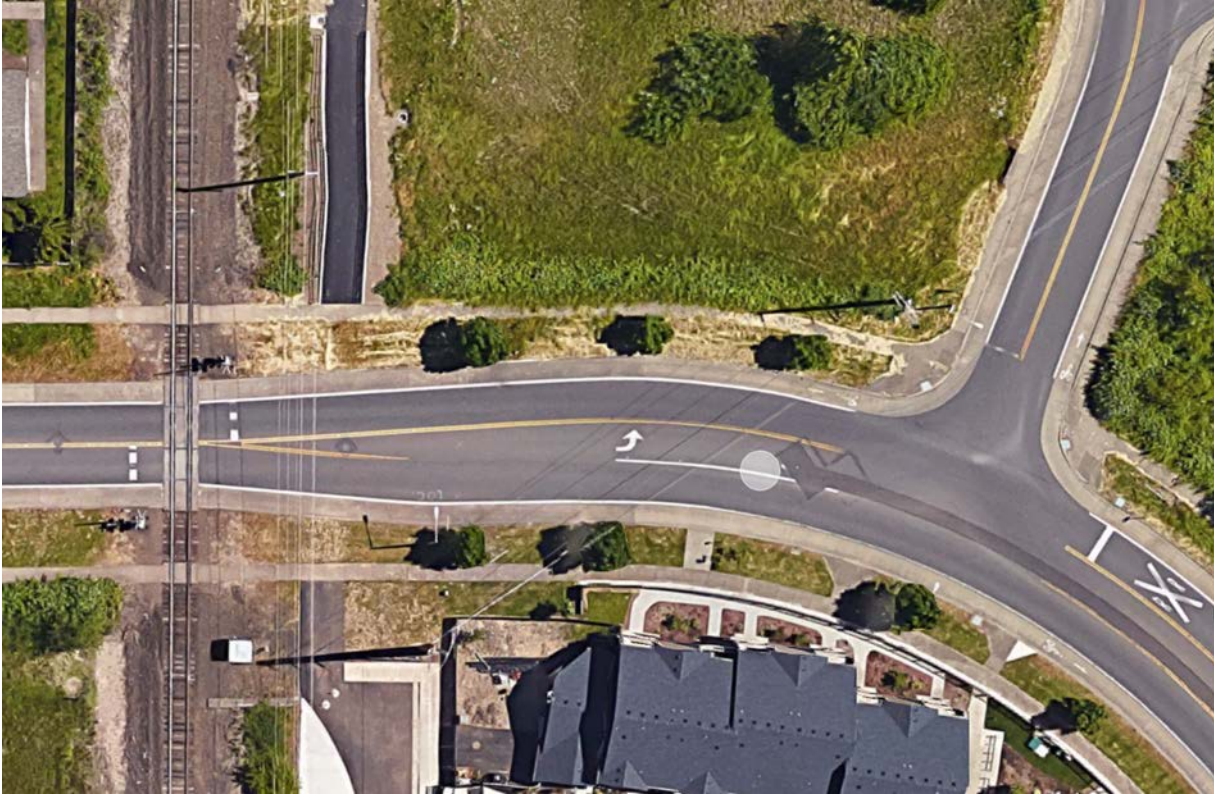
**Figure 3.39: Satellite photo of the Walnut Blvd crossing in Corvallis, OR (Google, 2016)
(Trail is marked in orange)**

The road is a two-lane road leading into the city of Corvallis and is marked as a 35-mph zone. In 2001 the AADT was 3236. During the observations, a count of 61 cars per 15 minutes or 244 cars per hour was made.

The crossing is not illuminated, though one street lamp is near the location. There have been no recorded incidents at this crossing. Nearby facilities include a several apartment complexes with new construction underway, along with recreational areas.

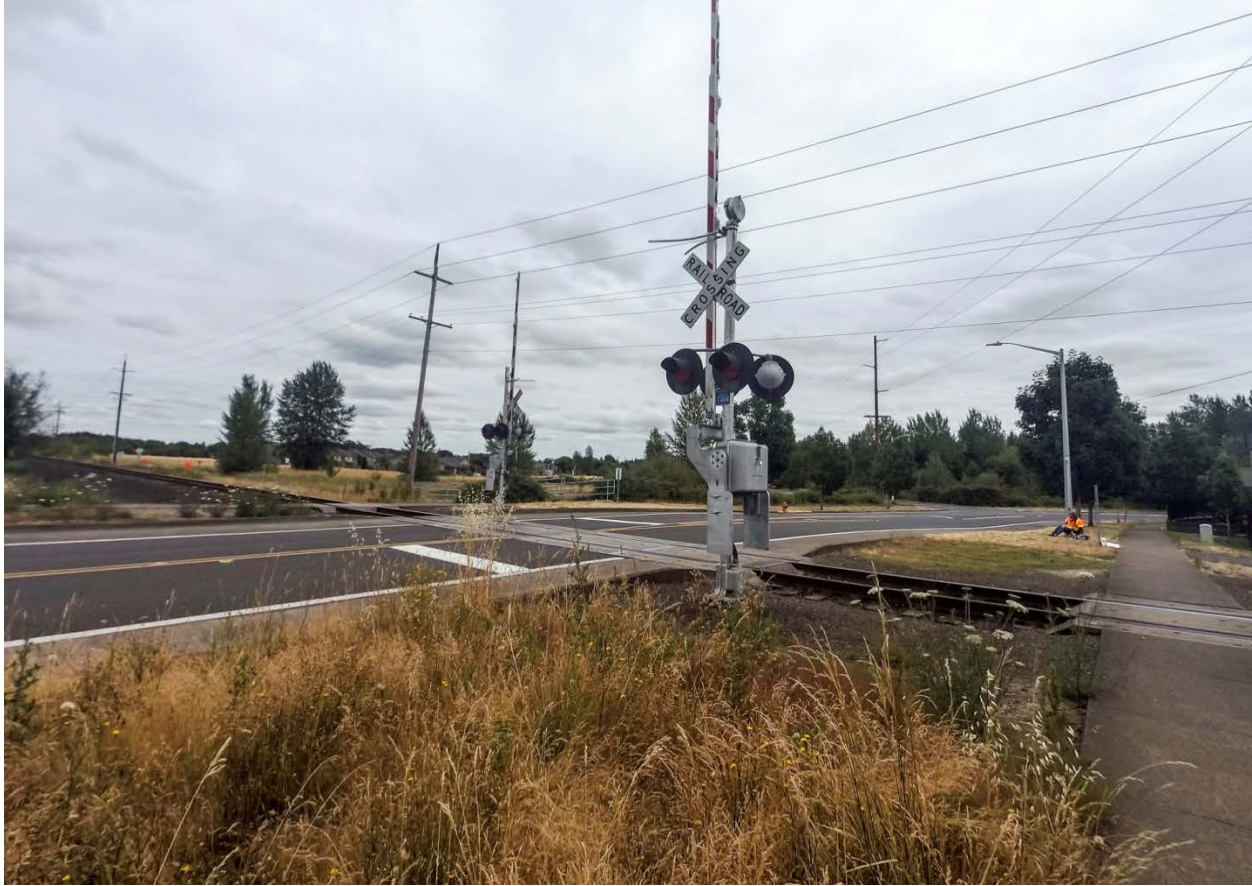
Figure 3.40: Active treatments at the NE Walnut Blvd crossing

The treatments at this location are very like the treatments found at the NE Conifer Blvd crossing. There are active treatments, including gates, lights and bells. The crossing is signaled with cross bucks, railroad road markings and a stop line.

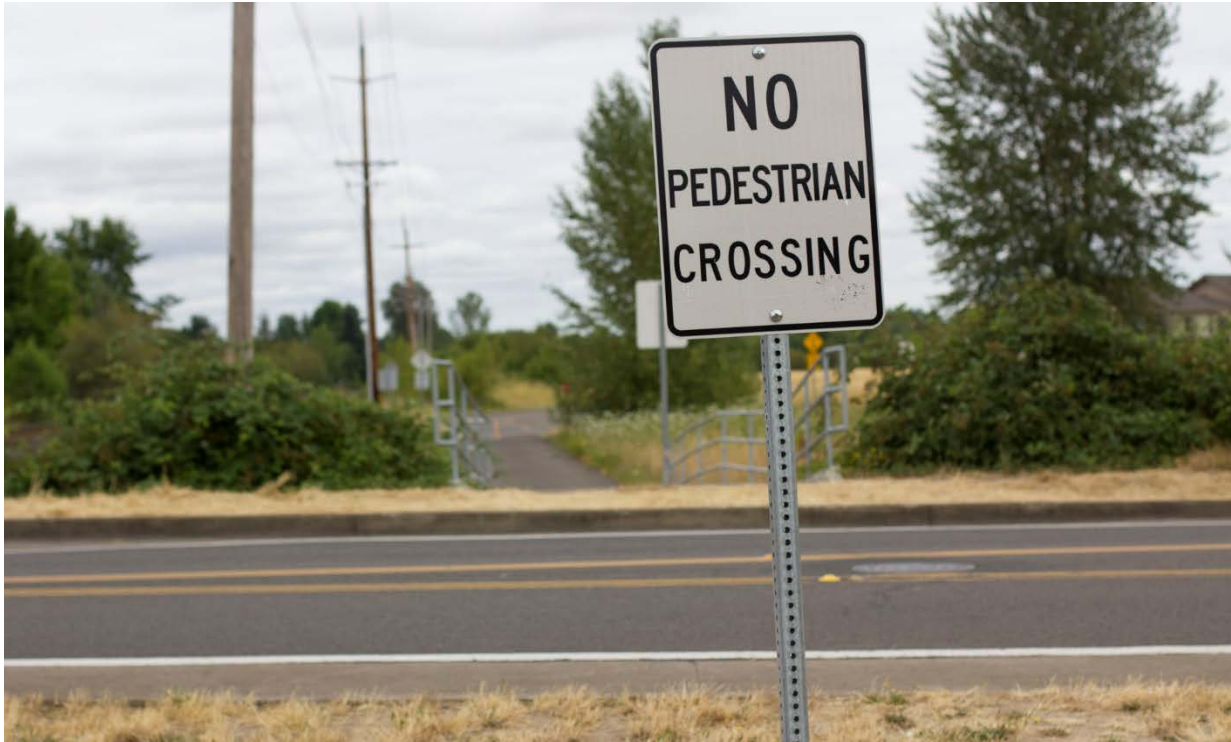
Figure 3.41: At NE Walnut Blvd it is prohibited under ORS 810.080 to cross the road between the two trailheads

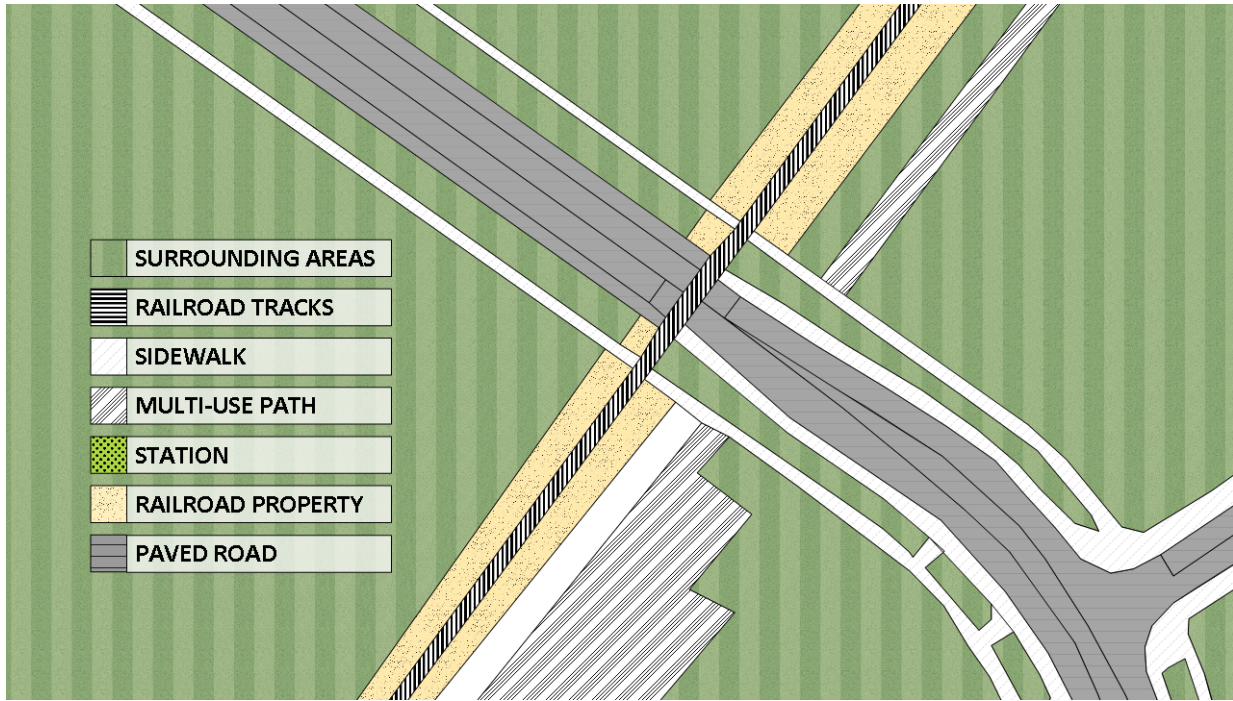
Figure 3.42: Diagram of NE Walnut Blvd

A simplified diagram of NE Walnut Blvd. is included below to exemplify the dynamic movements of road and path users at this crossing.

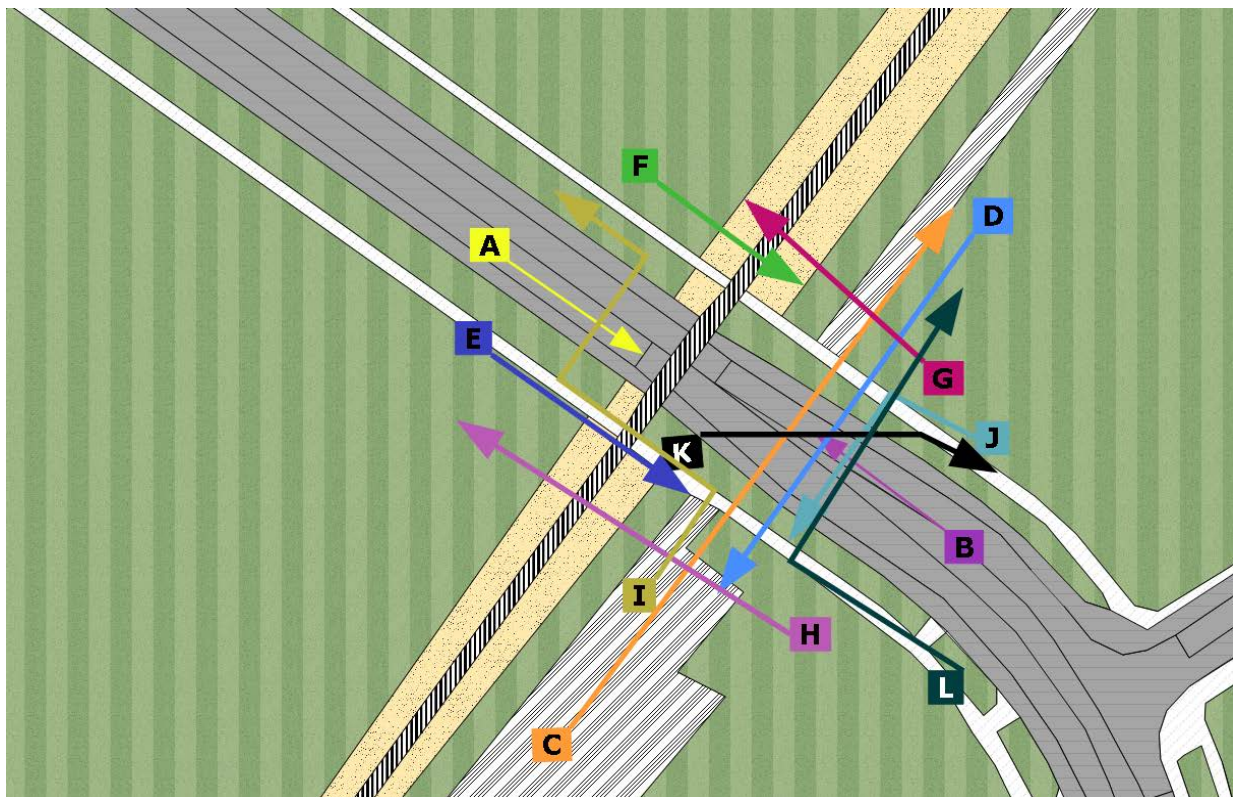
Figure 3.44: Diagram depicting observed pedestrian and bike movements

Most frequently observed pedestrian movement is Movement C, which also becomes a prohibited movement once pedestrians proceed to cross the street to continue onto the path.

Observed prohibited pedestrian movements include Movement C, D, I, J, & K.

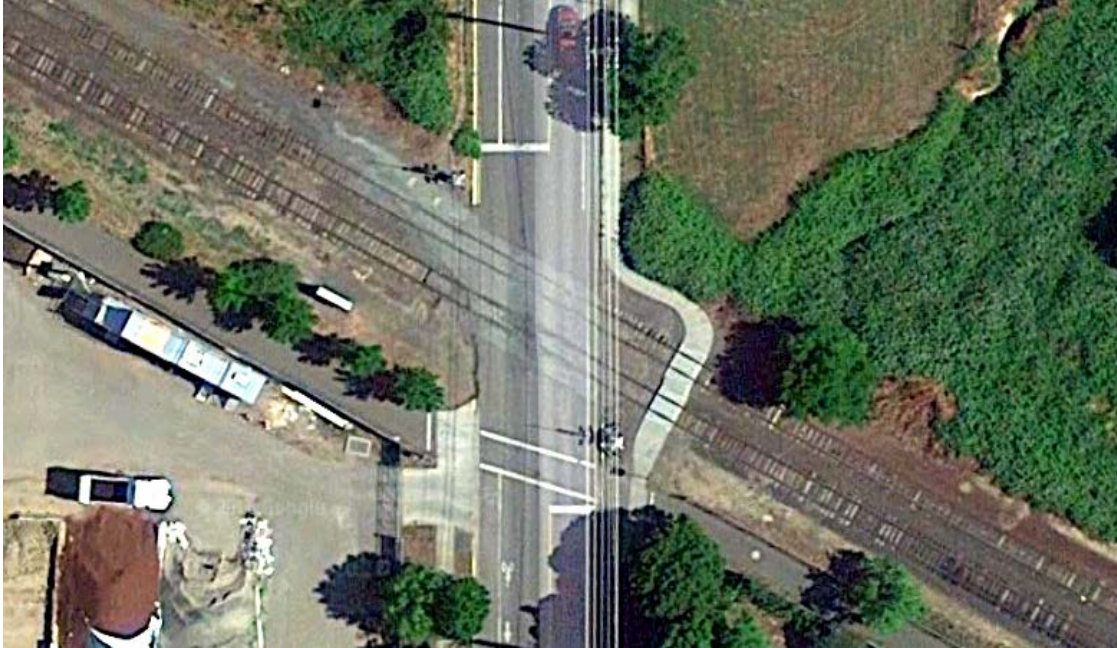
**Figure 3.45: Satellite photo of the Mountain Ave crossing in Ashland, OR (Google, 2016)
(Trail is marked in orange)**

The road is a two-lane road leading into the city of Ashland and is marked as a 25-mph zone. The AADT is around 5000. During the observations, a count of 82 cars per 15 minutes or 330 cars per hour was made.

The crossing and adjacent street is lighted with two street lamps, and there have been no recorded incidents at this crossing. Nearby facilities include a church and industrial facilities.

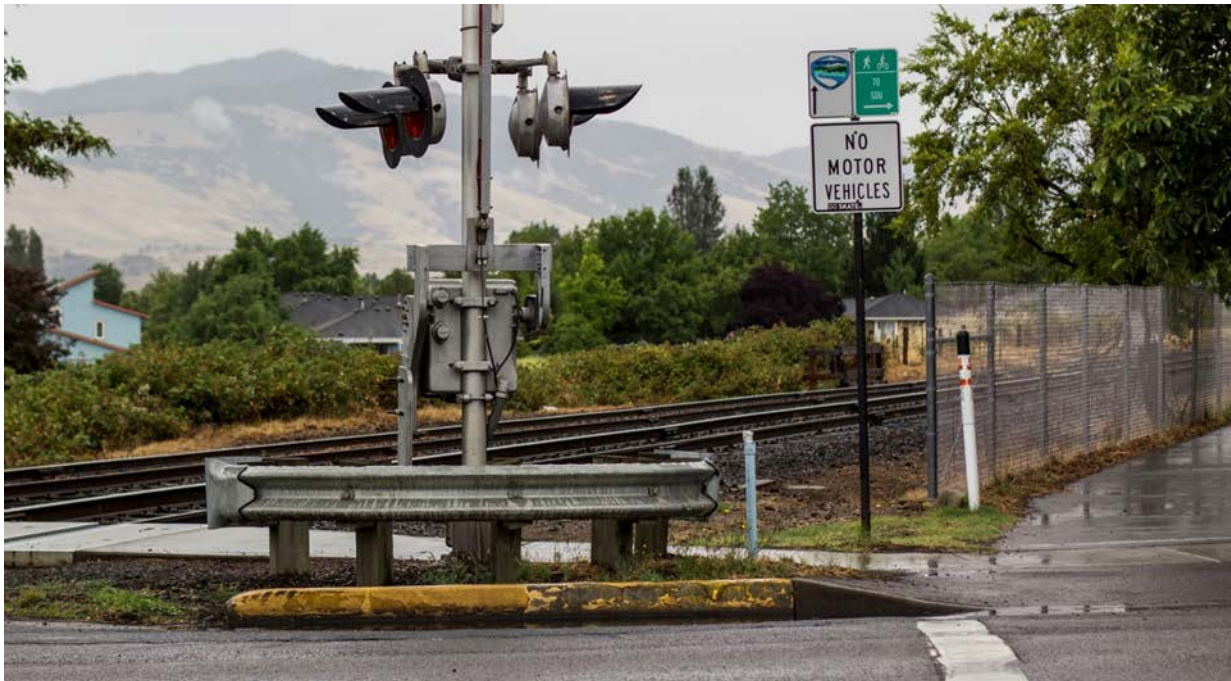
The treatment at this site are primarily active and included active lights and active gates, along with bells. The site was also equipped with cross bucks. Stop lines were used to indicate where bikes and cars should stop for trail users and trains.

Figure 3.46: The active treatments and the trailhead at the N Mountain Ave crossing

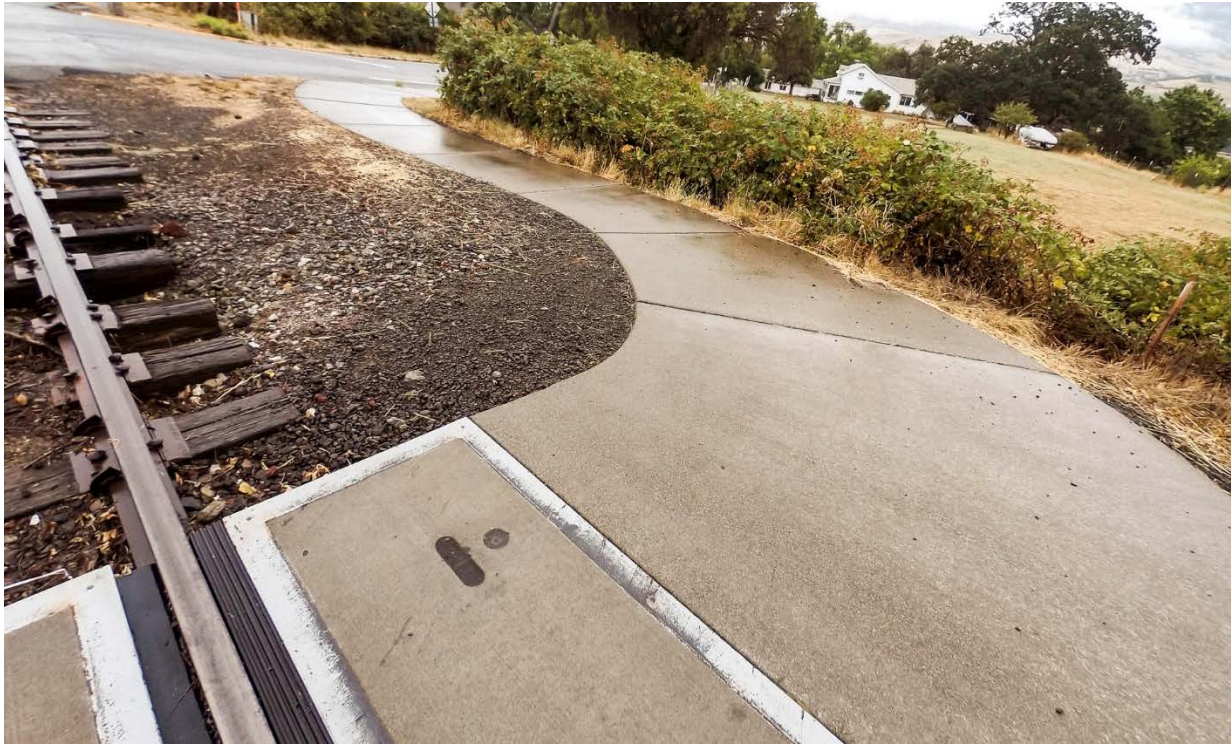
Figure 3.47: Curving the foot path enables pedestrians and bikes to cross at a 90° angle, to meet ADA access and encourages pedestrians to look to the sides before crossing

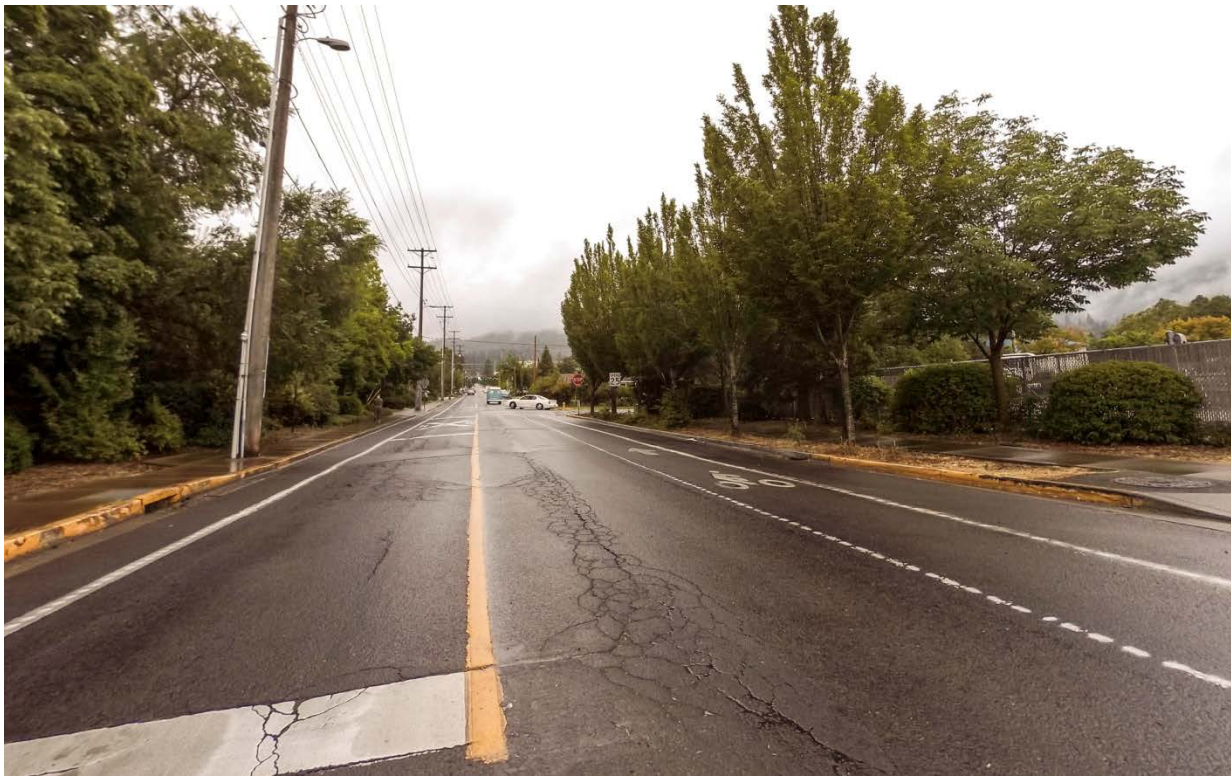
Figure 3.48: Bike facilities at the N Mountain Ave crossing

In this location, separate bike lanes are found on both sides of the street. They were however not commonly used by bikes, and many cars etc. were seen driving in them or even parking. As paint is the only thing used to separate, it is not always clear what is bike facilities and what is parking or something else.
